Cultural Heritage Conservation Plan & Commemoration Strategy

628 New Dundee Road, Kitchener ON

Date: November 2023

Prepared for: Fusion Homes

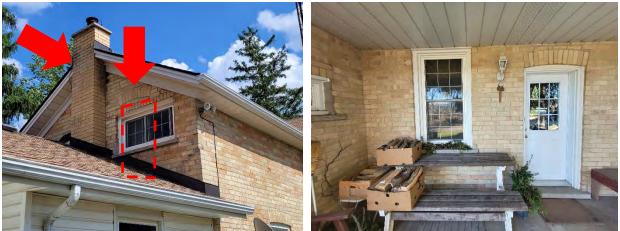
Figures 9 & 10: (left) View of north elevation (note exterior chimney and altered window opening). Approximate location of original window opening outlined with red dashed line. (right) Detail view of east elevation (ground floor), (Source: MHBC, 2022; MHBC, 2023)

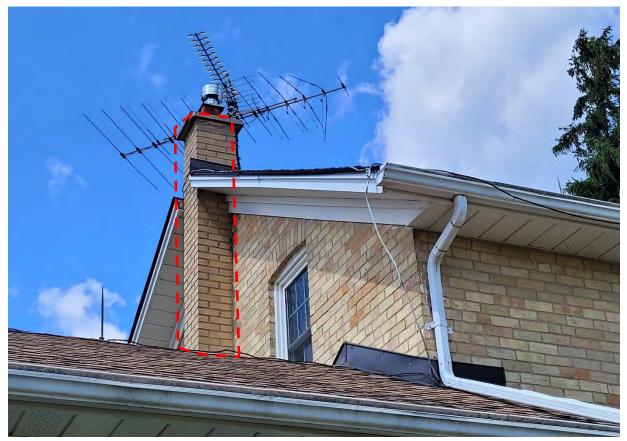
Figure 24: Detail view of existing chimney at south elevation, demonstrating different (contemporary) bricks and is not original to the structure (Source: MHBC, 2023)

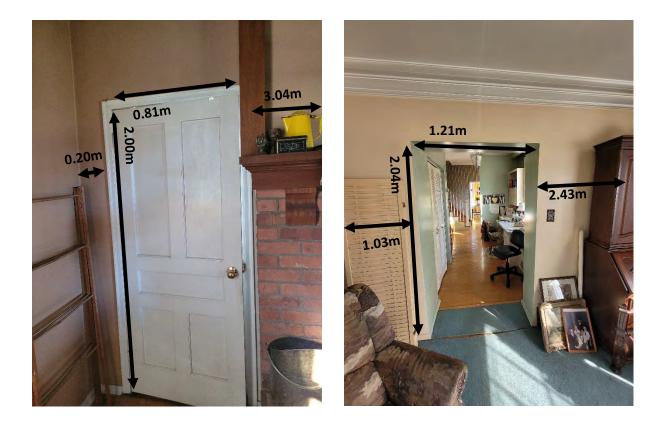
The removal of Sections "C", "D", "E", and "F" will expose the following door openings of the buildings (See Figures 26 – 28). These openings will require remediation. These door openings will be a) boarded-up shortly after the openings are exposed, b) remain boarded-up during re-location, and c) will be remediated when plans for alterations are formulated as part of Phase II.

Figures 26 & 27: (left) View of door opening at the south elevation (Door "A"), looking south, (right) View of door opening at the west elevation (Door "B"), looking east, (Source: MHBC, 2023)

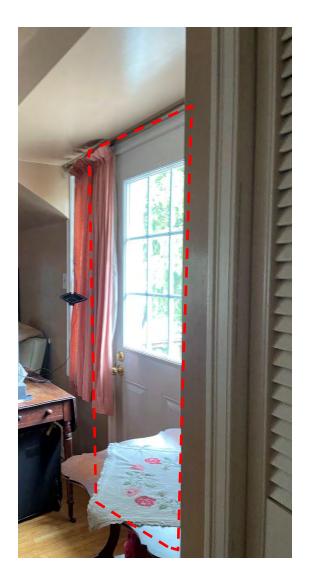
Figures 28: View of door opening to be exposed following the removal of Section "F", at the east elevation of Section "B" (Source: MHBC, 2023)

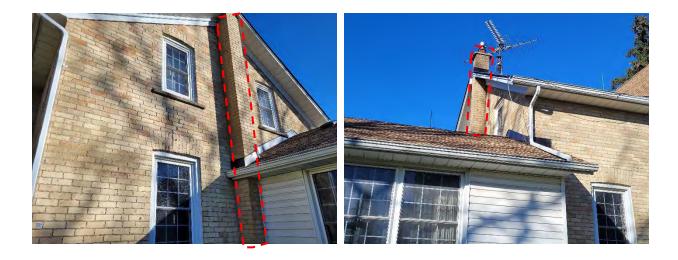
The chimneys proposed for removal are located at the west elevation of Section "A", and the north elevation of Section "B" (See Figures 29 & 30).

Figures 29 & 30: (left) View of west elevation of Section "A" noting 20<sup>th</sup> century chimney proposed for removal, (right) View of north elevation of Section "B" noting 20<sup>th</sup> century chimney proposed for removal, (Source: MHBC, 2023)

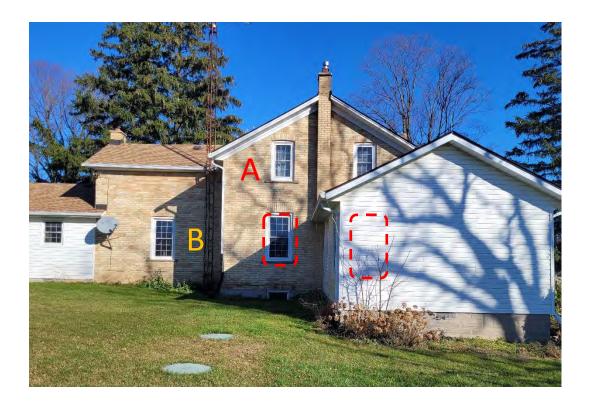
Figure 31: View of west elevation, looking north, noting location of door opening at the interior of the building (west wall of Section "A"). (Source: MHBC, 2023)

The removal of Section "E" will expose a door opening at the west elevation of Section "A" (See Figure 31). This opening will be boarded-up and protected until Phase II of the work is initiated.

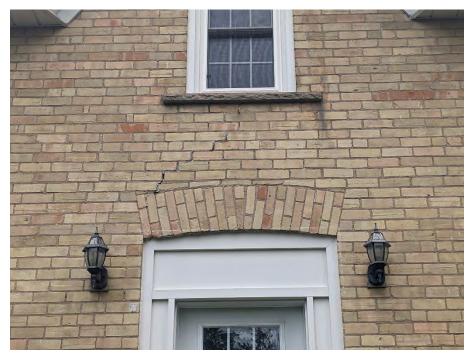
Photograph 1 – Step Cracks Over Door Opening

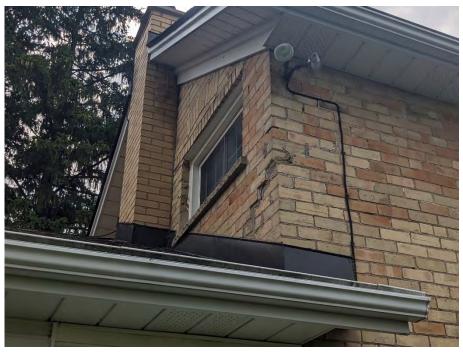
Photograph 2 – Damaged Corner Repaired with Cement

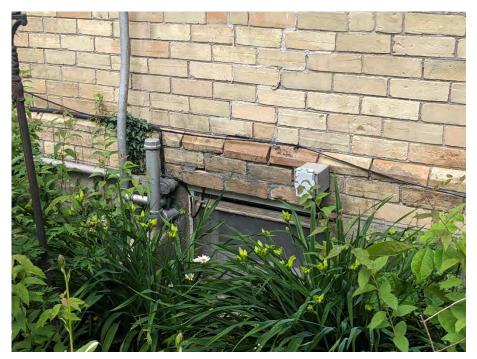
Photograph 3 – Joint Cracking and Sealant Repairs
