BUILDING CONDITION ASSESSMENT

Kitchener Housing

25 JOSEPH ST., Kitchener, ON N2G 4X6

November 22, 2022

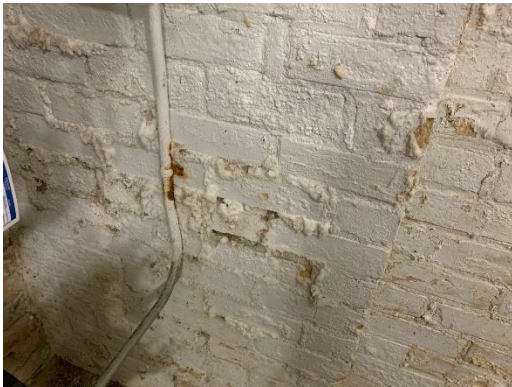
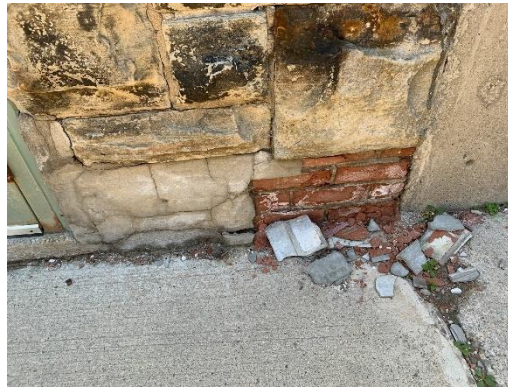
Action Cost:	\$10,000	Action Year:	2024
Expected Useful Life:	100	Repeat Cycle:	5
Average CoF:	4	Average PoF	3

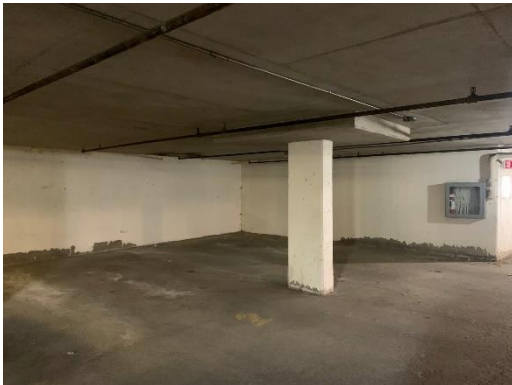
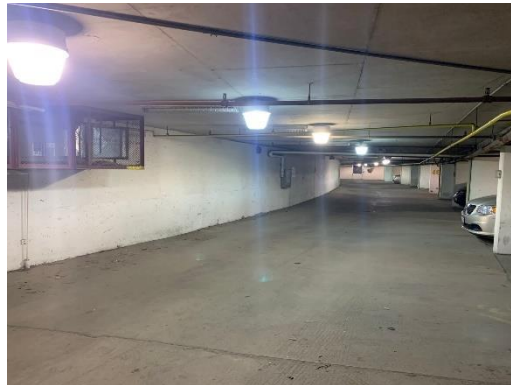
Action Cost:	\$30,000	Action Year:	2024
Expected Useful Life:	20	Repeat Cycle:	20
Average CoF:	4	Average PoF	3

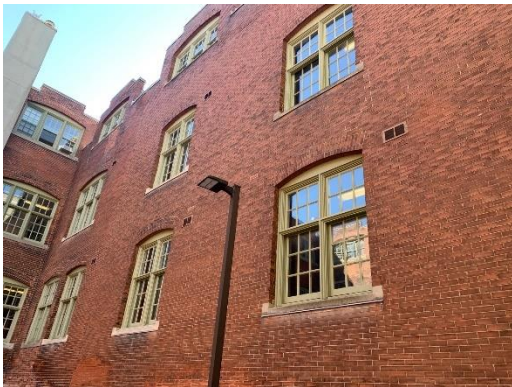
Action Cost:	\$340,000	Action Year:	2023
Expected Useful Life:	30	Repeat Cycle:	30
Average CoF:	2	Average PoF:	4

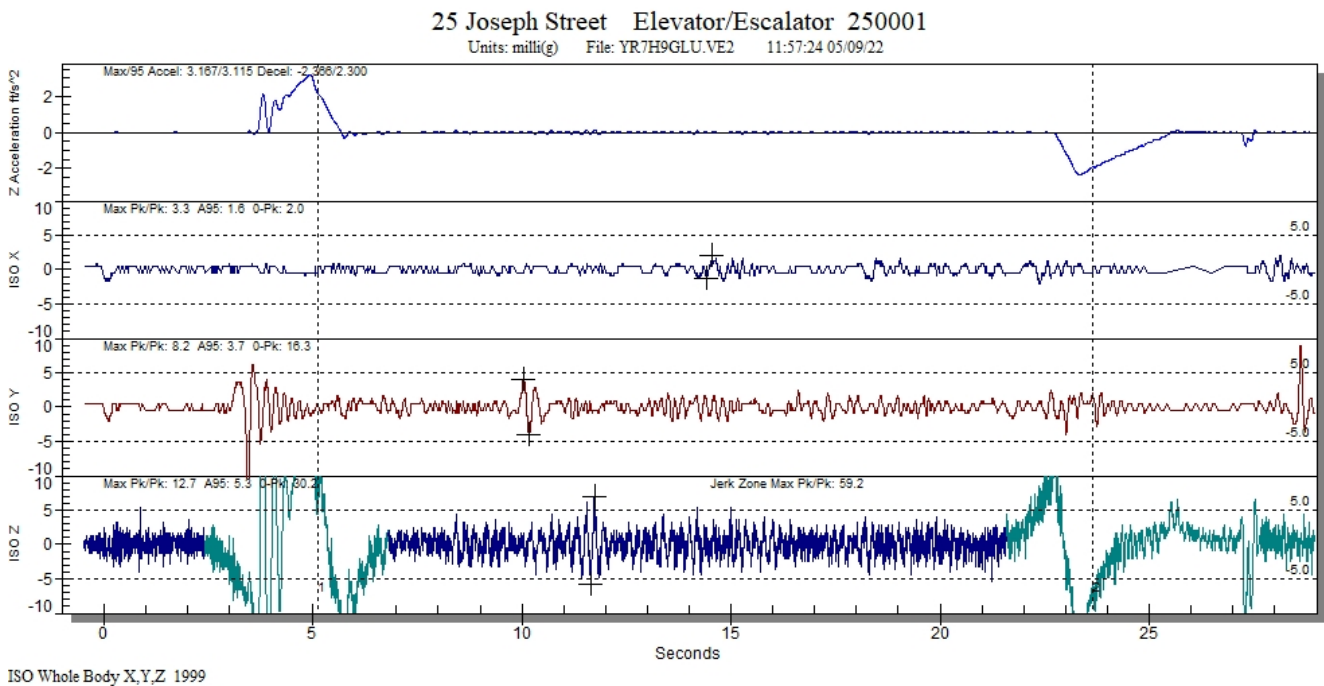
Passenger - 1

The ride quality appears to be good in all axes. No further action is required by the contractor other than monitoring.

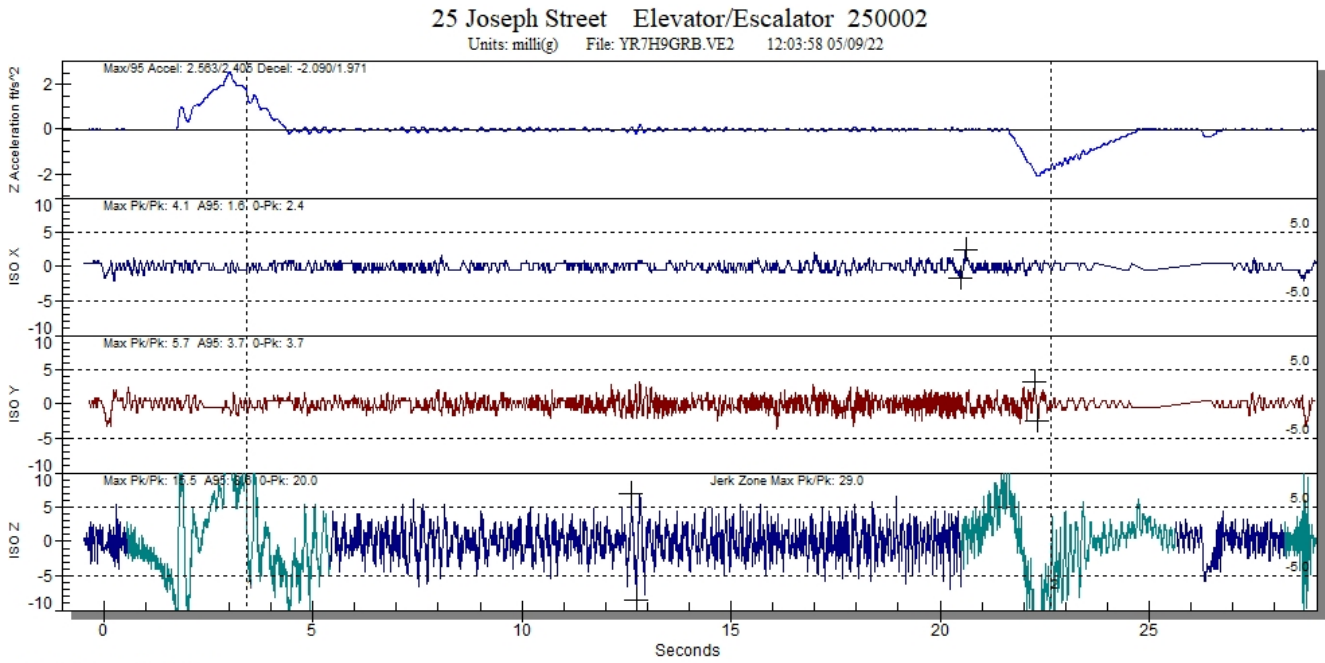
Passenger - 2

The ride quality appears to be poor in the Z-axis. The readings are greater than the suggested value and should be improved. The contractor should review the ride quality in the Z-axis and make the necessary adjustment or repairs to rollers, rails, stabilizers, etc. as required.
