Documentation, Salvage & Commemoration Report (revised)

1027 King Street East,
Kitchener ON.

Date:
January, 2024
(original submission October 2023;
updated December 2023; and
January 2024)

Prepared for:
VIVE Development

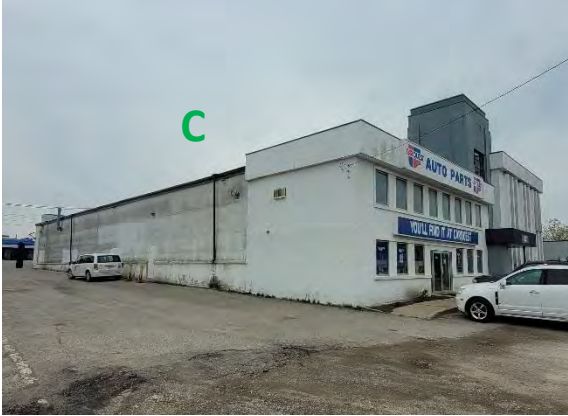
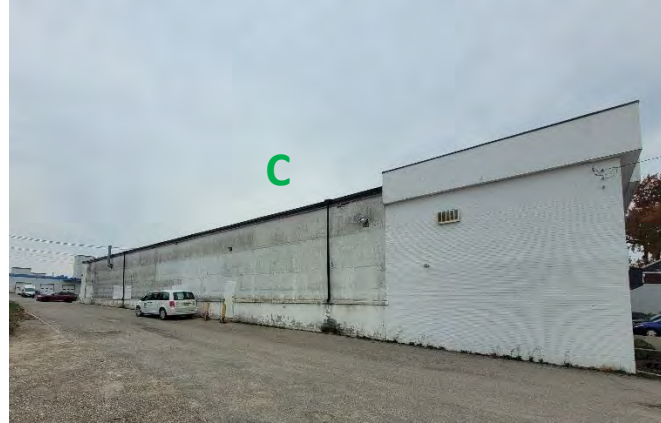
The east elevation has been significantly altered, where all original industrial-style building windows have been stuccoed or parged over.

Figures 8 & 9: (left) View of building looking south-west from King Street East, (right) **Secondary view of east elevation of Section "C", looking west from parking lot adjacent to King Street East** (Source: MHBC, 2023)

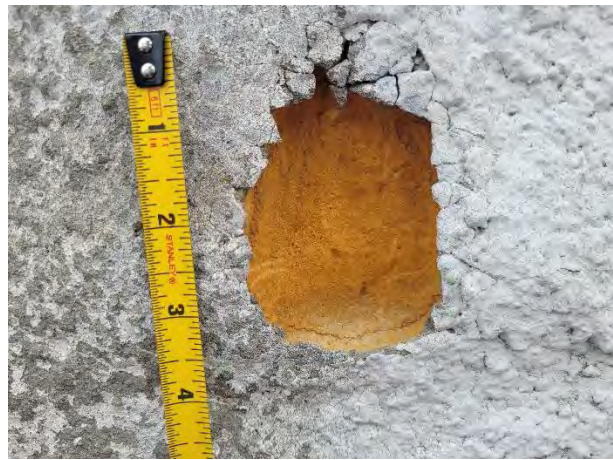
The east elevation has been covered with spray foam insulation and stucco. As a result, the windows underneath these materials have been damaged and are no longer salvageable (See Figure 11).

Figures 10 & 11: (left) View of east elevation, looking north-west from Charles Street East, (right) **Detail view of east elevation (Section "C") and spray foam and stucco over industrial windows**, (Source: MHBC, 2023)

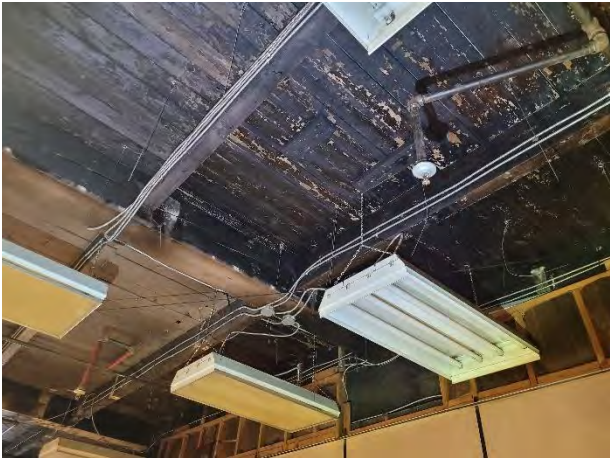
The main floor of **Section 'A'** is not at ground level. Instead, it is elevated above the ground level above the basement. The second floor of **Section 'A'** has been altered to include partitioned walls to function as office space. The building has been carpeted and re-finished with 20th century materials. It is important to note that the ceiling provides evidence of considerable fire damage, where the ceiling in several places has been scorched black.

Figures 18 & 19: (left) View of open area, looking south-west, (right) Detail view of ceiling noting fire damage, (Source: MHBC, 2023)

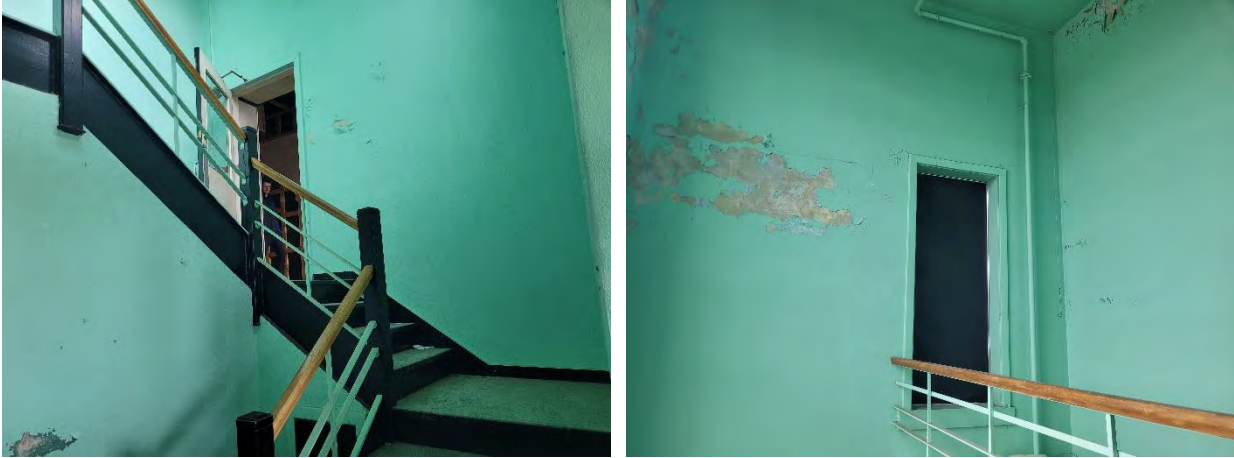
This portion of Section 'B' facilitates as a staircase only and provides access to the roof. This portion of the building provides evidence of water damage, including peeling paint, mold and rot.

Figures 24 & 25: (left) View of staircase and entrance to the main floor of Section "C", (right) View of roof entrance from Section "B", looking south-east, (Source: MHBC, 2023)

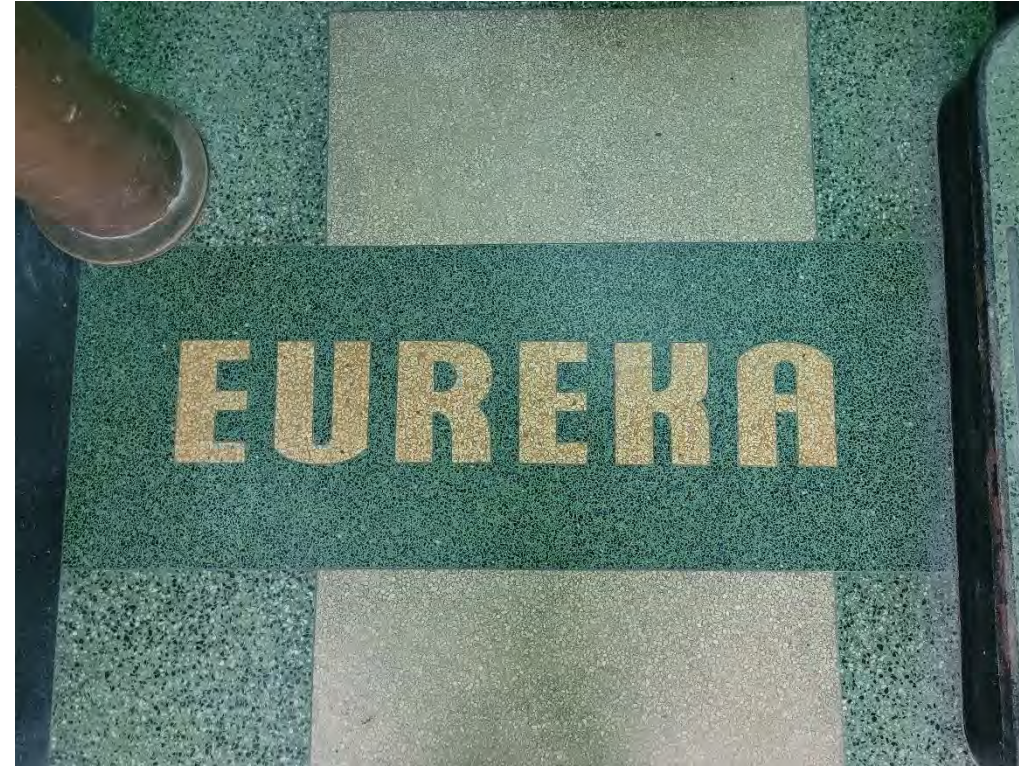
Photos 1 & 2: (left) View of lobby area, ground floor Section "B", looking north, (right) Detail of "EUREKA" terrazzo floor tile, ground floor, (Source: MHBC, 2023)

- **“Eureka” Terazzo Tile (Section B, ground floor);**
- Exterior column (Section B, exterior north elevation);
- Door/window/frame and cornices (Section B, exterior north elevation); and
- Exterior cladding (Section B, exterior front elevation).

These items are recommended for salvage and re-use on-site as part of an interior display as per the description and rendering provided in this report.
