HERITAGE IMPACT ASSESSMENT

2091 Bleams Road, Kitchener

RE: Barn and Farmhouse – Structural Condition Assessment 2091 Bleams Road, Kitchener, Ontario

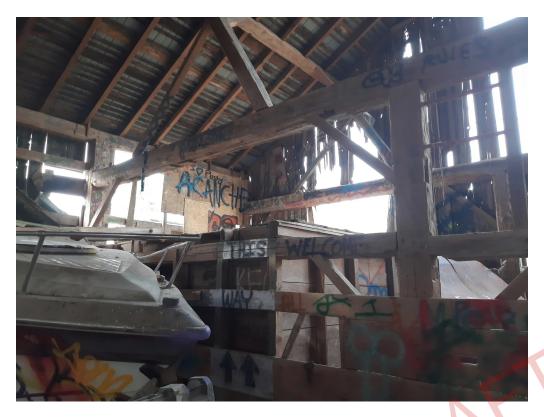
Photograph No. 1 – Missing Wall Cladding, Interior Framing Exposure to Elements

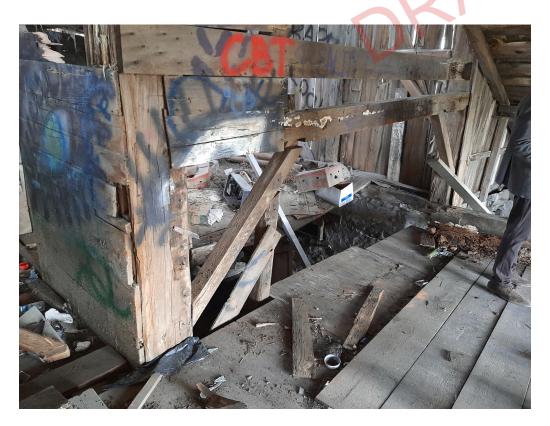
Photograph No. 2 – Compromised Brace Connection, Unsafe Open Floor

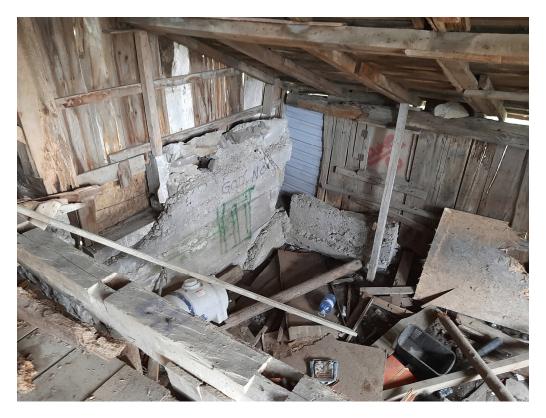
The concrete foundation wall shown in Photographs 3, 4 and 5 is badly deteriorated, cracked, poorly connected at corners, and lacks lateral bracing at the top.

Photograph No. 3 – Unguarded Edge of Floor, Deteriorated Concrete Foundation Wall

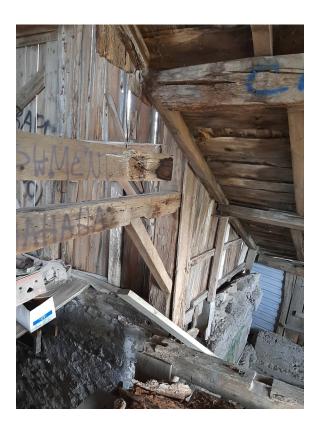
The structural condition of the barn varies throughout with some deficiencies that are of a significant nature. The structural frame of the barn, comprised of posts and beams with knee braces, is generally plumb and level in most of the front section adjacent to Bleams Road (Photograph 1). However, there are several members of the frame elsewhere that are missing or have compromised connections (see Photographs 2 & 3). The knee brace in Photograph 2 for example is poorly connected to the beam and the roof support post is altogether missing in Photograph 4. The roof is relying presently on support from the exterior cladding.

Photograph No. 4 – Post Missing, Unsupported Roof Beam

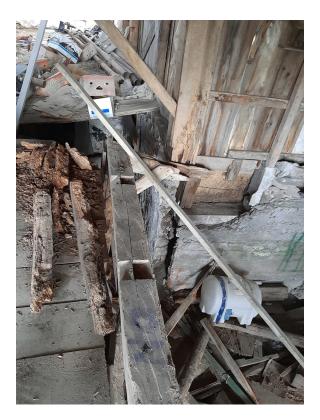
Photograph No. 5 – Unsafe Condition, Compromised and Deficient Bracing and Connection of Wall and Floor Framing

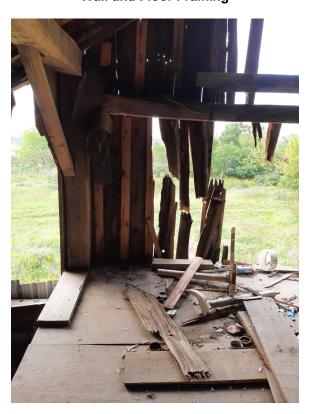
Exterior barn boards are cracked or missing in many areas and present a risk of people falling out (~8' drop) to grade below (Photographs 6 and 10).

Photograph No. 6 - Unguarded Area, Missing and Deteriorated Wall Boards

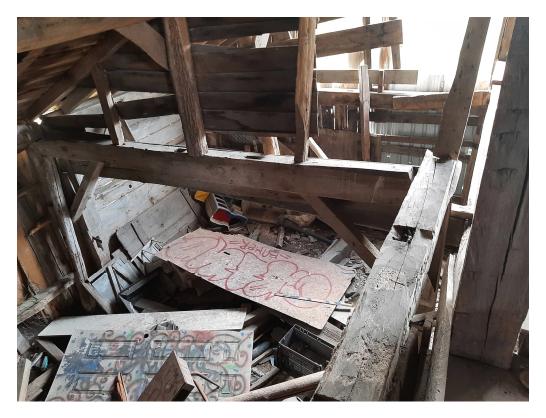
The barn framing shown in Photograph 7 shows worn, deteriorated wood conditions with several open or loose connections. Exterior cladding is missing or damaged; also shown in Photograph 10.

Photograph No. 7 – Deteriorated Framing and Connections

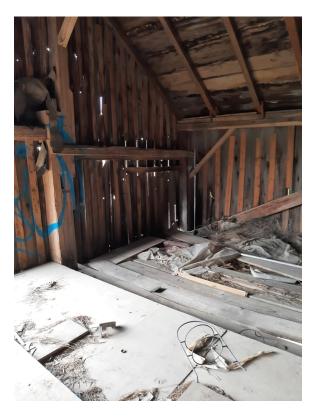
Photograph No. 8 – Unsafe and Unsecured Flooring

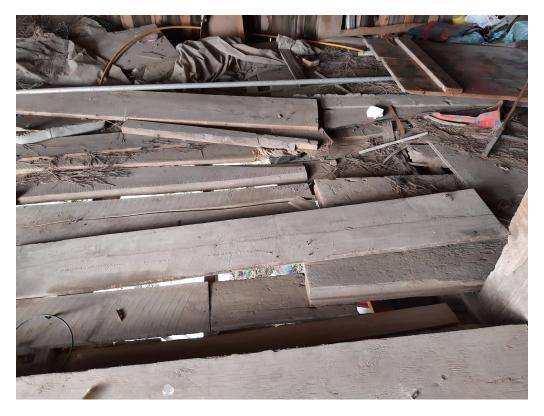
Photograph No. 9 – Unsafe Floor; Unsecured Flooring

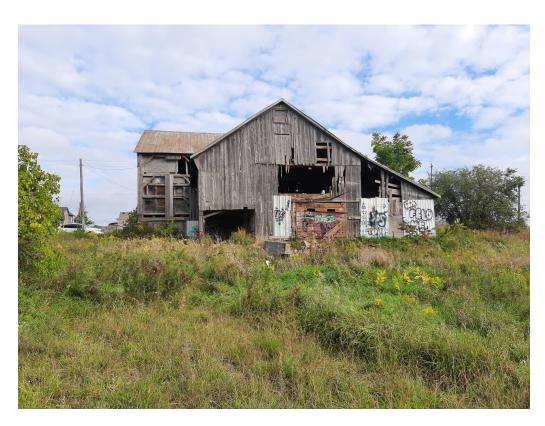
Photograph No. 10 – South Elevation Wall Boards Missing

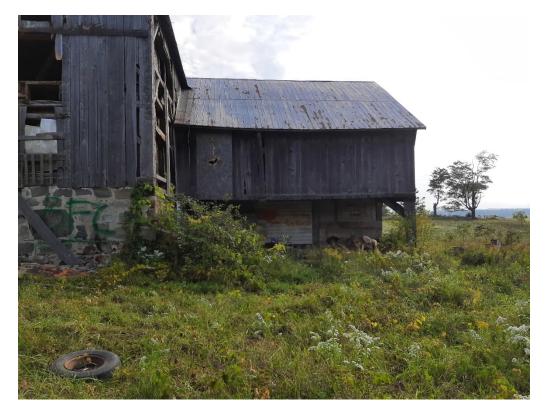
Photograph No. 11 – West Elevation; Building Sagging from Insufficient Support

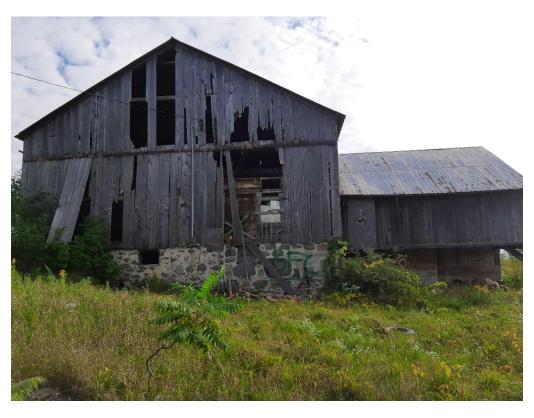
Exterior wall cladding is missing to varying degrees throughout the barn, leading to rain and snow infiltration accelerating the deterioration of interior structural elements (Photograph 12). Many of these areas provide easy access points for trespassers. The stone foundation wall pictured in Photograph 12 is generally true and plumb but has several cracks and stones missing (Photograph 13).

Photograph No. 12 – West Elevation; Wall Boards Missing

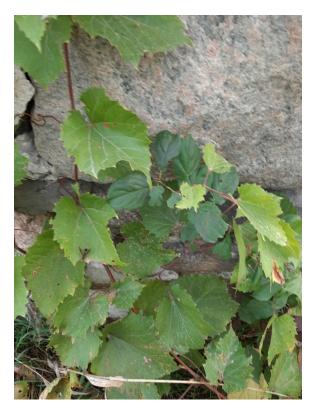
Photograph No. 13 – Stone Foundation Wall Deterioration

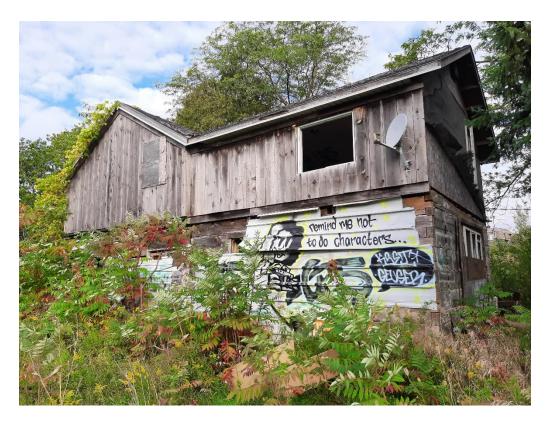
The farmhouse structure is generally in fair to poor condition with walls and floors typically plumb and level, respectively (Photograph 14). The exterior cladding and log structure is exposed, weathered and has some instances of wood rot (Photograph 15). The bottom log of the wall shown in Photographs 17 and 18 is completely rotted through the center.

Debris and loose materials are scattered throughout and around the exterior. Windows and doors are missing allowing snow and rain to enter the interior. Vines growing on the roof will contribute to moisture infiltration and damage to roofing (Photograph 14).

Photograph No. 14 - Overall Photo Of House

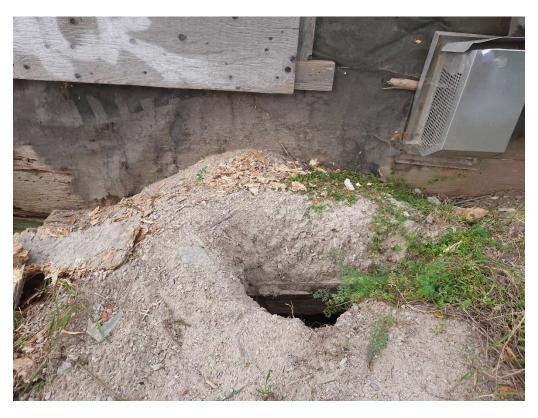
Photograph No. 15 – Soil Pile Causing Rot of Wood Framing

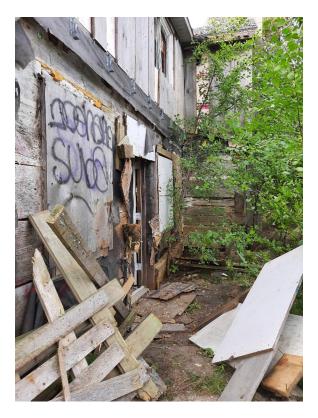
Photograph No. 16 – Unprotected Exposed Wall – Deterioration

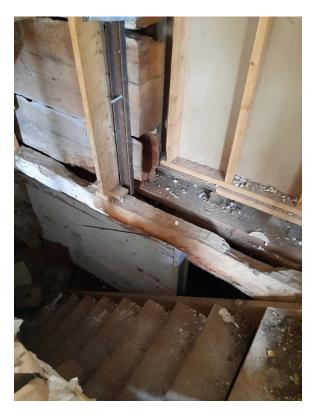
Photograph No. 17 - Stair to Basement - Rot of Bottom Wall Log

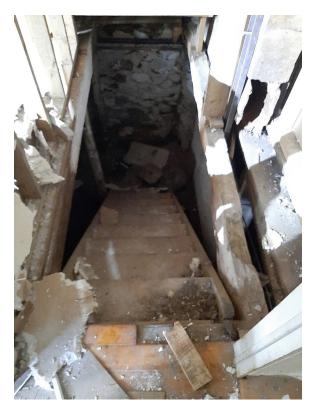
Photograph No. 18 – Stair to Basement; rot of log (right)

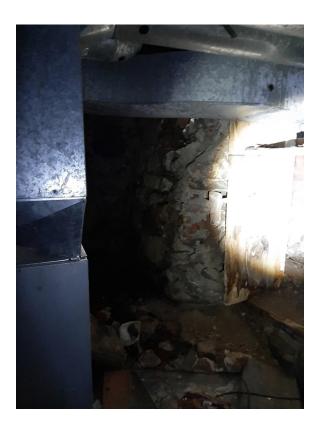
The stone foundation wall supports the exterior perimeter walls as well as the single interior wall. Mortar deterioration was observed on the interior around the stone (Photograph 19). The stone foundation wall has several window wells as well as a full height door opening (boarded up). These openings are not completely sealed and permit water infiltration and rodents into the building.

Photograph No. 19 – Basement Foundation Wall Mortar Deterioration

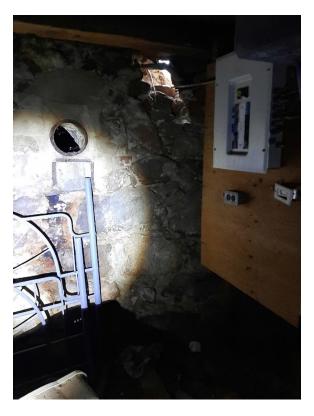
Photograph No. 20 – Foundation Wall Deterioration Open Window Well

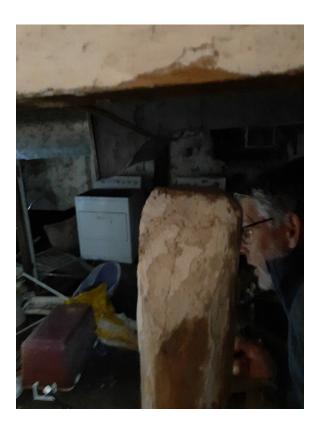
The support post at the bottom of the stair to the basement is loose without connection to the floor beam (Photograph 21).

Photograph No. 21 – Loose Disconnected Support Post

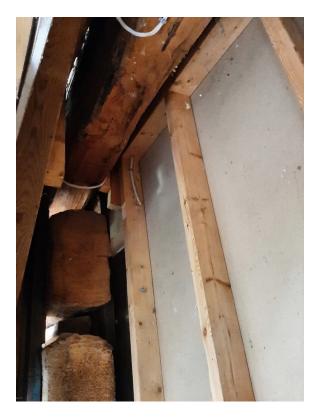
Photograph No. 22 – Upper Story Wall End Logs Unbraced (No Framing)

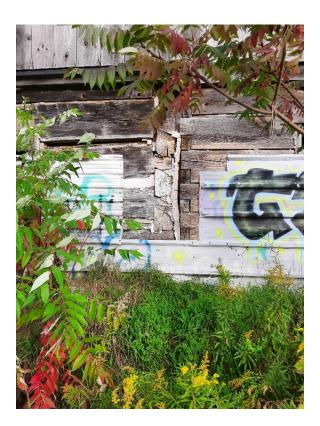
Photograph No. 23 – Wall Joinery Indicates Staged Construction
