Heritage Conservation Plan CITY OF KITCHENER // 10 DUKE STREET WEST

REVISION 1: JANUARY 2024
APRIL 25, 2022

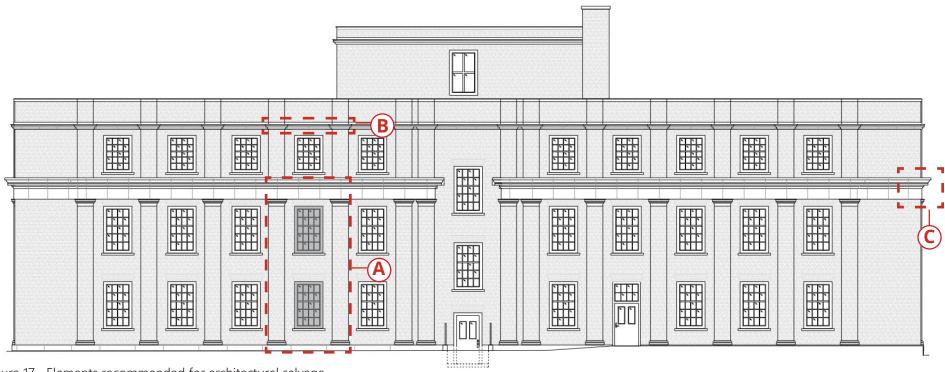
Per building condition assessment conducted on September 6, 2023, the annotated attributes of the north elevation were found to be in a good condition for salvage as there was no significant weathering, masonry cracks or signs of water damage.

Figure 17. Elements recommended for architectural salvage

- Facade portion (Attributes) recommended for salvage
- Existing windows not recommended for salvage

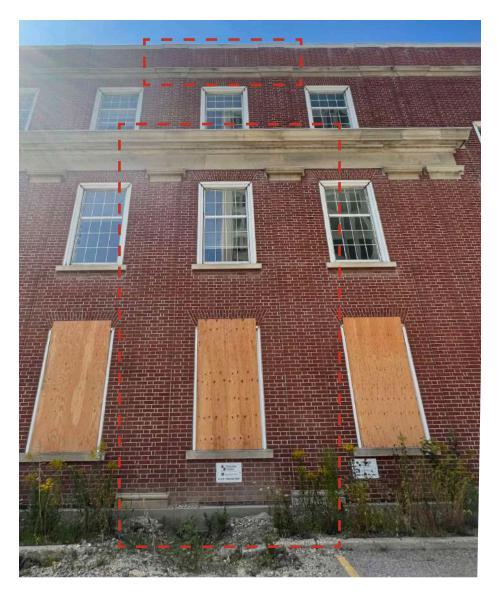
Elements from a typical bay (A) (B) and (C) as shown above are recommended to be salvaged in its entirety as it would preserve the following attributes:

- · Red Flemish brick (quantity as shown in the red boxed zone in image above;
- Brick voussoirs (above two windows at first and second level);
- Two stone sills (windows at first and second level);
- Part of the stone band between 2nd and 3rd floors;
- Part of the stone band below the parapet;
- Pilasters capitals and base (2 each); and,
- Corner cornice piece (1).

Figure 18. Close up of the typical bay at north elevation recommended to be salvaged. Existing window systems are not recommended to be salvaged. (mCs September 2023)

- Bricks and stone are recommended to be dismantled individually using a chipping hammer as this would avoid breaking the bricks/stone.
- Dismantling can be done by drilling holes to the mortar joint surrounding the brick.
- A flat pointed bar or mason's chisel is recommended during demolition to try and shear the mortar from the brick, to take advantage of the lesser strength in tension, rather than trying to lower the strength in compression.

- The demolished bricks/stones are recommended to be piled up on pallets and secured with a strong plastic wrap or straps to keep the latter from falling.
- The pallets are recommended to be moved using a forklift and transport to the storage location.

- The salvaged items are recommended to be stored in a sheltered place, protected from water and temperature fluctuations.

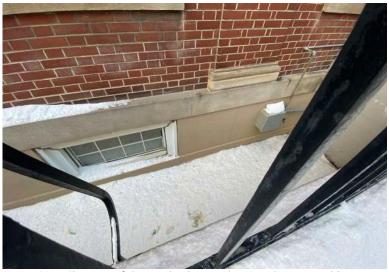
Figure 21. Close up of the grade change showing the exposed limestone and retaining wall. (mCs, 2022)

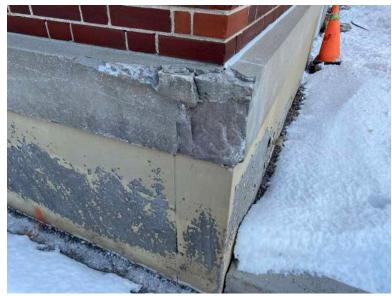
Figure 22. Vehicle impact damage at the southwest corner of the building. (mCs, 2022)

Previously completed repairs with incompatible materials or repairs that do not match the existing character of the façade or building shall be removed and replaced with salvaged materials and repaired in accordance with these standards to the satisfaction of the heritage consultant. This includes the vehicle impact noted on the south-west corner of the Duke Street elevation (see Figure 22). Existing brick masonry repairs are of an incompatible colour and shall be replaced with salvaged materials. The limestone banding and foundation veneer shall also be replaced with typical salvaged materials.

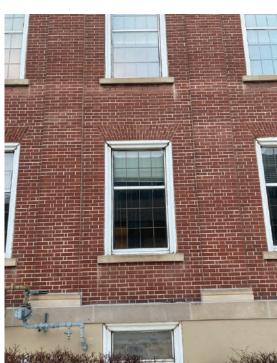
Figure 13. South bay 4 with damage and staining.

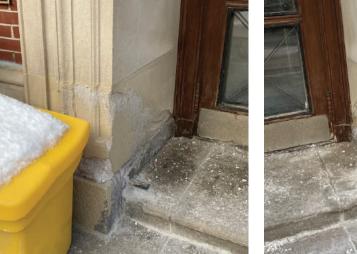
Figure 4. Damaged & painted stone at front entry-left.

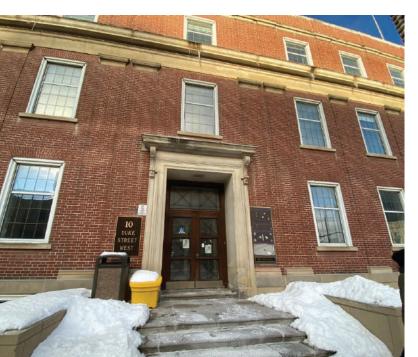
Figure 14. Overall front entry on Duke St, stone detailing, travertine steps & threshold.

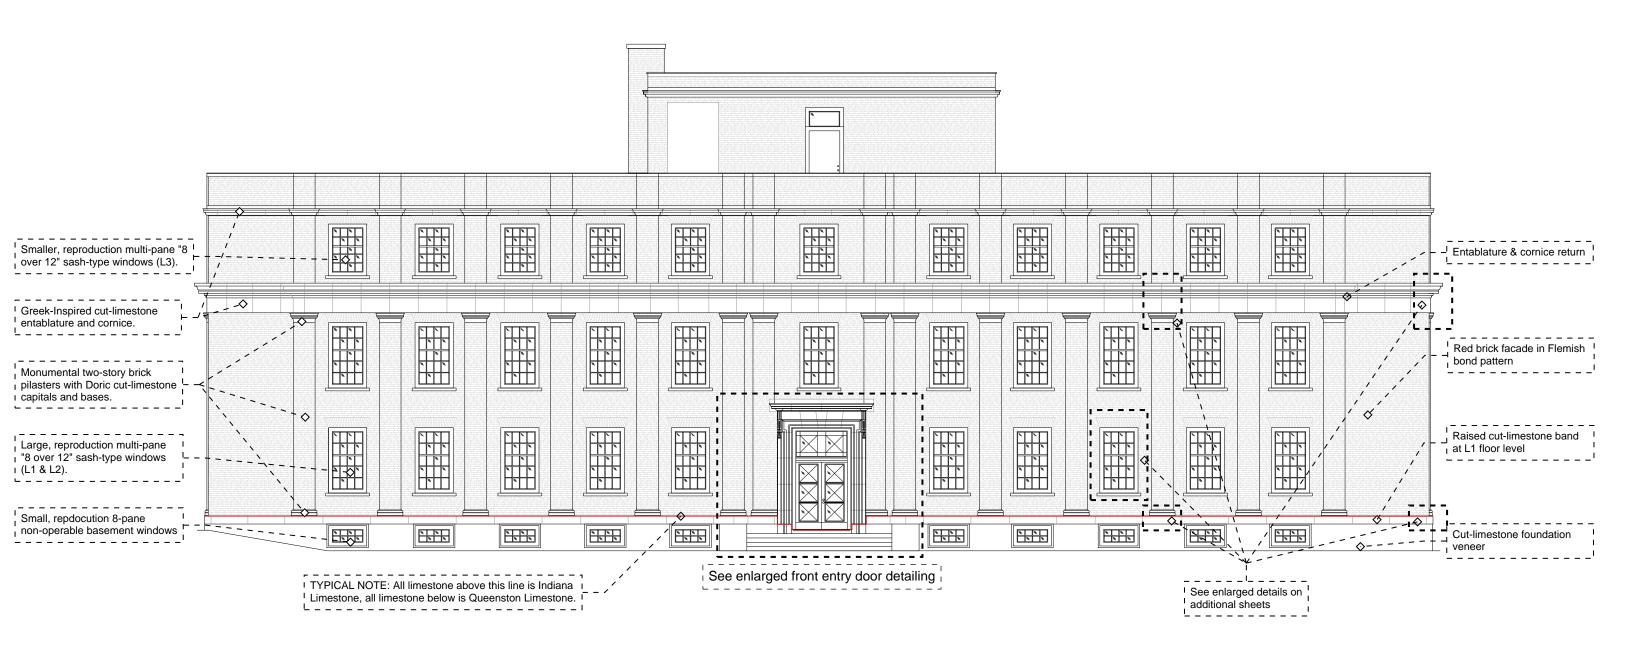
Project: 22003
Drawn By: P.R.
Date: 2022-03-08
Drawing No.: HA-2

10 Duke Street West, Kitchener, ON. South Facade (Duke Street) Heritage Attributes & existing condition

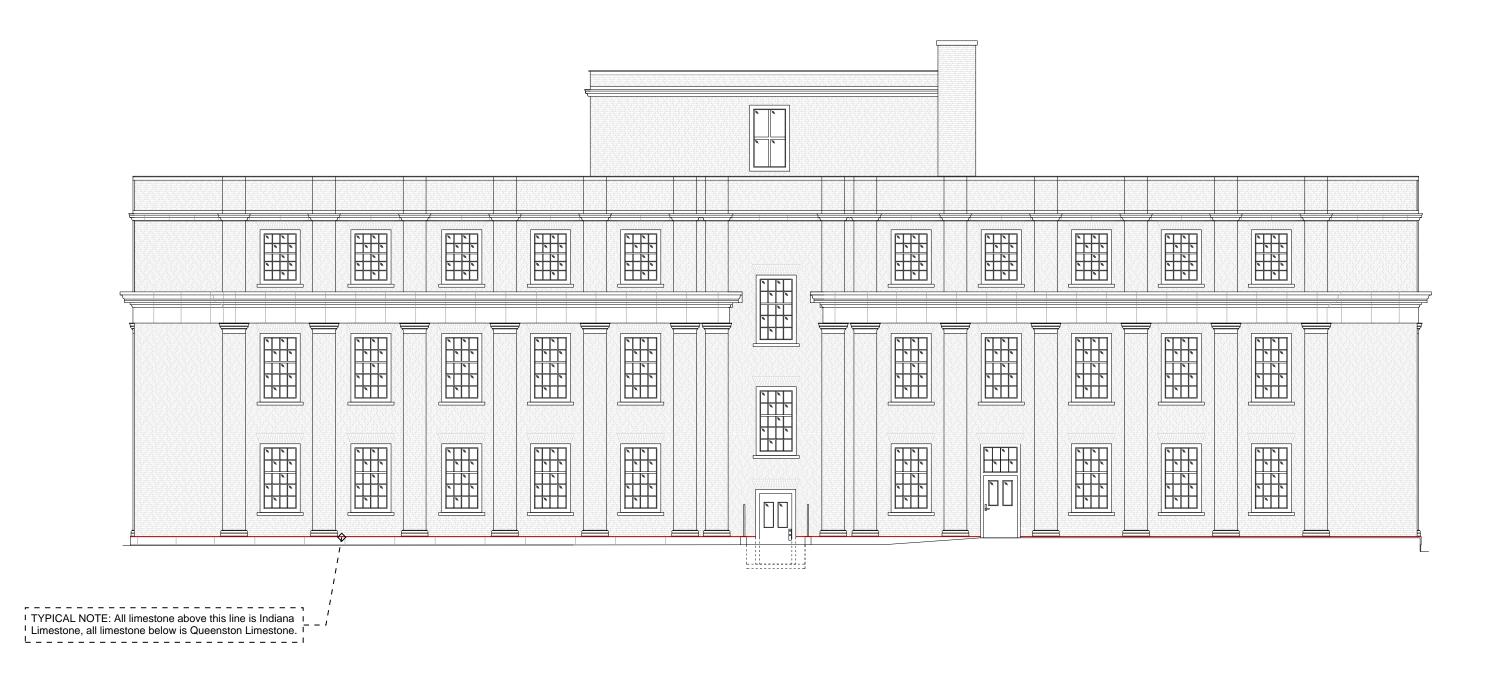
2022-03-08 Drawing No.: HA-4

North (Rear) Facade, to be fully removed.

10 Duke Street West, Kitchener, ON - North Facade Heritage Attributes & existing condition
