REPORT REGARDING STRUCTURAL ASSESSMENT OF FIRE DAMAGED BUILDING

AT
36 LANCASTER STREET EAST
KITCHENER, ONTARIO

**Re: Structural Assessment of Fire Damaged Building
36 Lancaster Street East, Kitchener, Ontario
Insured: [REDACTED]
Client Claim Ref.: [REDACTED]
Date of Claim: August 4, 2023**

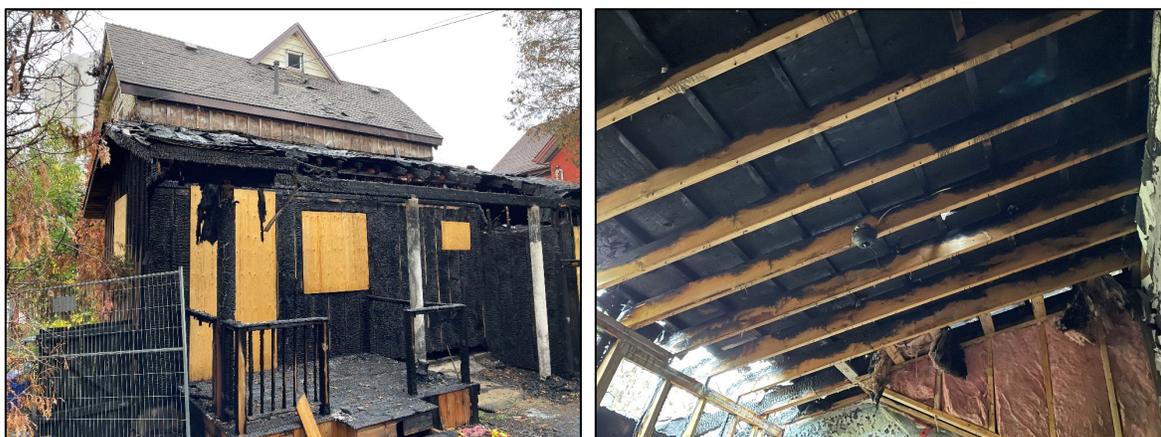
The fire resulted in significant charring to almost all of the roof rafters forming the roof above the rear addition. This includes the roof extension above the rear deck and supporting beam which was mostly consumed by the fire.

Based on the information available, it is our opinion that the recent fire resulted in significant structural damage to the majority of the rear addition roof and rear exterior wall to the extent that the complete replacement of this roof section and rear exterior wall is warranted. The fire also damaged the rear exterior deck to the extent that its complete replacement is warranted. Localized fire damage was noted to the rear end of the first-floor joists for the rear addition to the extent that the augmentation or replacement of at least some of these joists is warranted, the full extent of which is subject to further review. Localized fire damage was also noted to the interior stud wall supporting the roof of the addition along the rear wall of the original building to the extent that the partial replacement of this wall is also warranted, again the extent of which is subject to further review.

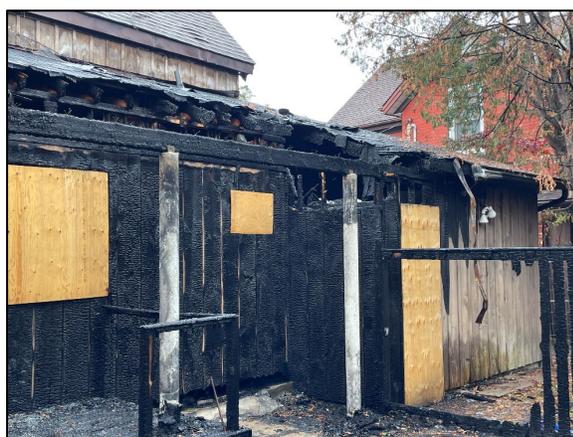
The roof framing above the garage addition was concealed at the time of our review; however, it appears that this roof framing was likely also at least locally damaged by the fire.

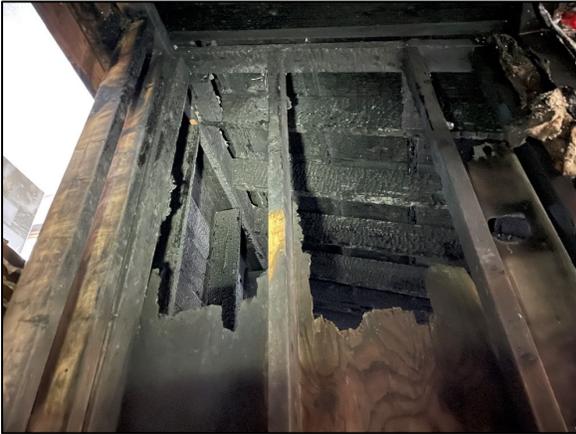
Fire damage to the roof extended up and damaged the top of the interior loadbearing wall where the roof of the rear addition meets the original building above the laundry room. This wall appears to have been constructed on the exterior side of the original brick masonry and is assumed to provide loadbearing support for the roof of the addition. It is subject to confirmation following the removal of interior finishes if the adjacent wall of the original building was also damaged.

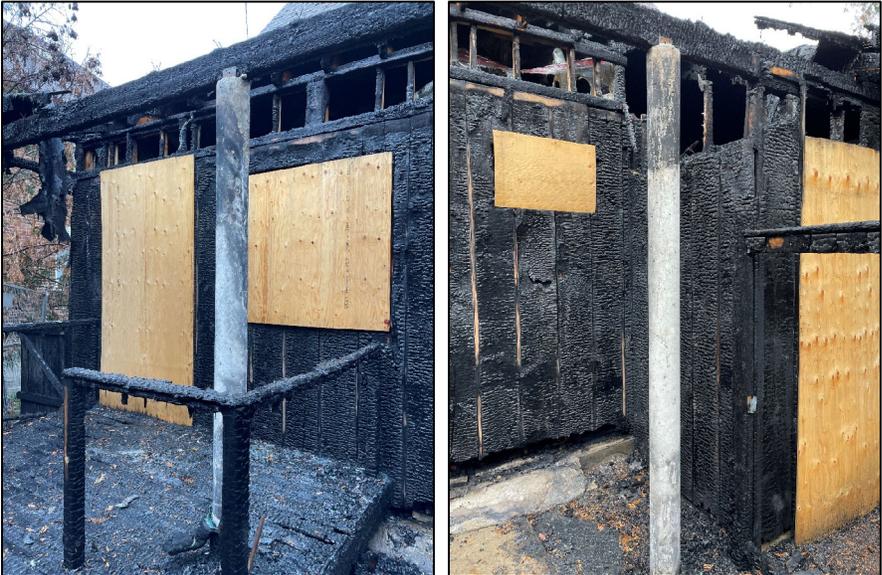
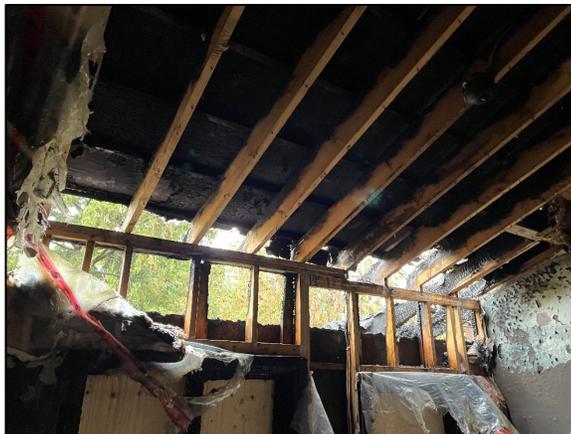
The fire also damaged the majority of the rear exterior wall of the first-floor bedroom and bathroom within the addition. The full extent of damage to the wall is subject to confirmation; however, it appears that the exterior edge at the top of the wall studs were damaged along the majority of the rear wall.

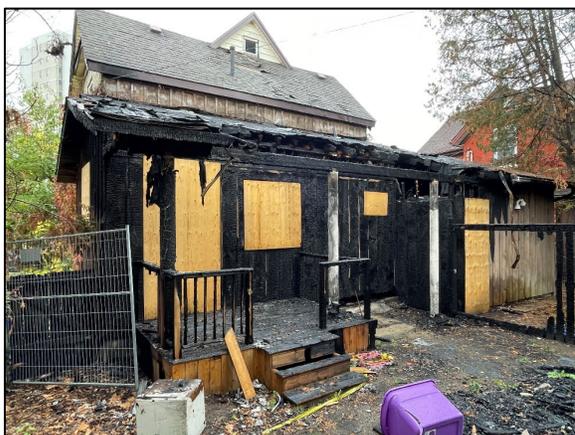
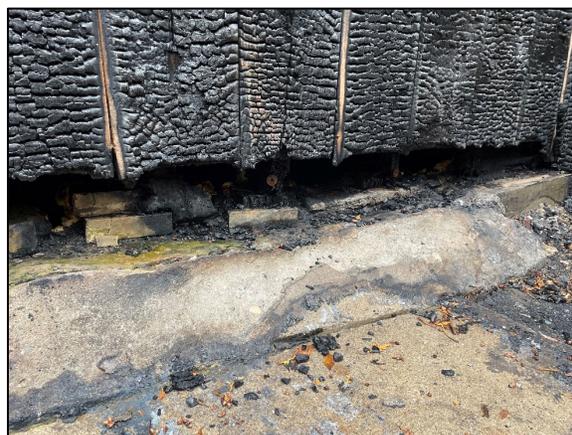
The fire damaged the rear exterior deck as well as the rear ends of the first-floor joists of the addition. Where checked, the floor does not appear to have included a rim joist along the rear exterior wall, allowing the fire to enter the crawl space. The full extent of damage to the currently concealed floor joists is subject to confirmation and will likely require the removal of the floor sheathing.

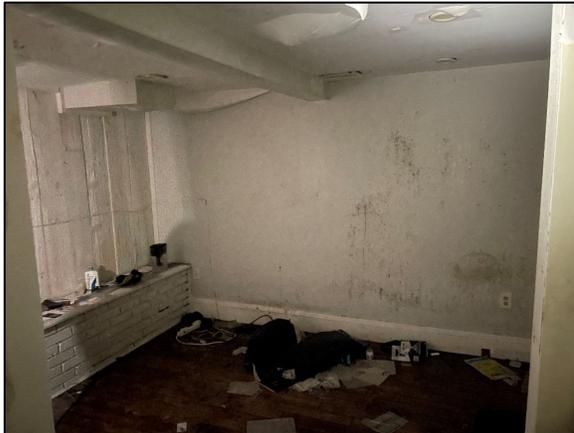
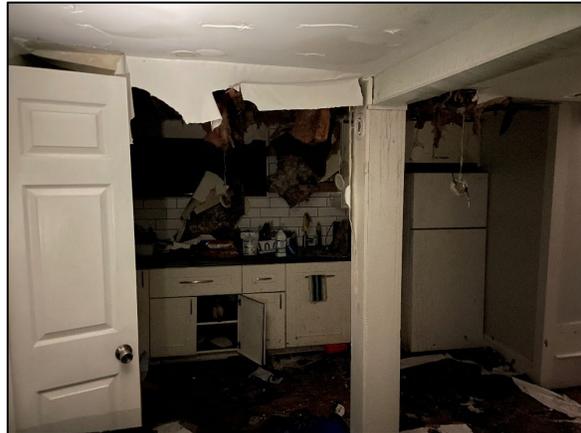
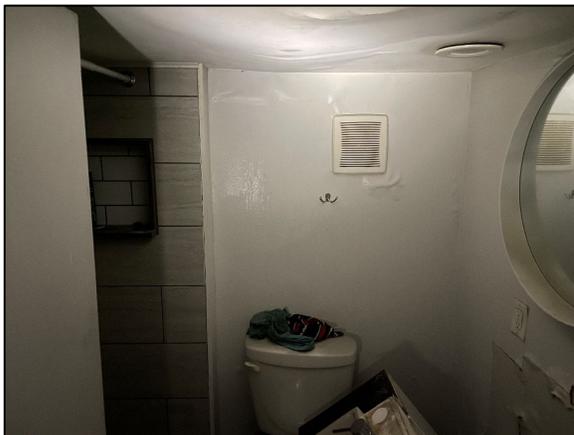
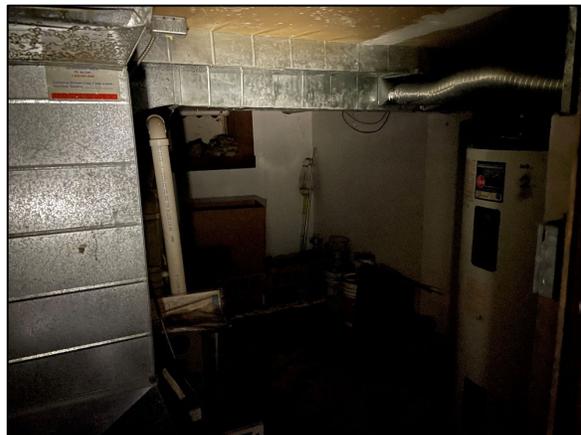
Basement

7. The following photographs depict the general conditions of the interior finishes of the building noted during our inspection; the full extent of which is beyond our mandate and therefore was not assessed at the time of our inspections (related clean-ups had yet to be completed). It should be noted that the Code required unit fire separations provided by the drywall or plaster ceiling and wall finishes between the units included widespread fire, water, and/or smoke damages.

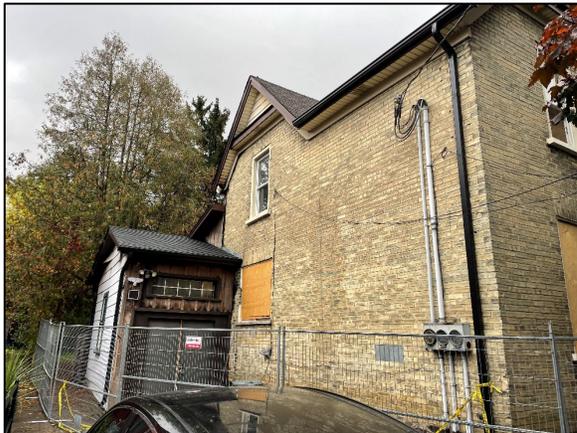
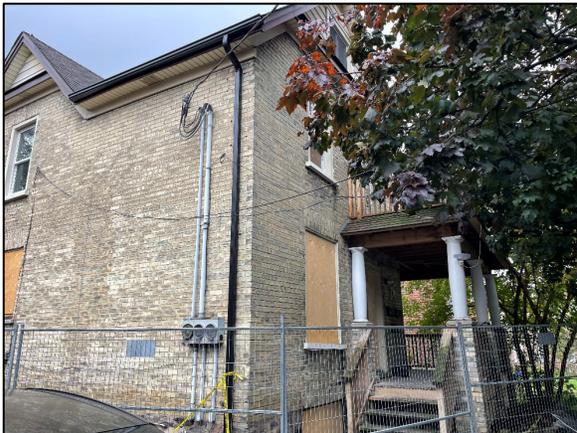
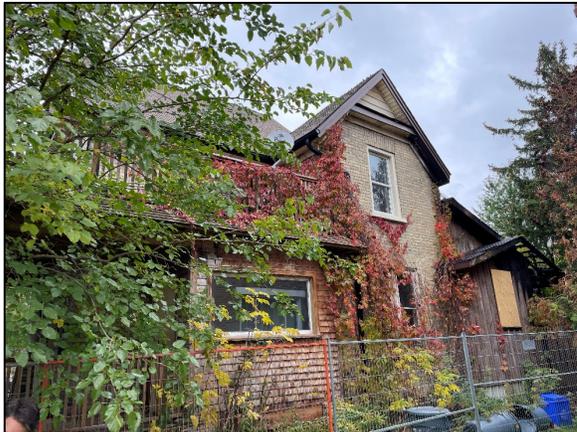
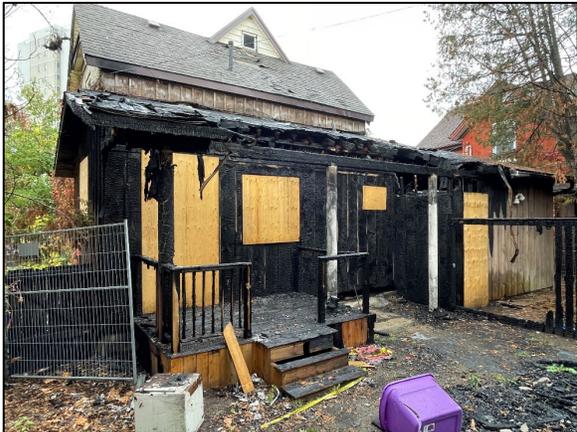
8. The following photographs depict the general conditions of the exterior of the building noted during our inspection. Externally, fire related damages included widespread damage to the exterior wall cladding and roofing of the rear addition. The fire also resulted in at least localized smoke staining of the exterior brick masonry on the original house, the full extent of which is beyond the scope of this report and subject to confirmation.

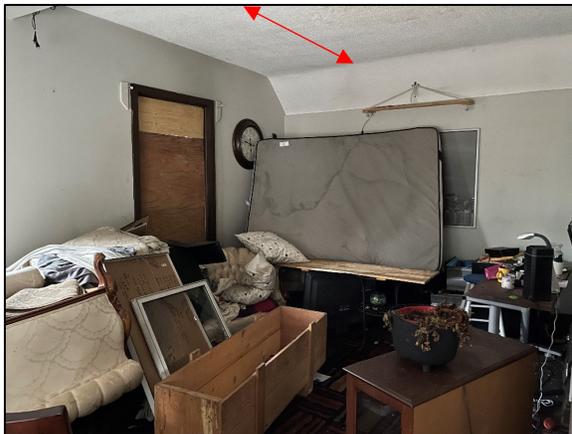
- The third floor joists appear to be secured to sides of roof rafters as the original house includes partially closed ceilings on the second floor level. This framing was concealed at the time of our review; however, in our experience it is unlikely that the third floor joists include adequate bearing support as required by Code. It should also be noted that the third floor may have originally been intended for use as an unconditioned attic space, and as a result the third floor joists may not have been intended to support occupancy loading.

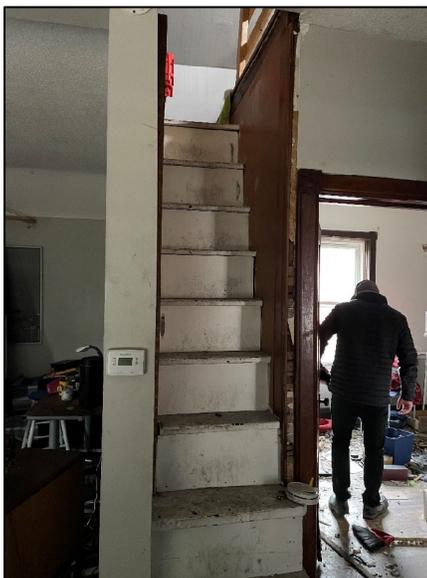
- Access to the third floor is provided via very steep, narrow stairs which do not include a handrail. These stairs would evidently not meet current Code requirements and in our opinion are a falling/safety hazard. As previously discussed, it is unclear if the third floor was originally intended as occupied space or if it was converted from an attic sometime since original construction.

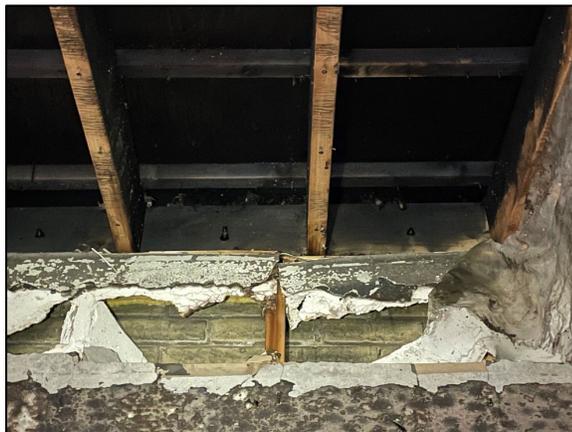
- As previously discussed, the rear addition does not appear to include a rim joist along the rear exterior end. In our opinion, a rim joist is required at this location in order to adequately transfer the loading from the wall and roof above to the foundation.
- The roof of the rear addition appears to be supported in some areas by a ledge board bolted to the rear exterior wall of the original house. The ledge board appears to be located near mid-height of the wall and it is unclear if the ledge board bolts are adequately fastened to the building

structure. It should be noted that the ledger board should not be secured to the brick veneer which is not intended to support roof loads.

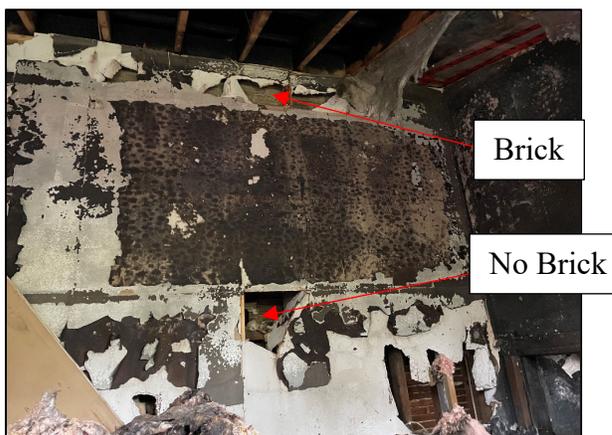
- Where visible, the rear wall of the original building appears to include openings in the brick masonry, while maintaining sections of brick above. It is unclear if the remaining brick above these openings is adequately supported.

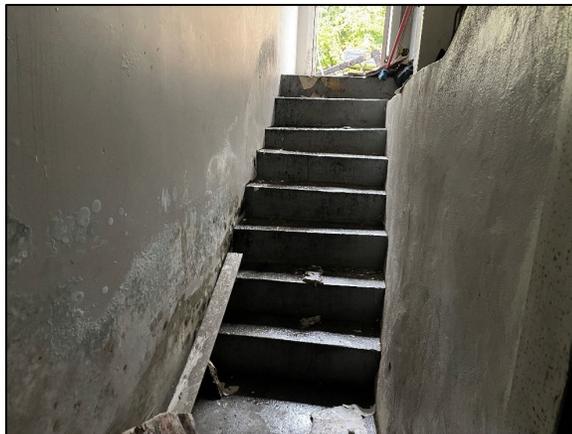
- As previously discussed, the roofs of the original building and rear addition include sloped ceilings which provide limited space for thermal insulation and Code required ventilation between the insulation and roof sheathing. In our opinion, the existing roof assemblies do not include adequate insulation and ventilation with respect to current Standards and as a result may be susceptible to long-term performance issues such as excessive condensation build-ups during the winter months.
- The basement stairs does not include a handrail as required by the current Code.
