# **236 Gehl Place – Scoped HIA For Demolition of Additions to the Original Log Home**

April 25, 2024

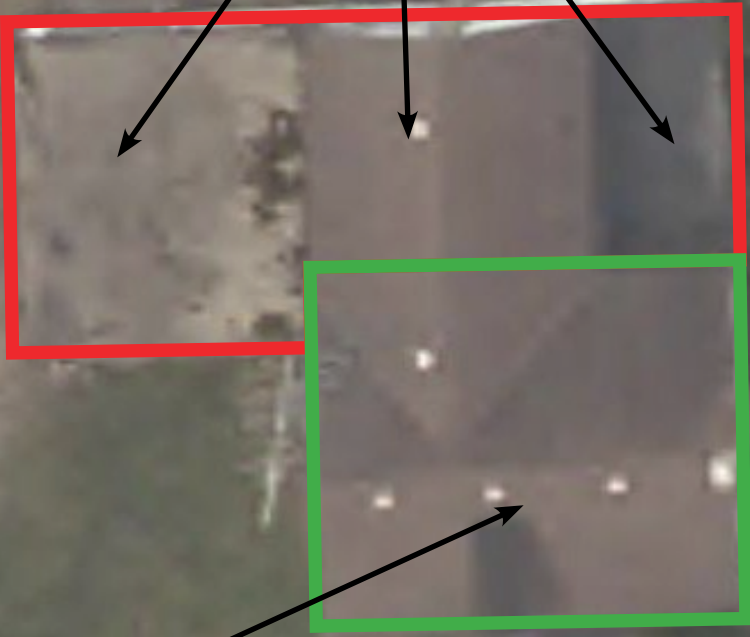
**Aerial - Limits of Demolition**

**Non-original additions  
proposed for demolition**

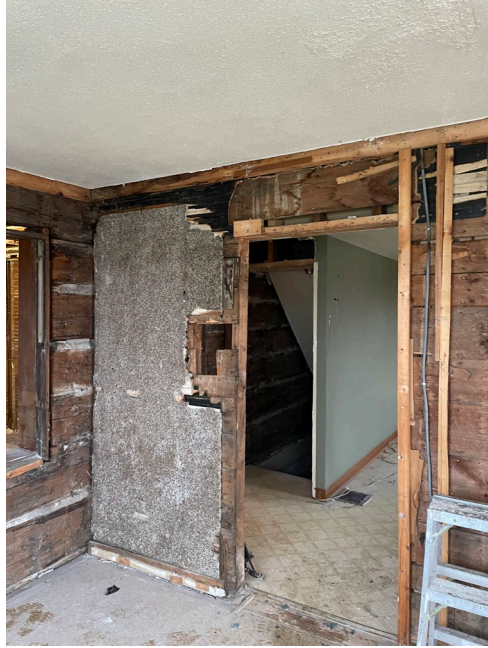
**REMNANT  
OF STUCCO  
SIDING AT  
FAMILY  
ROOM  
SOUTHWEST**

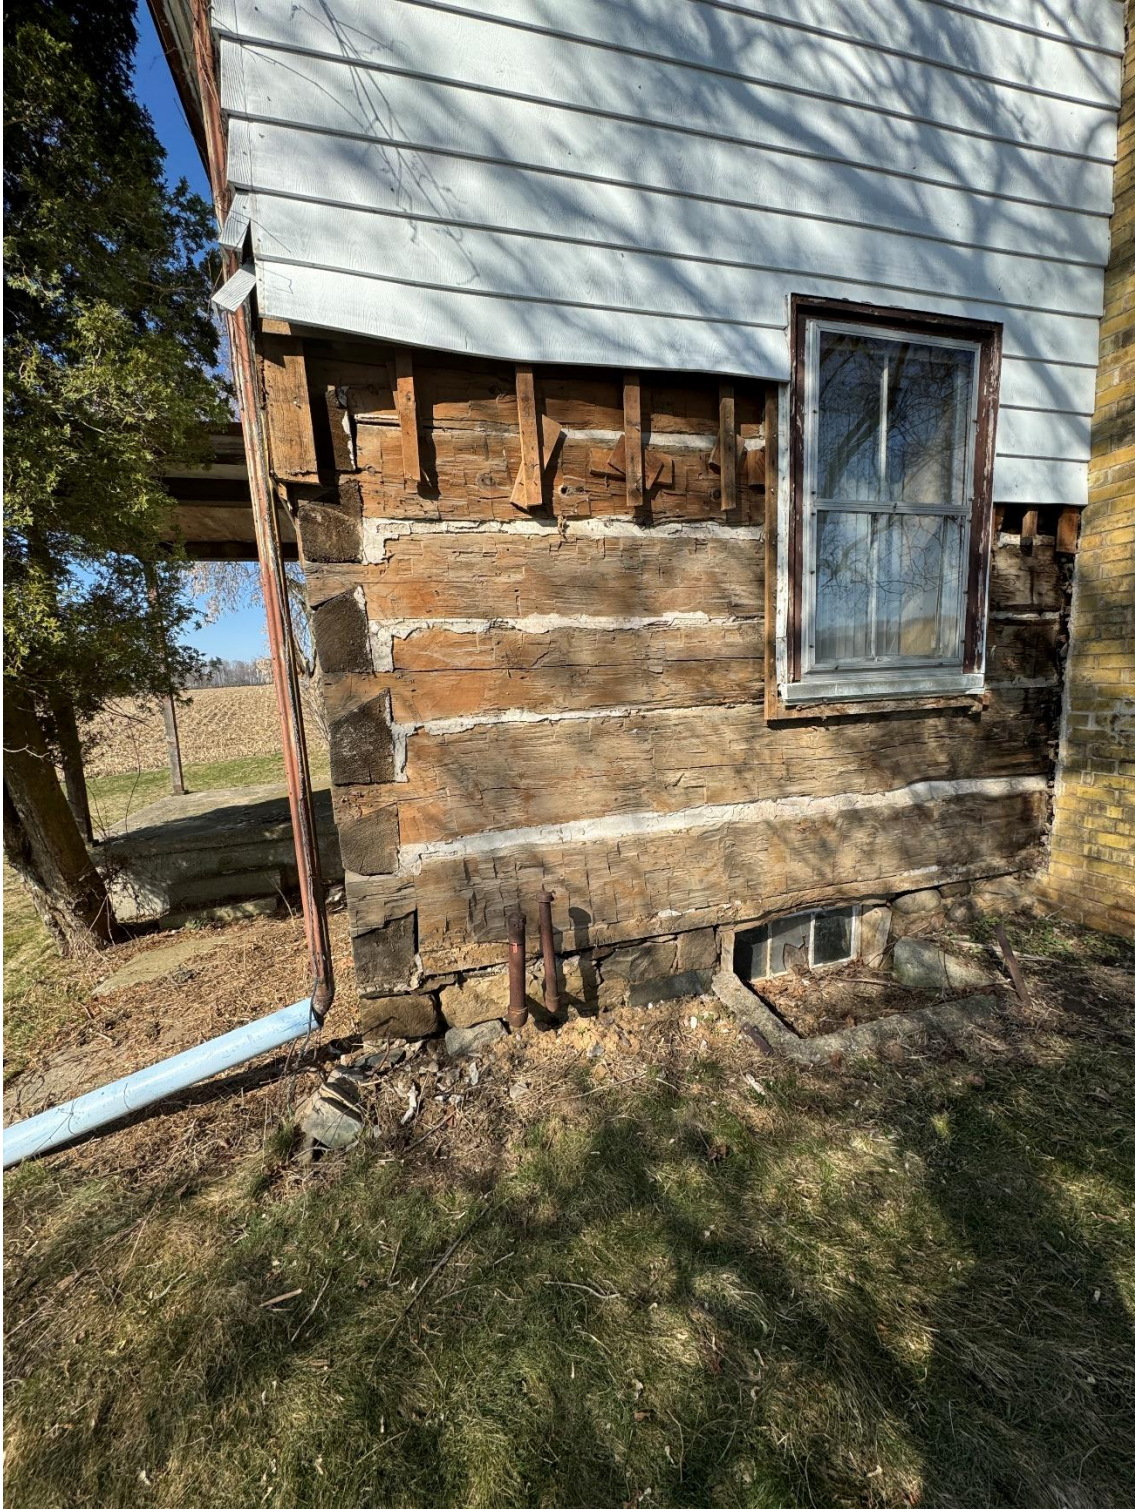
Photo #5: Exterior log wall and dutchman / finger joint corner from east elevation

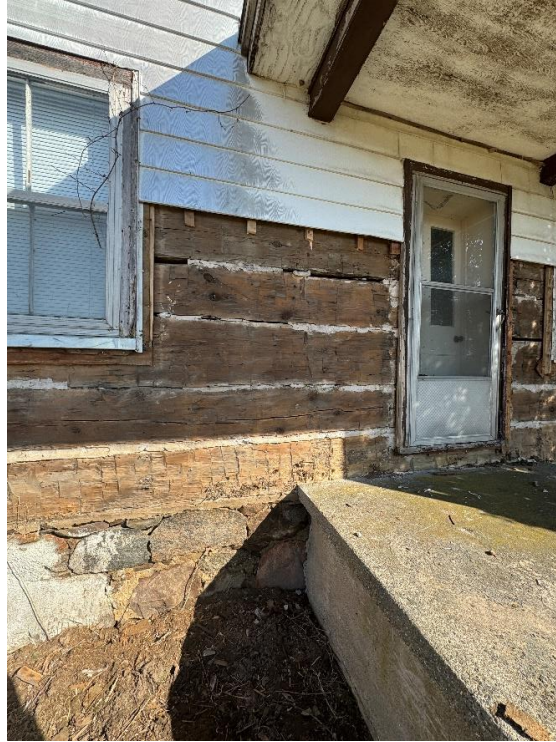
The exterior walls of the log structure were constructed of rectangular logs 12 to 18 inches deep, and approximately 8" wide. The log walls were chinked along the horizontal joints which is typical for log structures of this era. Corners are finished with a finger joint lap with minimal cracking or shrinkage present (Photos 1, 2, 3, 4). The end grain at corners appeared to be in fair condition showing minimal signs of rotting or checking (Photo 9). Minor deterioration was observed specifically around windows which is relatively common, as these areas are typical prone to moisture accumulation, typically as a result of poor sealant around the window frames. The deterioration was less than was expected following the removal of the siding. The chinking appeared to be in fair condition around the entire perimeter with few locations showing minor cracking, in other locations chinking had fallen out completely (Photo 6). This is not uncommon for chinking as the timber logs will expand and contract over time due to expansion and shrinkage caused by changes in moisture content in the timber. It is recommended that chinking be repaired as required to maintain the integrity of the log structure.

Photo #6: South elevation, crumbling chinking, exposed rubble wall

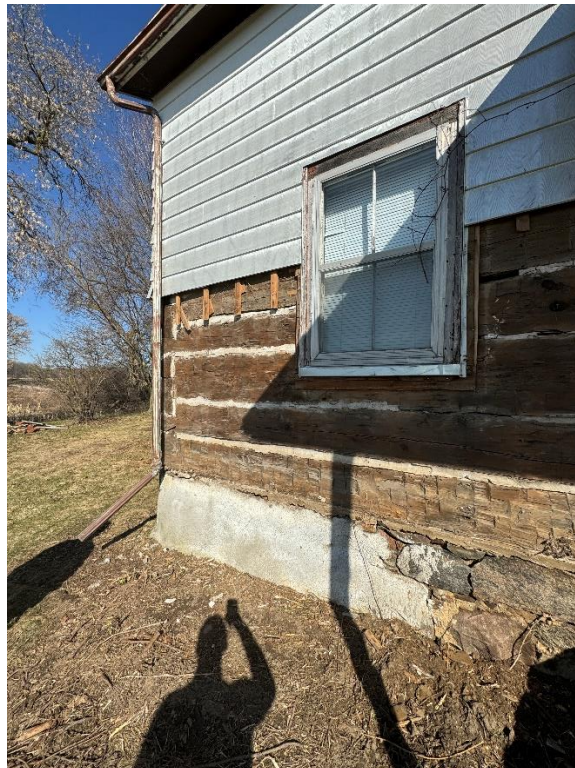
The heritage structure sits on a stone-rubble foundation that is exposed around both the interior and exterior. From the exterior, one corner had parging present, however, in most locations there was no parging visible – it is unclear whether this was a result of the exterior finish demolition, or if the rubble wall has been left unparged (Photos 7, 8). In some locations, it appeared that the mortar which binds the large stones in the foundation together has severely deteriorated such that it appears there are large gaps between individual stones (Photo 11). The condition may be consistent if the exterior rubble wall was left unprotected and allowed to weather over the years. This is not uncommon if vegetation was present in front of the wall which likely accelerated weathering on the rubble wall. From the interior however, this did not appear to be the case. Stones were well embedded into a mortar which appeared to be well maintained showing only minor signs of cracking (Photo 14).

Photo #7: South elevation, partial parging at corner

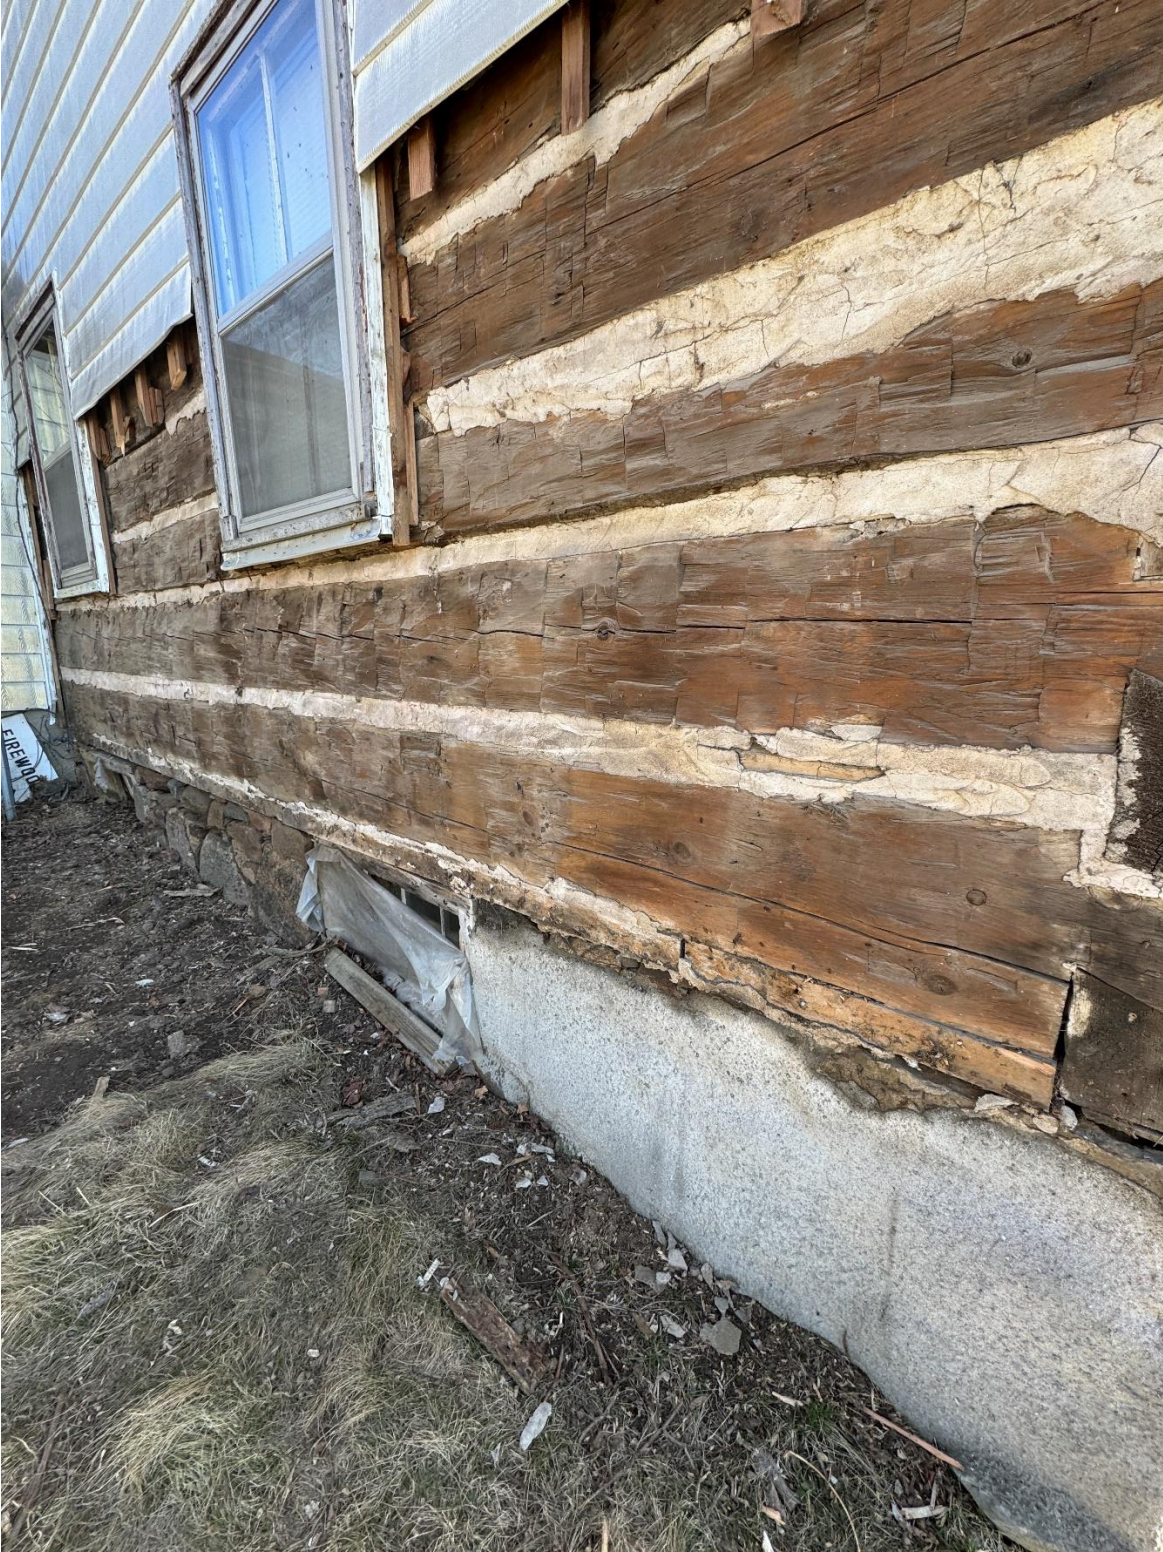
Photo #8: West elevation, partially parged foundation, exposed wall with chinking

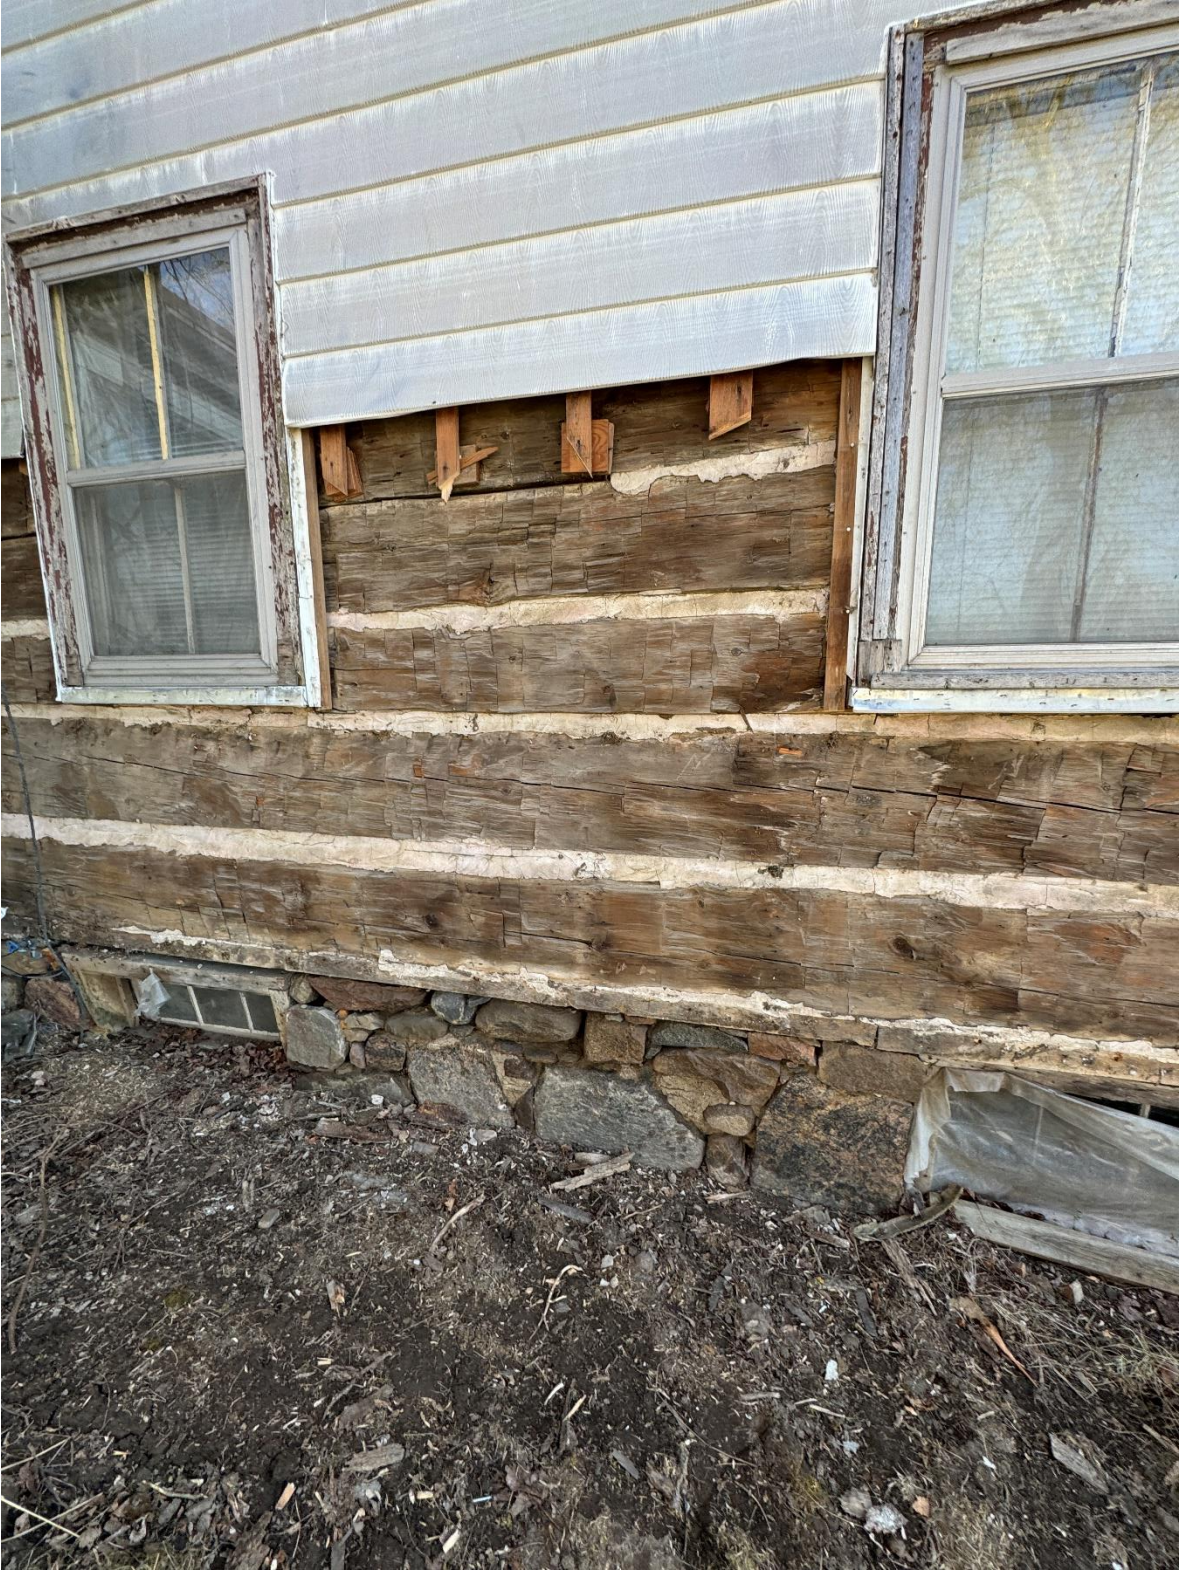
Photo #11: East elevation, exposed rubble foundation, crumbling mortar and chinking

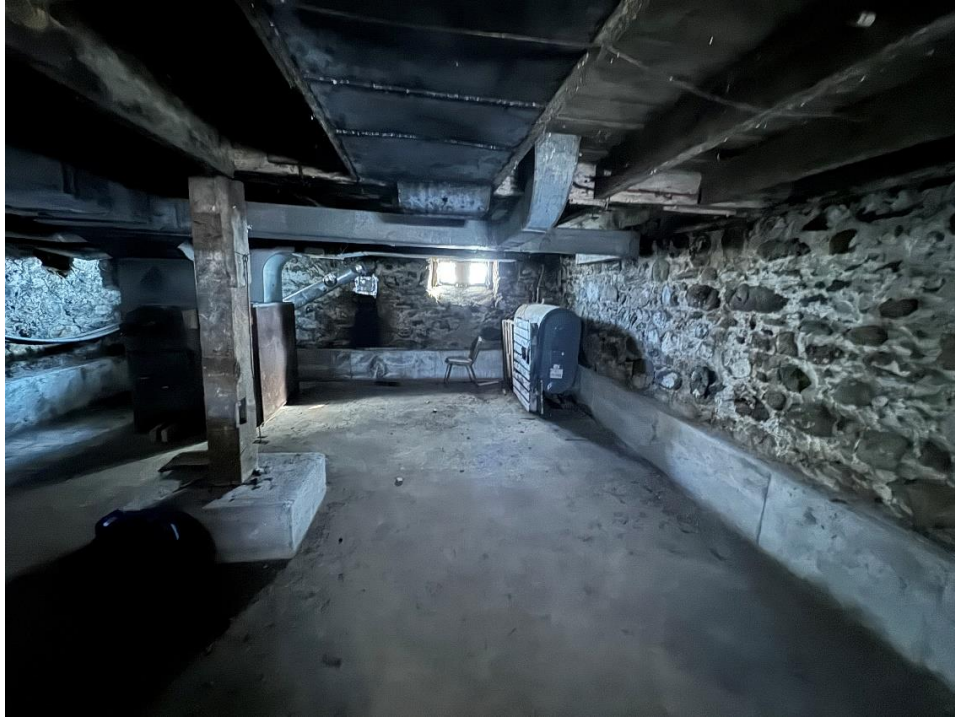
From the interior, it is also evident that underpinning was completed at some point to lower the basement slab. The ledge of underpinning is approximately 24" tall with the width unknown, however it is likely that the ledge extends underneath the existing rubble. There are no signs of major disturbances as a result of the underpinning such as slab or rubble wall cracking indicating no structural issues (Photo 13).

Photo #13: Basement, underpinning, rubble foundation wall

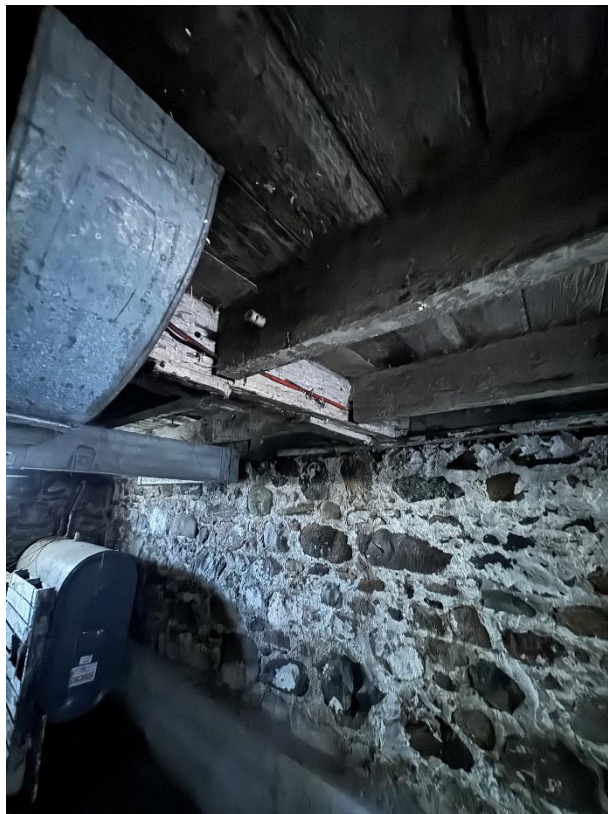
Photo #14: Basement, joists cracking and notching. Plank decking spanning over joists.

Minor repairs to the ground floor are required as a result of joists damages. We would recommend sistering damaged floor joists with new 2x8 sawn lumber.

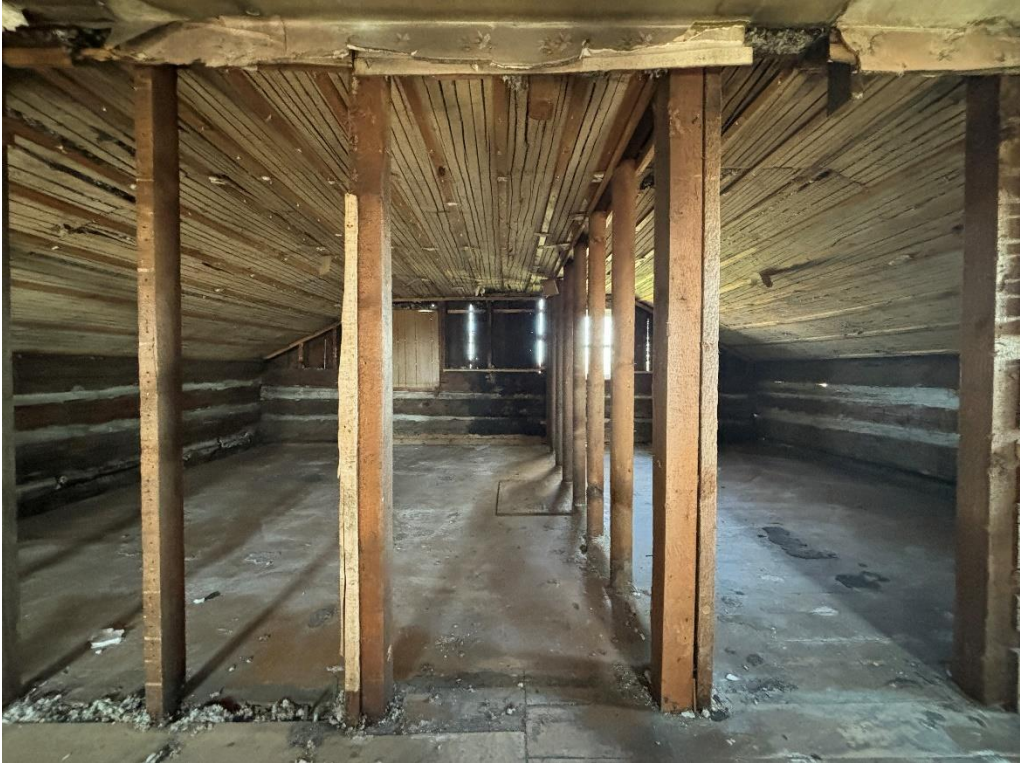
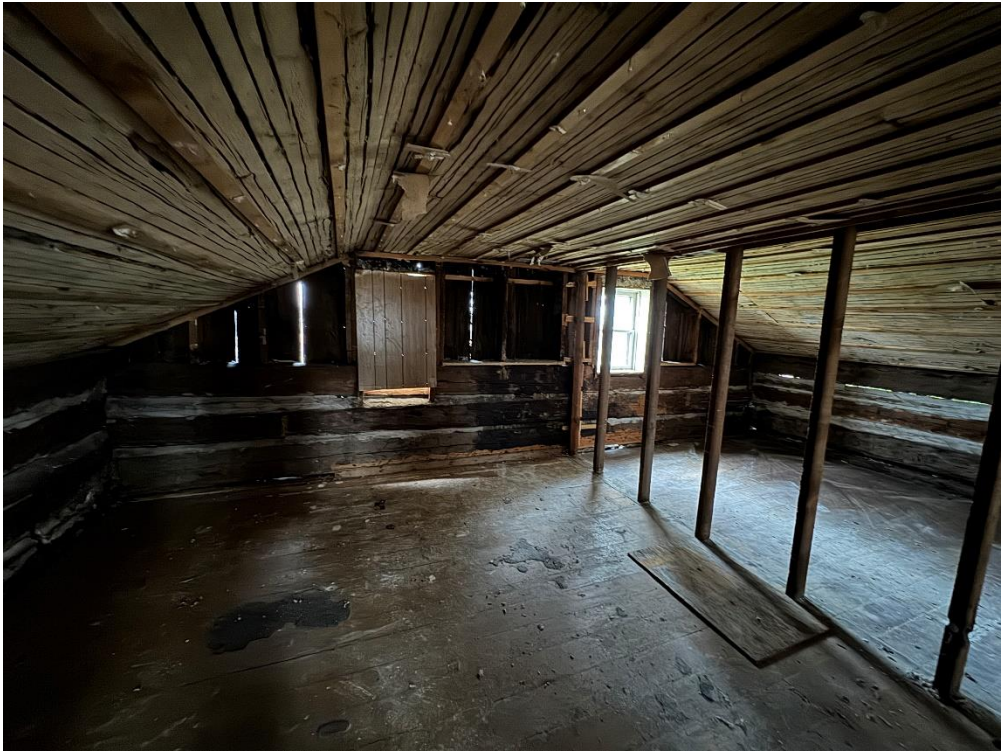
The roof framing is conventional stick framed rafters with ceiling joists spanning from exterior wall-to-wall. The rafters were found to be approximately 5.5" x 2.5" at what appears to be 30-36" on centers. The size and spacing of the rafters should be confirmed on-site. Collar ties fasten the rafters at approximately midspan of both rafters. (Photos 17, 18) The roof ridge over the additions appears to be sagging significantly more than the roof over the timber log structure.

Without removing finishes and conducting a more extensive review of the roof structure, it is not immediately clear what the cause of the sagging is. However, it is not uncommon for older roofs to show large deflections such as those observed here. The cause can vary from general deterioration to extensive shrink and swell cycles experienced over

Photo #17: Roof framing finishes removed.

many years. It is recommended to monitor the roof to ensure the sagging does not continue to worsen. Ultimately, the roof over the original log structure is in fair condition. Reinforcing the roof sag may require shoring and jacking the existing roof up followed by sistering of existing rafters and/or collar ties. At the time of writing this report, it is difficult to ascertain the overall reinforcing required. A full analysis should be completed to conclude the adequacy of the existing roof and any reinforcing which may be required in due course. It is not recommended to try and remove the permanent deformation of the roof as it is likely the result of wood shrinkage and long duration loading. It may be advisable to sister the roof members if the building is to be re-occupied. Additional rafter thickness would also provide the opportunity for better roof ventilation and insulation.
