**Cultural Heritage Protection Plan & Temporary Protection Plan  
58-60 Ellen Street East & 115 Lancaster Street East  
City of Kitchener  
Region of Waterloo  
Lot 3, German Company Tract  
Geographic Township of Waterloo  
Former Waterloo County**

HR-517-2024

2024-10-01

**58-60 Ellen & 115 Lancaster  
Structural Condition Assessment Rev1**

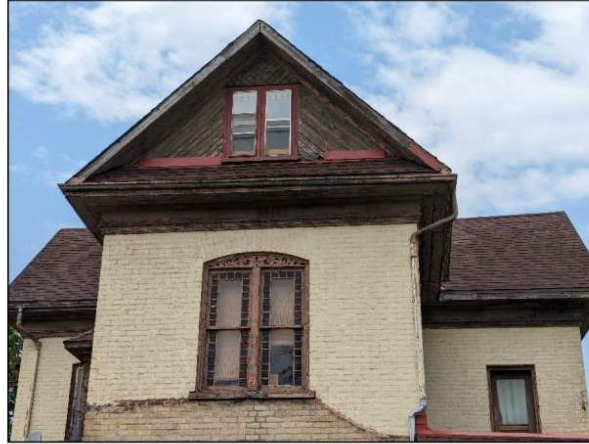
Photograph 3: Missing Fascia and Flashing and Access to Attic

Brick step cracking and previous portland repairs were noted at various locations around the building including above the arched window in Photograph 3. The wood fascia boards around the building were largely exposed to the elements and had deteriorated in some locations. Metal fascia was installed in some locations, the missing fascia was found throughout. Counter flashing was also noted as missing in a few locations (Photograph 3 & Photograph 9). A rodent hole into the eaves was noted and covered with metal wire (Photograph 3). This hole should be patched to prevent water ingress into the building.

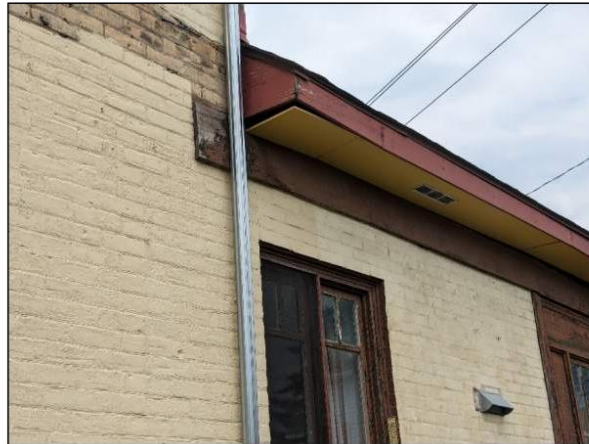
Photograph 4: Loose Soffit

The painted wood soffit was noted to be loose at one location (Photograph 4). This soffit should be repaired prior to becoming detached from the building.

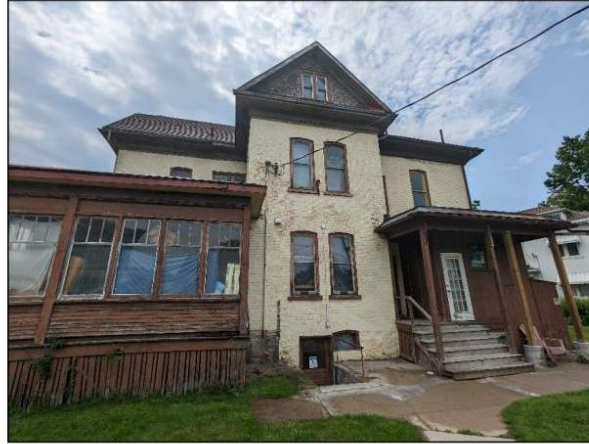
Photograph 5: Lancaster Street Elevation

The undersigned was informed that the wood additions (Photograph 5) on both the north and south sides of the Lancaster Street elevation will be removed in the proposed addition. As such, these areas were not reviewed as part of this assessment.

The wood deck and stairs in Photograph 5 and tongue and groove boards that were loose. These boards should be checked and fastened to the framing.

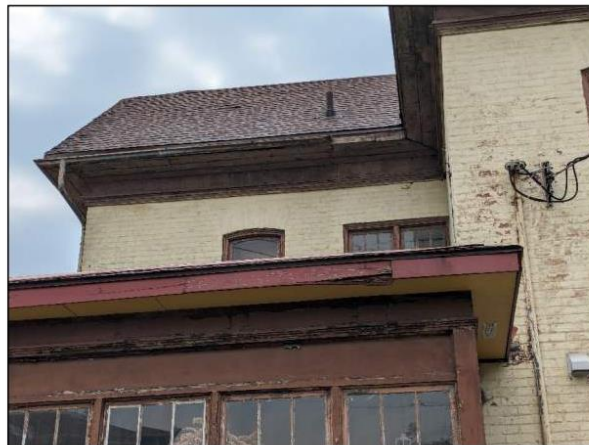
Photograph 6: Missing Eavestrough and Shingle Issue

On the south side of the Lancaster Street elevation, eavestrough was missing near the valley in the high roof (Photograph 6). Other eavestroughs were noted to be missing such as near the front door (Photograph 7). Several downspouts were noted to be defective around the building (Photograph 7). Downspouts should be leak free and deposit water at least 6'-0" away from the building with soil graded such that water flows away from the building.

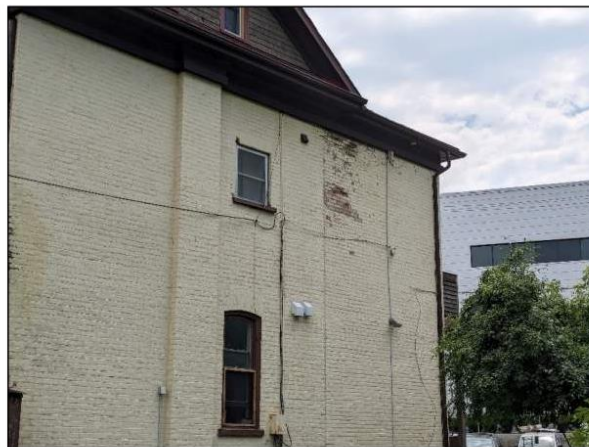
Photograph 8: Deteriorated and Missing Bricks

Brick spalling was noted at several locations around the building (Photograph 8). The spalling was typically located where heavy wetting had occurred. The northeast corner of the building showed signs of paint peeling. This was likely caused by a leaking downspout. It is unknown if there is brick or mortar deterioration at this area due to the remaining paint obstructing direct visual observation. A brick was missing above the flat window arch on the north side of the building (Photograph 8).

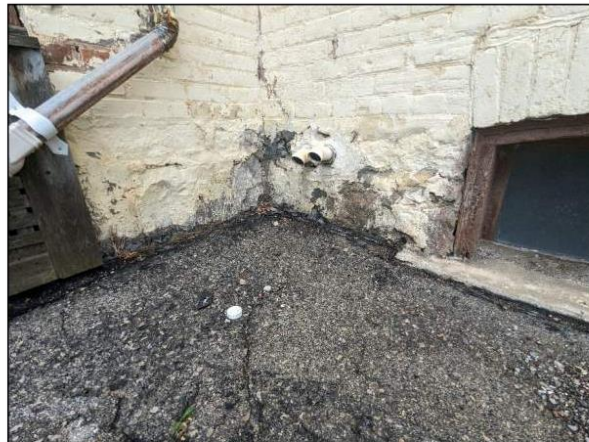
Photograph 10: Deteriorated Wood Window Frame and Rubblestone Foundation

The rubblestone foundation had mortar loss near grade as can be seen in Photograph 10. This picture also shows a deteriorated wood windowsill at grade. This was also noted with wood door frames at the second level. Wood building materials are typical not recommended within 6" of grade to decrease deterioration rates.

10. Replace deteriorated window frames with new window frames. New frames should consist of a durable material fashioned to maintain the current appearance.

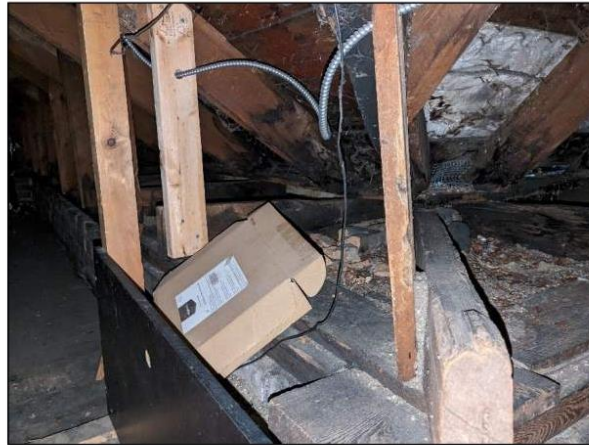
Photograph 12: Deterioration of Rafters

Access to the eaves was possible in one unit. Signs of water damage and rafter deterioration was noted near a valley. These rafter tails were in poor condition. The undersigned was informed that the shingles were replaced in approximately 2016. All signs of leaks appeared to not to have active water ingress. These rafter tails should be reinforced with the next roof replacement.

1. The comprehensive restoration strategy should include removal of the paint using the least invasive method possible or anticipate an accelerated brick maintenance schedule.
2. Repair deteriorated rafter tails with the next roof replacement (Tacoma 2024:15).

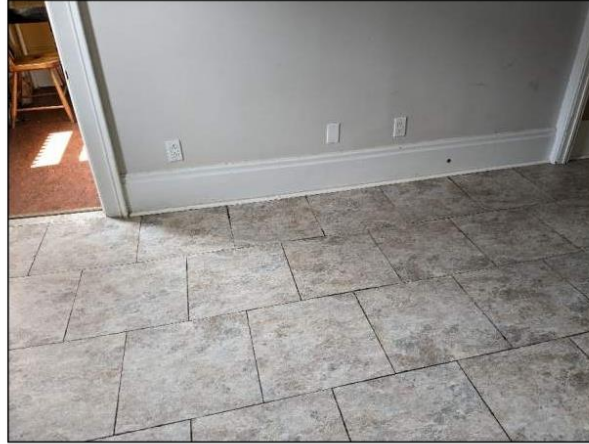
Photograph 14: Unit 3 Sloping Floors

Sloping floors were noted in Unit 3 on the second floor. Due to applied finishes, the cause of the sloping floors could not be determined. As part of the proposed renovations, the area should be exposed to determine the root cause of the sloping floors. Reinforcement of the floor system should be made as required.

11. Investigate the sloping floors in Unit 3 and repair as necessary.
12. Replace the basement concrete stair walkout.

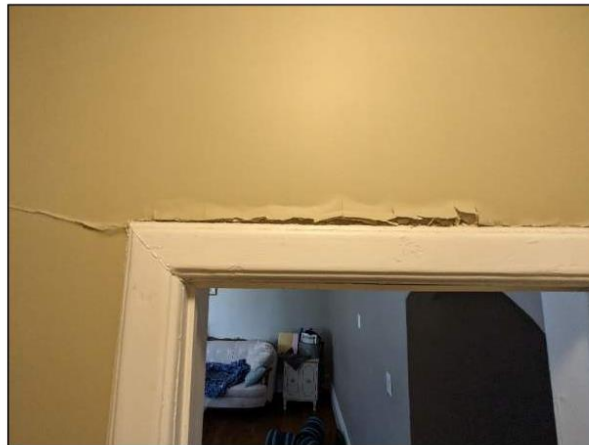
Photograph 15: Unit 1 Deteriorated Finishes

Photograph 15. This deterioration is likely related to typical building movement and not signs of underlying structural issues. These unit finishes were in poor condition.

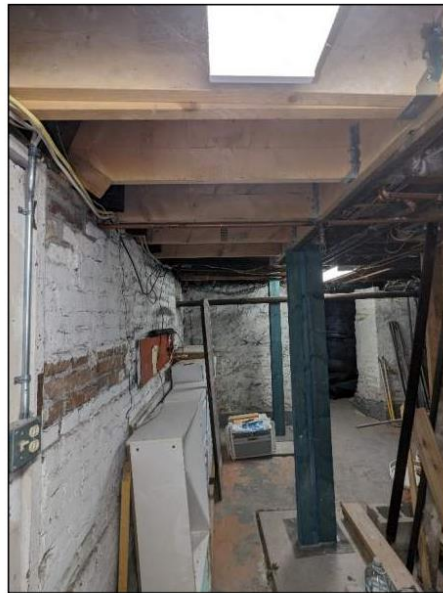
Photograph 16: Typical Basement Conditions

The rubblestone foundation walls and interior mass masonry was found to be in fair condition (Photograph 16). The floor structure was also in fair condition with localized areas previously reinforcement (Photograph 17).

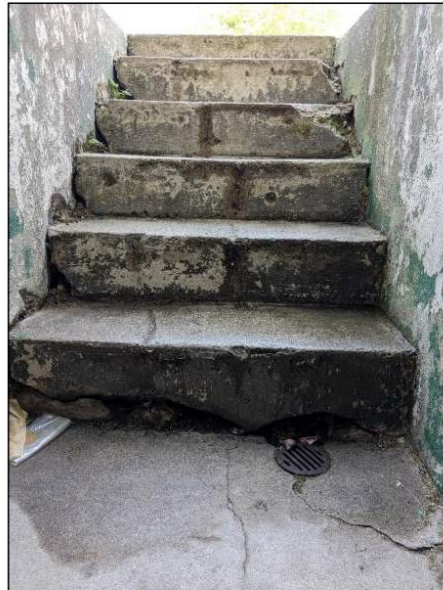
Photograph 18: Basement Walkout Stair Deterioration

The basement concrete walkout stairs were in poor condition with spalling occurring on most steps (Photograph 18). These stairs should be replaced in the upcoming renovations.
