FINAL
Documentation & Salvage Report
58-60 Ellen Street East & 115 Lancaster Street East
City of Kitchener
Region of Waterloo
Lot 3, German Company Tract
Geographic Township of Waterloo
Former Waterloo County

HR-517-2024
Project #: 2023-0269/2023-0269

2024-10-01

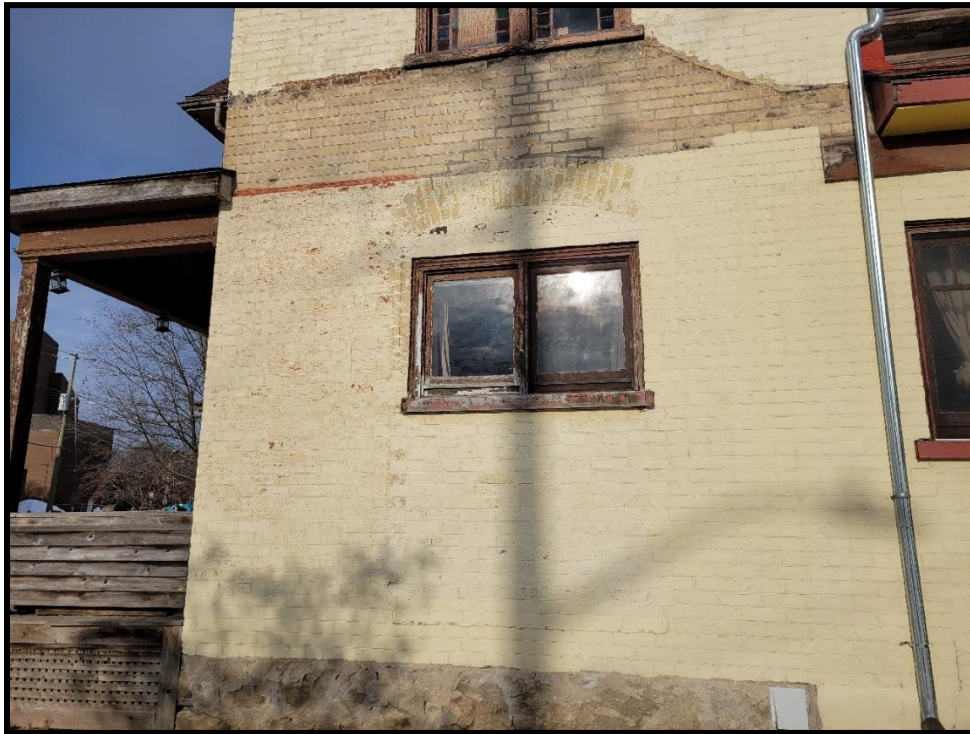
A portion of the brick on the residence's façade is currently unpainted and reveals that the building is constructed of buff brick masonry (see Image 10). The shape of the unpainted section of brick also suggests that the façade formerly featured a porch structure with a bell-cast roof (see Image 11). Further, a concrete pedestrian pathway that currently terminates in the centre of the grassed area in front of the structure delineates where the porch stairs would have landed. The first-storey window opening on the façade has been partially infilled and altered from its initial shape and may reflect a former door opening (see Image 11).

Image 11: Subject Property – Infilled Window Opening
(Photo taken December 20, 2021; Facing Northwest)

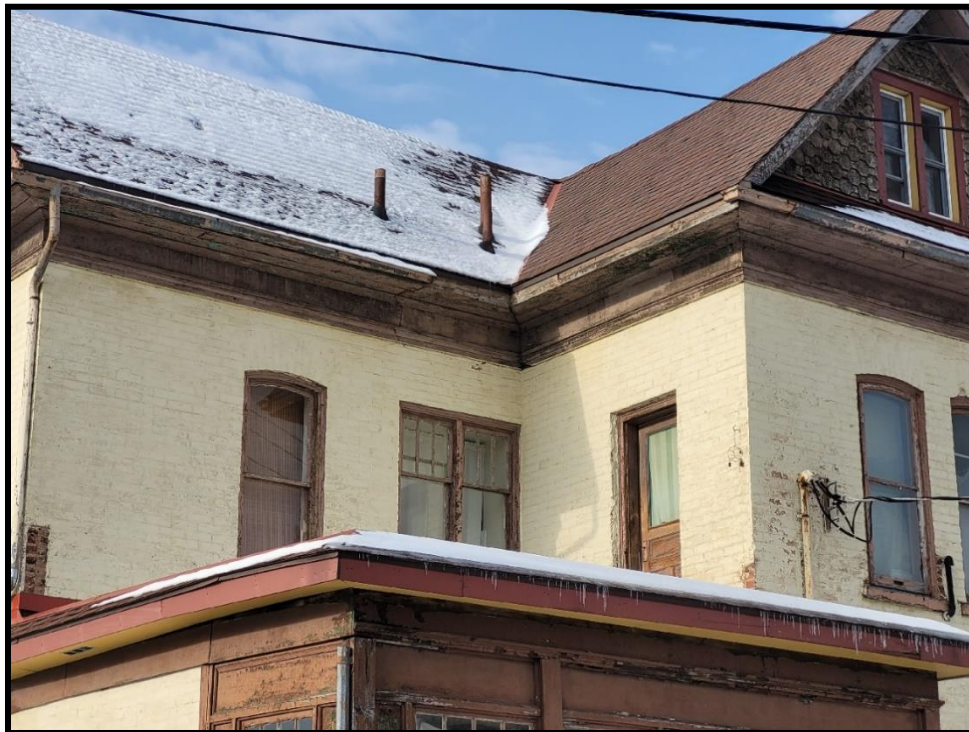
Image 16: Subject Property – Modified Openings on Second Storey
(Photo taken December 20, 2021; Facing West)

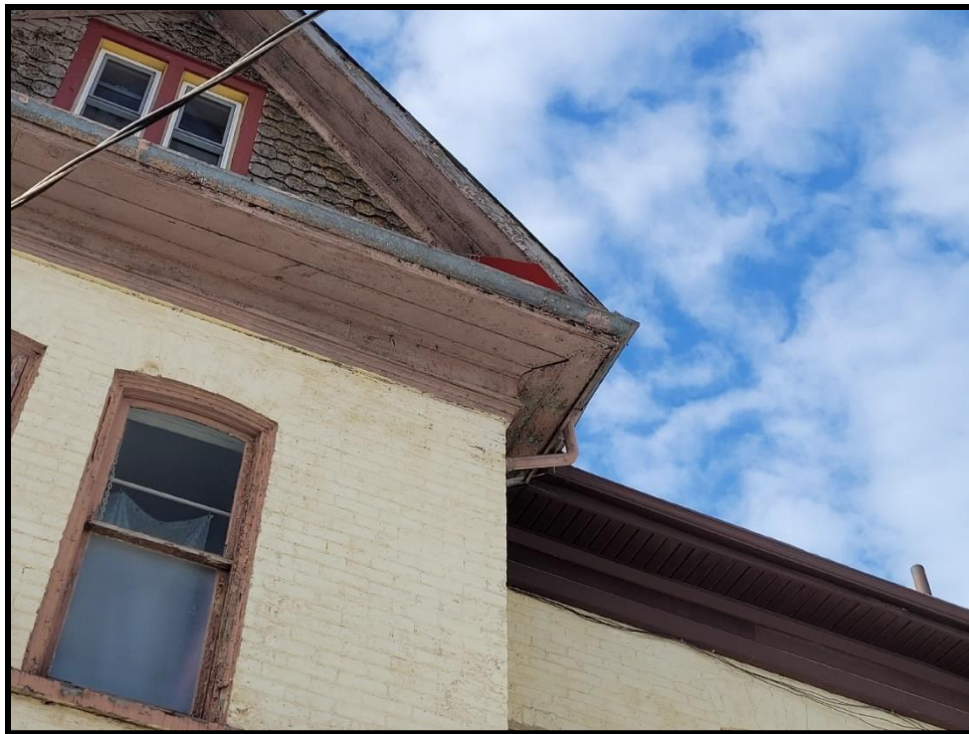
Image 18: Subject Property – Molded Wooden Cornice Showing Area Clad with Aluminium Flashing
(Photo taken December 20, 2021; Facing West)

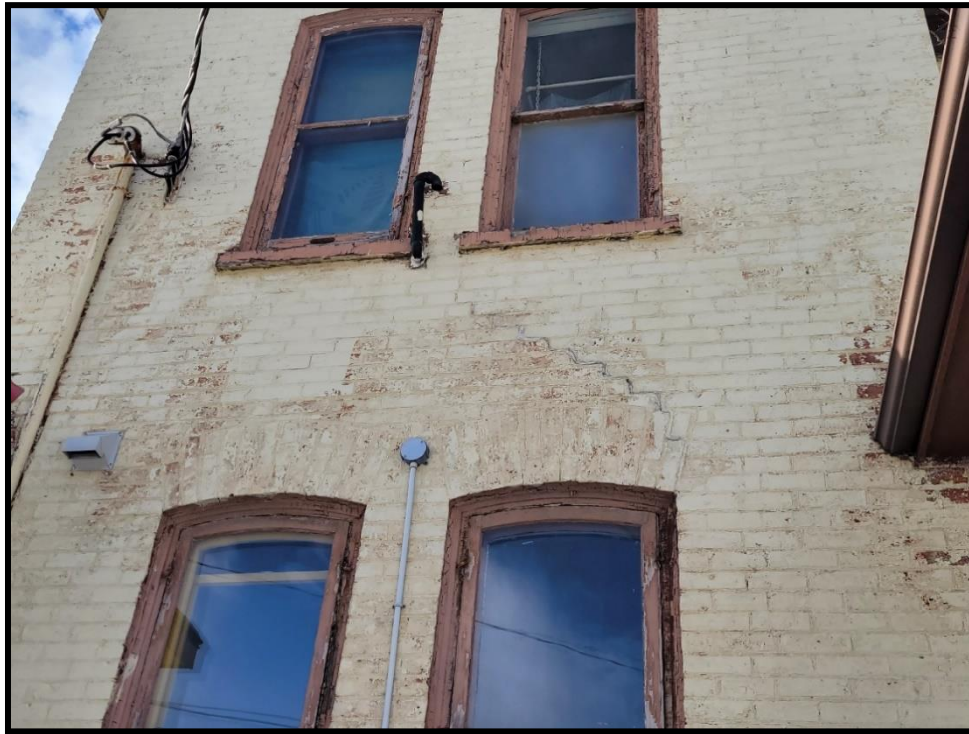
Image 23: Subject Property – Running Cracks Visible in Masonry
(Photo taken December 20, 2021; Facing West)

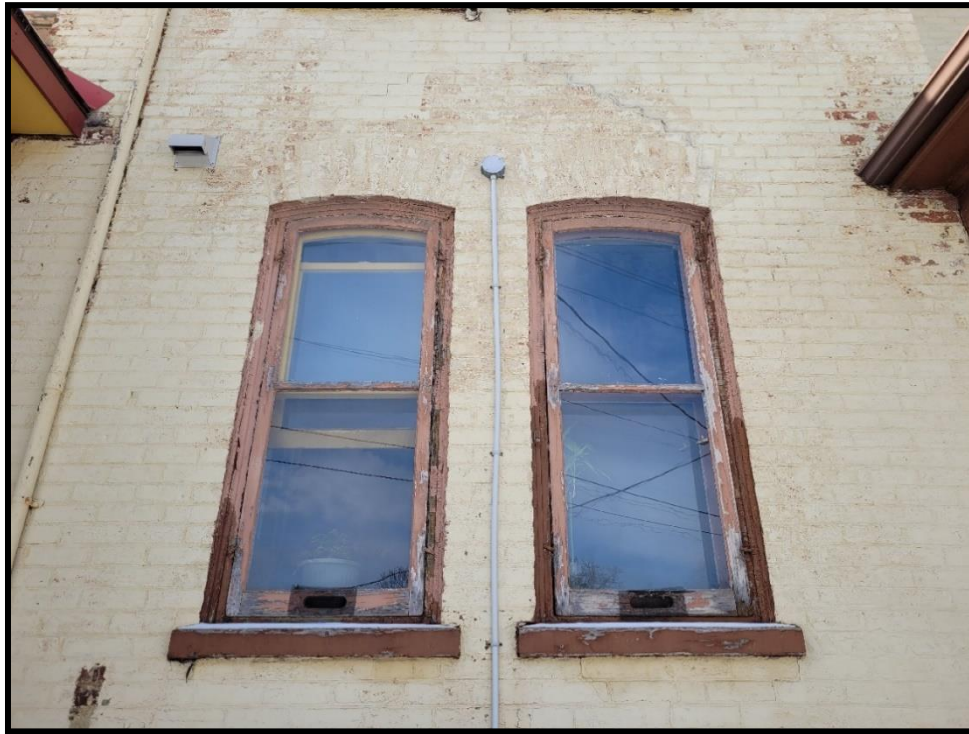
Image 25: Subject Property – Interior and Storm Windows of Varying Conditions
(Photo taken December 20, 2021; Facing West)

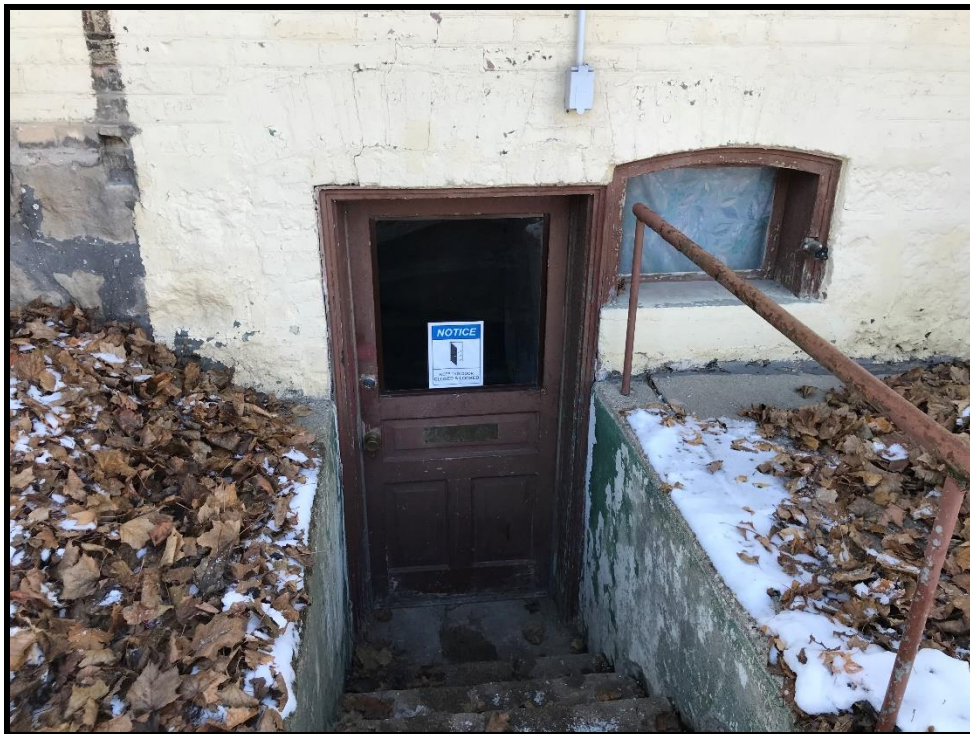
Image 26: Subject Property – Basement Door Showing Modified Opening
(Photo taken December 20, 2021; Facing West)

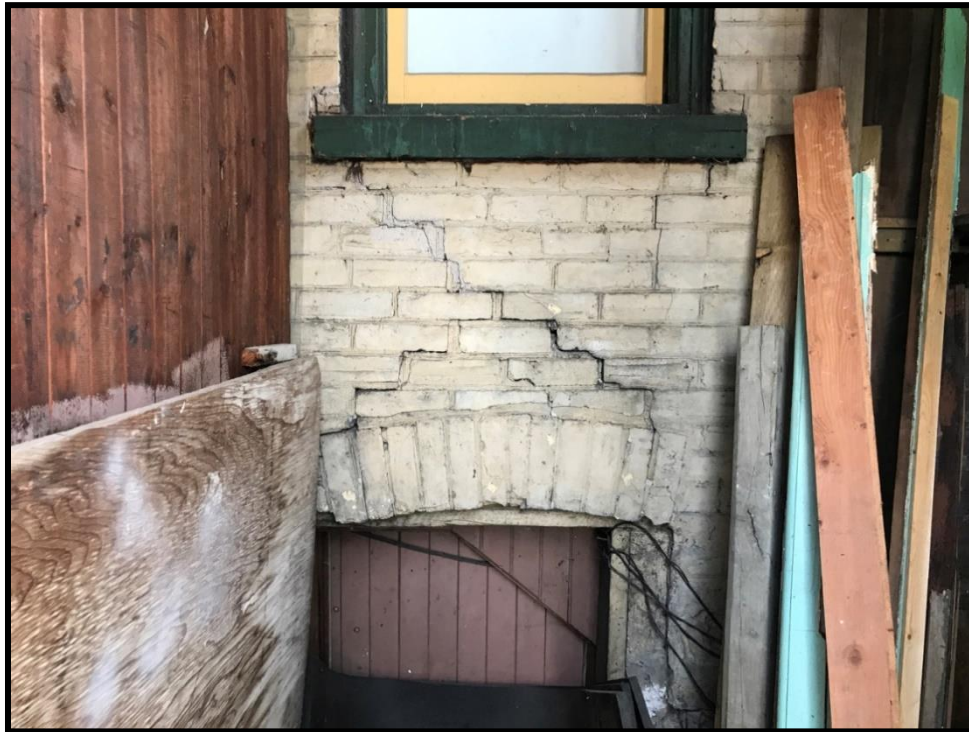
this portion shows sign of deterioration through running cracks and a fallen arch above the basement door (see Image 29).

Image 29: Subject Building – Running Cracks in Masonry and Fallen Arch
(Photo taken December 20, 2021; Facing Southwest)

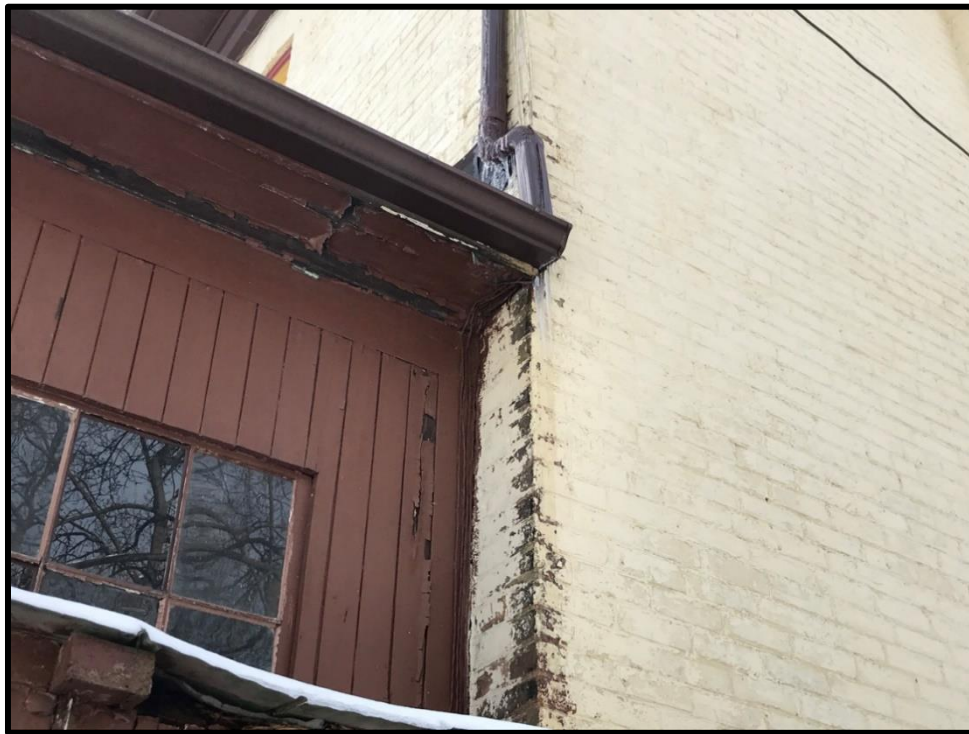
Image 32: Subject Property – Brick Discolouration Showing Water Shedding Issues
(Photo taken December 20, 2021; Facing Southwest)

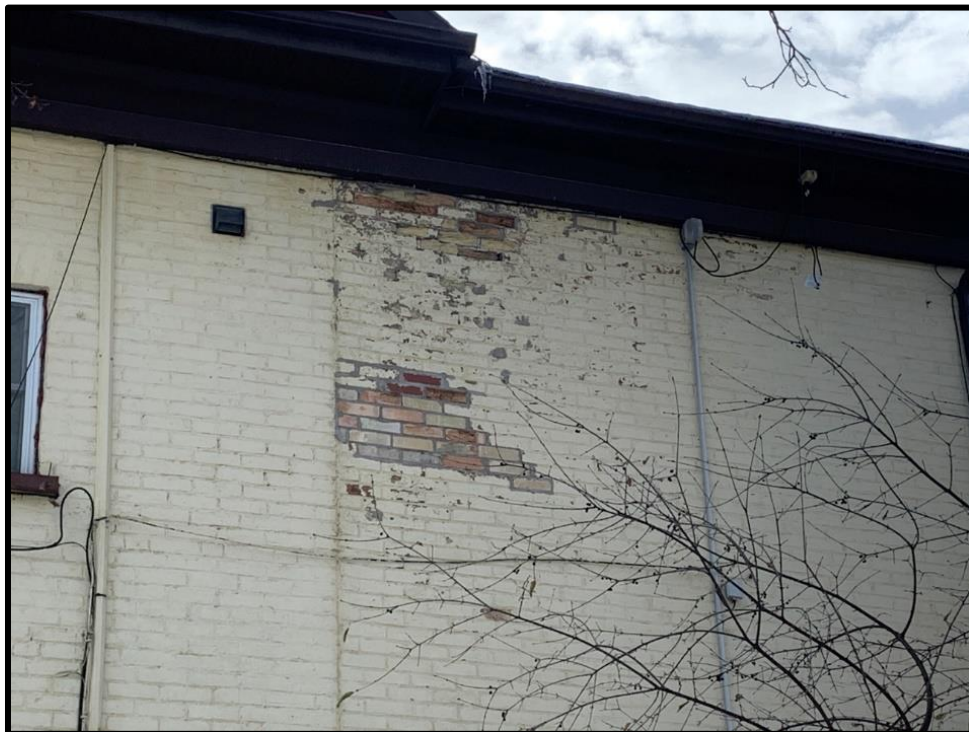
Image 36: Subject Property – Brick and Mortar Deterioration/Replacement
(Photo taken December 20, 2021; Facing South)

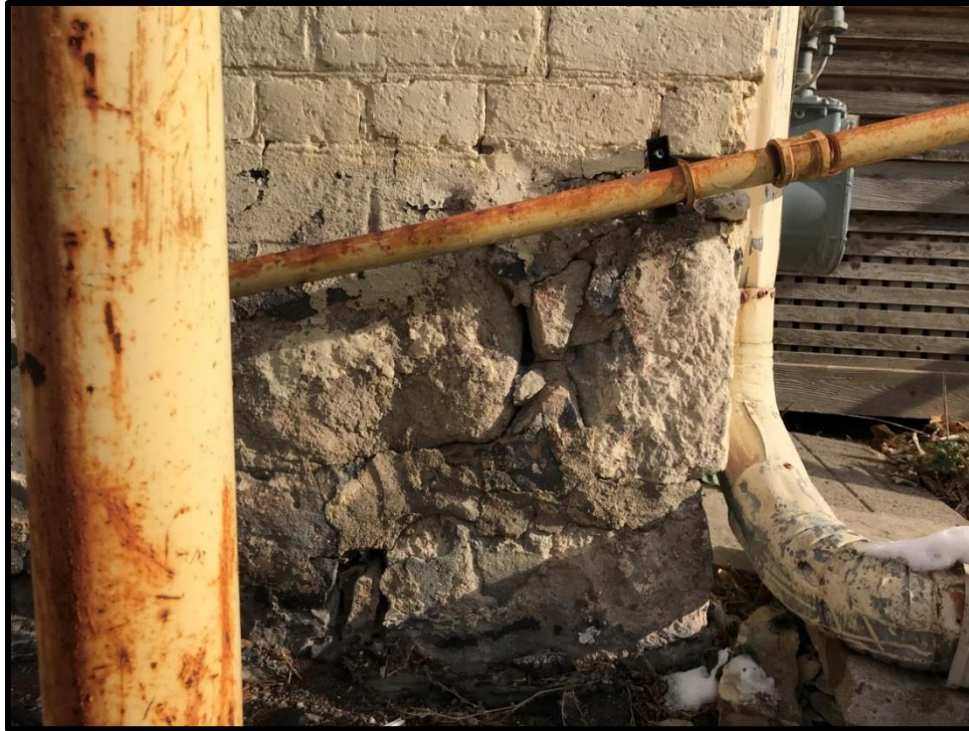
Image 49: Subject Property – Stone Foundation with Deteriorated Mortar
(Photo taken December 20, 2021; Facing East)
