STRUCTURAL REPORT Masonry Parapet Review

Date: May 2, 2025 No. of Pages: 4 + Encl.

Project: Registry Theatre – Masonry Parapet Review **Project No.:** TW-02128-25

Address: 122 Frederick Street, Kitchener

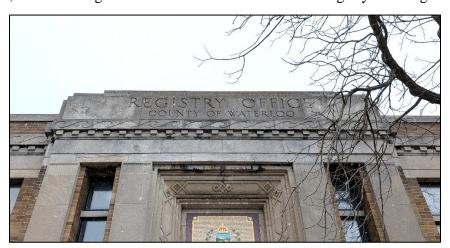
Photograph 1: Carved parapet stones above main entry

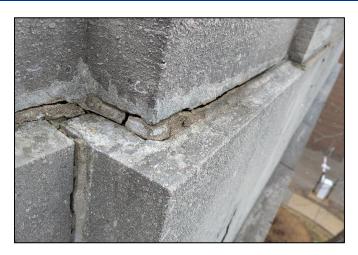
There are capstones that sit on top of the carved parapet stones. The outside face of the capstones are inset between ½"-2" from the carved parapet face-stones. The horizontal mortar joint between the capstone and the carved parapet stones is cracked and open along portions of its length (refer to Photograph 3 below). The capstone overhangs the parapet wall on the inside face, however, it was observed that some of the capstones do not have a proper drip edge along the entire inside face of the stone.

Photograph 3: Cracked mortar along joint above carved "R" parapet stone

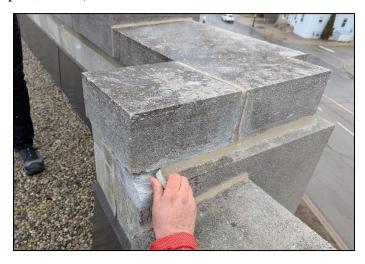
The sealant on the capstone joints which was applied approximately 2 years ago was noted to be quite firm. The sealant was observed to be detaching from the stones in multiple locations. In one location, the sealant could be peeled easily off the joint, indicating that it has failed (refer to Photograph 4, below).

Photograph 4: Failed sealant along horizontal joint of capstone
