Heritage Impact Assessment

East Side Lands Trunk Sewer

Region of Waterloo, Ontario

Interim Draft Report

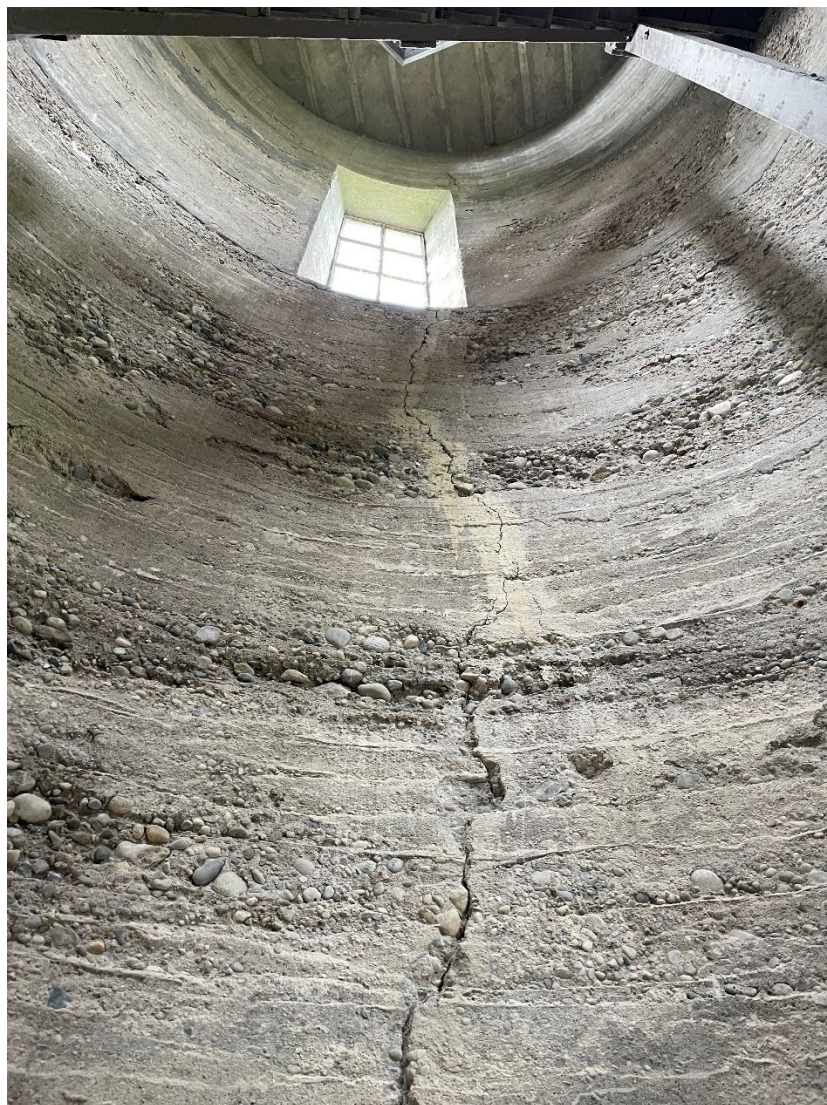
Figure 18: Example of crack in concrete interior of tower (A.S.I., 2024).

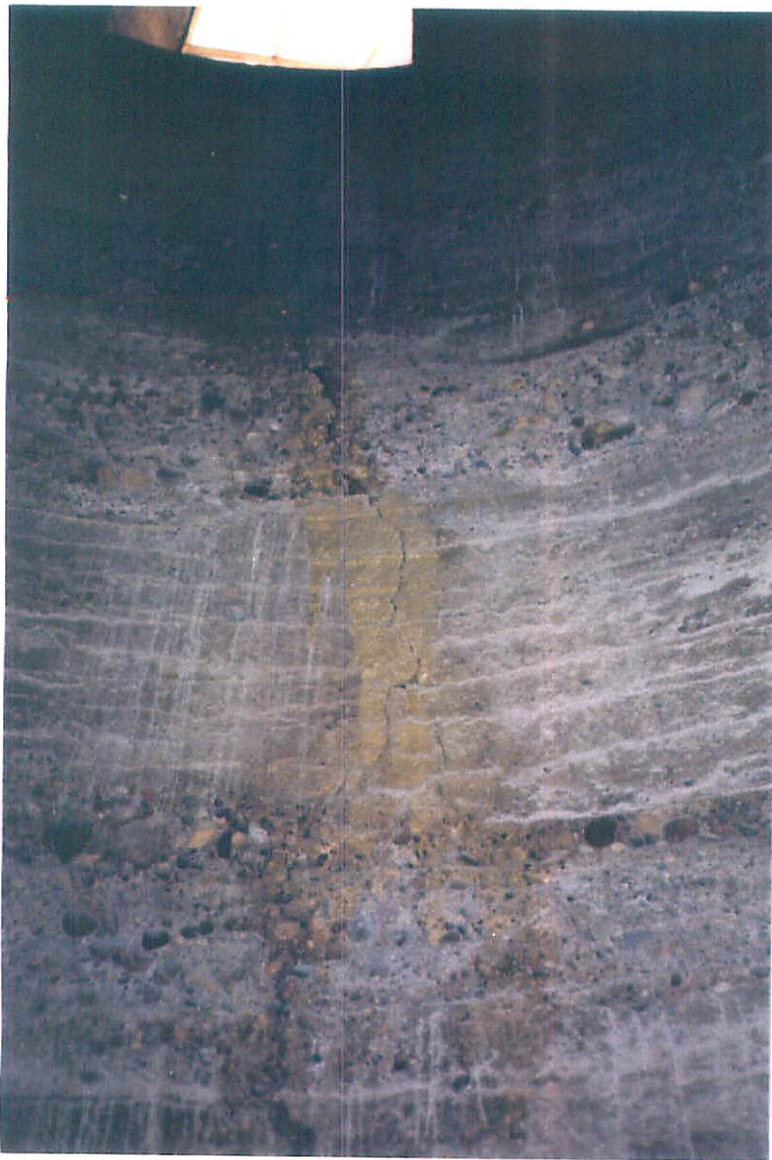
Photo 3: Interior crack in
concrete - epoxy repair

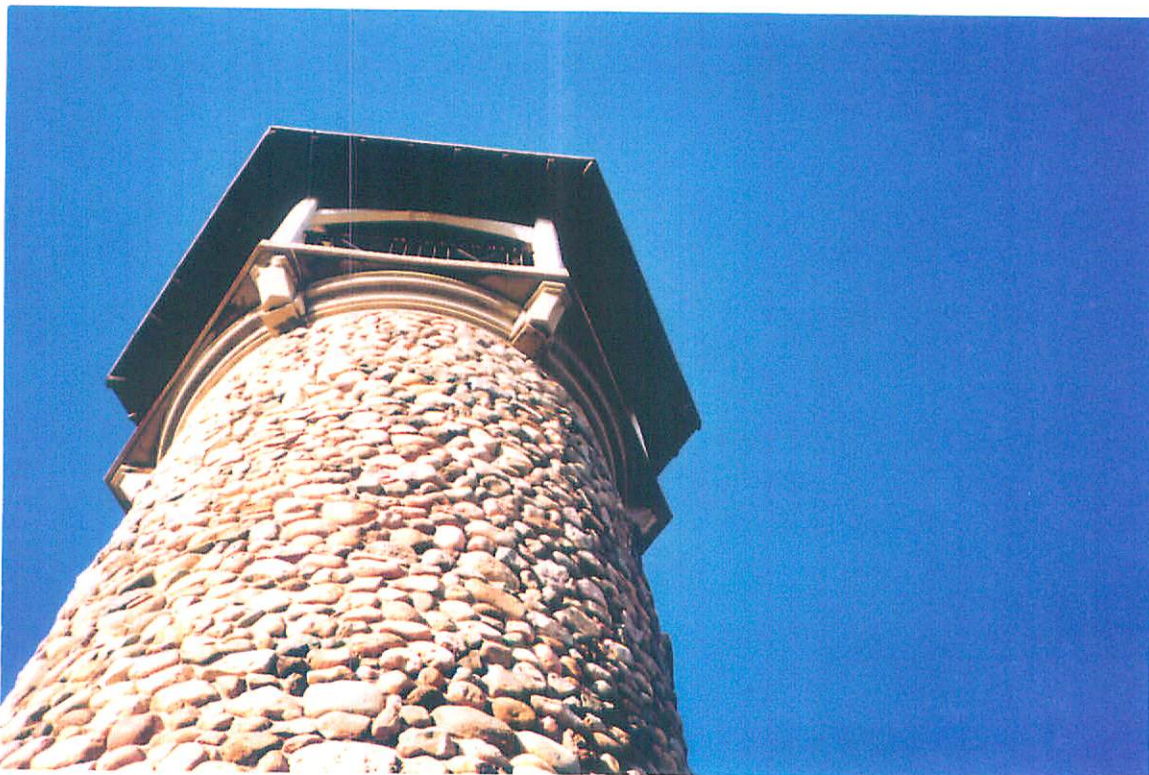
Photo 4:
Stone bulge

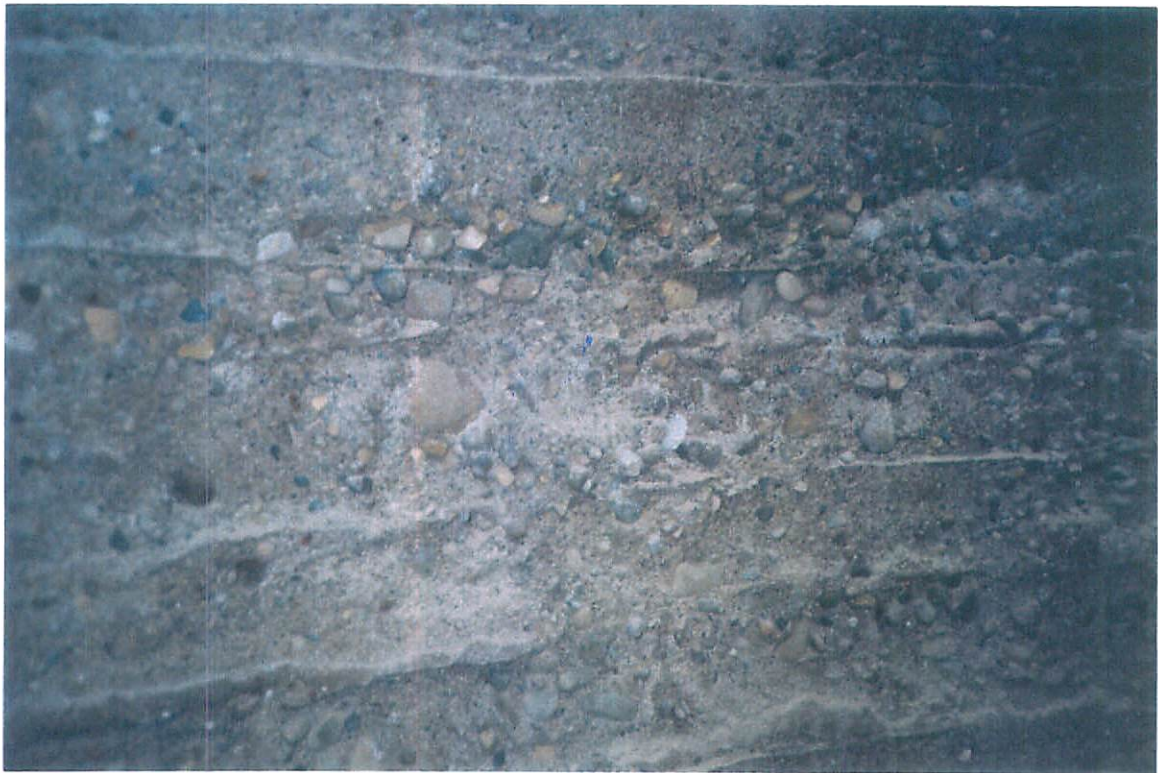
Photo 5: Interior concrete deterioration

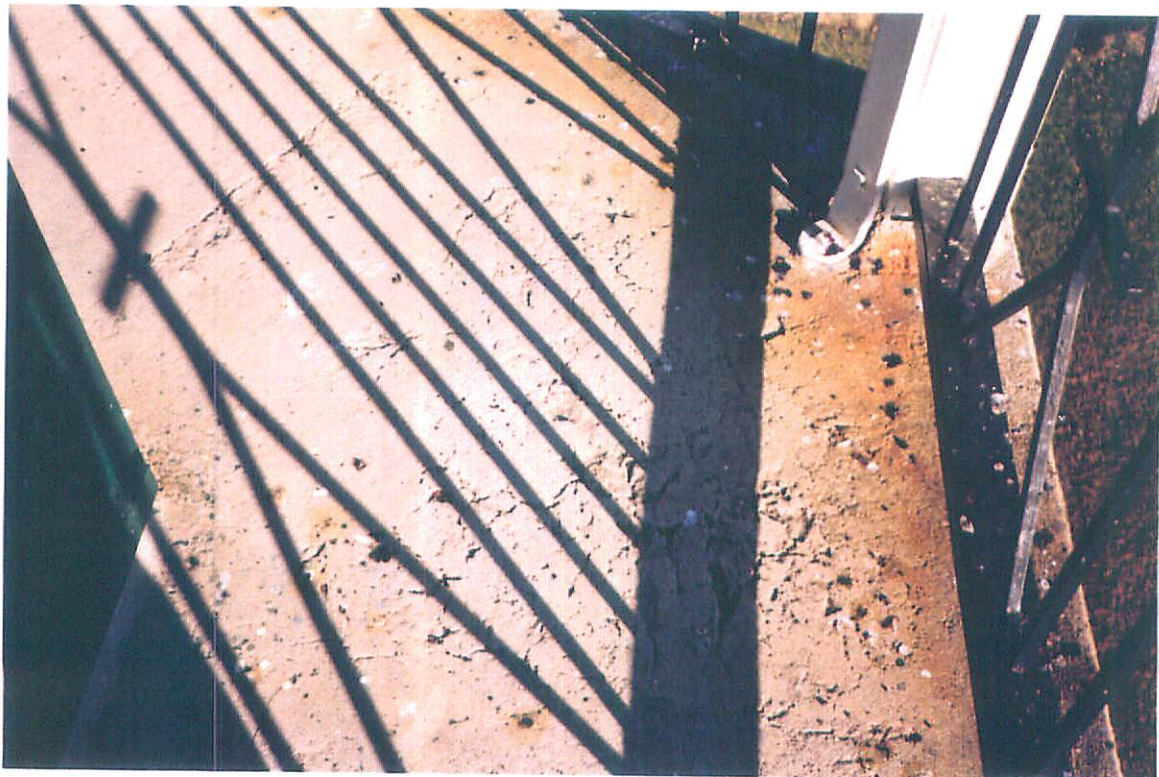
Photo 6: Top deck deterioration

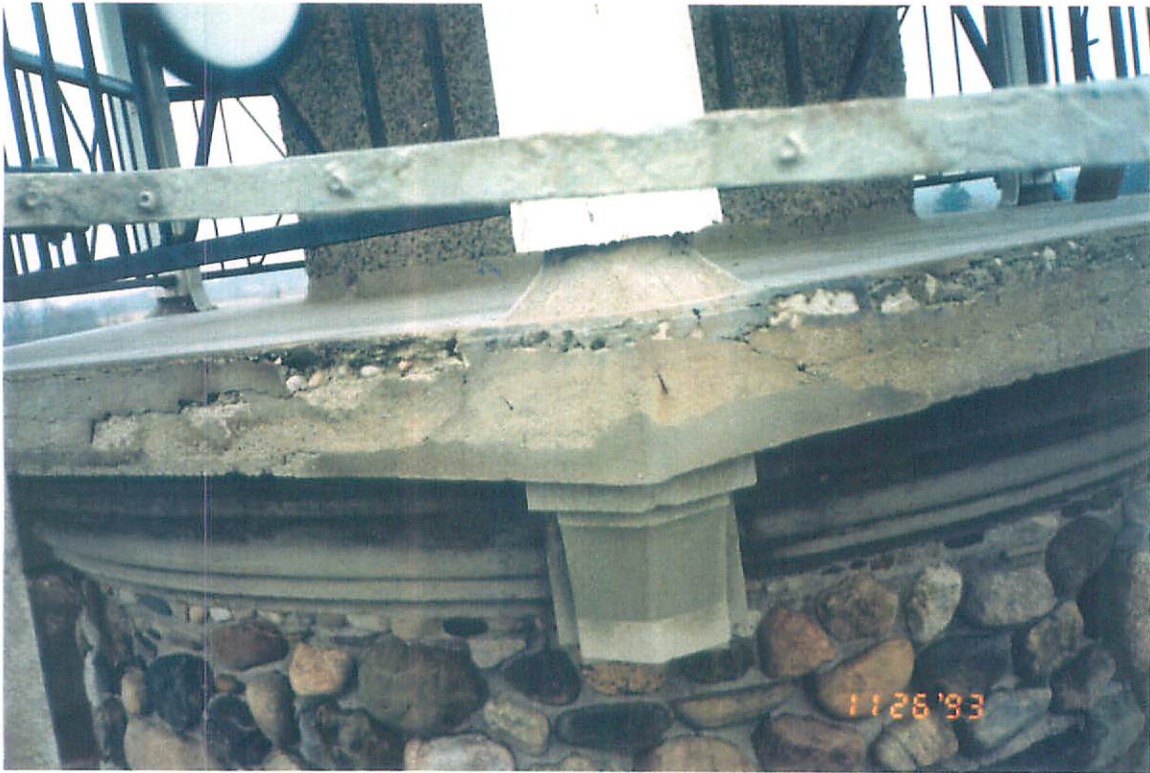
Photo 7: Top deck deterioration

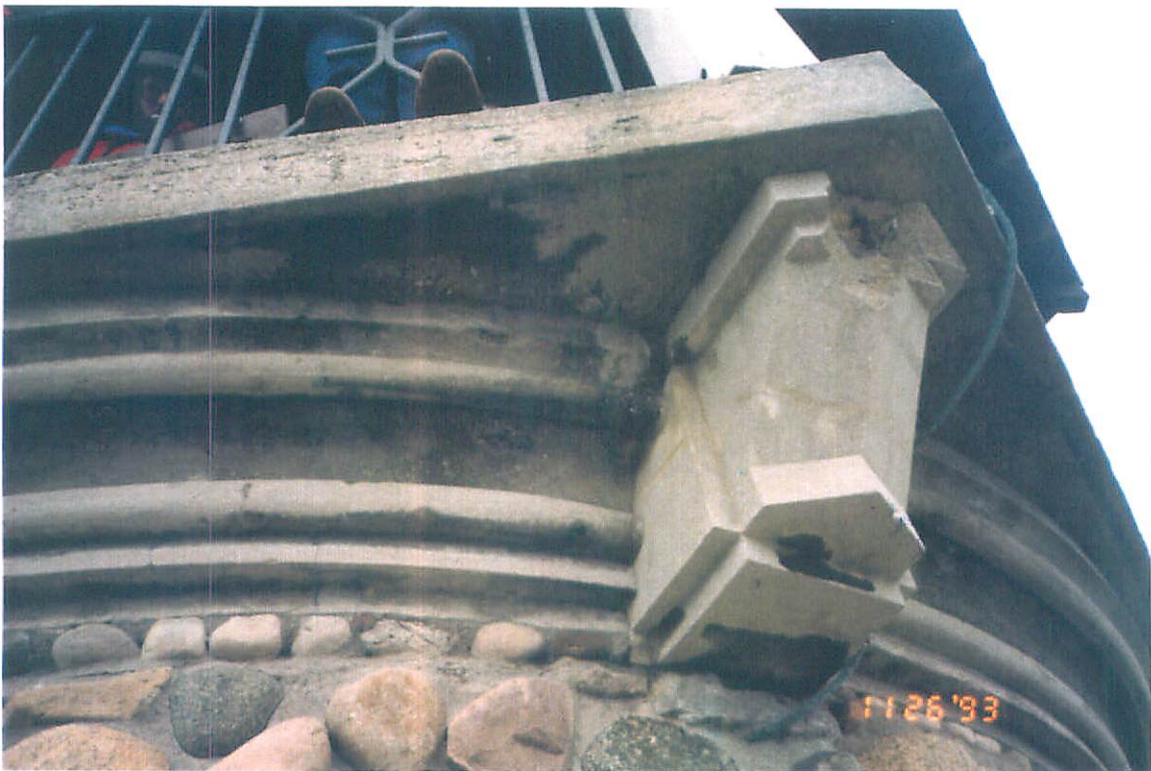
Photo 8: Corbel deterioration

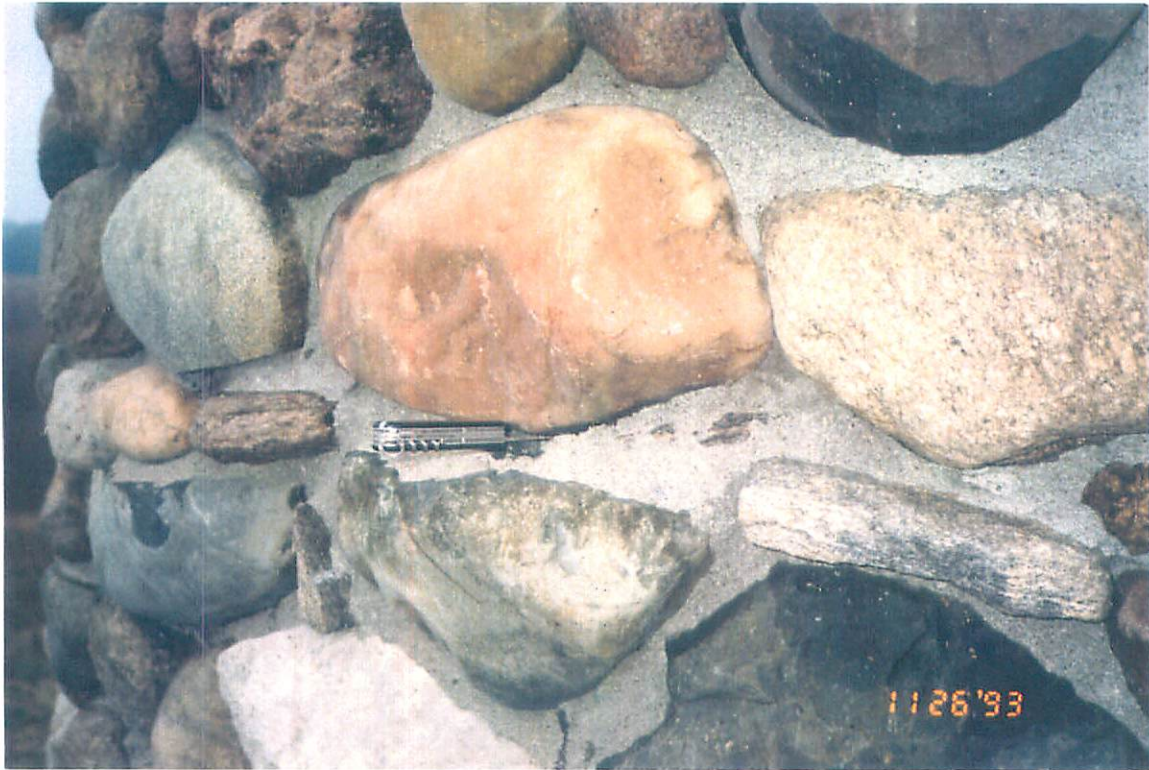
Photo 9: Stone joint deterioration

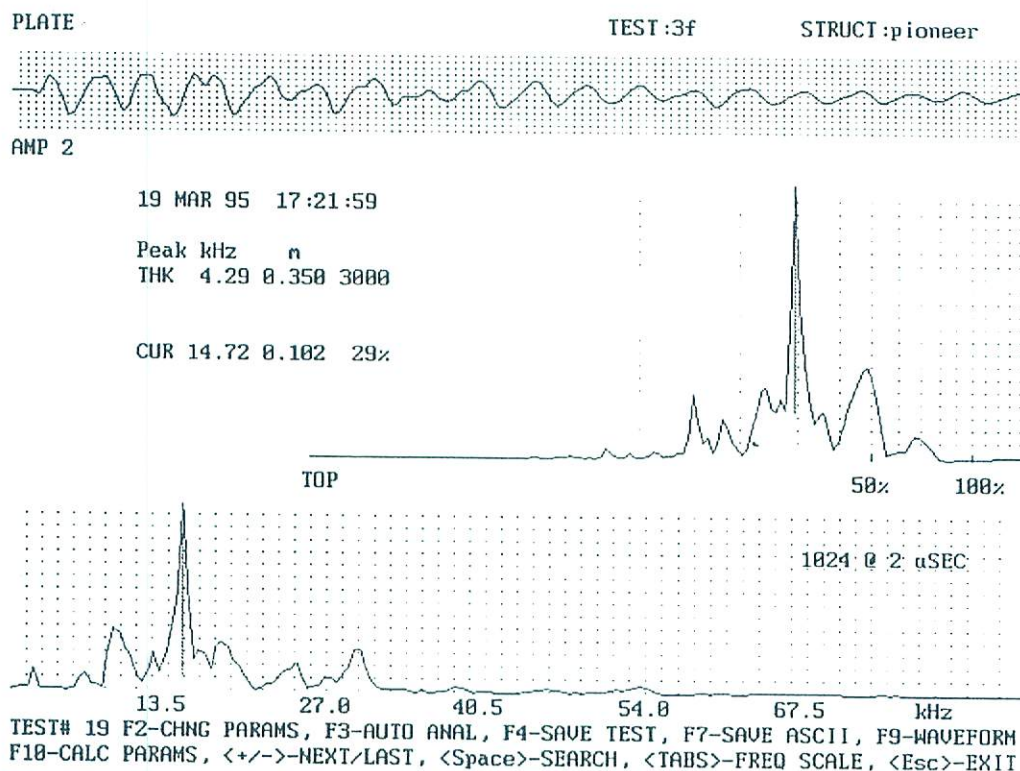
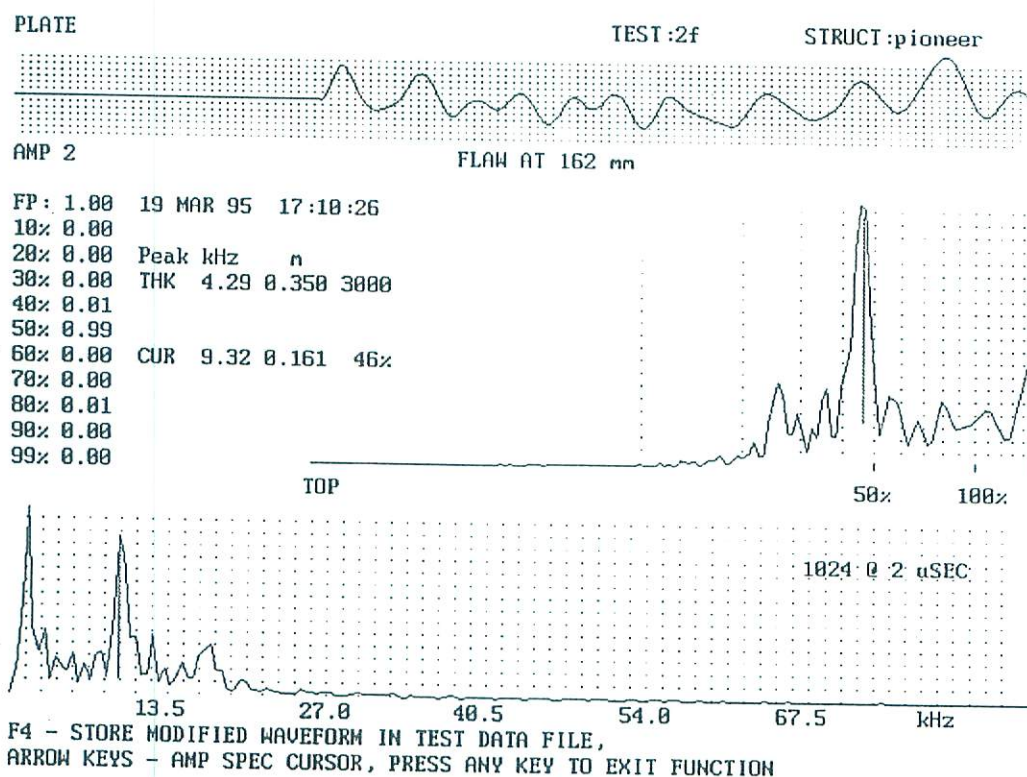
Figure 5.

Examples of signal response showing major fracture within concrete shell

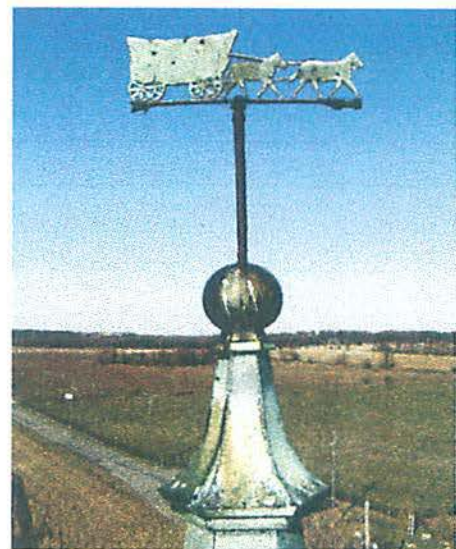
The weathervane operating mechanism is severely corroded and has not operated for some years. The original design does not appear very weather tight. The weathervane base is also severely corroded and is splitting at the ends. The Conestoga wagon and horse weathervane shows signs of corrosion, 'pitting' and has a number of 'bullet holes'.

Decorative cap and weathervane.

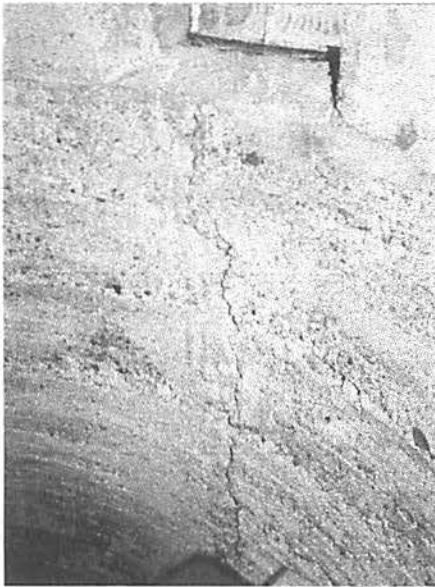
In 1990 the interior surface of the Tower was sandblasted in preparation for the application of 2 coats of a product called *Hydrozo*, in an attempt to seal the inner surface of the Tower. It is noted in later reports that this product has failed. At this time two of the longer cracks were injected with a pliable epoxy and 13 tell-tales were installed. No results of the monitoring of these devices has been reported. In June of 1994, readings were taken on 8 Demec and a Tell-tale structural monitoring system that was installed in March of that year. No significant movements or any trend in the movement of the masonry wall was determined at that time.

Core interior cracks and delamination.
