60 Victoria Street North, Kitchener

Heritage Conservation Plan

60 Victoria Street North, Kitchener, ON

February 28, 2025

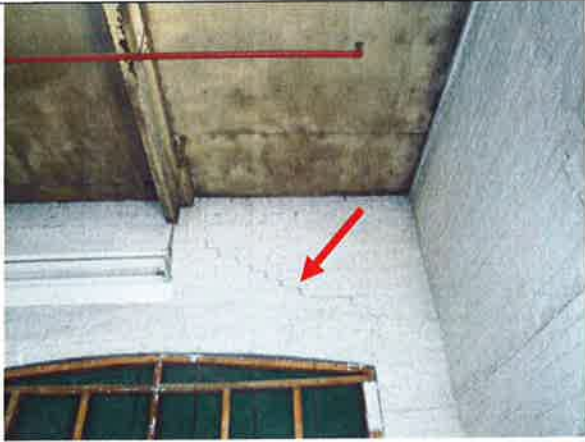
Picture 13

Some cracks were observed in the brick masonry (see Picture 13). In addition bricks were cut and/or removed to make passages for doorways and ducts (See Picture 21). Generally the building masonry appears to be in good condition without significant signs of structural distress.

Crack in the load bearing shear wall

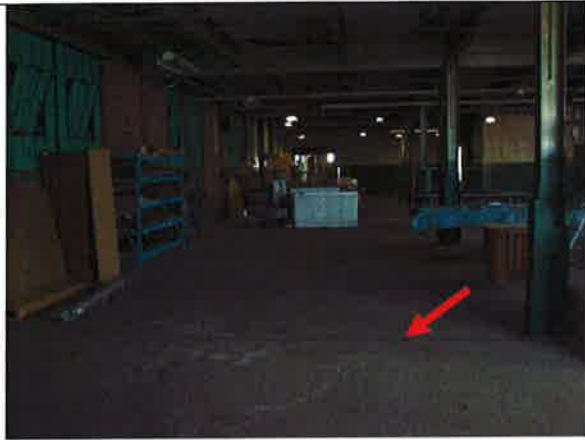
Picture 16

Several cracks were observed in the floor slabs throughout the building (see Picture 16). It is our opinion that these cracks do not require repair and that the floor is capable as-is to support the proposed office floor loading. The floors should be reviewed again for specific areas if the Region wishes to place higher loads than those noted above, such as for computer rooms or high density shelving or storage.

The geotechnical investigation suggests that the floor slab on grade is supported in areas on fill and that voids within the fill were also detected. Settlement of this fill may be partially responsible for several cracks observed in the floor slab throughout the building.

Crack in the floor slab

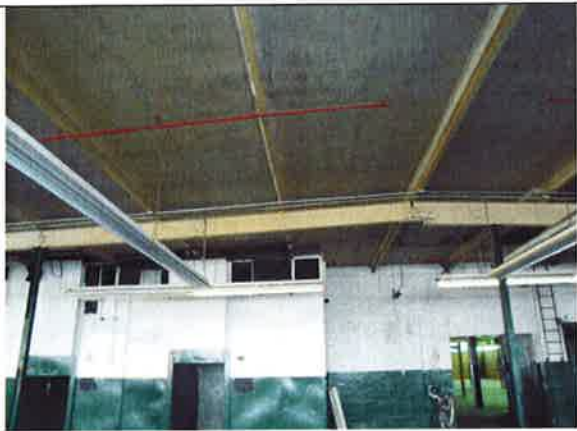
Picture 17

The roof framing and supporting columns in the third storey of the 1913 building are insufficient to support the current design snow load (see Picture 17). We recommend that these columns and beams be reinforced. Alternatively it is recommended that shoring jacks be placed temporarily under the roof beams to reduce the load on the columns and the stresses in the beams until reinforcement can be done. Upon your request, MTE can provide a reinforcement design or shoring plan.

Roof Framing (1913 portion)

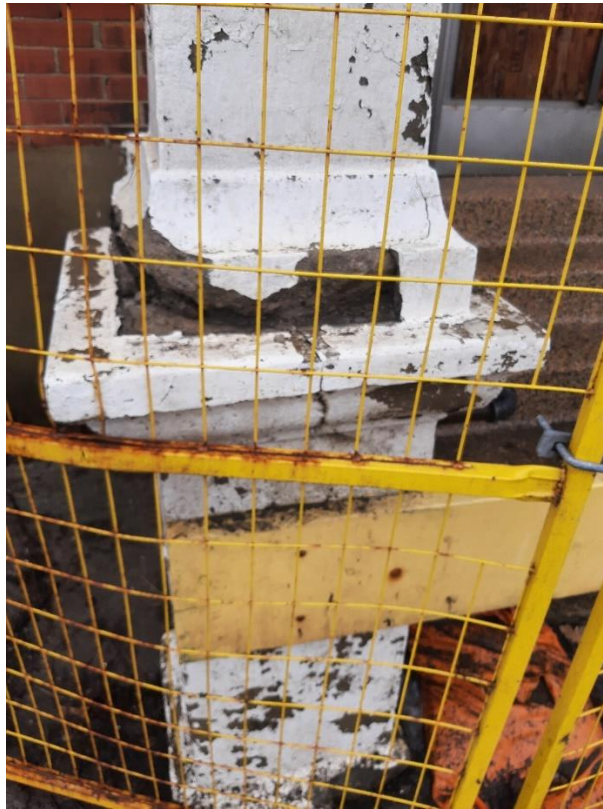
Photograph No. 3 – Left Entrance Column Deterioration

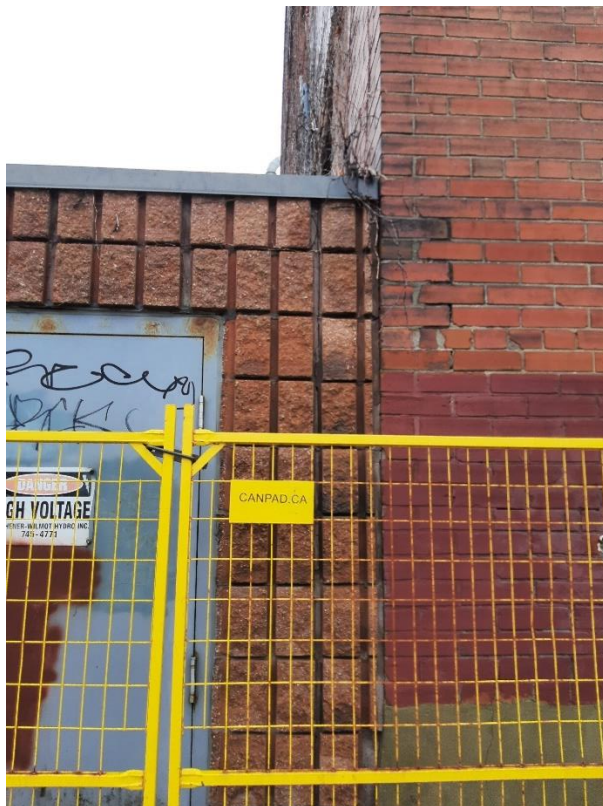
Photograph No. 4 – Brick Mortar Deterioration

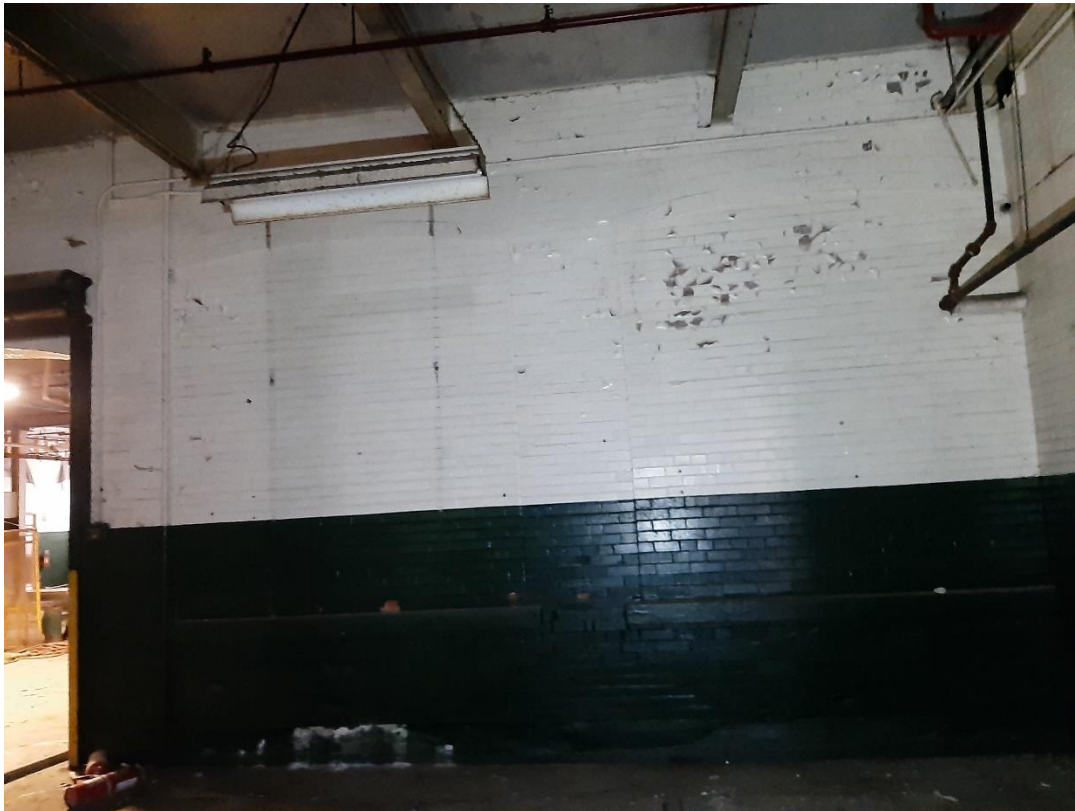
Photograph No. 15 – Ground Floor Painted Wall to Become Exposed East Facade

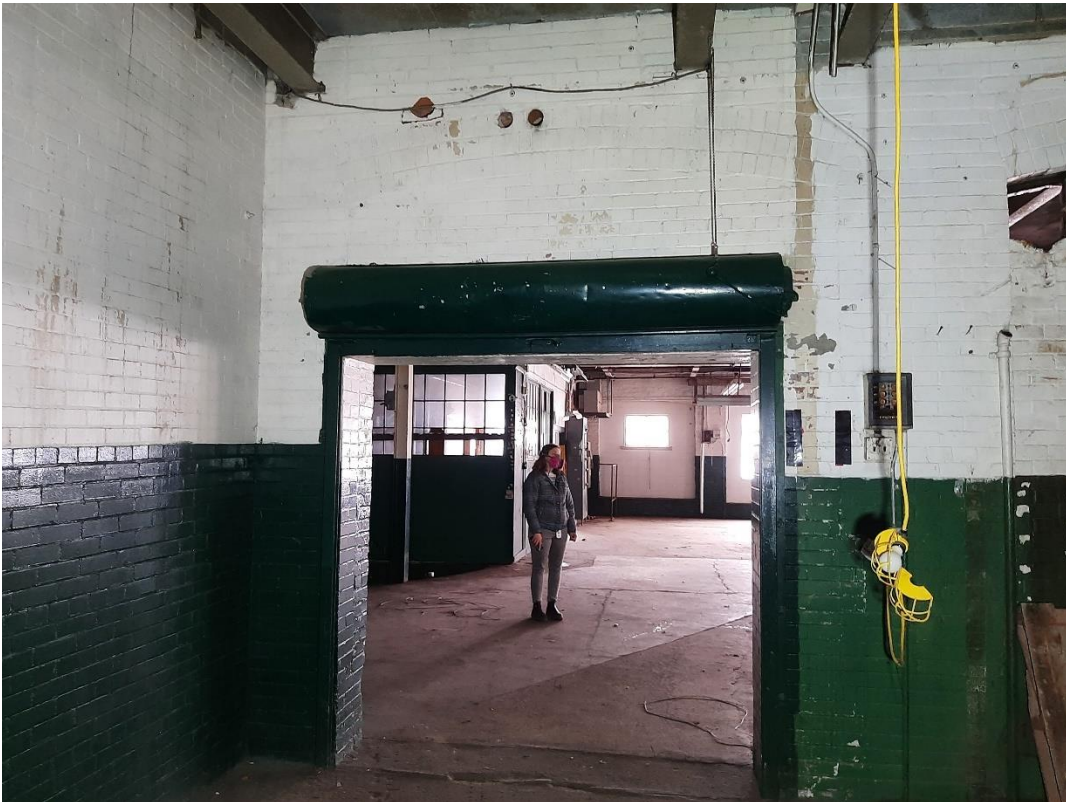
Photograph No. 21 – Second Floor Door to be infilled

3. Where existing doorways and openings along the east wall are exposed, they are to be infilled as per the demolition details with localized sheet metal siding, colour and profile to match the other existing siding infills at other façades. As sheet metal siding is not being installed over the entirety of the east façade, there will be masonry repairs at beam connection points and other wall openings will be infilled with masonry. Full thickness wall infills are to match the existing adjacent wall construction. These are detailed in the demolition drawings.

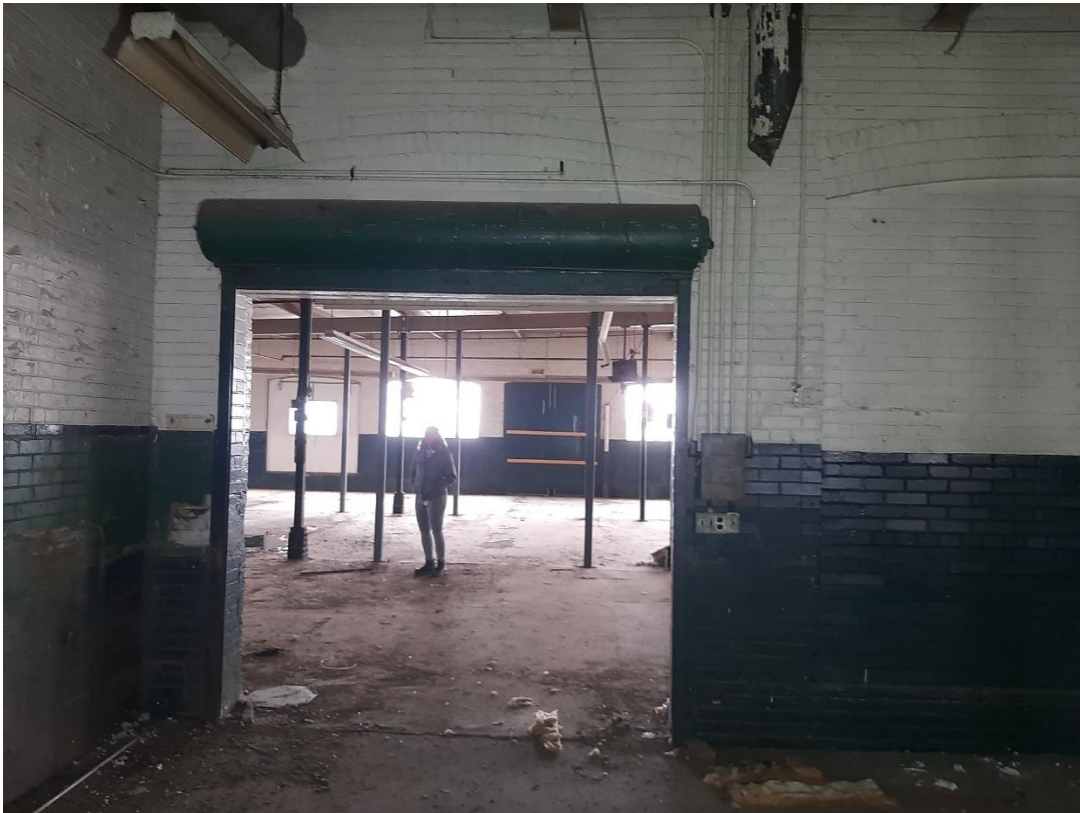
Photograph No. 29 – Third Floor Opening to be infilled

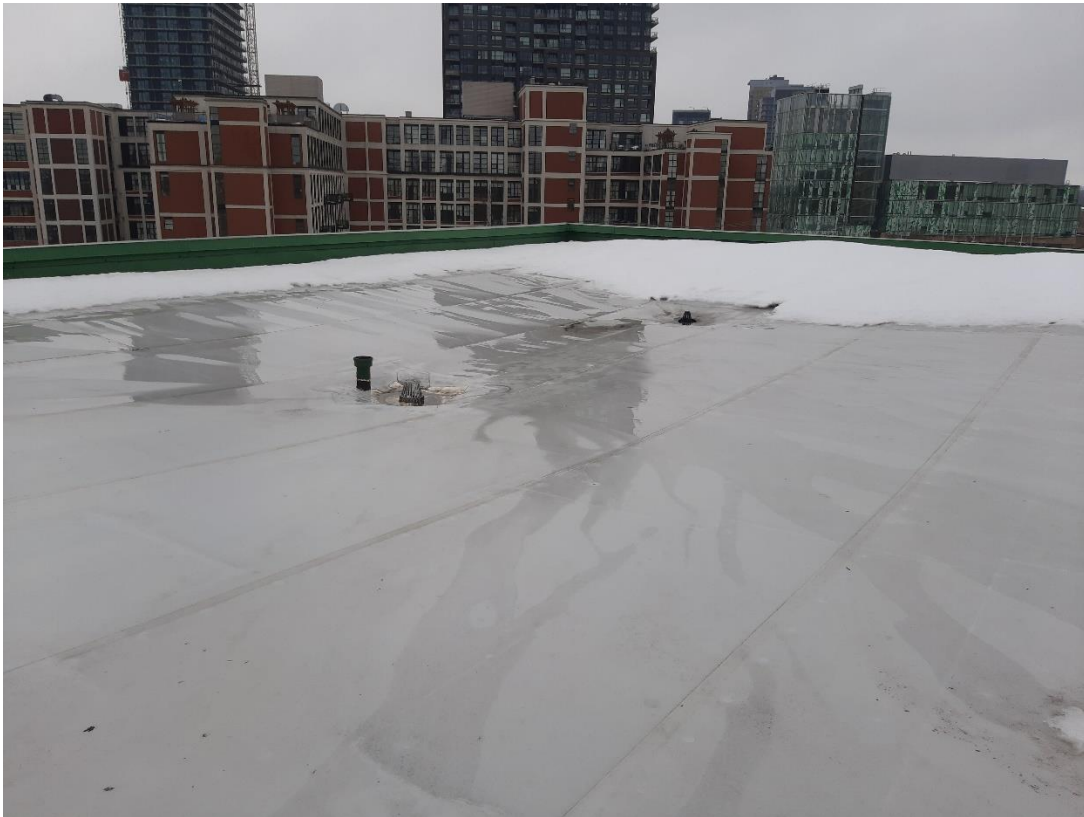
Photograph No. 32 – Roof, Suspected source of water leak thru building

- Make repairs to the roof around drains and any noted open seams to address water leakage. Install new roofing membrane flashing where the parapet wall is to be built up.

- Carry out a roof investigation to fully assess the roofing membrane and structural deck members at leak locations of the 1913 building.

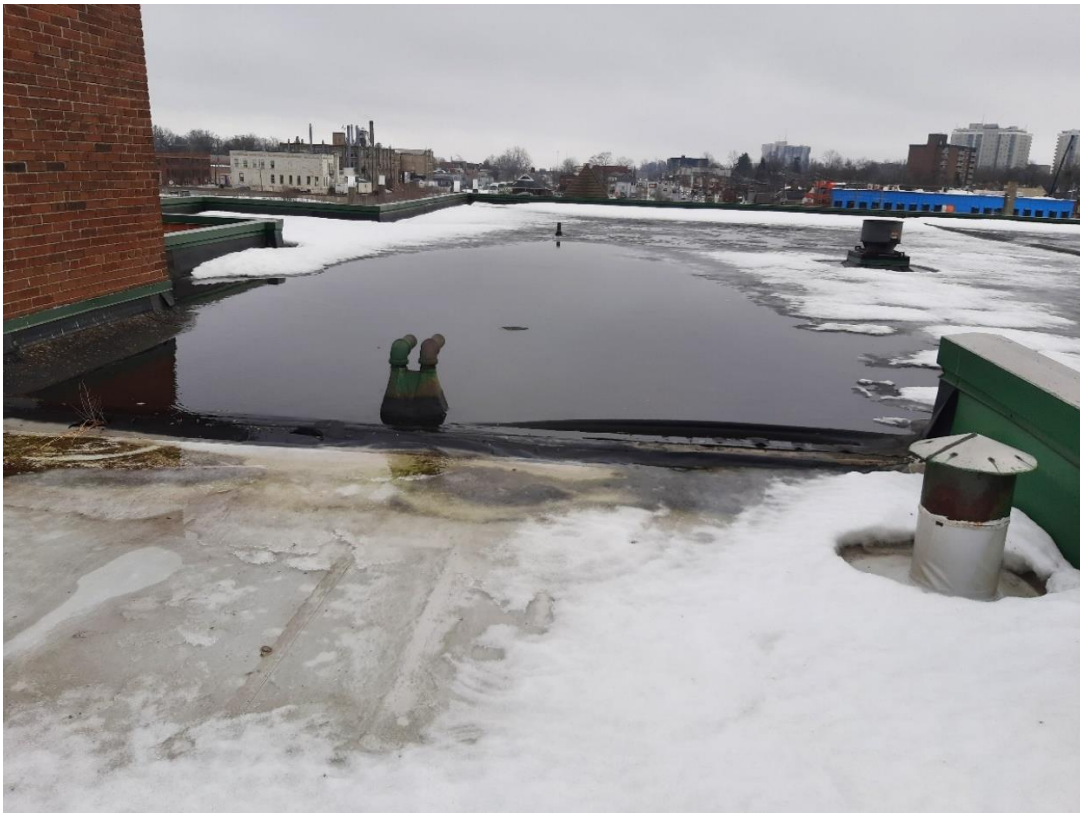
Photograph No. 36 – Edge of 1913 east wall, source of leak

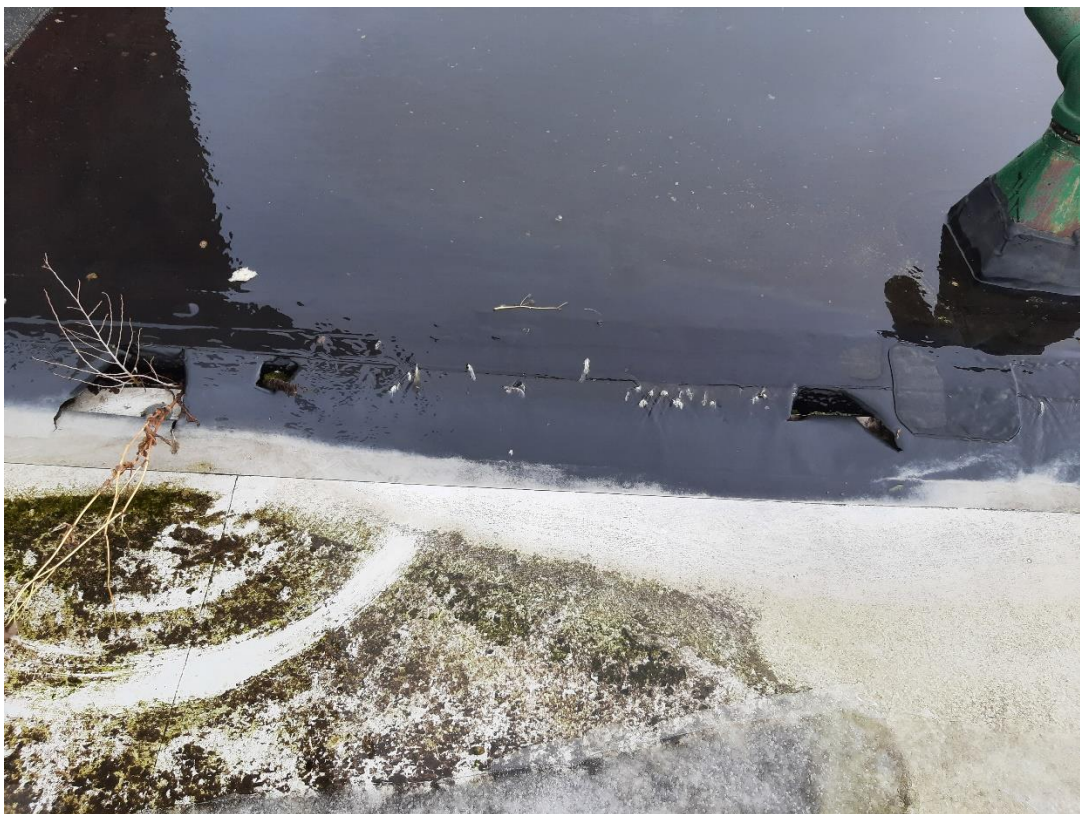
Photograph No. 37 – Edge of 1913 east wall, source of roof leak

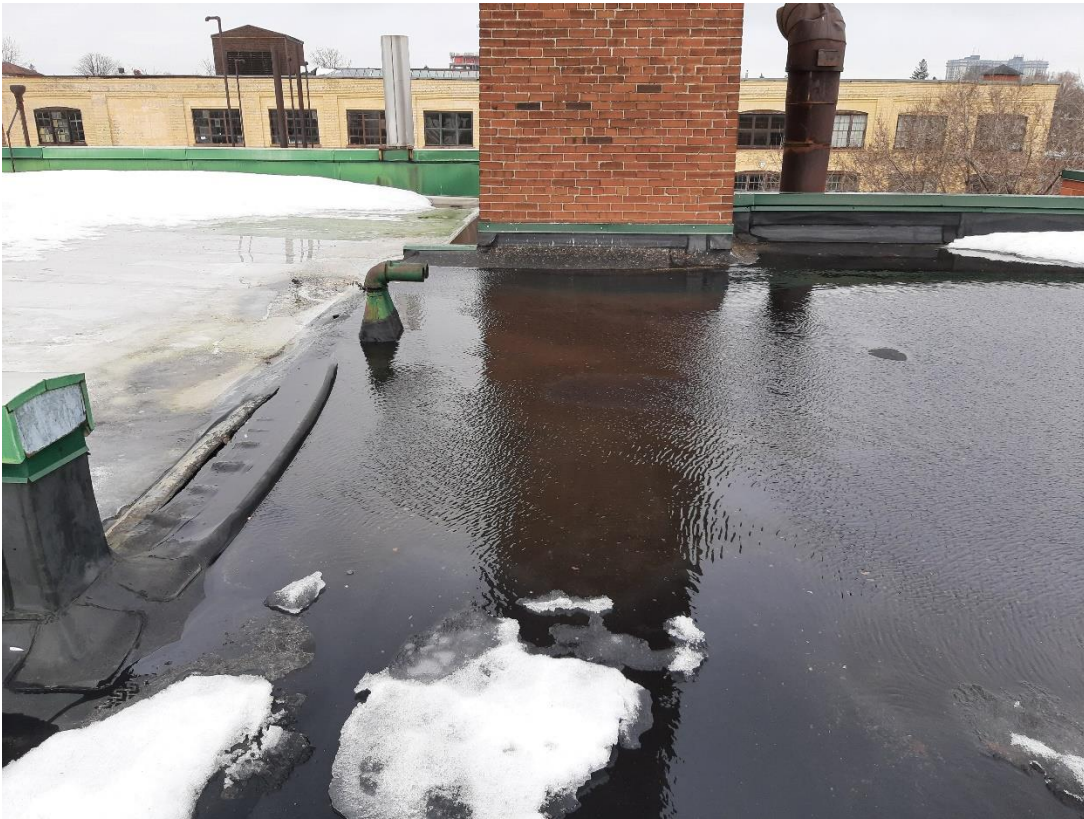
Photograph No. 38 – Edge of 1913 east wall, source of roof leak

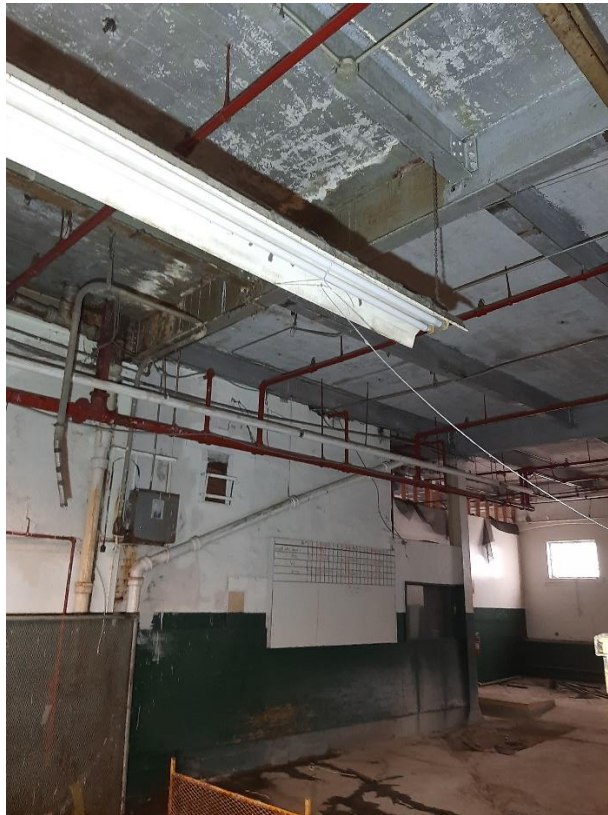
Photograph No. 41 – Ground Floor - Rain water leaking thru Concrete floor slab above

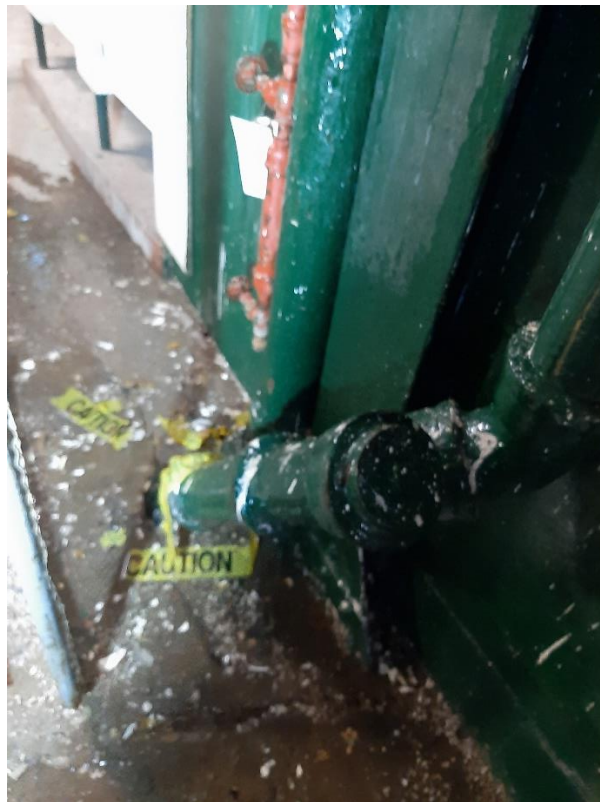
Photograph No. 42 – Ground Floor - Water from Roof Leak

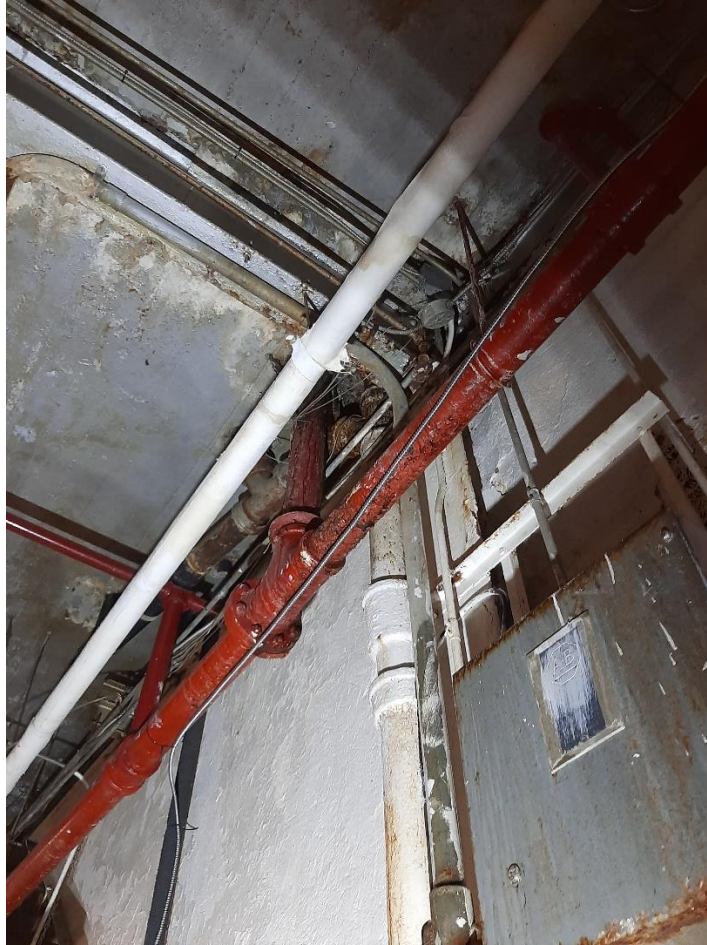
Photograph No. 43 – Ground Floor, Water Leak from Second Floor above

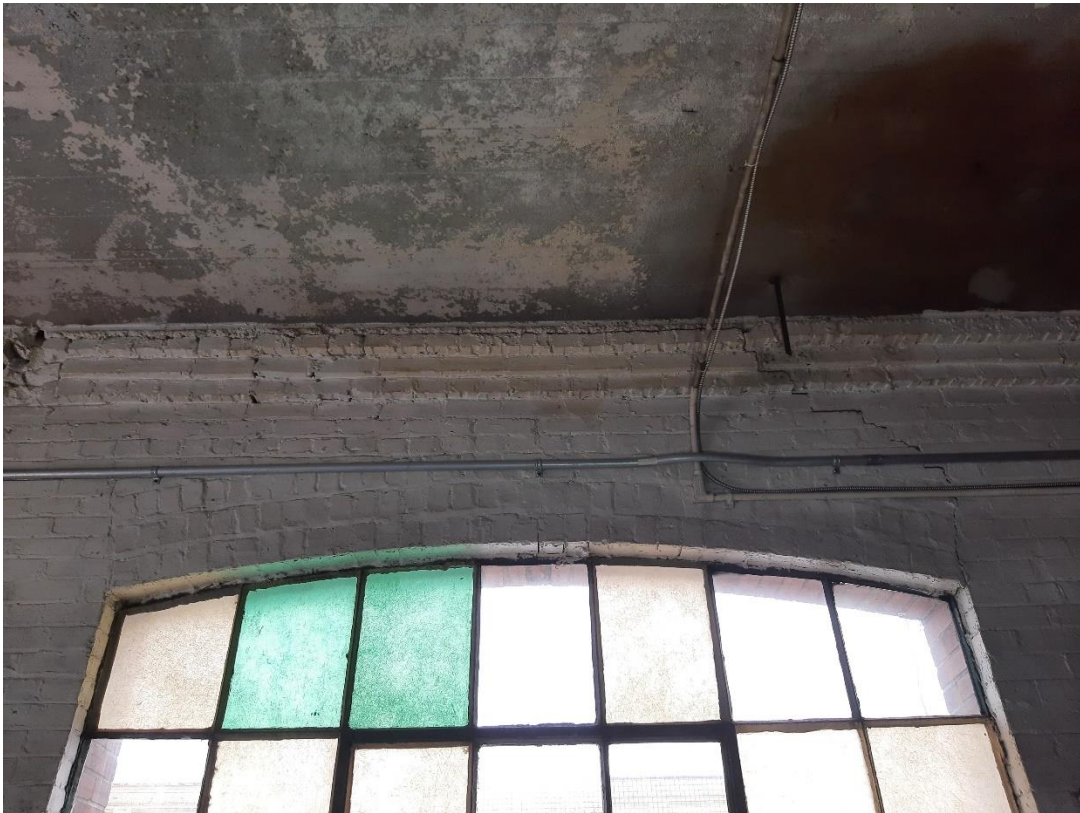
Photograph No. 47 – Second Floor Masonry in Good Condition

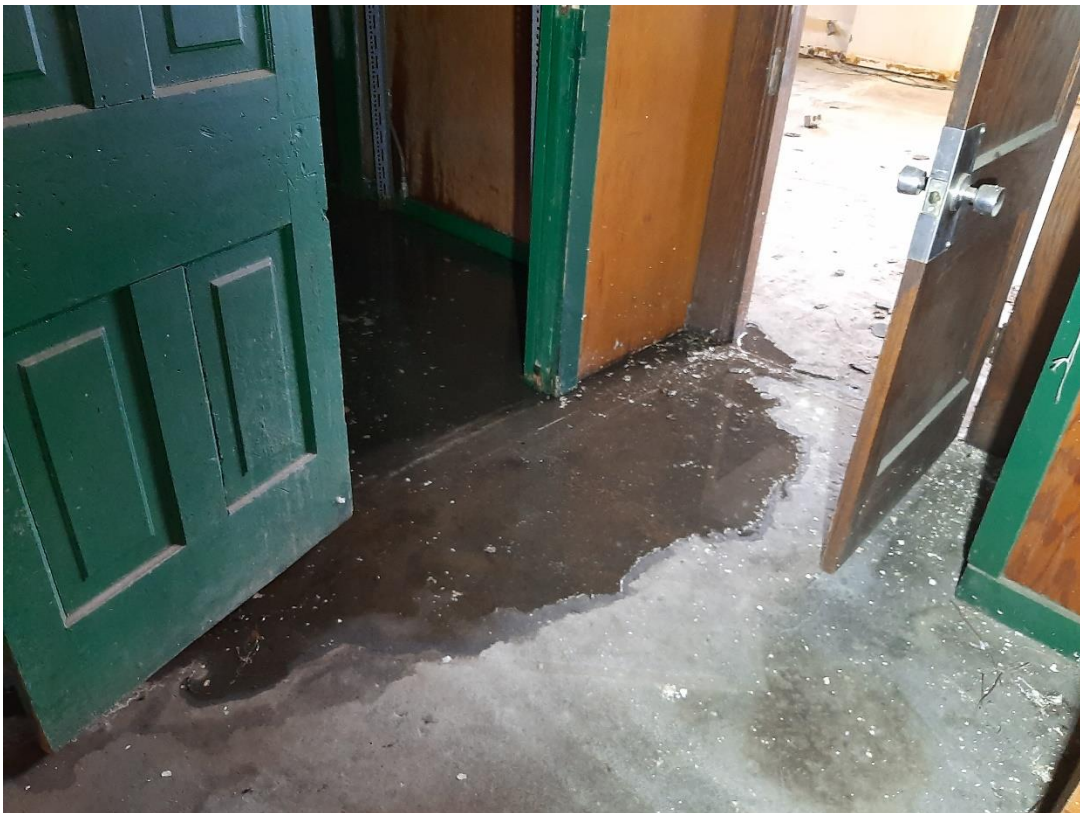
Photograph No. 48 – Second Floor, Water leak from roof

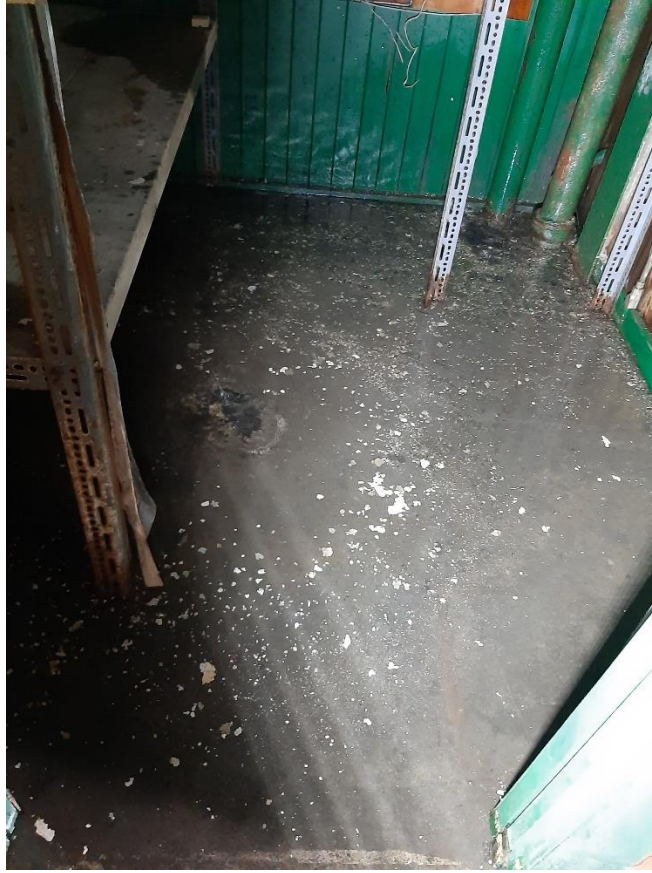
Photograph No. 49 – Second Floor, Water leak from roof

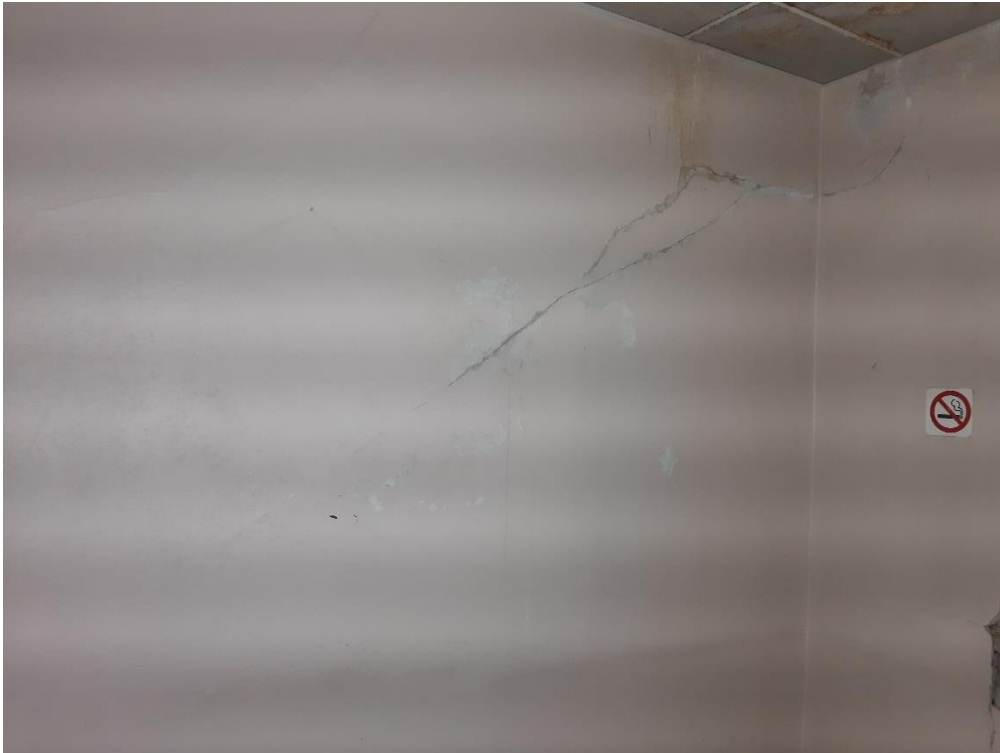
Photograph No. 50 – Second Floor - cracks in wall plaster

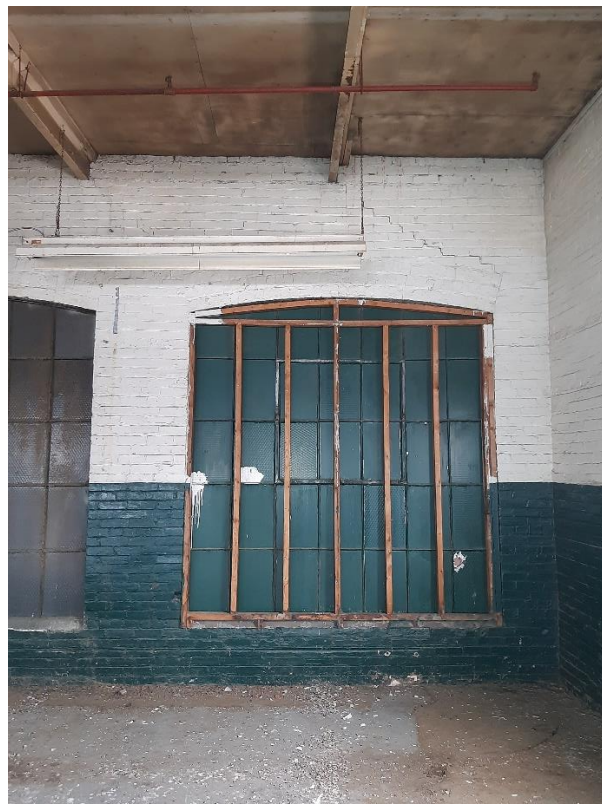
Photograph No. 52 – Third Floor - masonry cracks

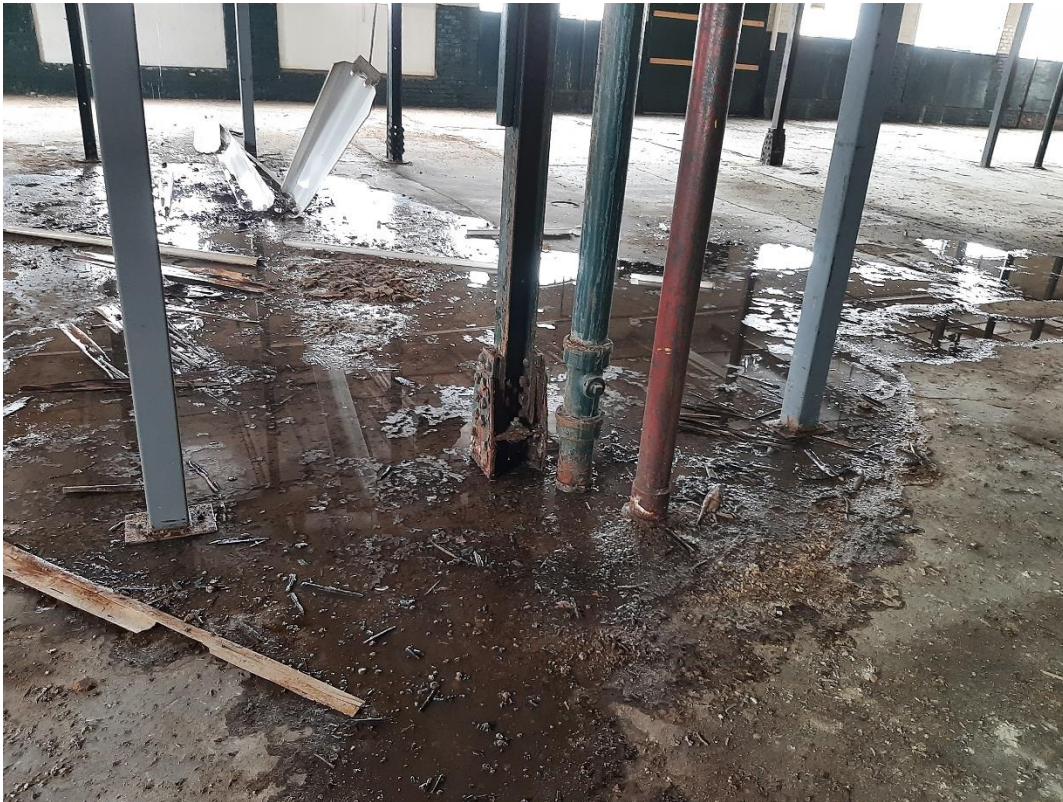
Photograph No. 53 – Third Floor - shoring in place since 2012

4. Existing shoring on the third floor of the original building is to be reviewed to note original position and conditions. It is to be periodically reviewed during demolition to ensure the shoring remains sound. The shoring is currently in place to provide additional support to the roof structure to manage current snow loads.

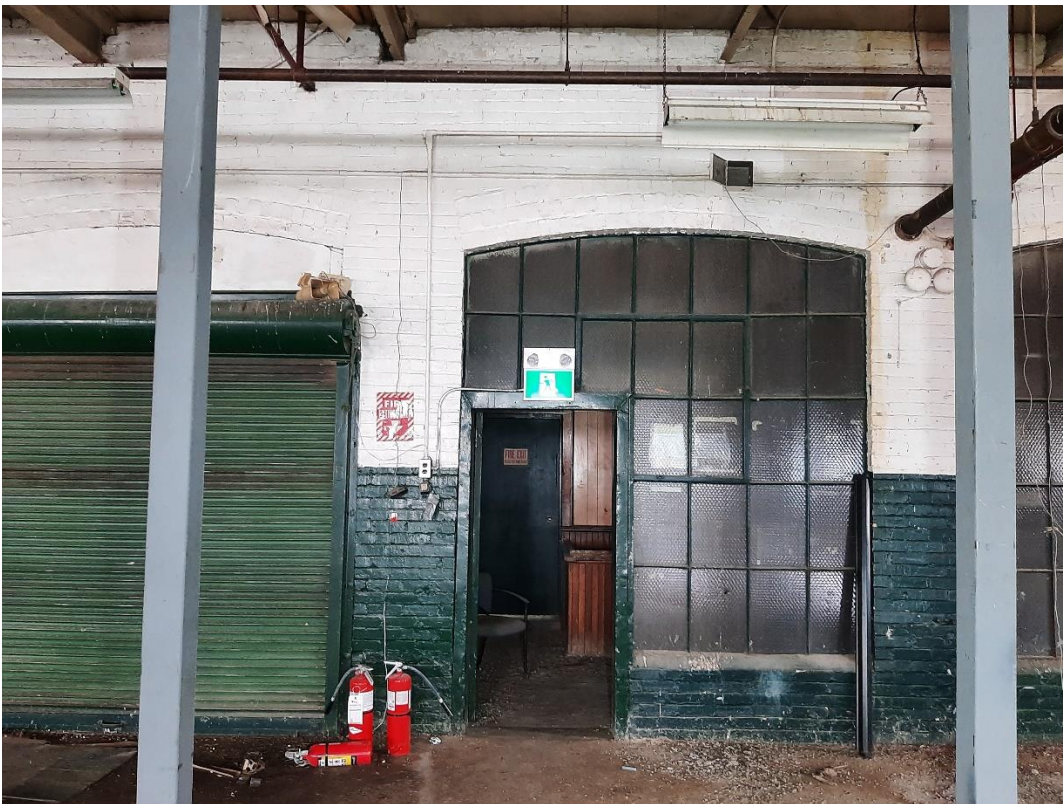
Photograph No. 54 – Third Floor, Masonry in Fair Condition

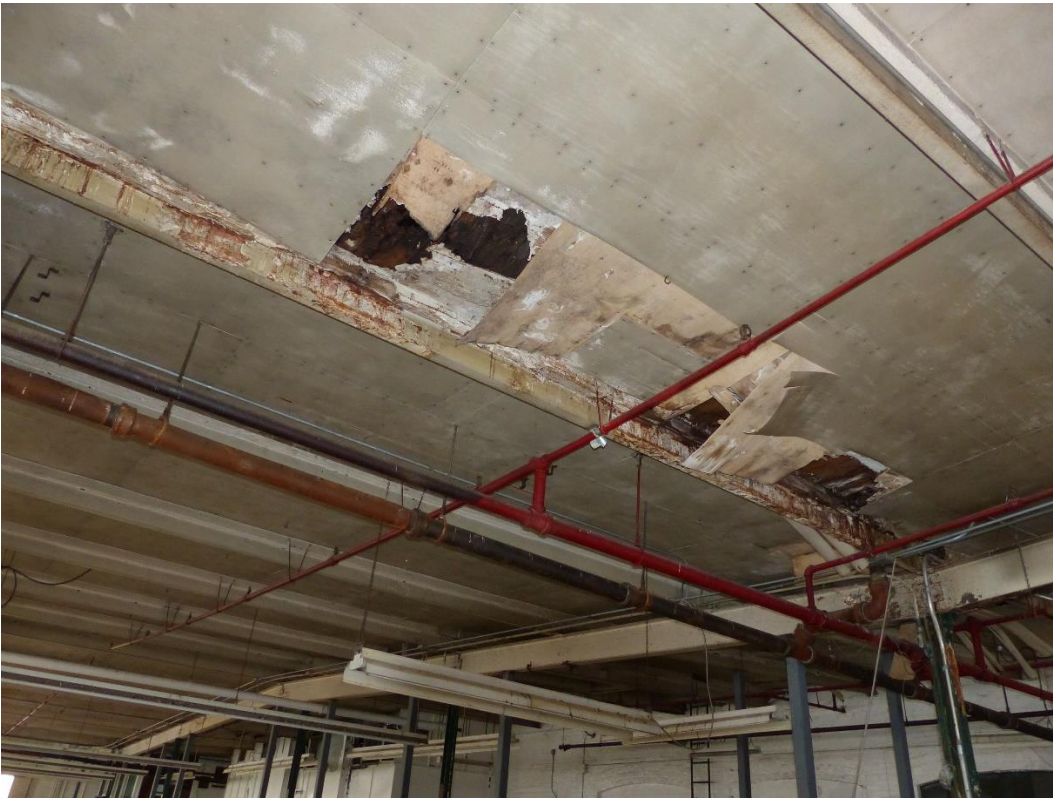
Photograph No. 55 – Third Floor - Ceiling Board damage from roof leak

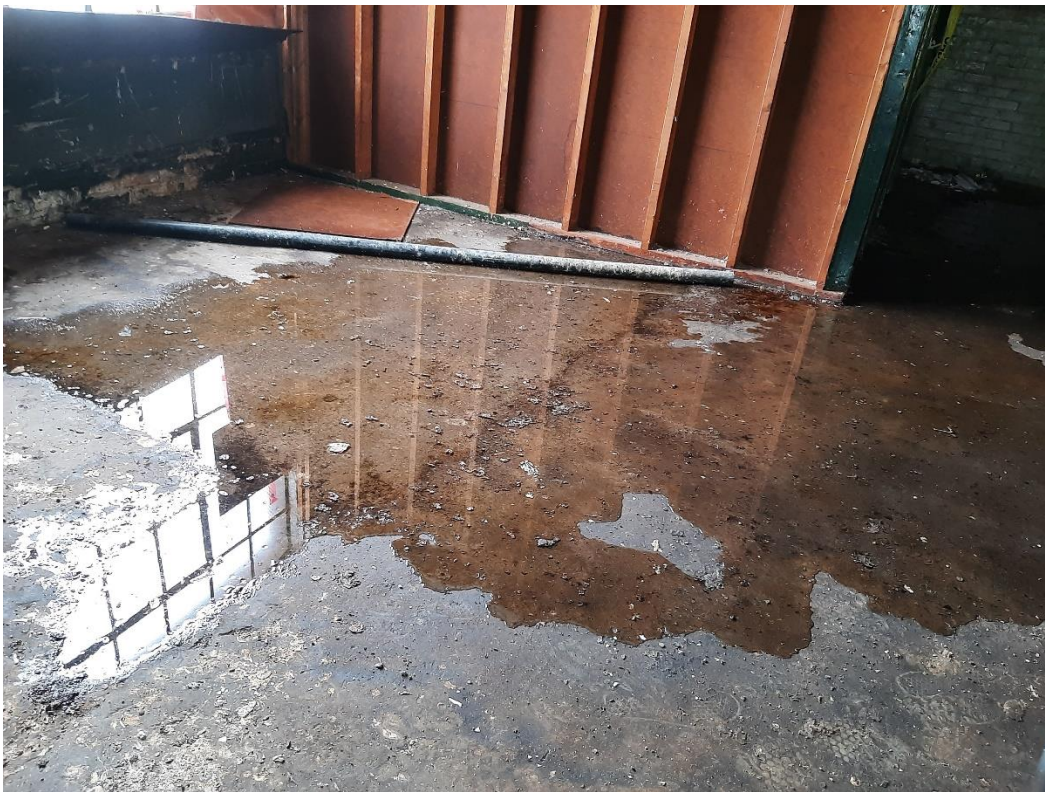
Photograph No. 56 – Third Floor - Water from Roof Leak

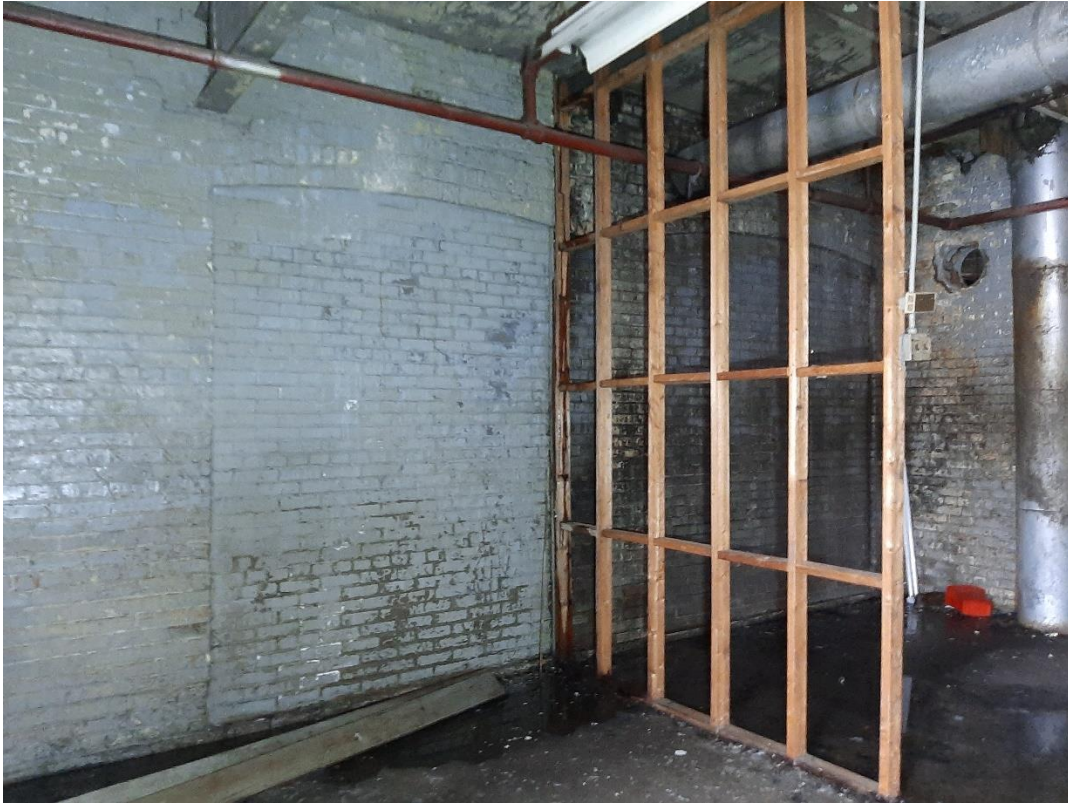
Photograph No. 57 – Third Floor - looking east, Masonry in fair condition

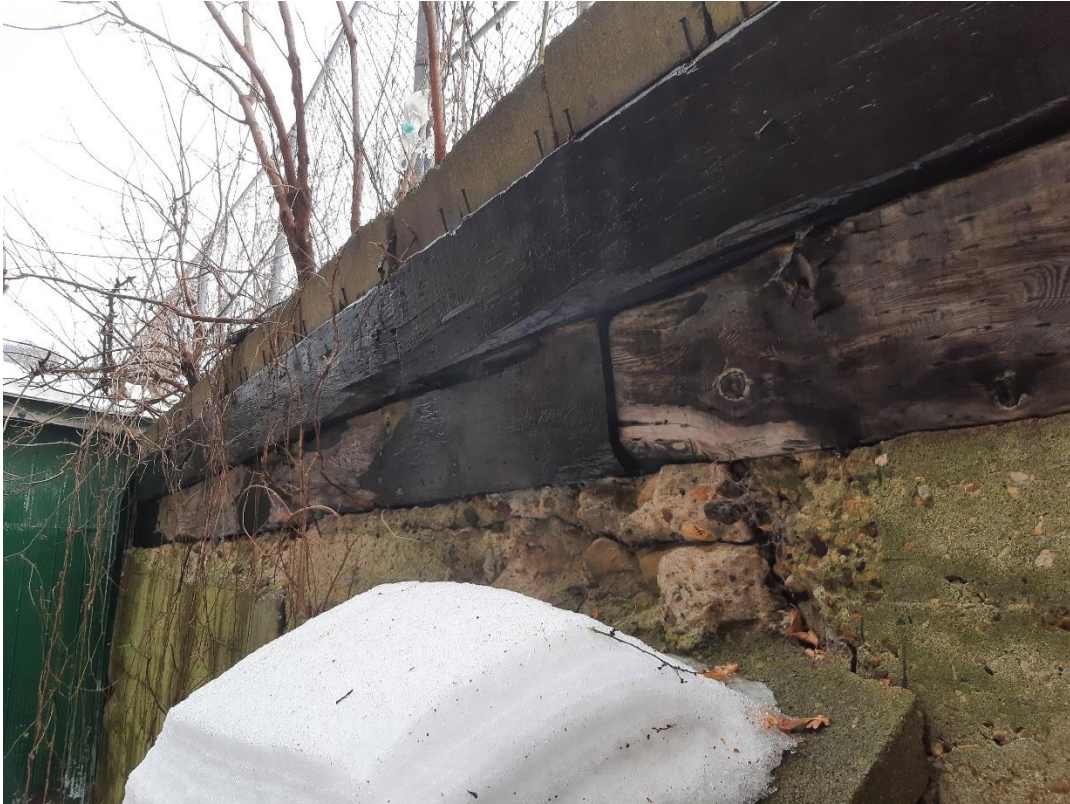
Photograph No. 65 – Courtyard, Timbers leaning, concrete deterioration

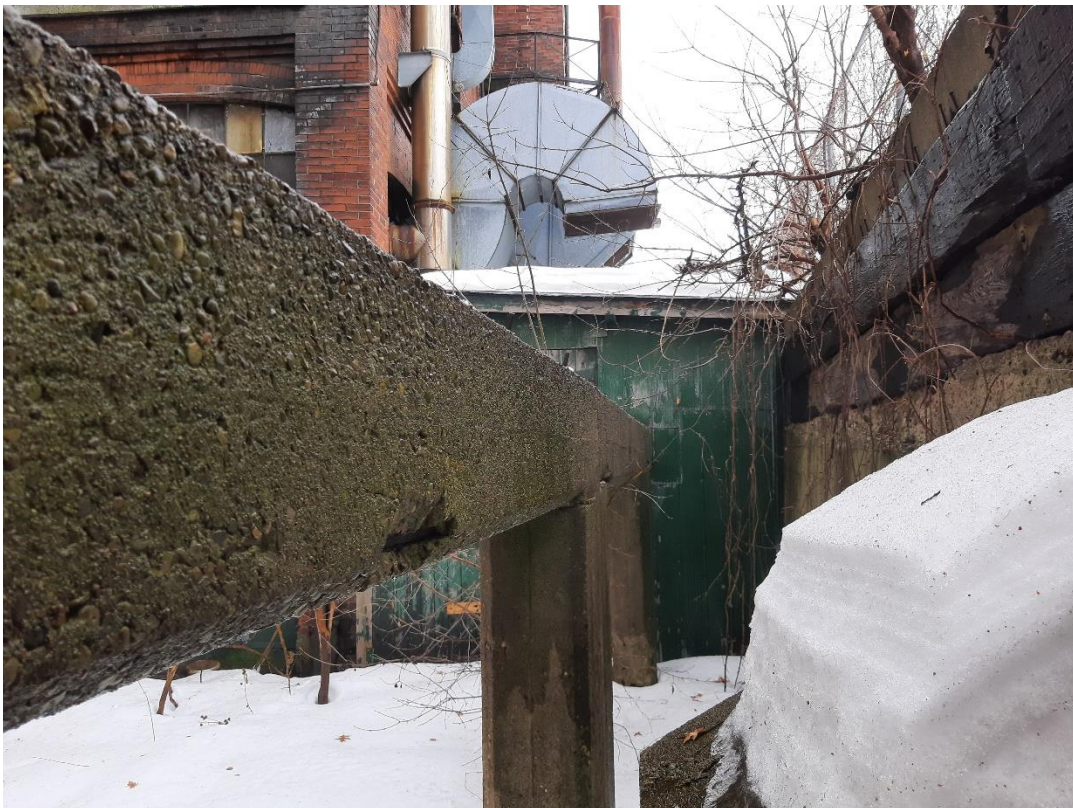
Photograph No. 66 – Courtyard, Timbers leaning, rot
