Date:	May 10, 2024	No. of Pages:	3 + Encl.
Project:	Feasibility and Condition Assessment	Project No.:	TW-1481-24
Address:	63 Courtland Avenue, Kitchener, Ontario	Permit No.:	N/A
Client:	Cantiro		
Distribution:	Cecilia Silva Vanessa Hicks	Cantiro MHBC	CSilva@cantiro.ca vhicks@mhbcpplan.com

Background

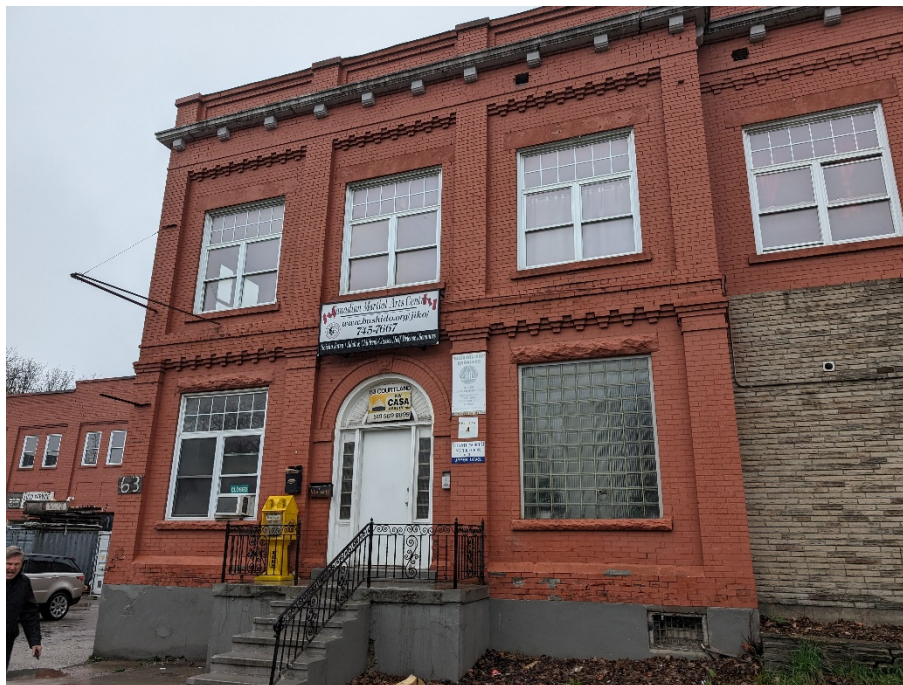
Photograph 1: Overview

Tacoma Engineers has been retained by Cantiro to carry out a structural review of the building located at 63 Courtland Avenue, Kitchener, Ontario. An overview of the building is shown in Photograph 1. The property is being considered for redevelopment, and the developer is wishing to understand the feasibility of retaining a portion of the building as a part of the proposed redevelopment. The subject building was originally constructed in 1909 by J.M. Schneider as a part of his business venture. As such, the building has historical value, and it is believed the City of Kitchener will want a portion retained as a part of any redevelopment of the property.

The building was found to be in fair condition, with no observed damage that would cause concern for structural stability. However, the exterior masonry was showing signs of distress due to lack / incorrect maintenance practices over the years. The exterior masonry will need to be restored as a part of any redevelopment to ensure that the historic fabric is not compromised by the exterior weather elements.
