<b>Date:</b>	December 9, 2024	<b>No. of Pages:</b>	3 + Encl.
<b>Project:</b>	Feasibility and Condition Assessment	<b>Project No.:</b>	TW-1481-24
<b>Address:</b>	63 Courtland Avenue, Kitchener, Ontario	<b>Permit No.:</b>	N/A
<b>Client:</b>	Cantiro		
<b>Distribution:</b>	Cecilia Silva Vanessa Hicks	Cantiro MHBC	CSilva@cantiro.ca vhicks@mhbcpplan.com

### Background

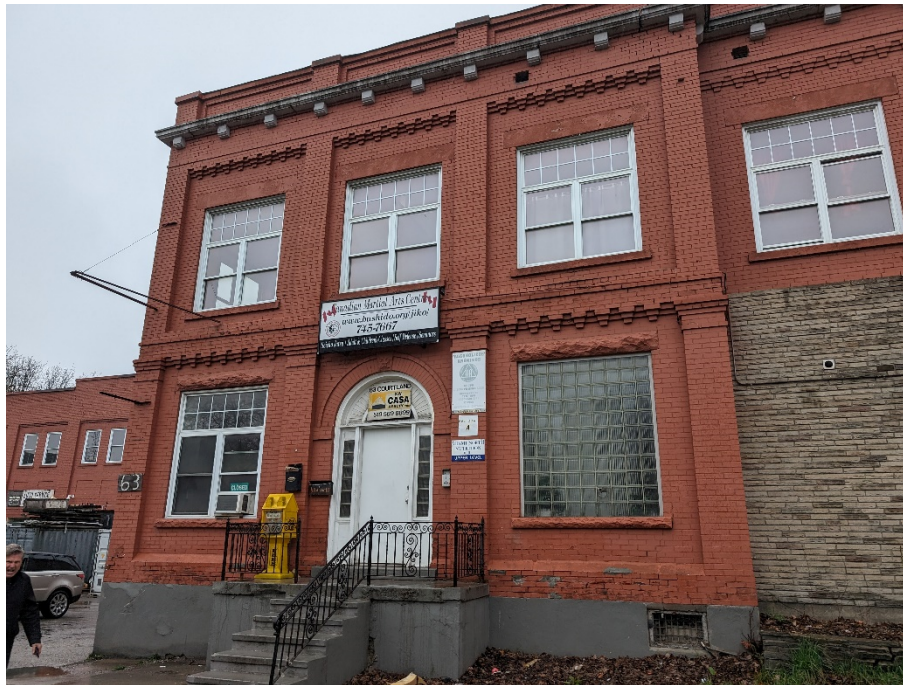
**Photograph 1: Overview**

The building was found to be in fair condition, with no observed damage that would cause concern for structural stability. However, the exterior masonry was showing signs of distress due to lack / incorrect maintenance practices over the years. Long term exposure to the elements will cause deterioration of the lime mortar joints in the brick, and the brick themselves. This damage can be accelerated with poor water management, caused by damaged downspouts, or poor roof flashings. The exterior masonry will need to be restored as a part of any redevelopment to ensure that the historic fabric is not compromised by the exterior weather elements.
