April 3, 2025 MTE File No.: C33233-301

RE: Rumpel Felt 1913 Heritage Building – Structural Assessment 60 Victoria Street North, Kitchener, Ontario

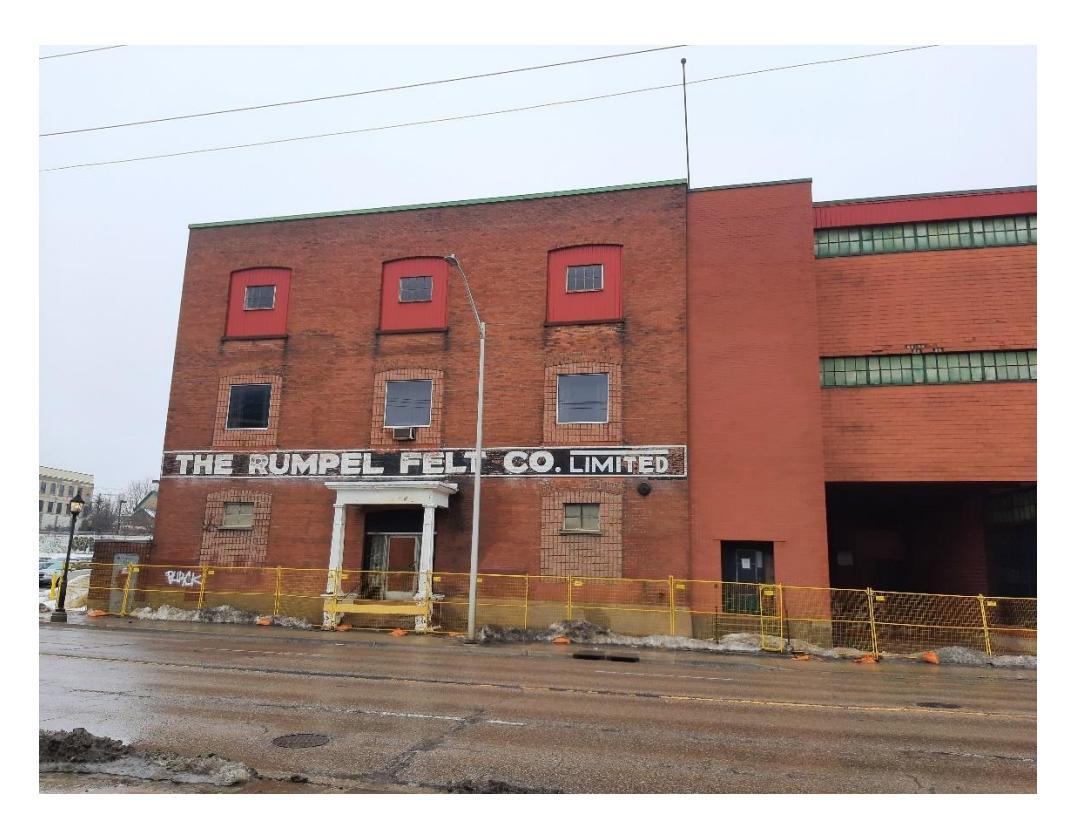
- The masonry is generally in good condition with limited cracks and mortar deterioration. Newer brick has been added to infill window areas, in satisfactory condition. (Photograph 1).

Photograph No. 1 – South Façade

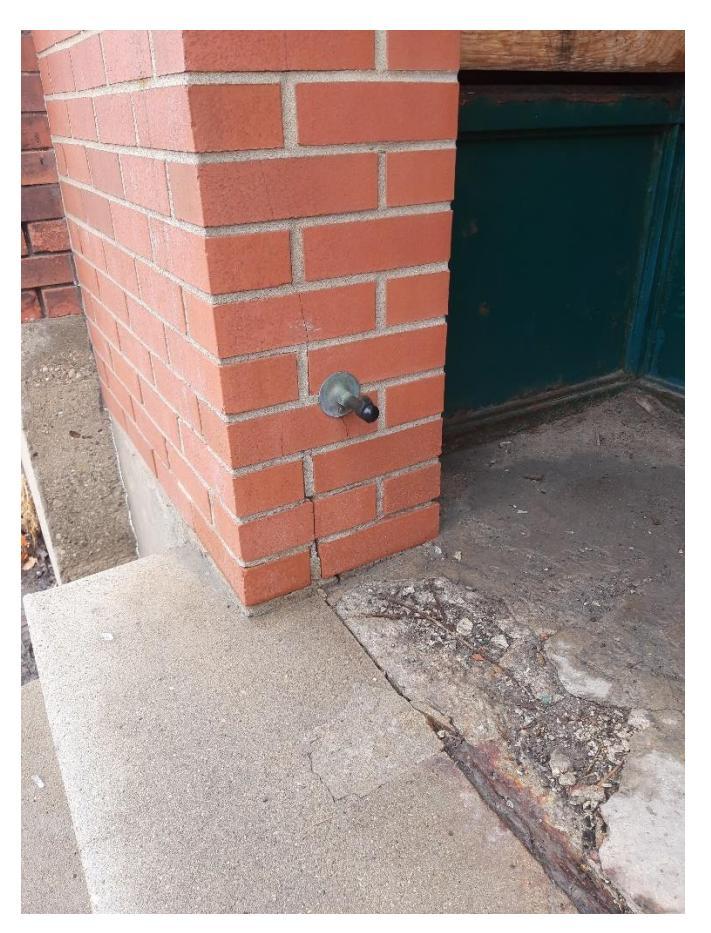
- East Entrance (Victoria St) Concrete steps and landing slab badly cracked, heaved (door has trouble opening). Recommend repair, and/or partial reconstruction. (Photograph 2). Hollow metal door is badly corroded (non structural, recommend replacement).

Photograph No. 2 – Right Entrance Floor Slab Deterioration

- 1. The front entrance concrete landing slab and stairs have significant deterioration and should be rehabilitated.
- Roof leaks should be addressed as soon as possible. Engage a roofing consultant to assess the roofing membranes and parapet details to ensure longevity.

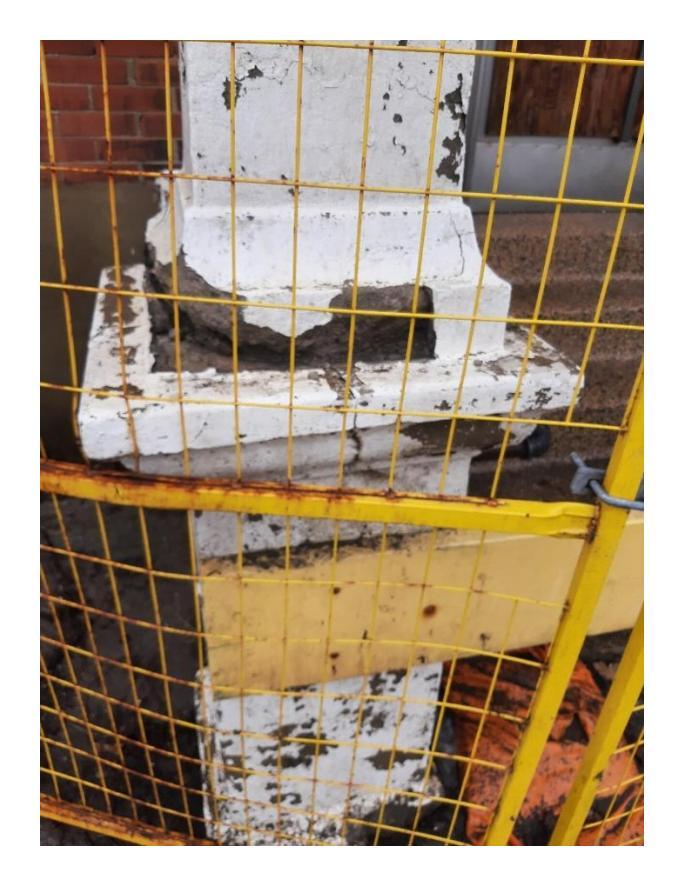
- Central Entrance (Victoria St) Concrete entrance posts & canopy are cracked; paint badly cracked/peeling; Concrete piers badly deteriorated (Photograph 3). The concrete steps are also badly deteriorated. Recommend further investigation to determine the extent of delamination and deterioration and to decide on restoration or replacement. Recommend providing hoarding enclosure as soon as possible to protect the structure from further deterioration until structure can be assessed.

Photograph No. 3 – Left Entrance Column Deterioration

- The front entrance concrete structure has undergone significant deterioration. Further
 investigation is required to determine the extent of delamination and deterioration and to
 decide on restoration or replacement. A hoarding enclosure should be placed as soon as
 possible to protect the structure from further deterioration until structure can be assessed.

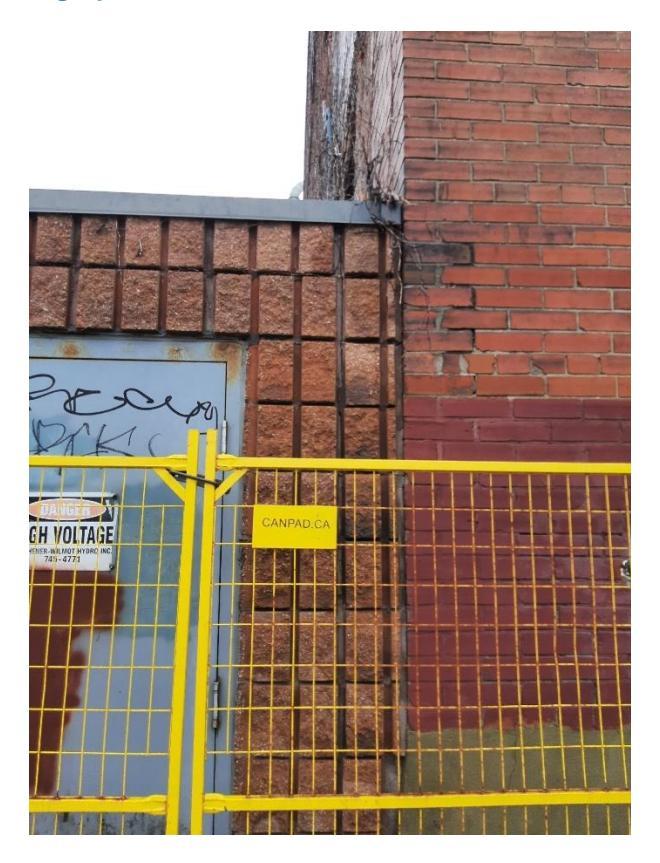
- 4. Brick mortar has deteriorated in areas; brick veneer cracked at entrance (Photograph 4).
- 5. Vines growing on the west wall hold moisture and are a threat to the long term durability of the brick and should be removed. (Photograph 7).

Photograph No. 4 – Brick Mortar Deterioration

- 4. Repoint all brick mortar deterioration. Monitor thru brick cracks or replace brick (Photograph 2).
 - 5. Infill all masonry holes and openings, toothing in to match existing courses. (e.g. Photographs 22,23).

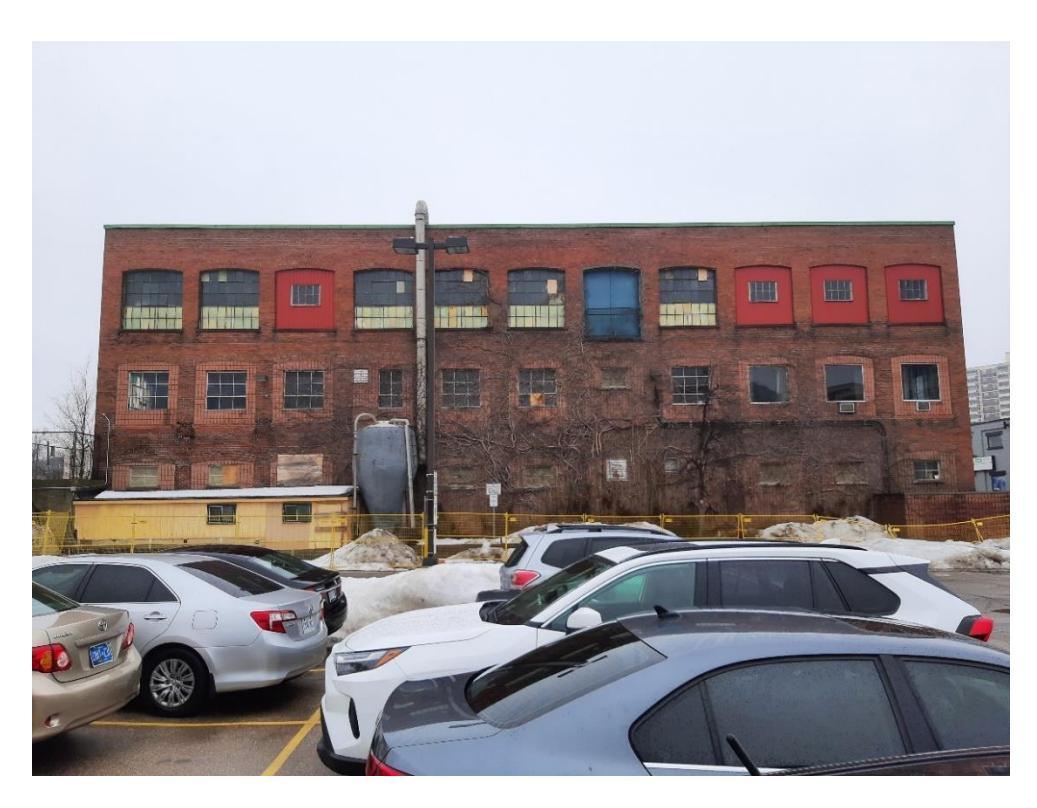
Photograph No. 7 – West Elevation

- 2. The condition of the roof members and deck at leak sites should be investigated and confirmed or remedied if found to be deficient.
 - 3. Remove vines from brick masonry.

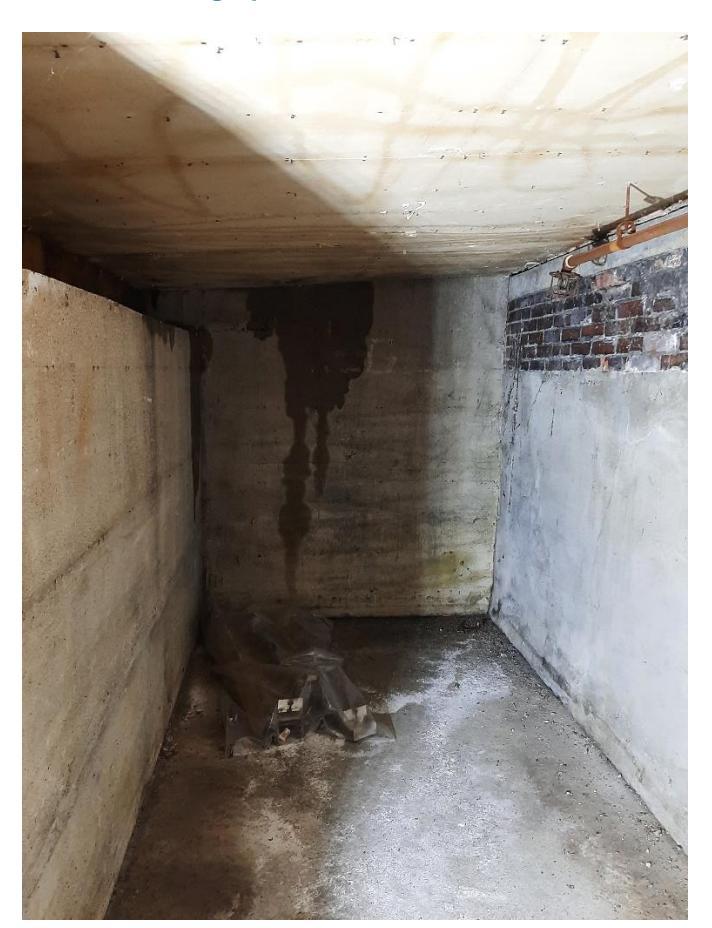
Photograph No. 8 – West Shed Addition, to be Removed

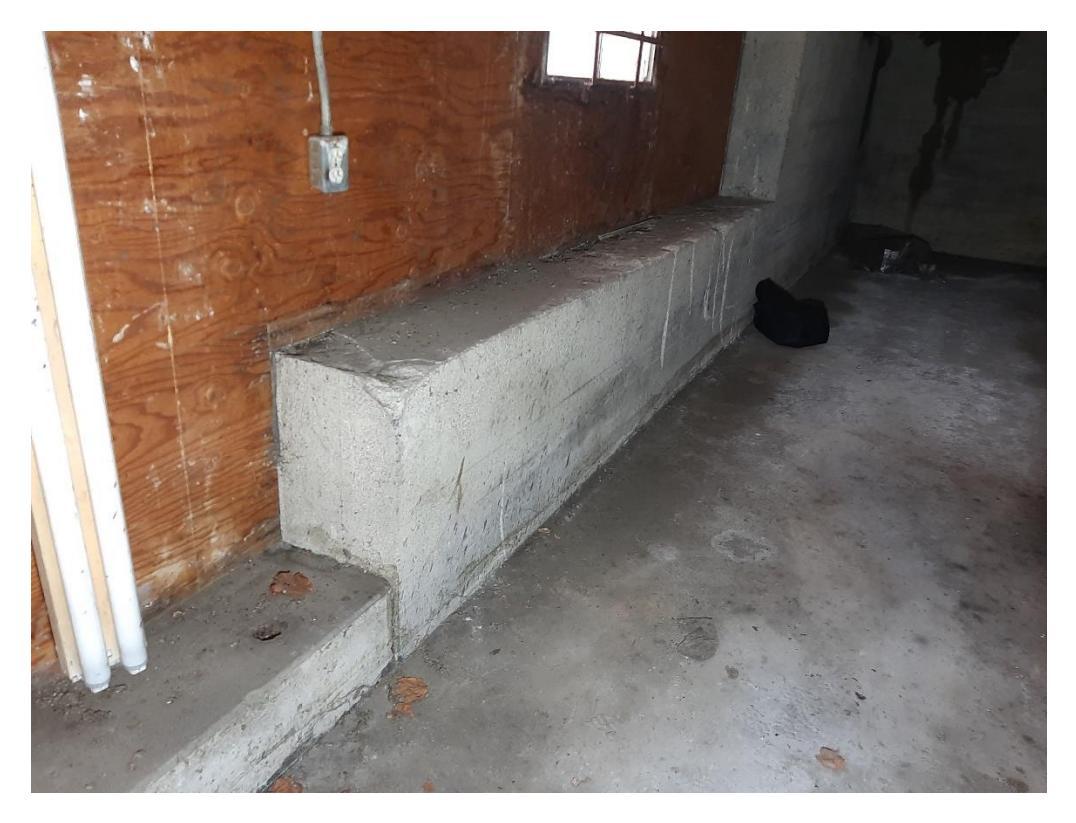
Photograph No. 9 – West Shed Addition Foundations, to be Removed

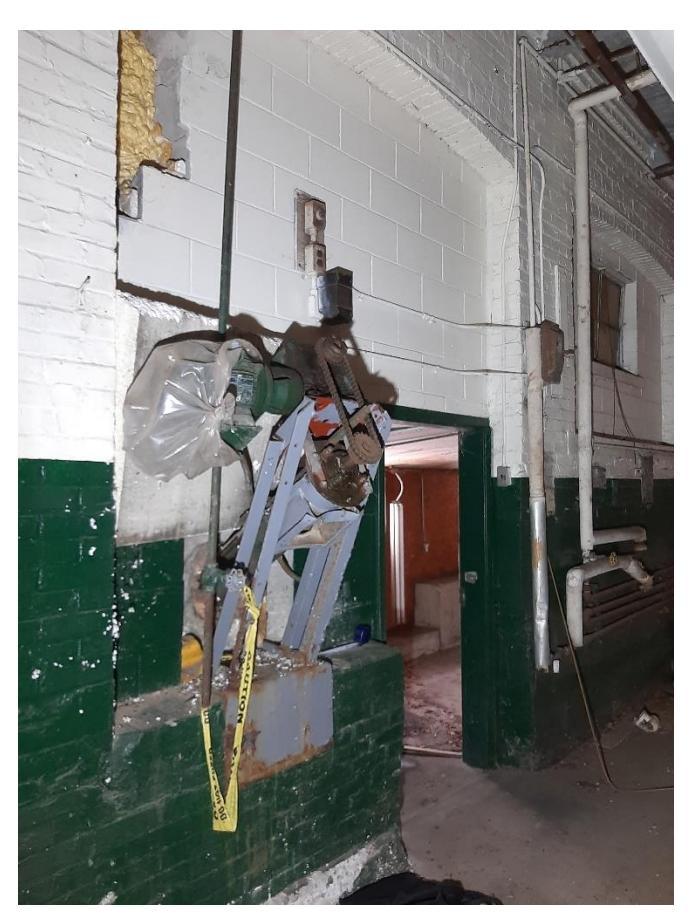
- 6. Window caulking worn/brittle; needs to be replaced/redone.
- 7. West shed was an addition; see door through blocked up window (Photographs 7-10).
- Very few cracks in masonry; some windowpanes missing or cracked. (Photographs 11-13). Evidence of step cracking and repointing of mortar (Photograph 13).

Photograph No. 10 – West Shed Entrance Within Former Window

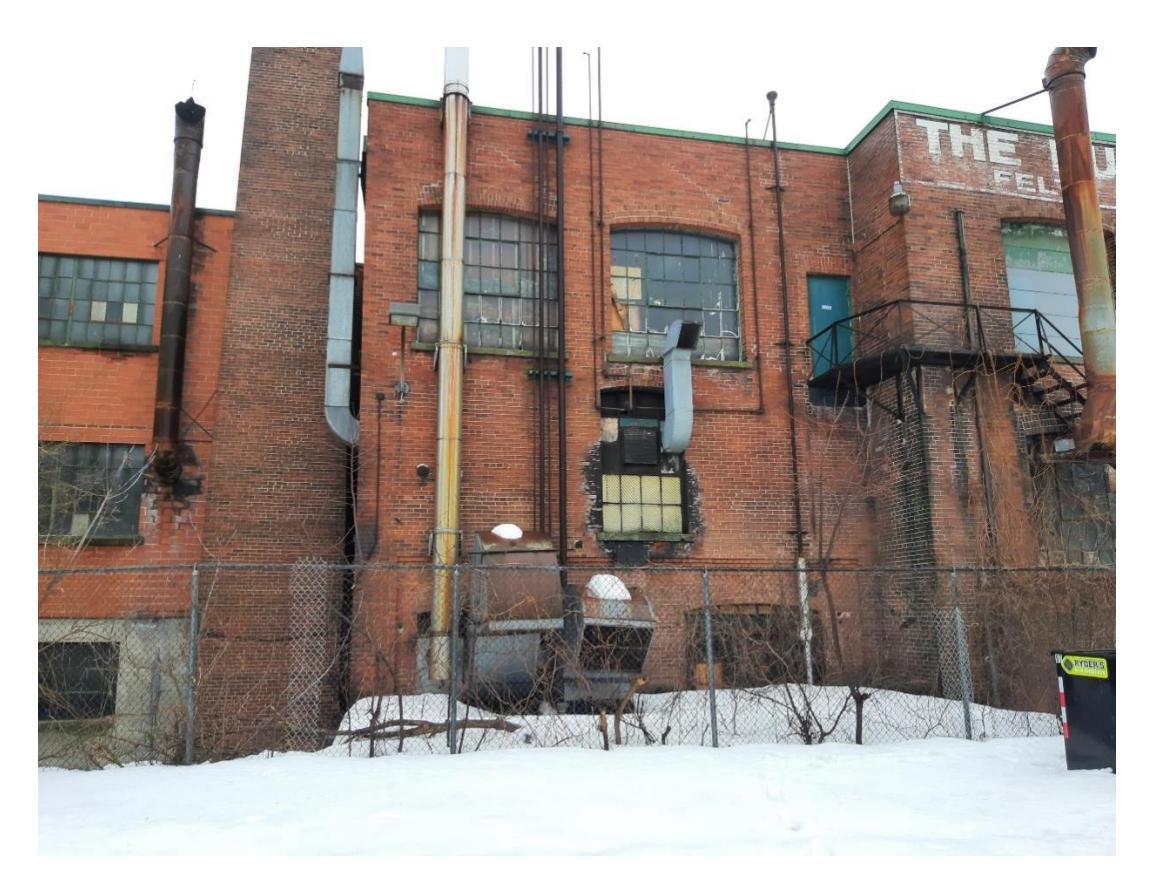
Photograph No. 13 – North Elevation - East Corner

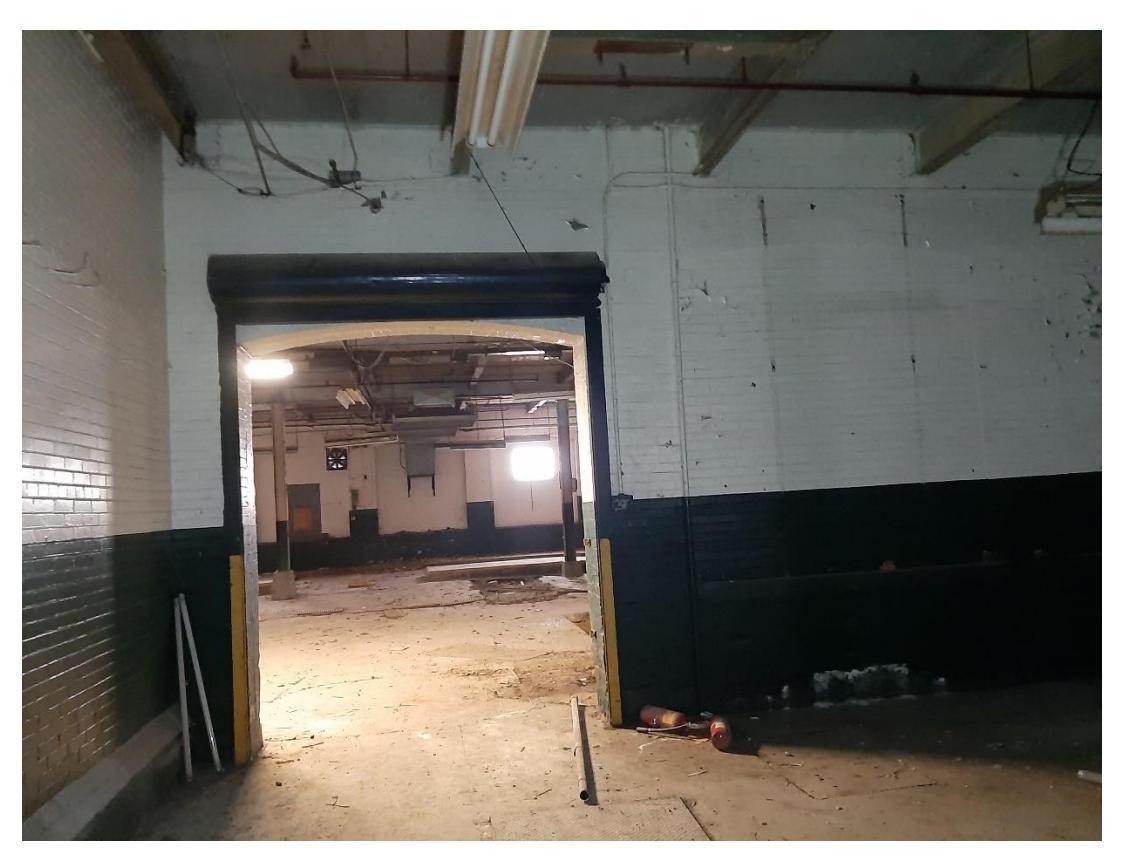
Photograph No. 14 – Ground Floor Door to be infilled

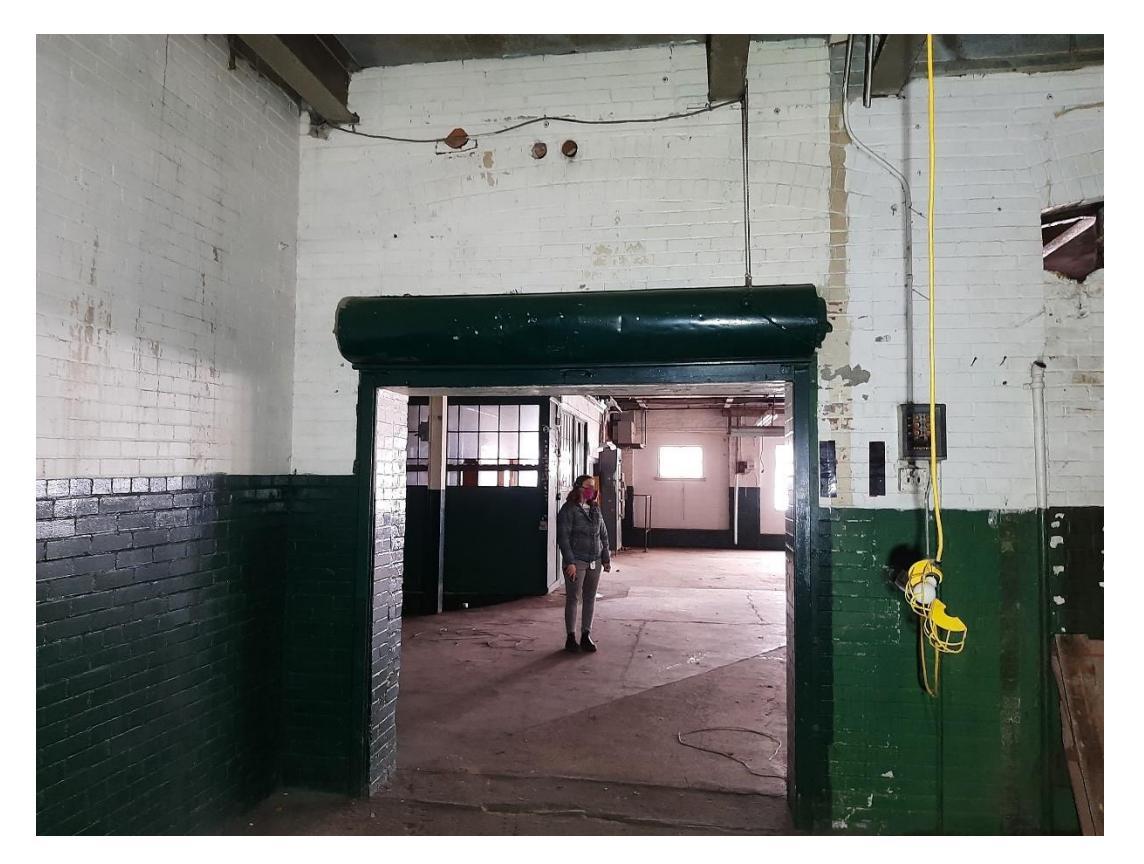
Photograph No. 21 – Second Floor Door to be infilled

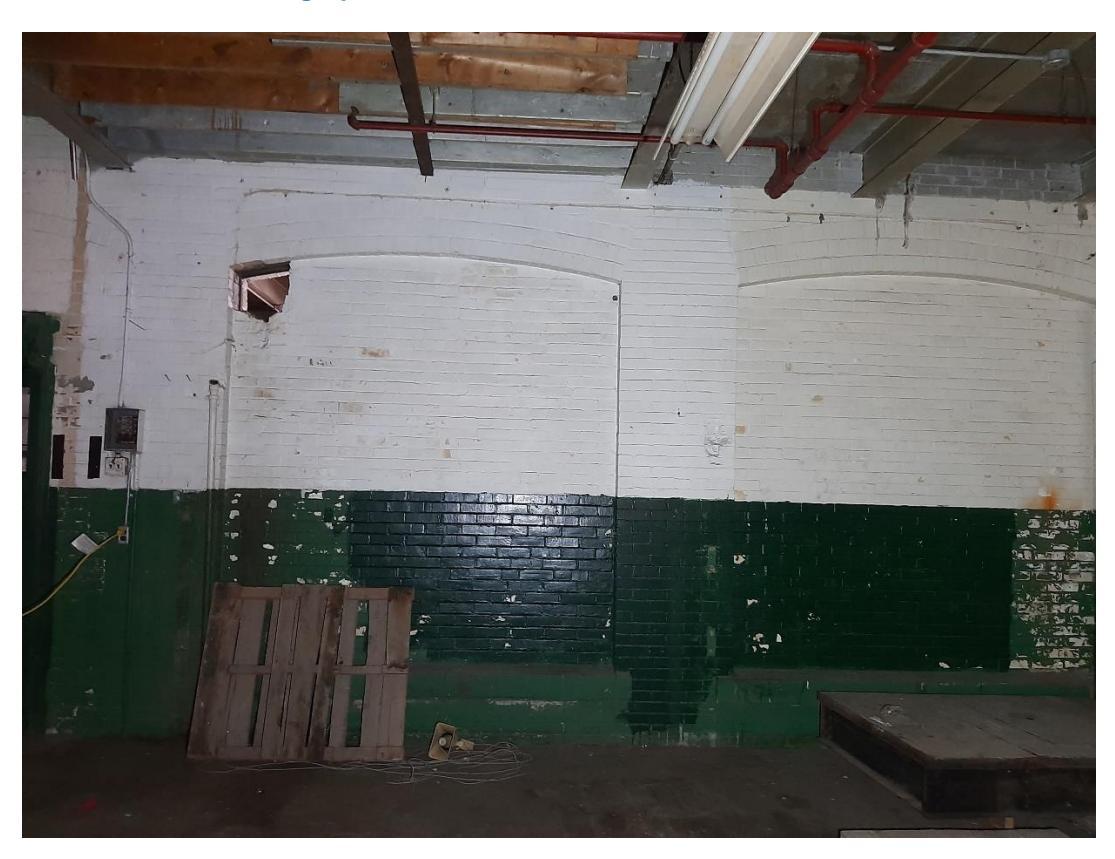
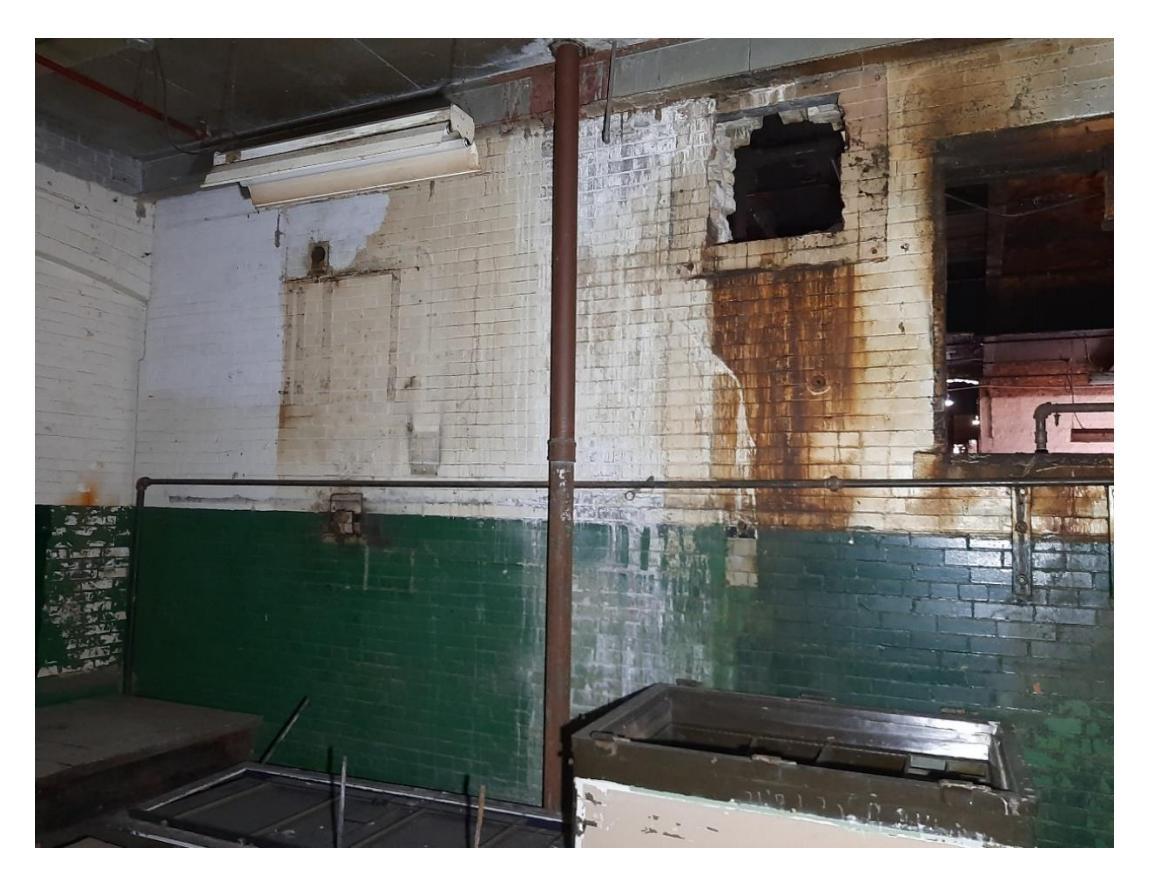
- 9. Painted brick masonry is generally in good condition; interior sheltered by additions (Photographs 13-31).; some openings through brick will need to be infilled with reclaimed brick from the Chimney (Photographs 22,23).

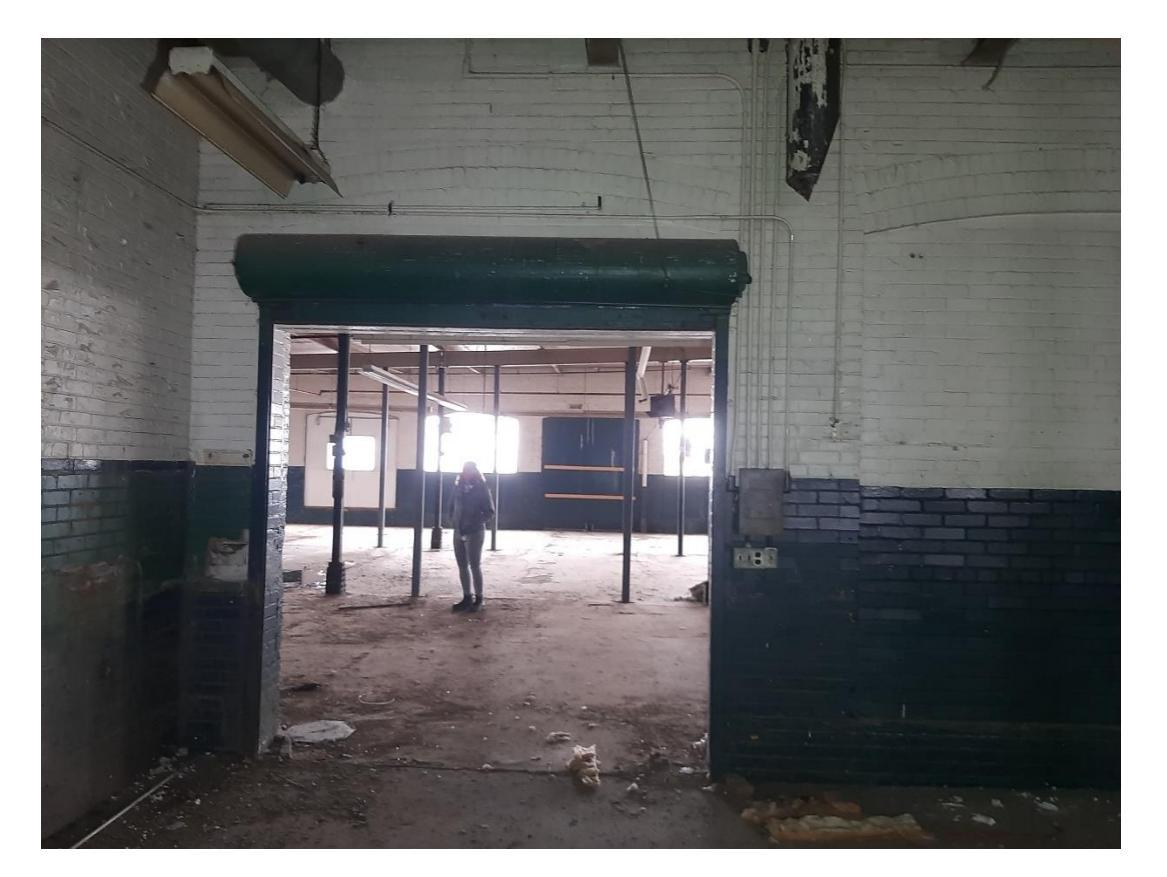
Photograph No. 29 – Third Floor Opening to be infilled

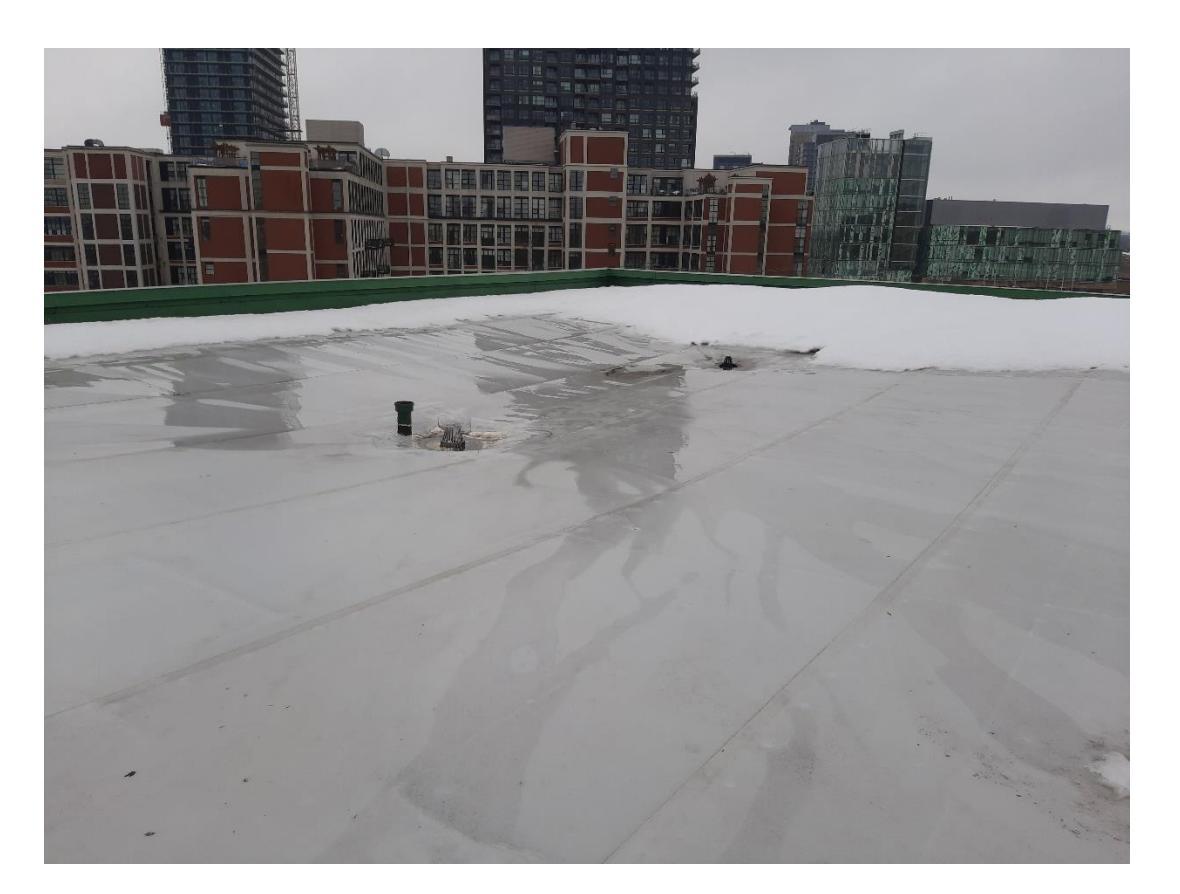
- Roof is leaking badly through the grey TPO membrane raining down through the roof/structure to third, second and ground floors. The leak is suspected at the two south drains of the 1913 building (Photographs 32), but this should be confirmed through investigation. Roofing repair is needed. The condition of the wood deck structure should be assessed for rot damage. Similarly, potential corrosion of the concealed portion of the steel roof beams should also be investigated. This will require a separate investigation requiring the removal of the plywood ceiling, for the extent of the portion of roof where the leak is found to be.

Photograph No. 32 – Roof, Suspected source of water leak thru building

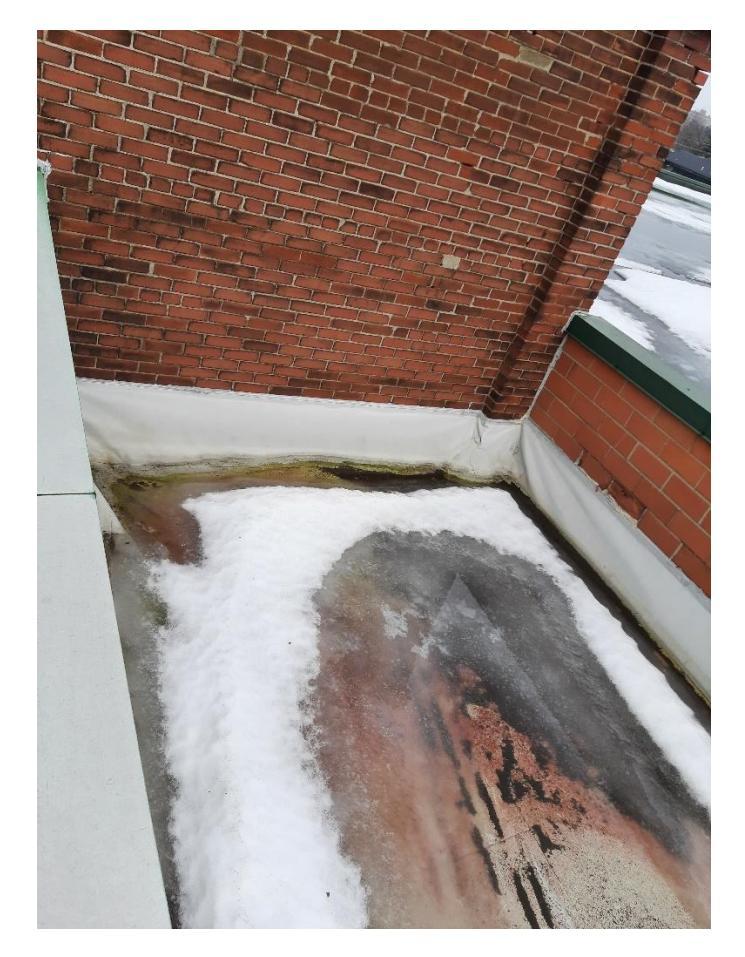
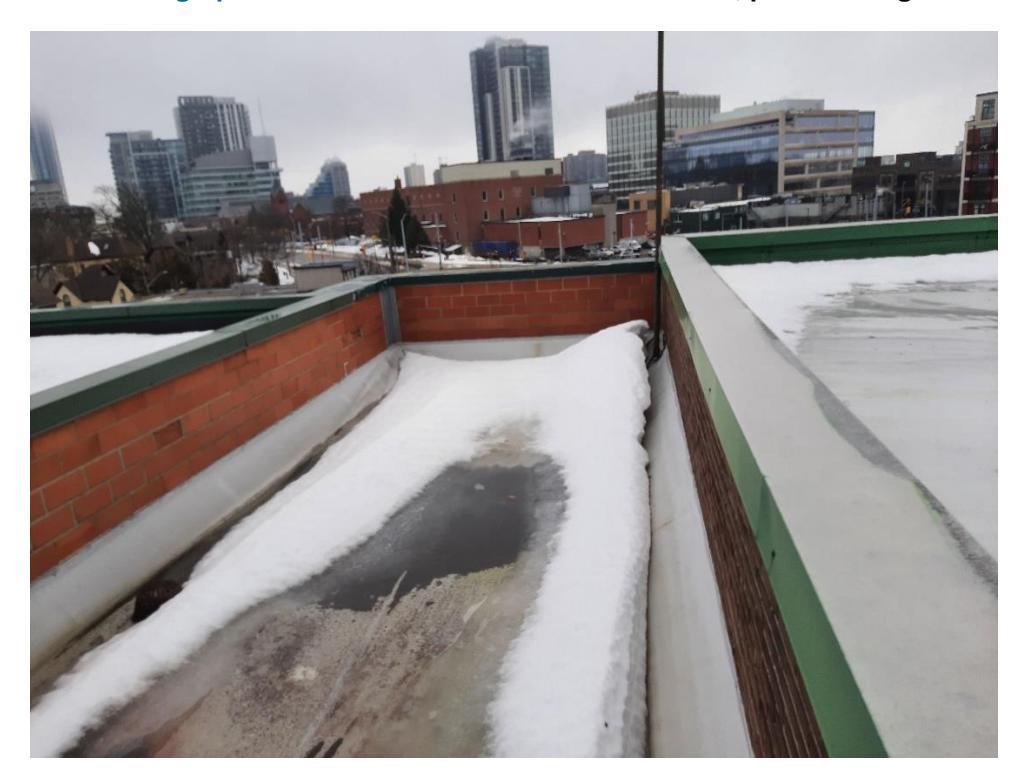
- 2. Roof is leaking badly through obvious holes in the black EPDM membrane at the 1962 addition near the chimney (Photographs 36-38).
- 3. Standing water was observed on the main stair roof (Photographs 34,35).

- 4. Roof EPDM of 1913 building is not well supported at parapets particularly at corners, which could be a leak source (Photographs 34,35). Recommend further investigation by roofing consultant.

Photograph No. 34– Small roof over entrance stair, poor drainage

Photograph No. 35 - Small roof over entrance stair, poor drainage

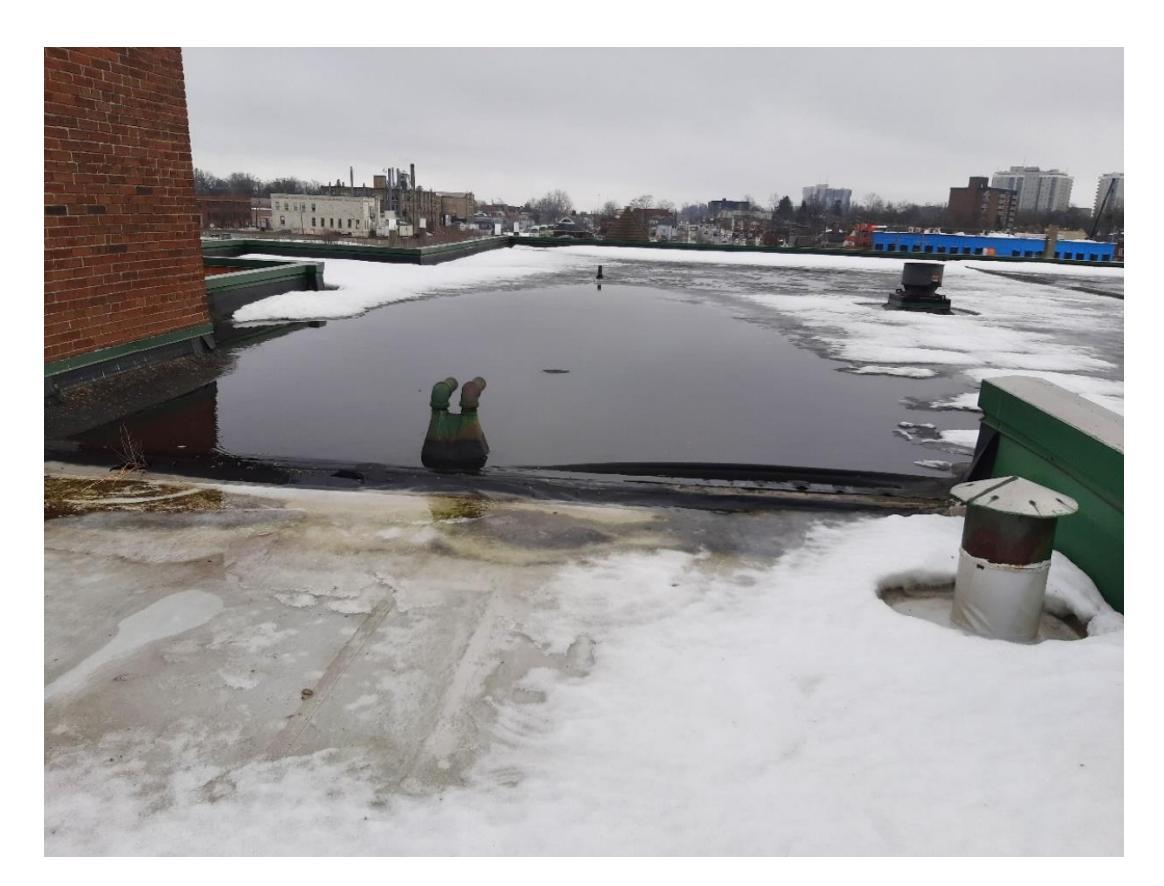
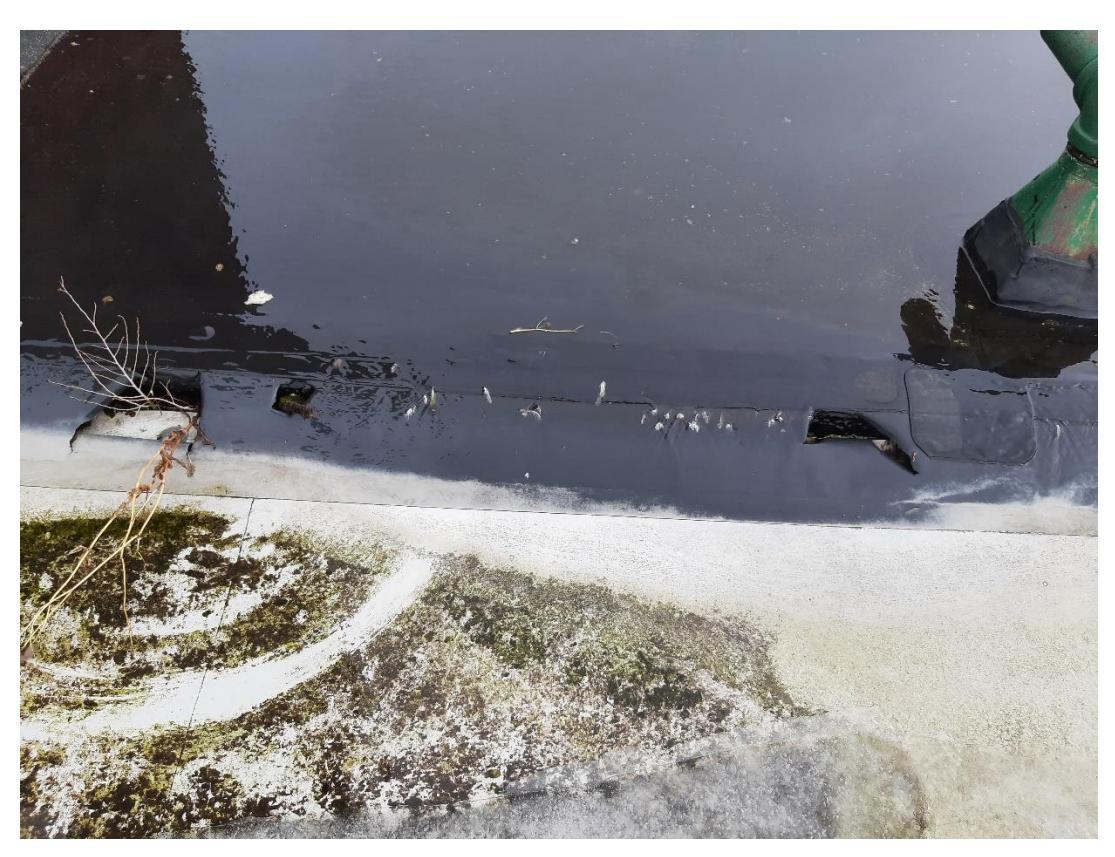
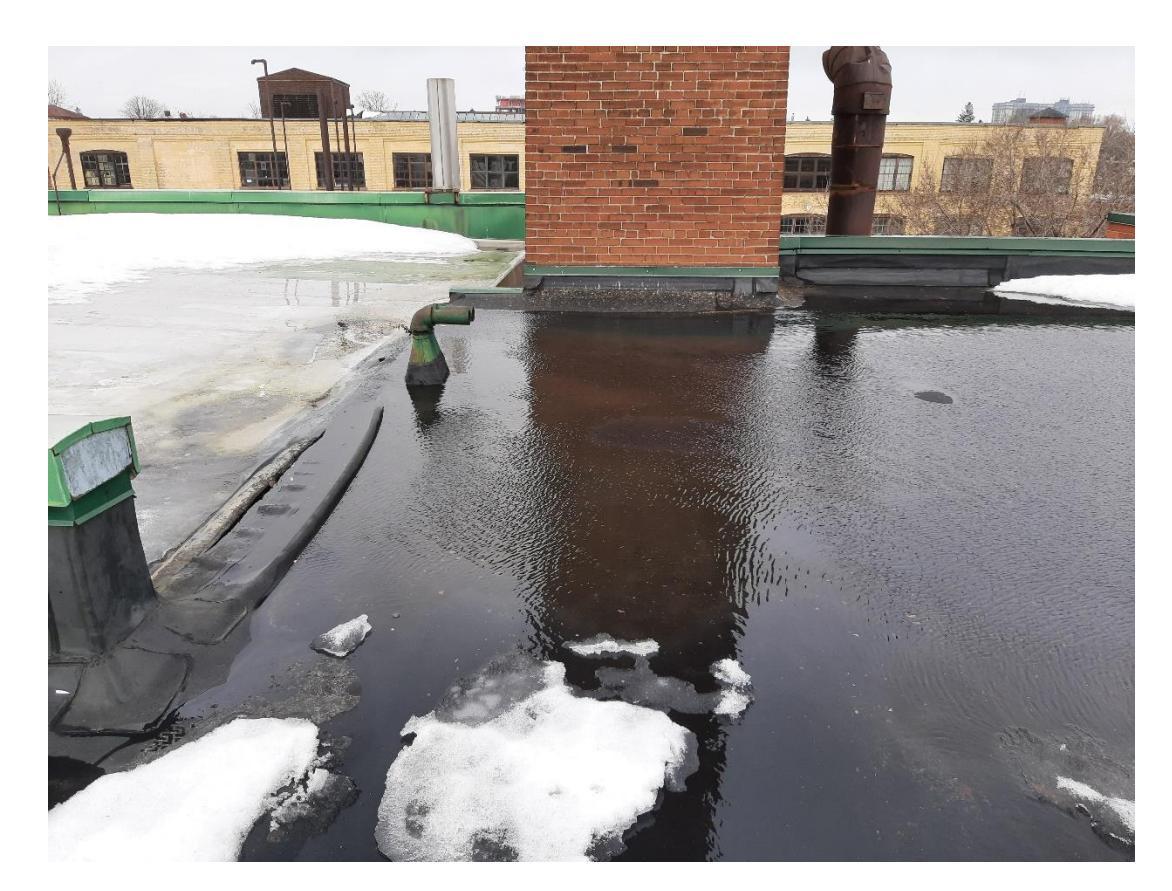
Photograph No. 36 – Edge of 1913 east wall, source of leak

Photograph No. 37 – Edge of 1913 east wall, source of roof leak

Photograph No. 38 – Edge of 1913 east wall, source of roof leak

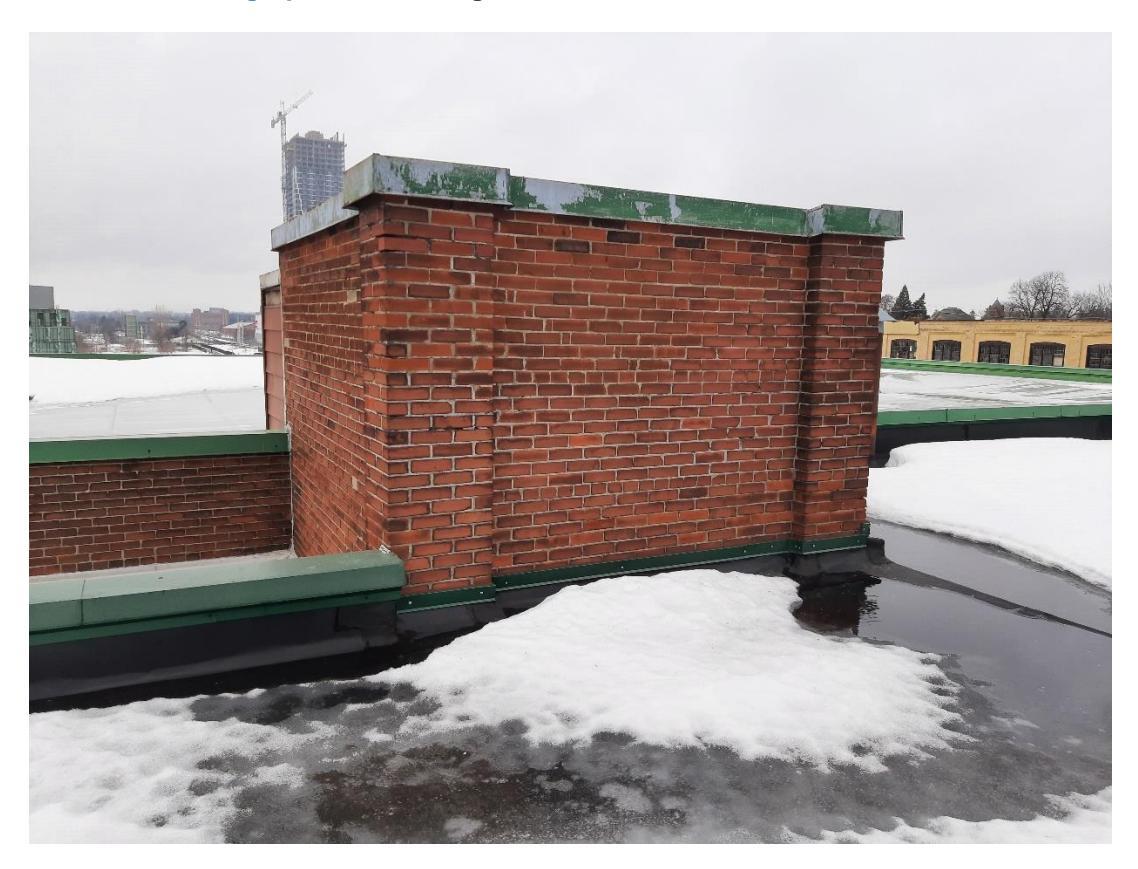
- 5. Some brick mortar deterioration was observed on the hoist shaft (Photograph 39). Recommend repointing mortar.

Photograph No. 39 – Lift Hoist shaft

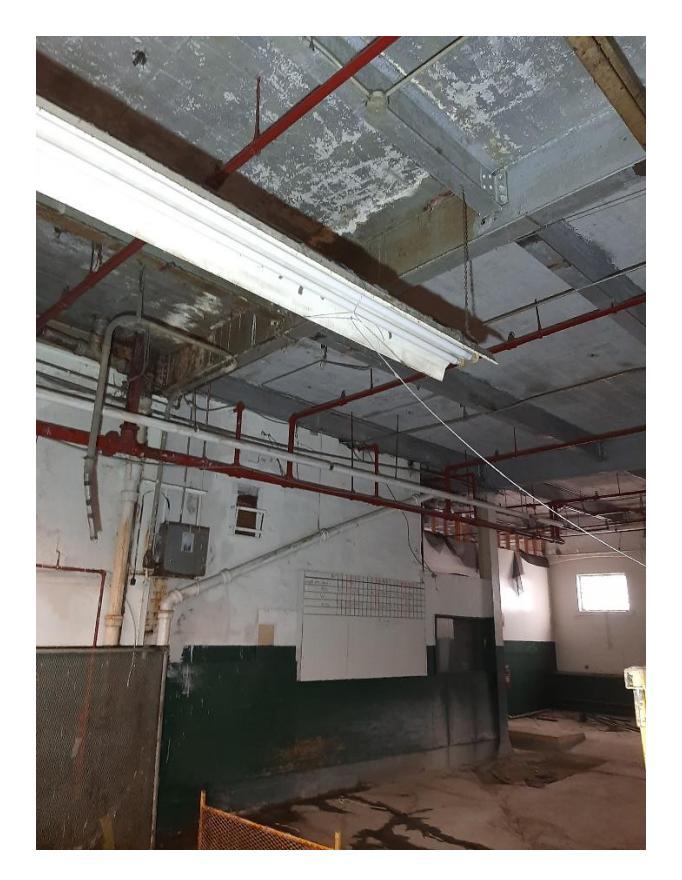
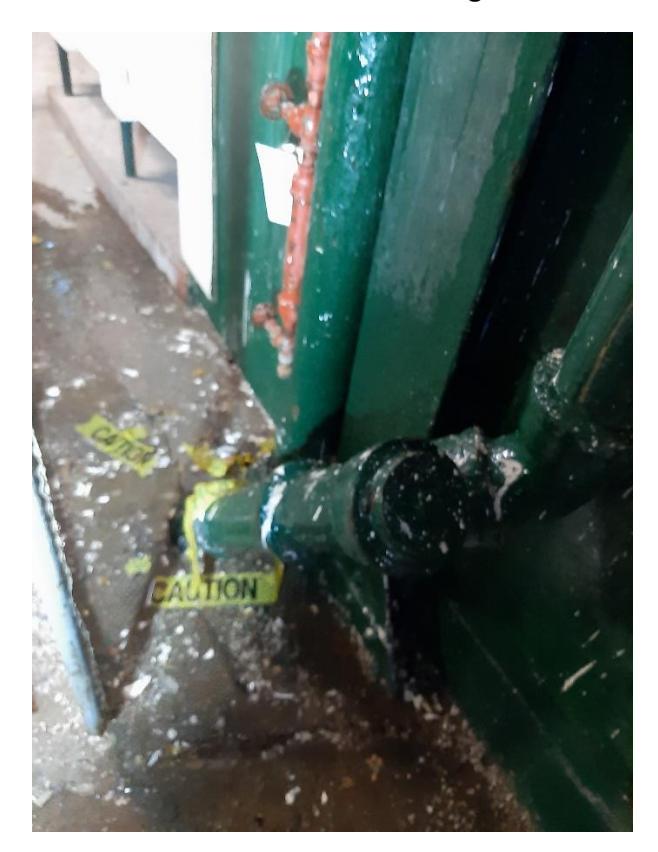
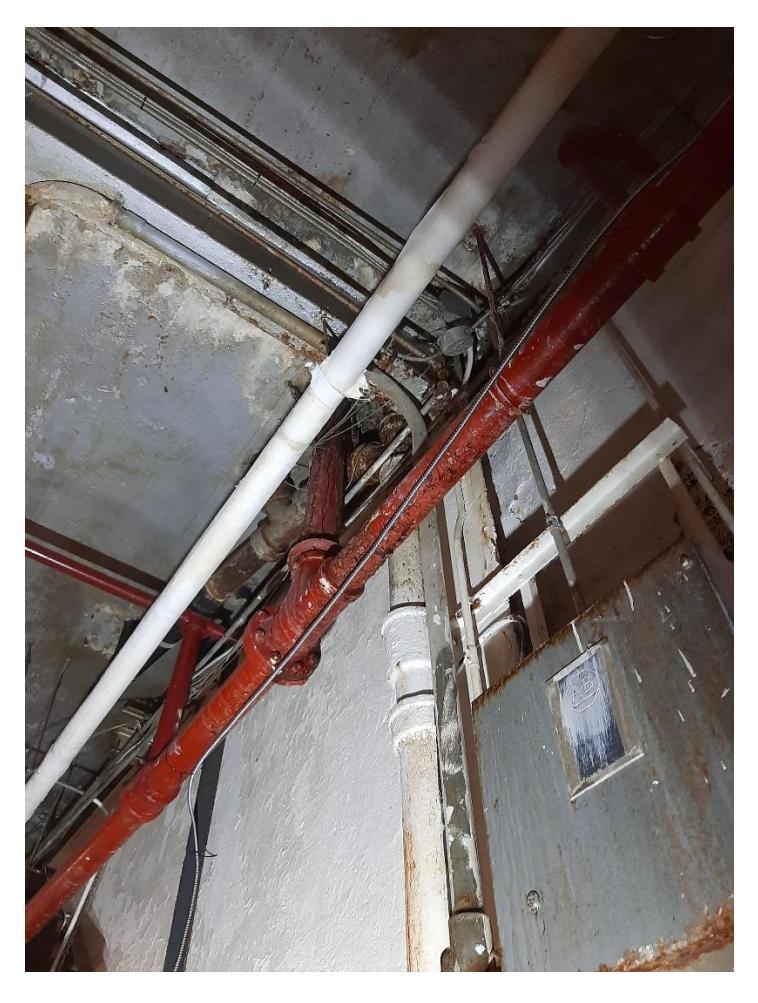
- 1. Water is infiltrating down through the concrete floors from leaks in the roof (Photographs 41,42,43,53,56,60). At least two sources of water leaks were observed. Refer to the Roof Section, above.

Photograph No. 41 – Ground Floor - Rain water leaking thru Concrete floor slab above

Photograph No. 42 – Ground Floor - Water from Roof Leak

Photograph No. 43 – Ground Floor, Water Leak from Second Floor above
