April 3, 2025 MTE File No.: C33233-301

RE: Rumpel Felt 1913 Heritage Building – Structural Assessment 60 Victoria Street North, Kitchener, Ontario

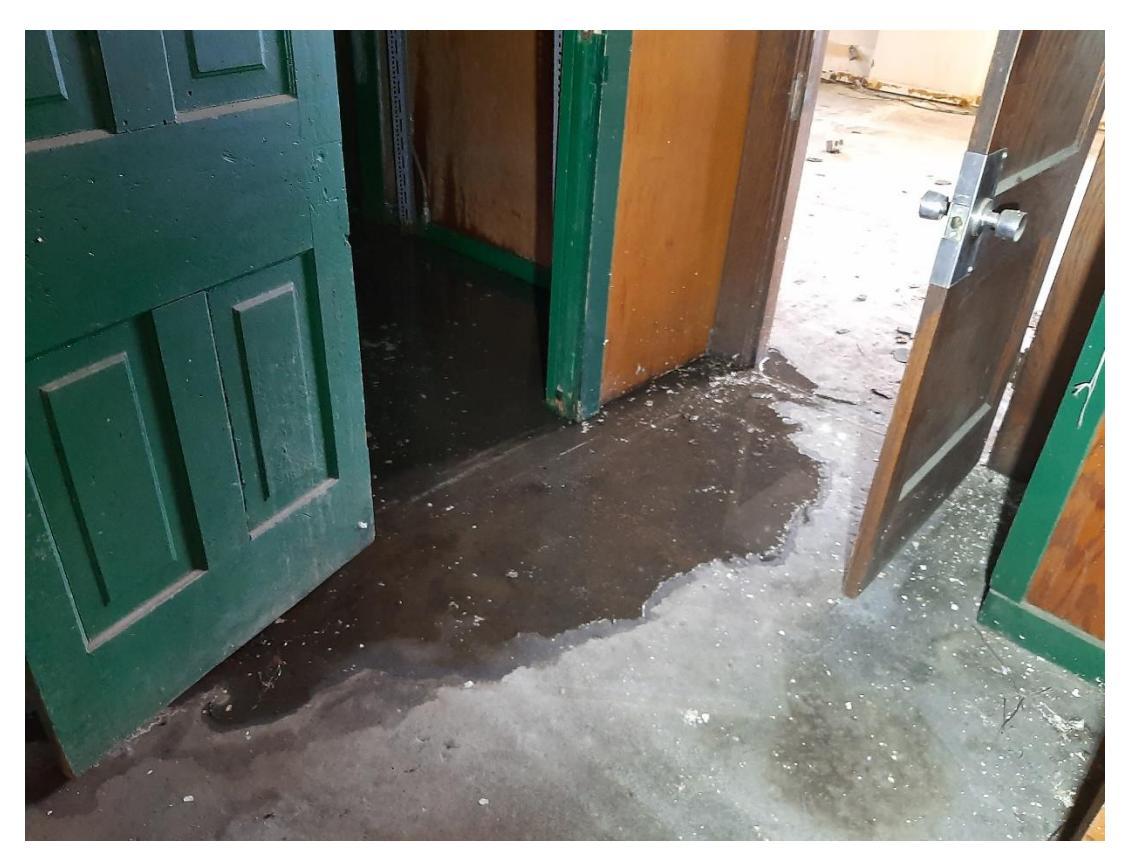
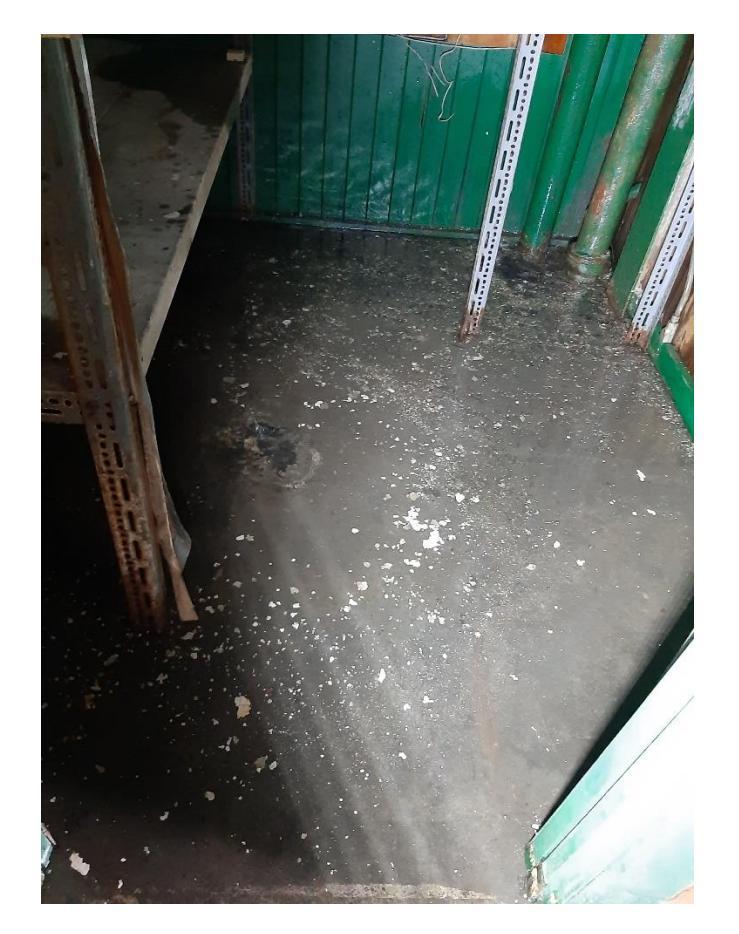
- 2. The brick is generally in good condition with very few cracks (Photographs 44-47, 52, 54, 57-60).
- 3. Standing water from roof leaking above was found on the second floor (Photographs 48-49). Floor Structure did not show any distress or deterioration as a result of the leak.

Photograph No. 48 – Second Floor, Water leak from roof

Photograph No. 49 – Second Floor, Water leak from roof

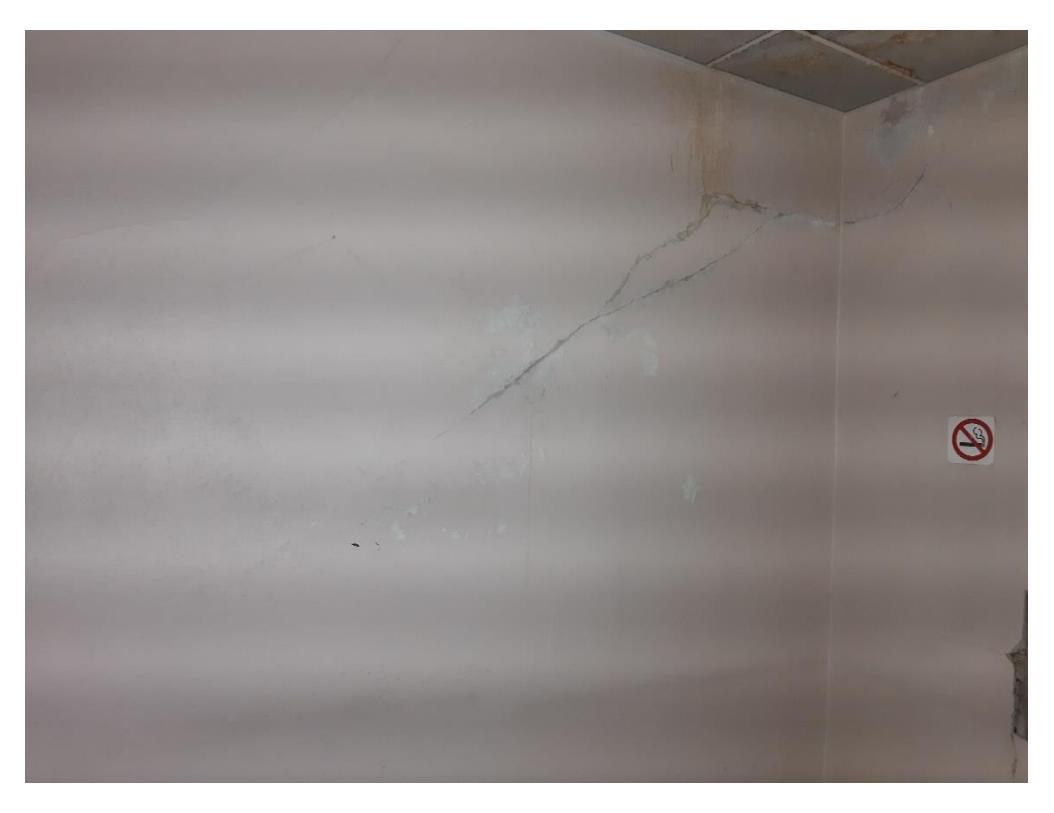
- Some cracking observed in plaster in the southeast corridor on second floor (Photographs 50). Assuming only surficial and do not suspect structural concern; However, further investigation would be required to assess whether structural in nature.

Photograph No. 50 – Second Floor - cracks in wall plaster

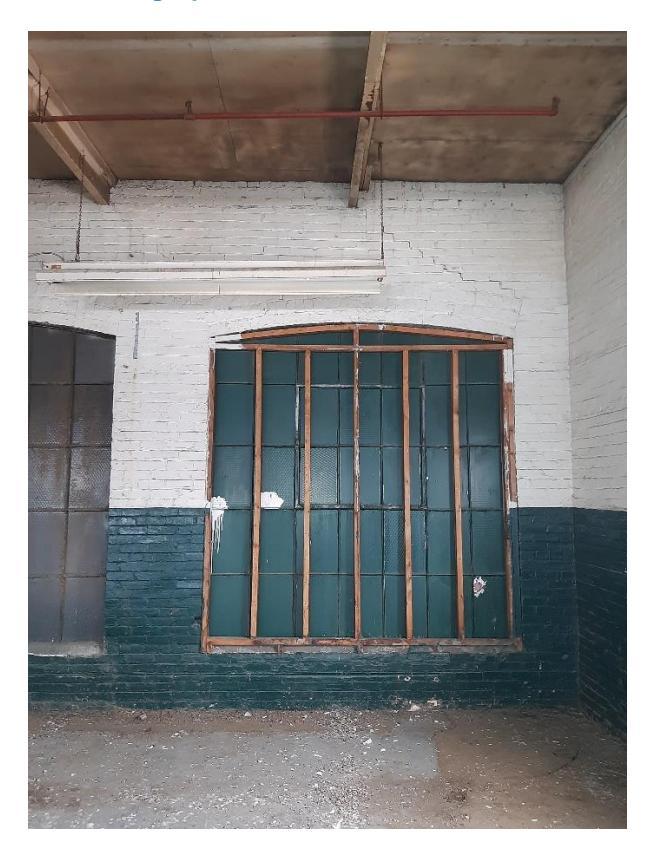
Photograph No. 52 – Third Floor - masonry cracks

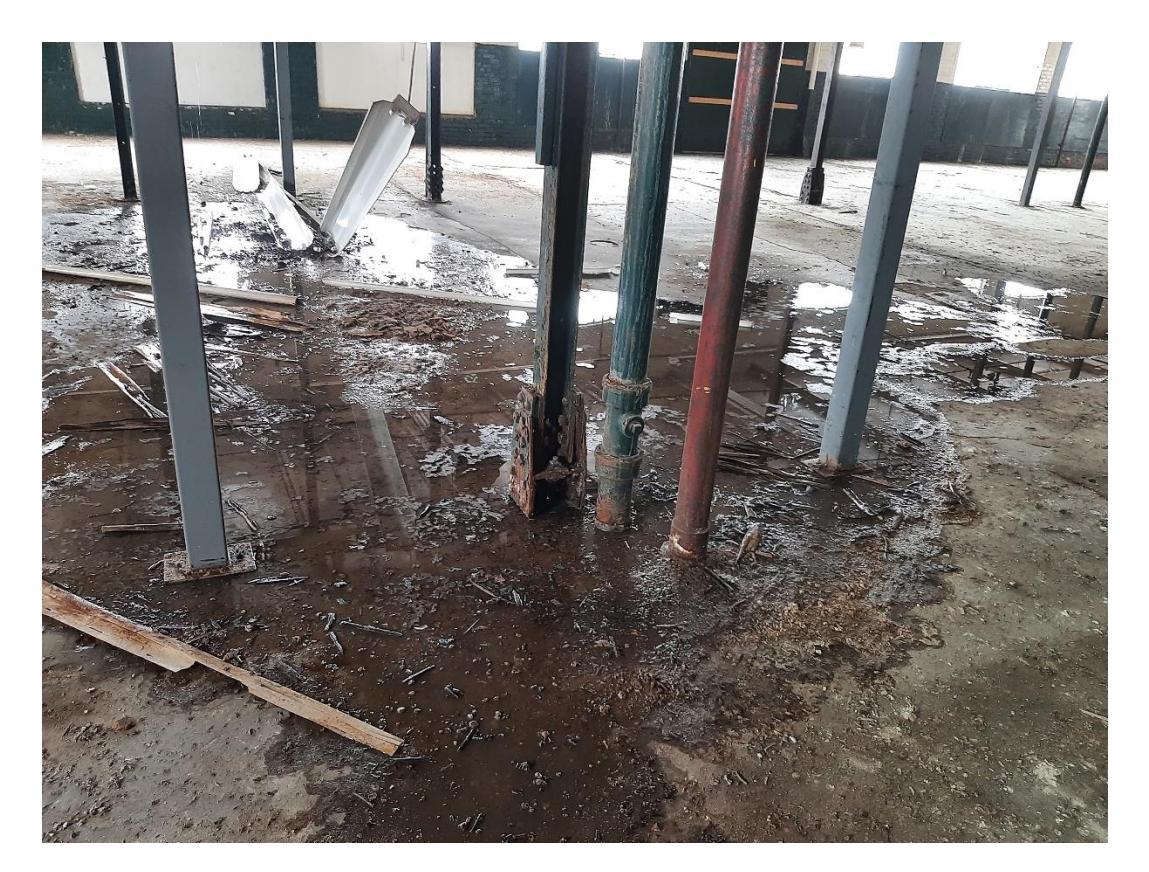
- 7. In the past 2011 structural assessment report, the steel roof beams were identified as insufficient to support the snow loads and were shored. Shoring of the roof beams should be monitored during demolition (Photographs 53-55). Moving forward if the Region wants to remove the shoring, then the beams and columns will need to be replaced or reinforced.

Photograph No. 53 – Third Floor - shoring in place since 2012

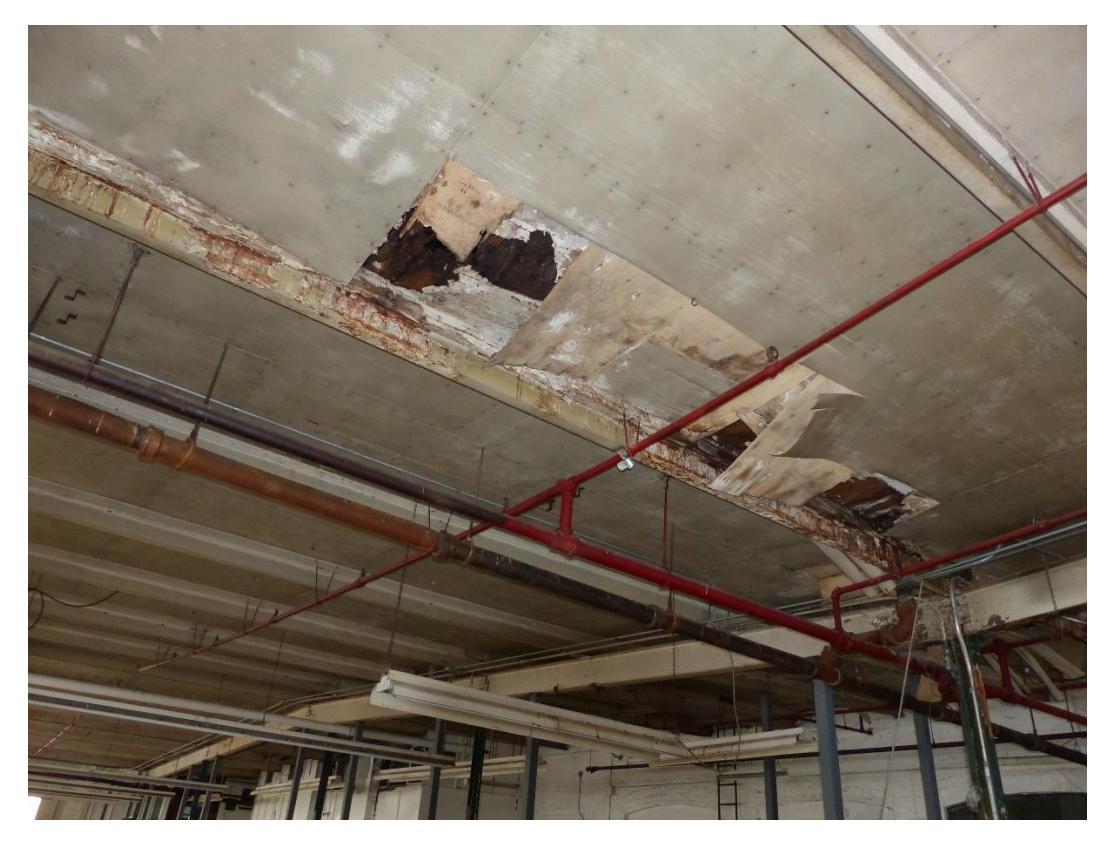
- 8. Damage to ceiling board from rain leak (Photograph 55). Further investigation is recommended to confirm integrity of wood roof joists. This will require removal of ceiling board to properly assess wood condition throughout, at roof leak locations.

Photograph No. 55 – Third Floor - Ceiling Board damage from roof leak

- 2. The condition of the roof members and deck at leak sites should be investigated and confirmed or remedied if found to be deficient.
 - 3. Remove vines from brick masonry.

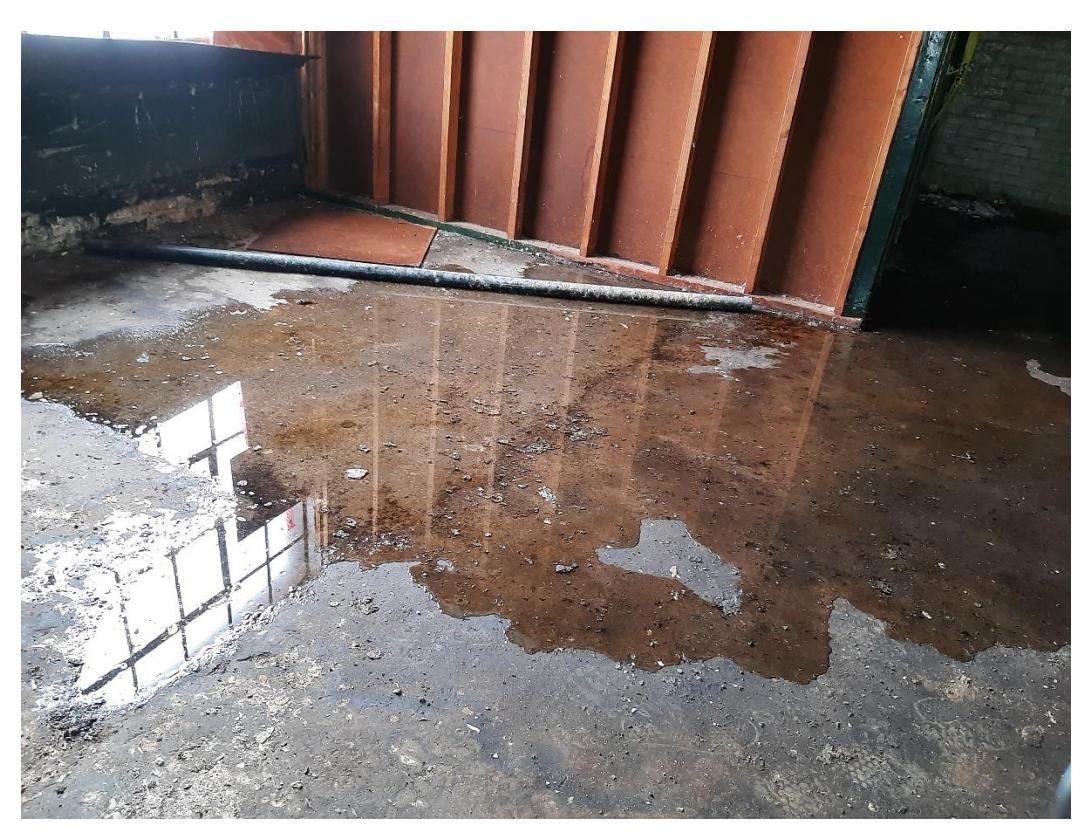
- 1. Water is infiltrating down through the concrete floors from leaks in the roof (Photographs 41,42,43,53,56,60). At least two sources of water leaks were observed. Refer to the Roof Section, above.

Photograph No. 56 – Third Floor - Water from Roof Leak

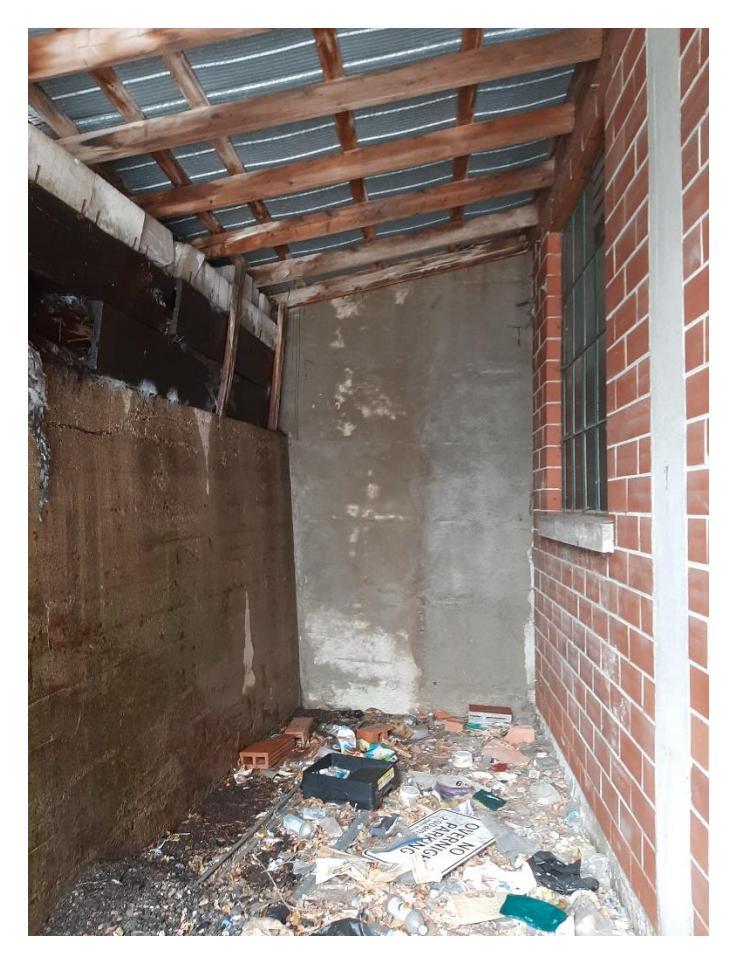
- 1. Timbers on retaining wall are leaning due to earth pressure, laneway and tree; some timbers are in poor condition; rot observed. Photographs 62-66. Roof shown in Photograph 61 bears on the masonry block and timbers, but ineffectively braces the timbers from leaning. These timbers will need to be restored in alignment and anchorage, and some replaced that have rotted.

Photograph No. 61 – Courtyard looking east

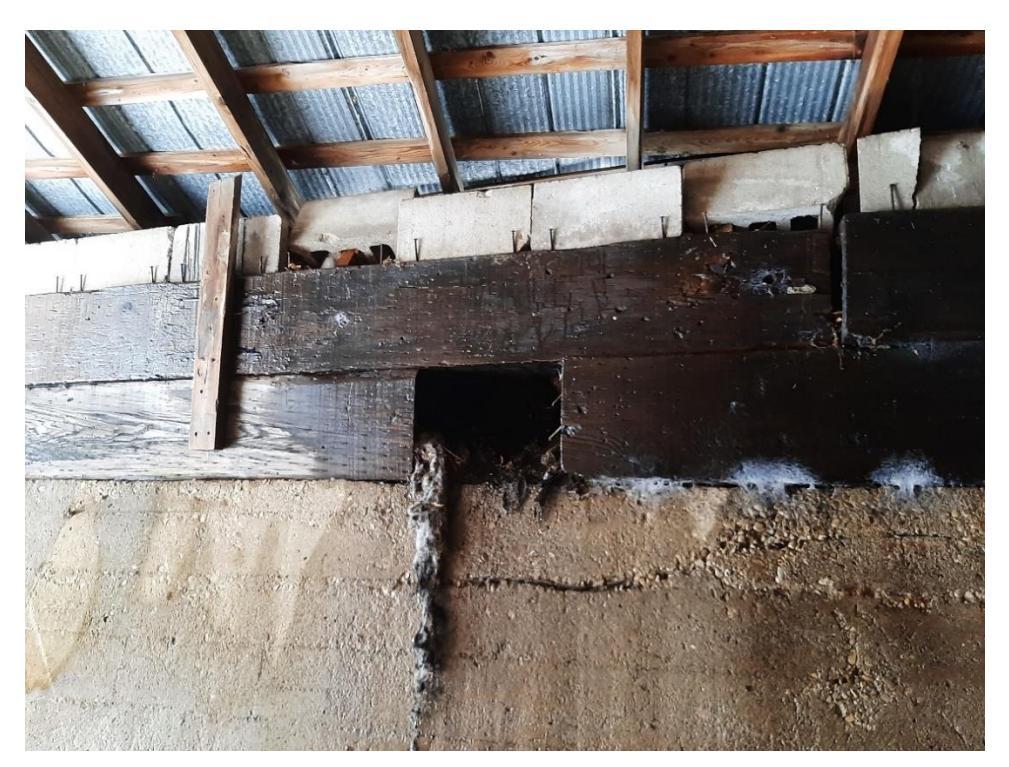
- 2. Lose laid masonry blocks are on top of the timbers. Only spikes are holding them from falling. Photograph 62.
- 3. Concrete buttress of retaining wall show signs of deterioration and should be repaired. Photographs 63, 65.

Photograph No. 62 – Courtyard, Timbers leaning, CMU Block at top

- 6. Remove tree which is applying pressure to the retaining wall.
 - 7. Restore or replace timber members along courtyard retaining wall. Remove lose laid concrete blocks from timbers.

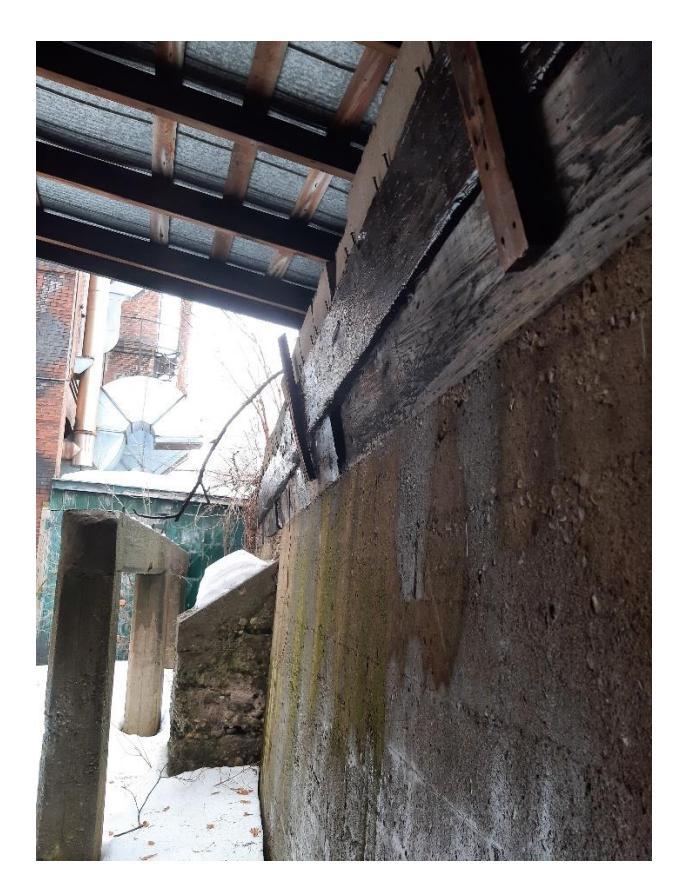
Photograph No. 63 – Courtyard Wall, Looking west, Timbers leaning, Vulnerable CMU Block at top

- 8. Restore the deteriorated areas of the concrete buttress of the courtyard retraining wall.

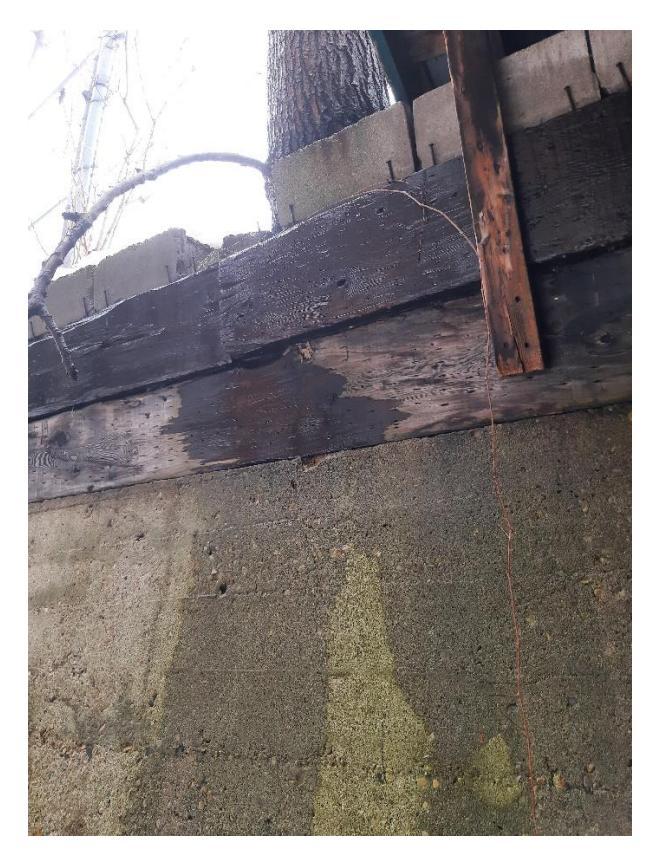
Photograph No. 64 – Courtyard Wall, Timbers leaning, Tree pushing

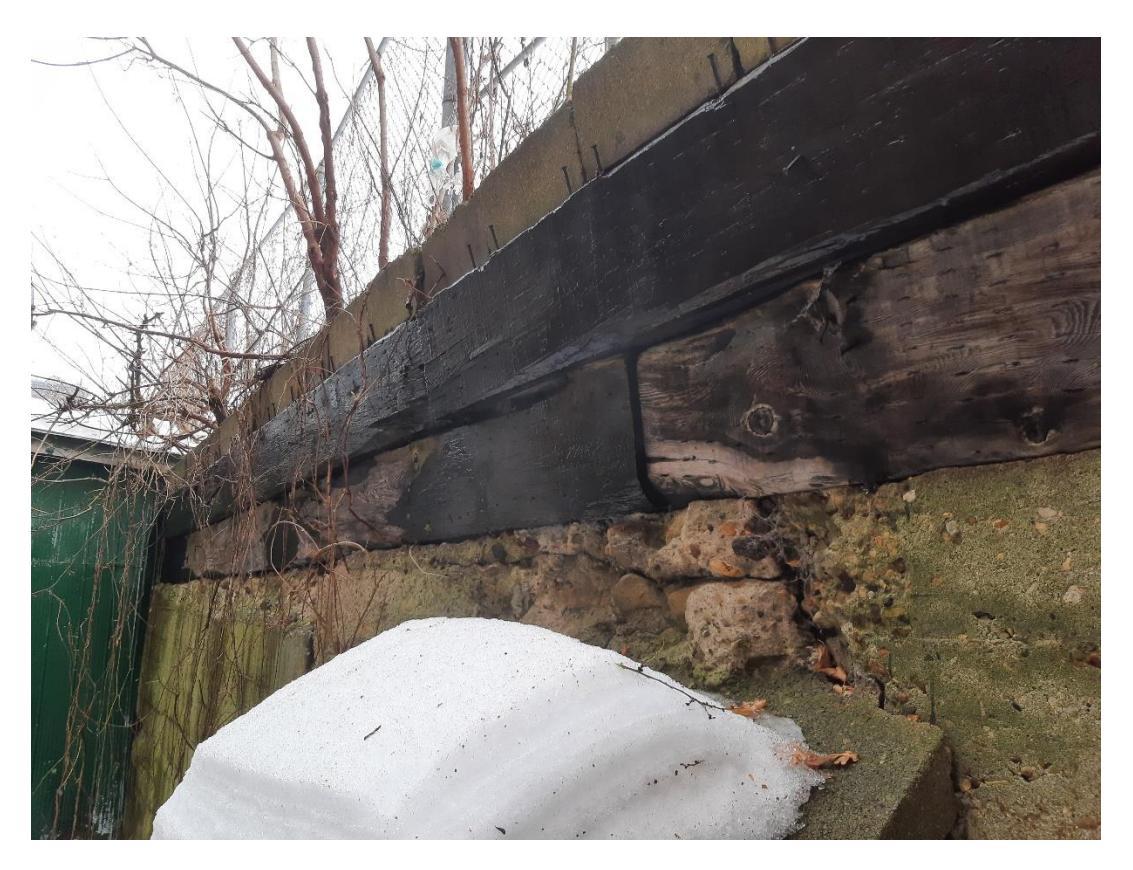
Photograph No. 65 – Courtyard, Timbers leaning, concrete deterioration

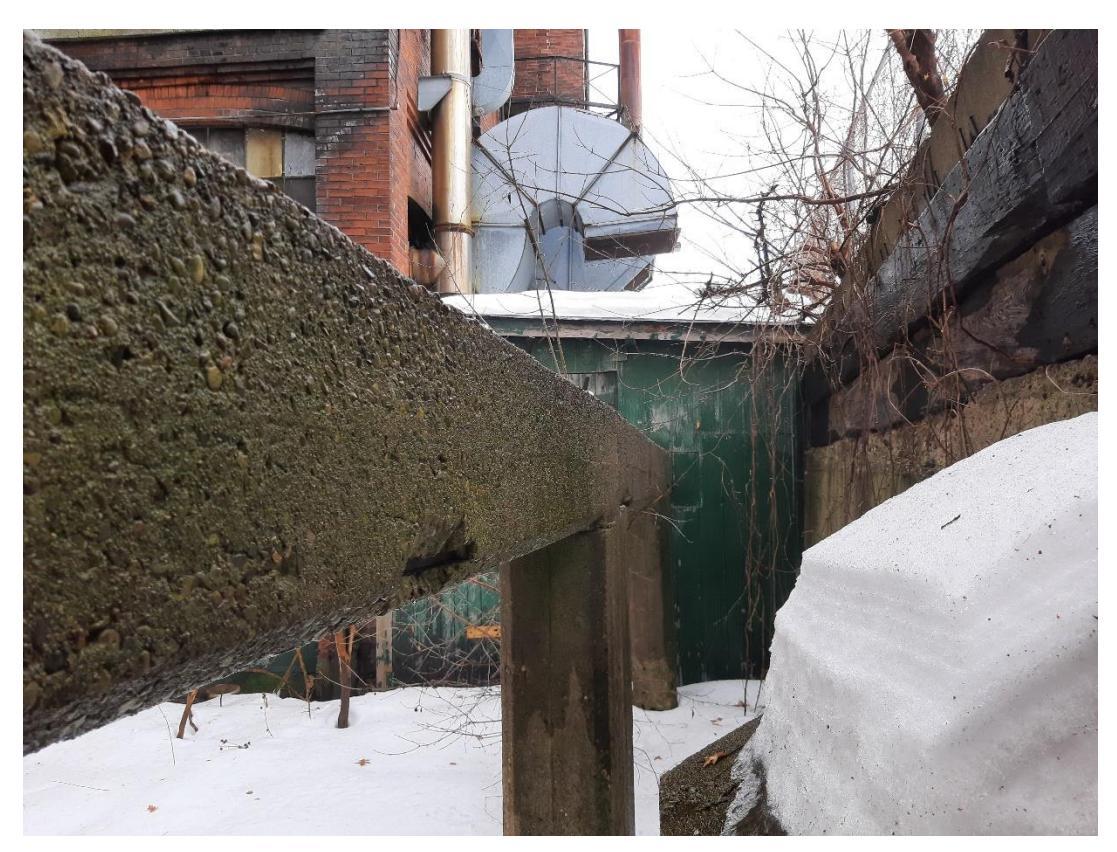
- 4. Free standing concrete beam on columns show signs of spalling. Photograph 66. This concrete beam and column structure is to be demolished, so no repair is recommended.

Photograph No. 66 – Courtyard, Timbers leaning, rot

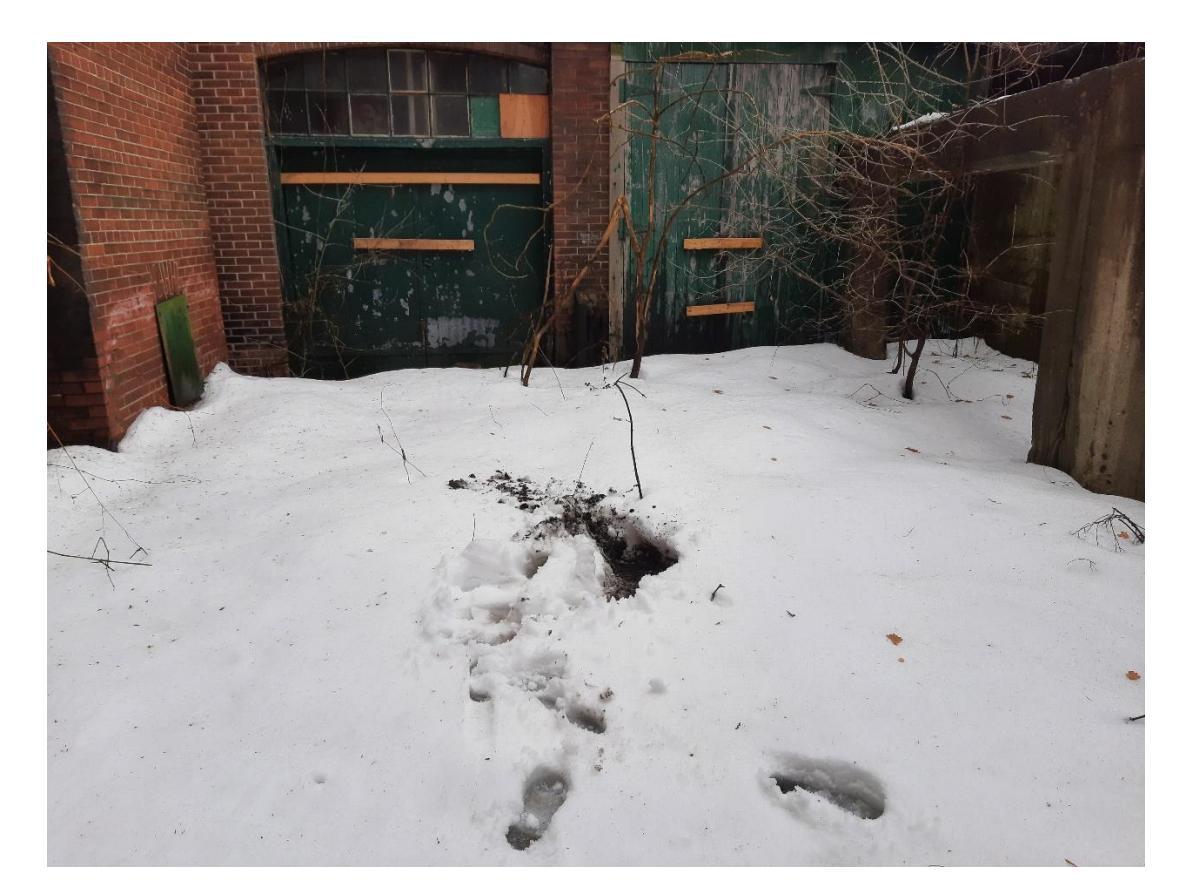
- 5. Drainage of the courtyard is believed to be natural, through soil infiltration, near center of courtyard. At first exploration, snow was vacant in local hole, likely thought be from heat. Snow was removed (prior to taking Photograph 67), but no catch basin or grate was found.

Photograph No. 67 – Courtyard, drainage in centre
