# Heritage Report

48 Ontario Street North

April 27, 2018

## 48 Ontario Street, Kitchener - Heritage Report

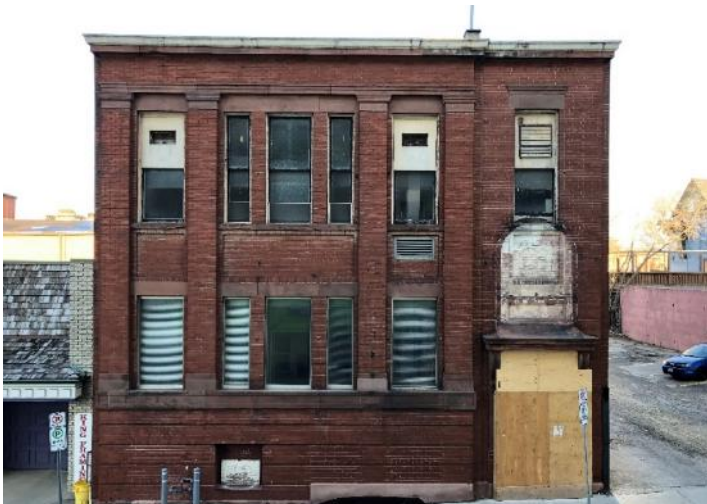
*East Elevation, Ontario Street, showing existing door and windows.*

The front entrance door is not original to the building. It will be replaced with a new prefinished graphite-coloured aluminum door and frame that is in keeping with the quality and style of the existing unit. The colour will match new windows. Remaining exterior doors will be removed and replaced with aluminum frame doors with full glazing.

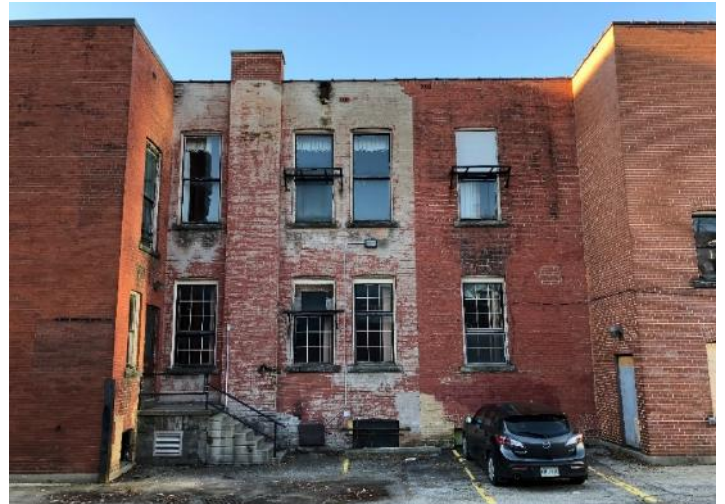
*Partial North Elevation, showing existing doors and windows.*

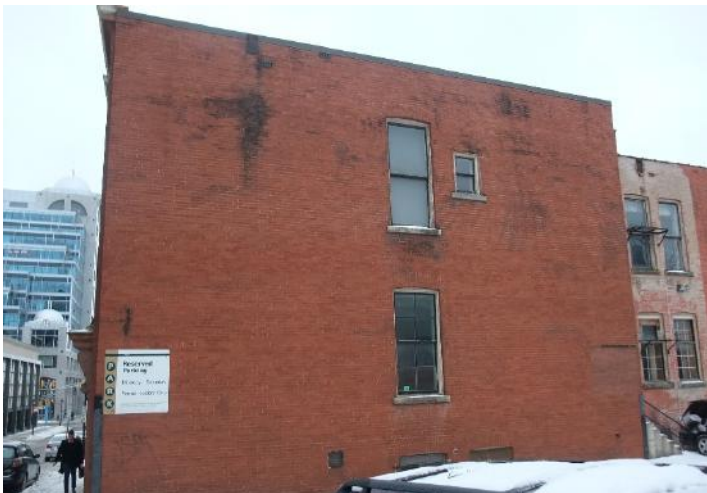
*Partial North façade; location of two new windows.*

Three new windows are proposed for the North façade, two of which will match the size and elevation of the two existing windows located closest to Ontario Street on the same façade. One new window is proposed between the first-floor windows towards the rear of the site, to match the size and type of the two windows on either side. A single existing wide, low opening on the North Elevation is proposed to be filled with matching, recessed brick. It is currently filled in with wall showing exposed waterproofing. Please refer also to the elevation drawings for more clarity. On the West façade, two new windows are proposed, both on the second floor. The new window openings will line up with the existing first floor window openings and the windows will match the size, type and finish of the windows to be installed below.

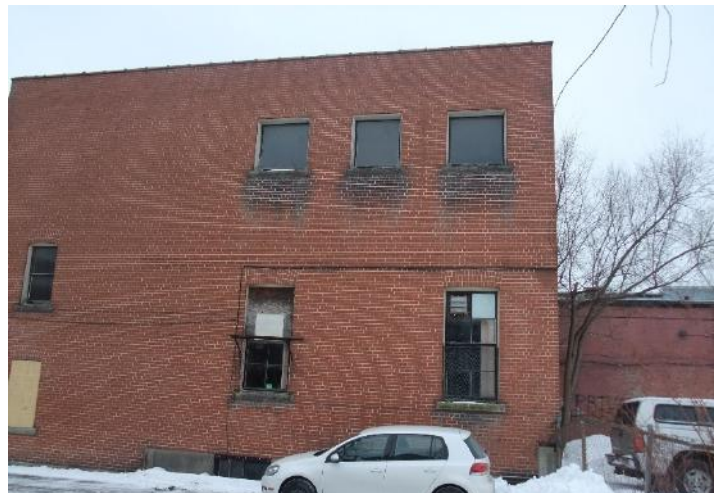
*Partial North façade; location of one new window.*

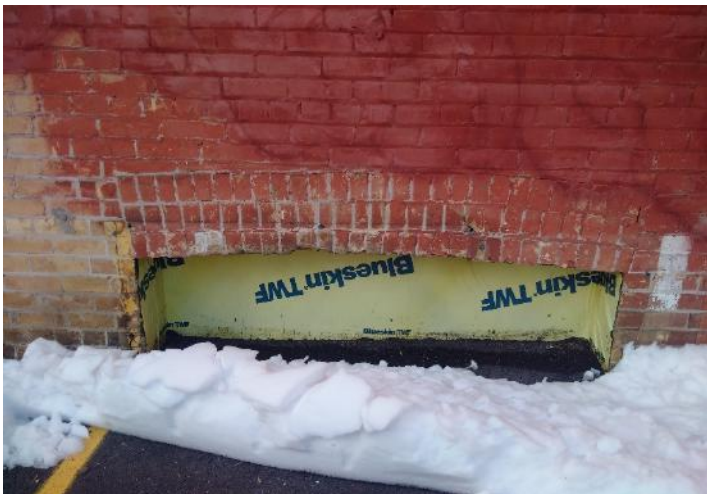
*Wide, low window (hidden by black car on Partial North Elevation on previous page). Existing opening to be infilled with recessed brick.*

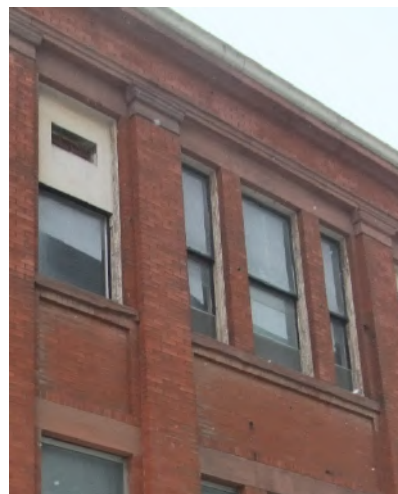
*Detail photo of East Elevation, existing brownstone sills.*

The first approach with regards to the existing brownstone window sills will be to clean and conserve where appropriate and as recommended by a qualified mason having experience working with natural stone, using recognized conservation methods appropriate for brownstone masonry to the satisfaction of heritage planning staff. Where brownstone window sills have been determined by a qualified professional to have deteriorated beyond repair, and upon approval by the Coordinator of Cultural Heritage Planning at the City of Kitchener, a secondary approach will be employed. This approach would include replacing brownstone sills with tinted pre-cast concrete sills to match the existing brownstone. It is anticipated that replacement sills will take two to three years to develop a patina to match the existing sills. Brownstone is generally no longer seen as a well-suited sill material for our harsh Canadian climate due to its high porosity, layered composition and susceptibility to water, salt, air pollution and freeze-thaw cycling<sup>ii</sup>. Please also refer to the appendix for a preliminary review of brownstone features conducted by Matt George, General Manager of G&B Masonry. Evaluation of the condition of existing sills is limited due to Voisin Capital Inc. not being the current owner of the building, and ownership not being transferred until a heritage permit has been approved. Where existing concrete sills are present, sills will be cleaned and re-caulked. All new window openings will be provided with new pre-cast concrete sills to complement replacement sills.

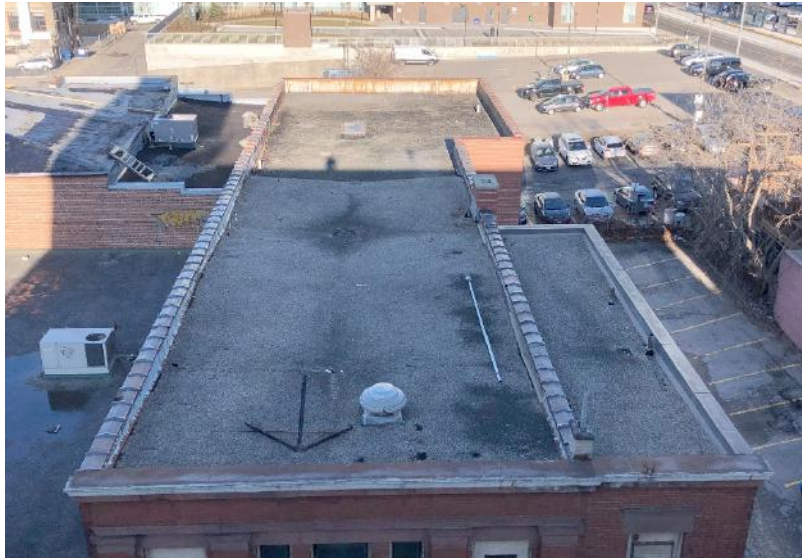
*Existing Roof*

The existing roof is in need of replacement and the existing parapet capping has deteriorated. The roof will be stripped down to the deck layer and the deteriorated clay parapet capping will be removed. New insulation and TPO membrane roof will be installed matching the existing roofline. This work will ensure the water-tightness of the building and protection from the elements. New roof drains will be installed as advised by roofing contractor. Parapet capping will be replaced with new black aluminum capping. The ornate roofline that runs along the Ontario Street façade will be replaced with a matching aluminum profile. The feasibility of installing new skylights will be investigated as part of the structural review. These skylights will not be visible from the ground. Evaluation of the condition of the existing roof structure is limited due to Voisin Capital Inc. not being the current owner of the building, and ownership not being transferred until a heritage permit has been approved.

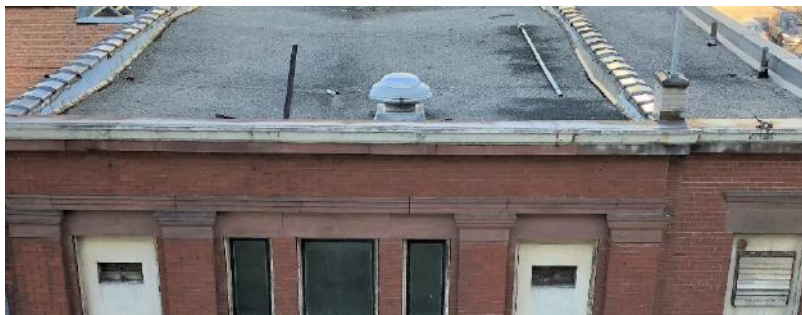
*Brownstone fascia band along roofline.*

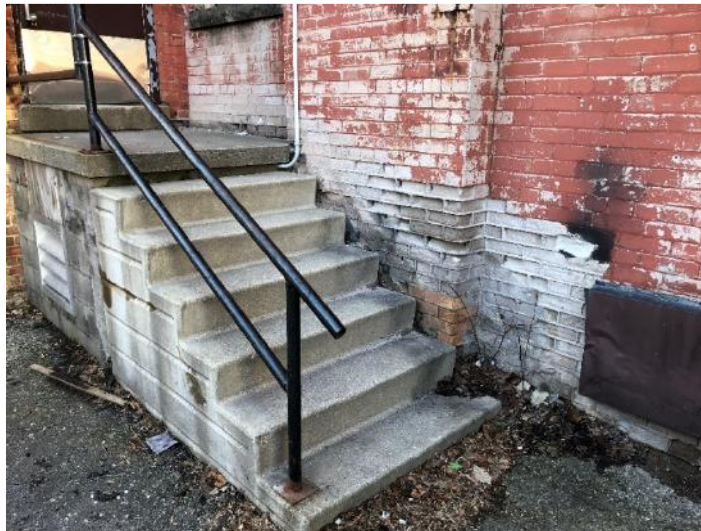
*Deterioration of mortar joints and masonry units*

Masonry work will not begin until the Coordinator of Cultural Heritage Planning at the City of Kitchener has met with the masonry contractors. Access to exterior walls is limited, so full examination of upper floor mortar joints will be completed at a later time. Along the Ontario Street East Elevation, brick facades will be cleaned and restored to the original red brick colour. Along various portions of the elevations, lack of maintenance and previous sandblasting has left mortar joints in poor condition. Where deemed necessary by a qualified masonry contractor, mortar joints will be cleaned using the least invasive method and repointed with mortar type 'N' – Betomix Plus (see appendix). Where the least invasive method (soapy water and brush) is not effective, an alternative method will be put forth for approval by the Coordinator of Cultural Heritage Planning at the City of Kitchener. No sand-blasting, water-blasting or invasive methods will be employed. Masonry units will be replaced with complementary units where deterioration is too severe to salvage existing. The bricks that closely match existing are Forterra Meridian Brick in "BU0147 - Williamsburg Red" and "BU1060 – Sundance Matte Yellow". The bricked in window openings at the basement level are to be reinstated. This work is necessary to ensure longevity of the walls and building envelope in the future. Paint was previously applied to the area above the entrance and on portions of the North façade. It is the owner's intent to restore the entrance area to match the unpainted portions. The recessed portion of the North façade, which was previously painted, will be painted in a Benjamin Moore Heritage Colour: OC-96 Gentle Cream. Minor masonry repair will take place on the South façade. The base will be re-parged where required to maintain the integrity of the building envelope and protect the exterior wall from the elements. New applied mortar will be stained as close as possible to the cleaned existing colour. Exposed masonry wall exterior corners within the parking area will receive new metal corner protectors to replace existing or missing corner protectors.

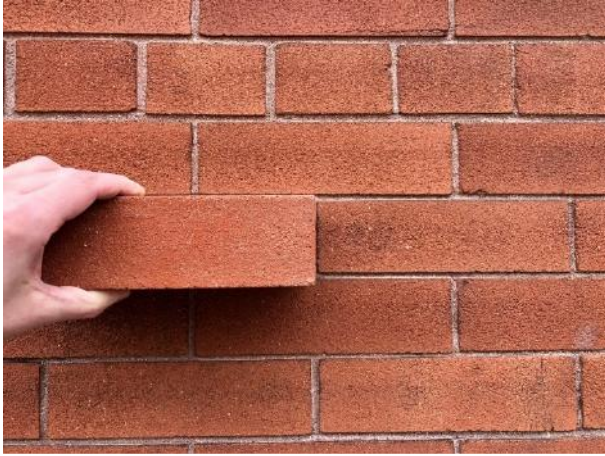
*Masonry Replacement Units: Williamsburg Red*

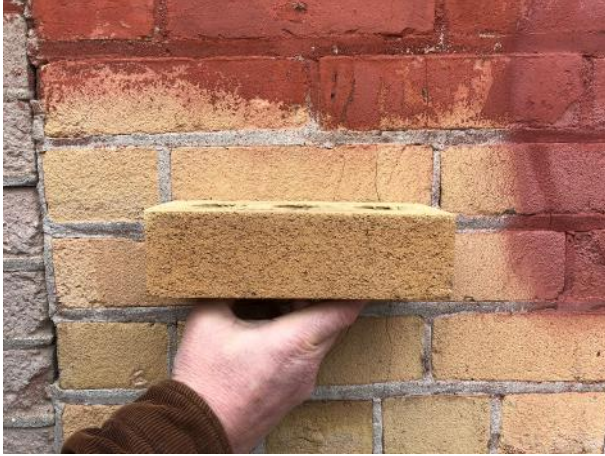
*Masonry Replacement Units: Sundance Matte Yellow*

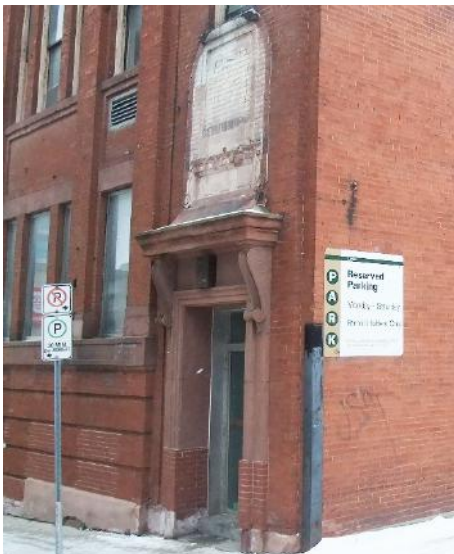
*Brownstone frontispiece*

The frontispiece that surrounds the entrance is in poor condition, with large portions missing or unsalvageable. The first approach will begin with the investigation of replacing the missing right frame and scroll pieces with matching brownstone pieces and repairing the cracked top portions. There are concerns with the feasibility of finding a qualified professional to source and carve replacement brownstone pieces that would not be cost-prohibitive. If the first approach is unfeasible as determined by a qualified professional, a secondary approach will be submitted for approval by the Coordinator of Cultural Heritage Planning at the City of Kitchener. This secondary approach will include replicating the missing brownstone pieces with colour-matched precast concrete. This would ensure a long-lasting, visually identical replacement. If the secondary approach was considered, the existing frontispiece will be studied and used as a mould to create the new formwork. The bottom masonry section, which is expected to have originally been brownstone, will be replaced with a colour-matched precast concrete replica using the existing formwork. The level of detail achieved by the new formwork will be as close as possible to the existing, and an example photograph has been provided below for reference. It is anticipated that new pre-cast units adjacent to existing brownstone will not be a perfect match, as the concrete will be subject to weathering and will take on a matching patina with time.

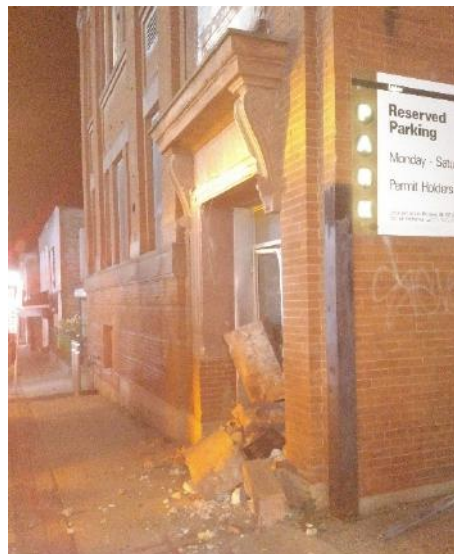
*Frontispiece after vehicle accident*

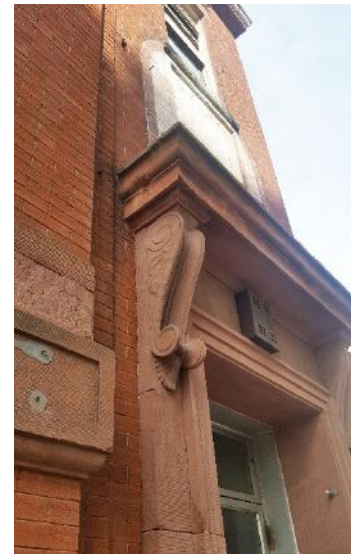
*Brownstone scroll brackets and entablature*

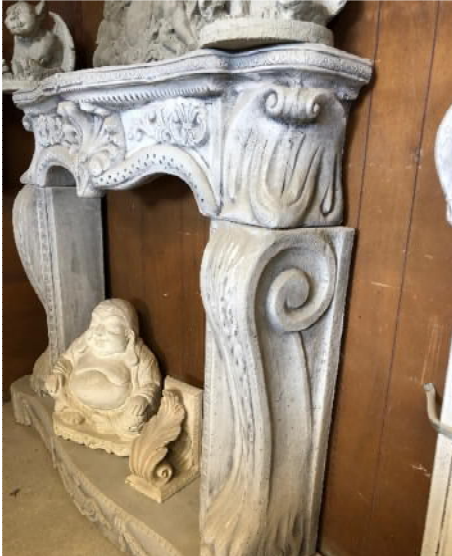
*Example of level of detail to be achieved with replacement pre-cast concrete. Existing entablature and frontispiece to be used in creating formwork.*

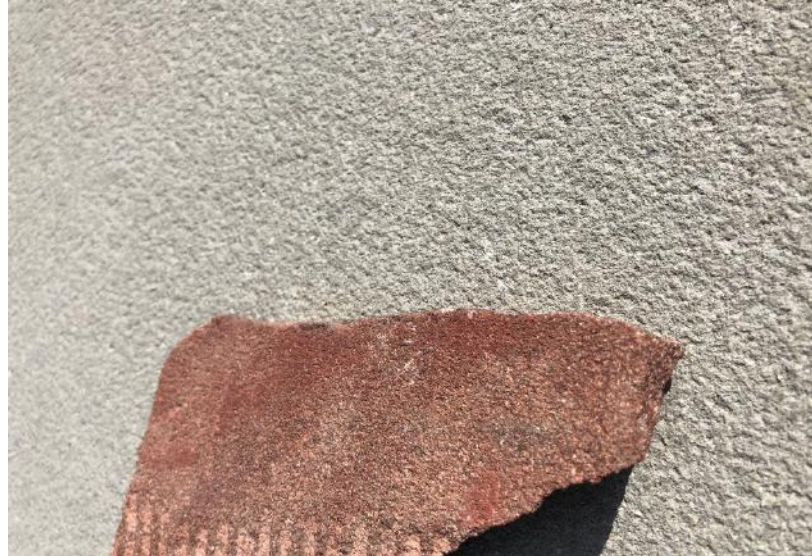
*Texture of new pre-cast concrete (beyond) compared to existing frontispiece (front).*

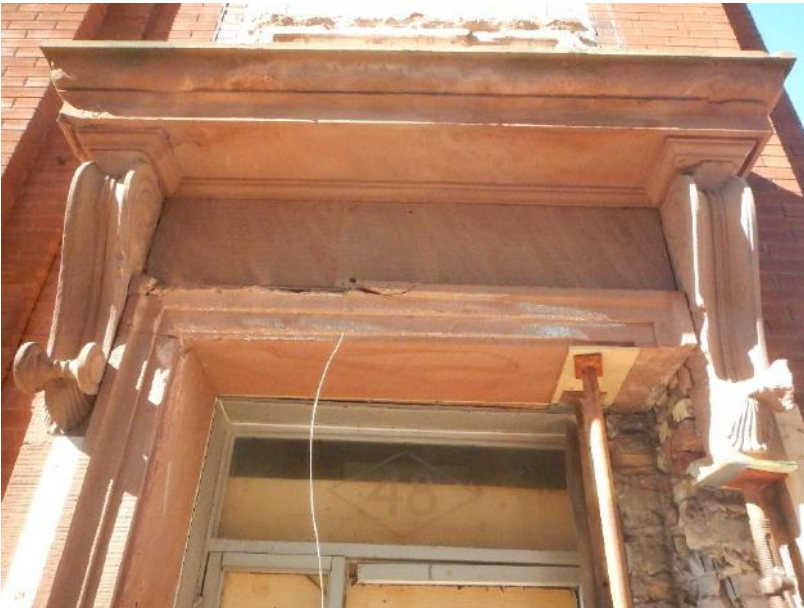
*Detail photo showing cracked top portion of entrance surround and broken scroll.*

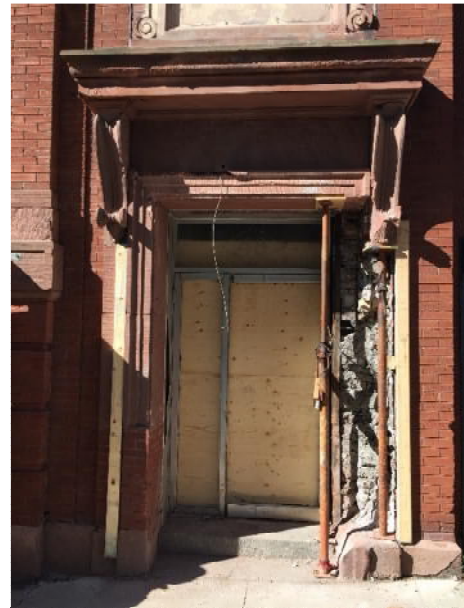
*Overall photo of damaged frontispiece.*

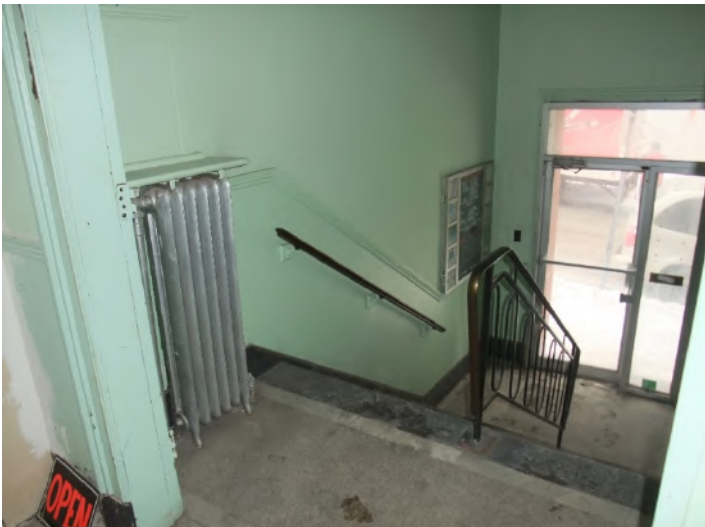
*Main entrance stair and terrazzo floor*

Ground floor terrazzo floors will be restored using a strip, sand and reseat process. The paint finish will be carefully removed from the existing metal stair guards and stringers. Rust will be removed and repairs will be carried out before receiving a new paint finish. The stair riser molding will be repaired where possible and replaced to match existing where missing or damaged. All risers will receive a new paint finish to match the existing colour. Existing slate stair treads and landing on the ground floor level will be carefully cleaned. If deemed necessary by tenants using the stairwell, a flexible anti-slip tape<sup>iii</sup> may be applied to tread nosings. Wooden handrails to be prepared for new stain and clear coat finish. The basement stair and stair from the ground floor to the second floor will be cleaned and refinished by a qualified professional using recognized conservation methods appropriate for the type of construction, to the satisfaction of heritage planning staff.

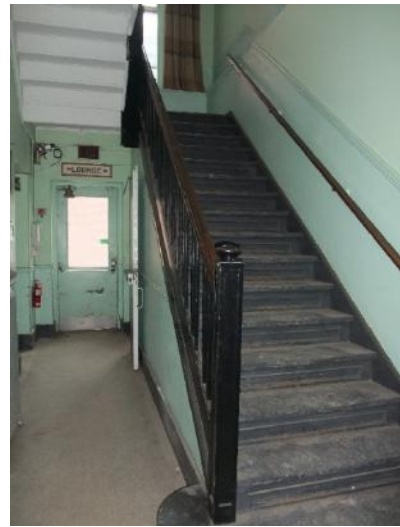
*Metal balustrade and newel-post, slate treads and metal risers*

The interior slate stair treads, stair risers, wooden handrails, metal balustrade and newel posts have been identified as heritage attributes. During the redevelopment, these areas will be protected during the removal of interior finishes, cleaned and restored. Prior to work commencing, the Coordinator of Cultural Heritage Planning at the City of Kitchener will meet with contractors responsible for removal of existing interior fixtures.

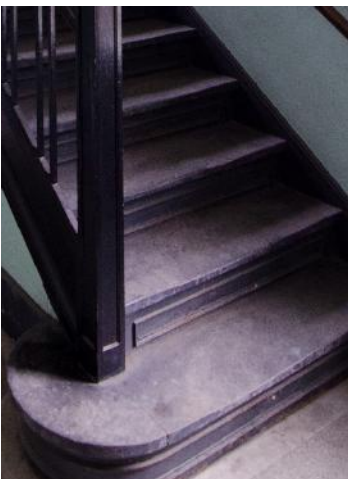
*Detail photo of metal risers.*

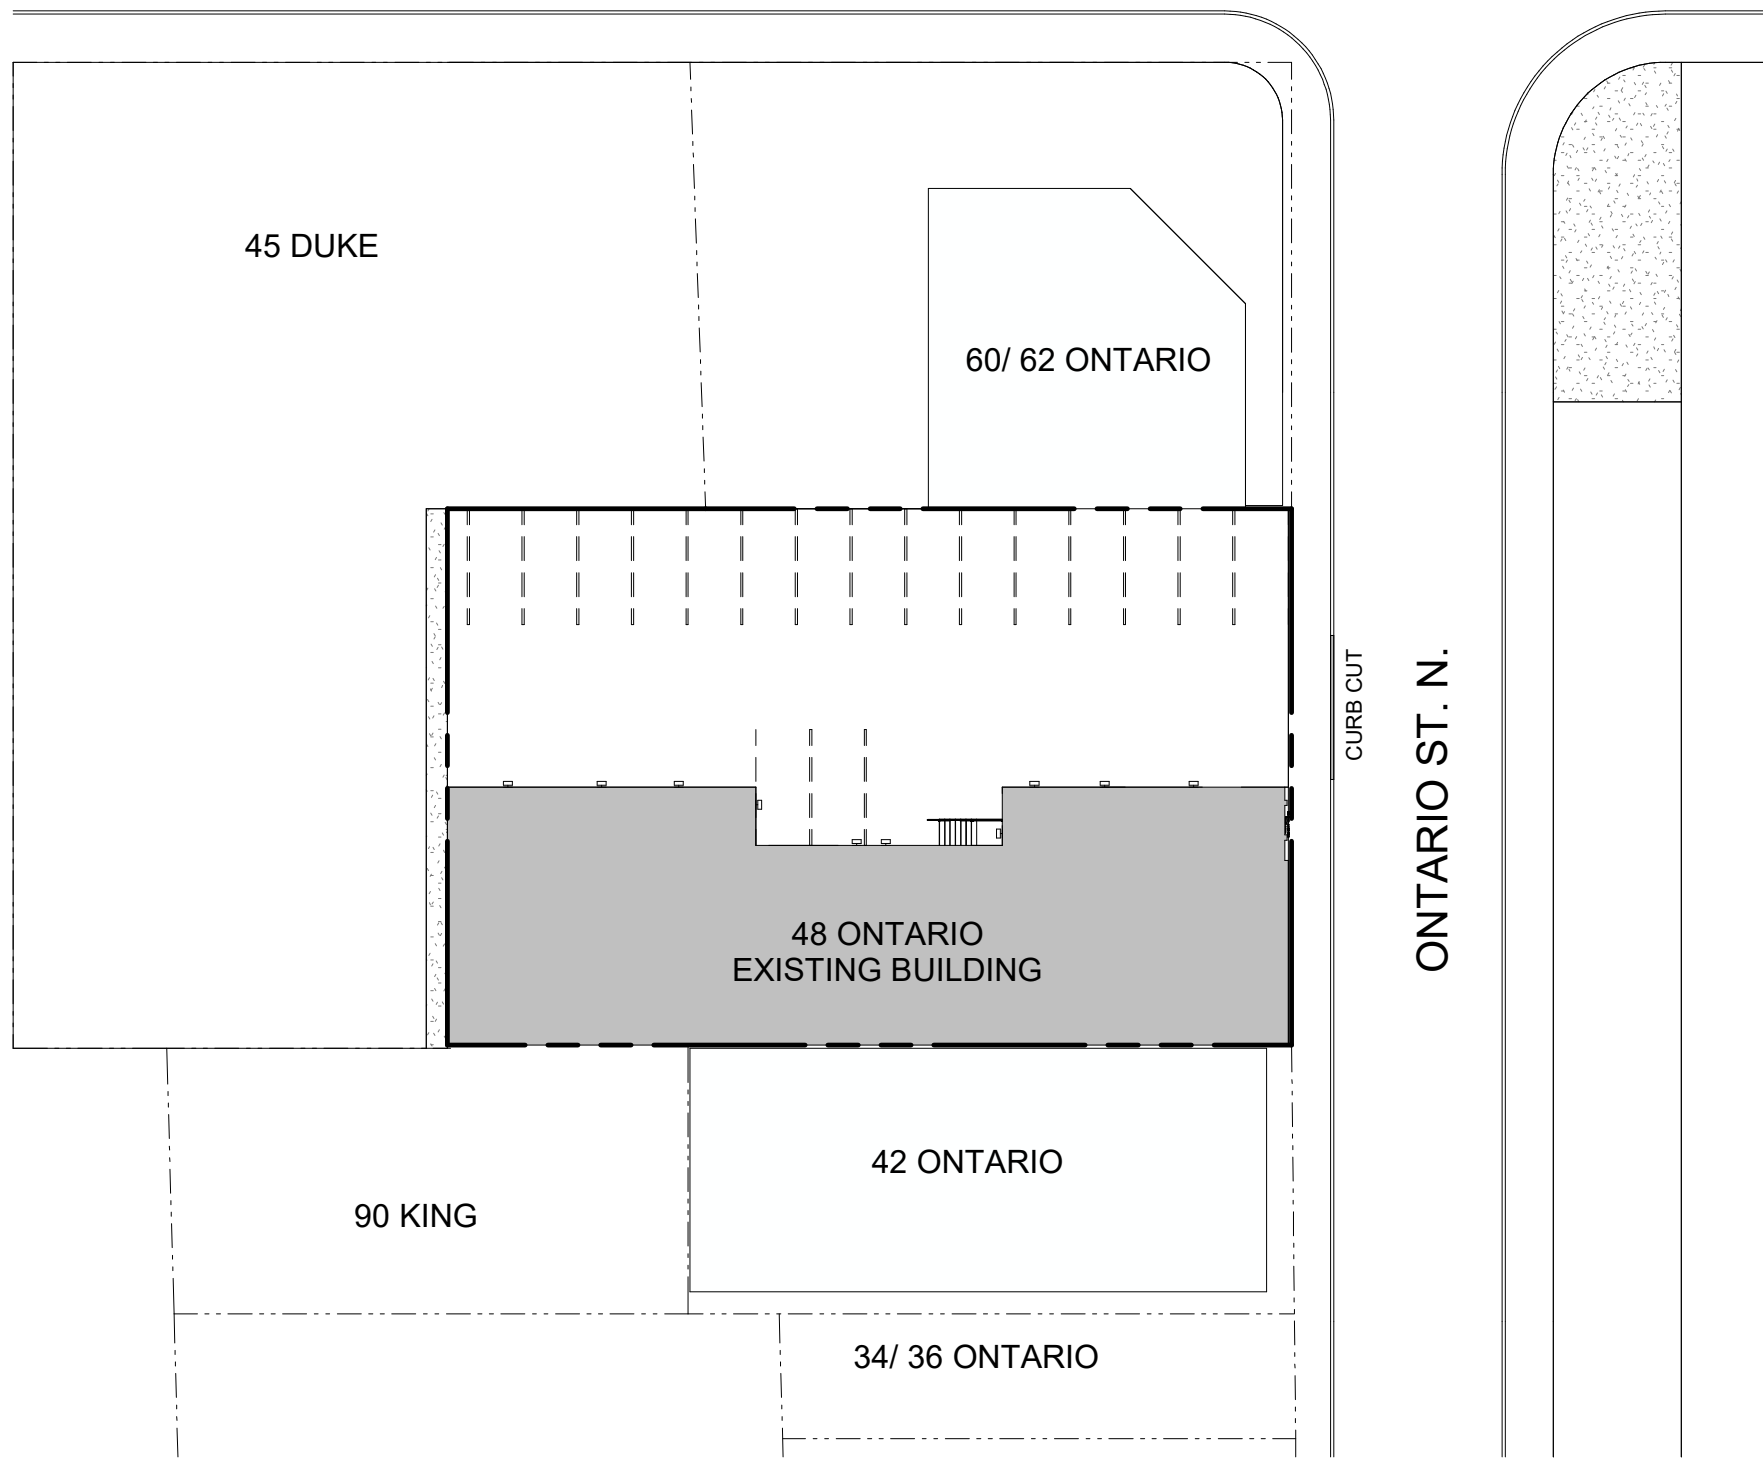
**1** **SITE PLAN**  
 1" = 30'-0"

SITE PLAN  
 48 ONTARIO STREET NORTH, KITCHENER

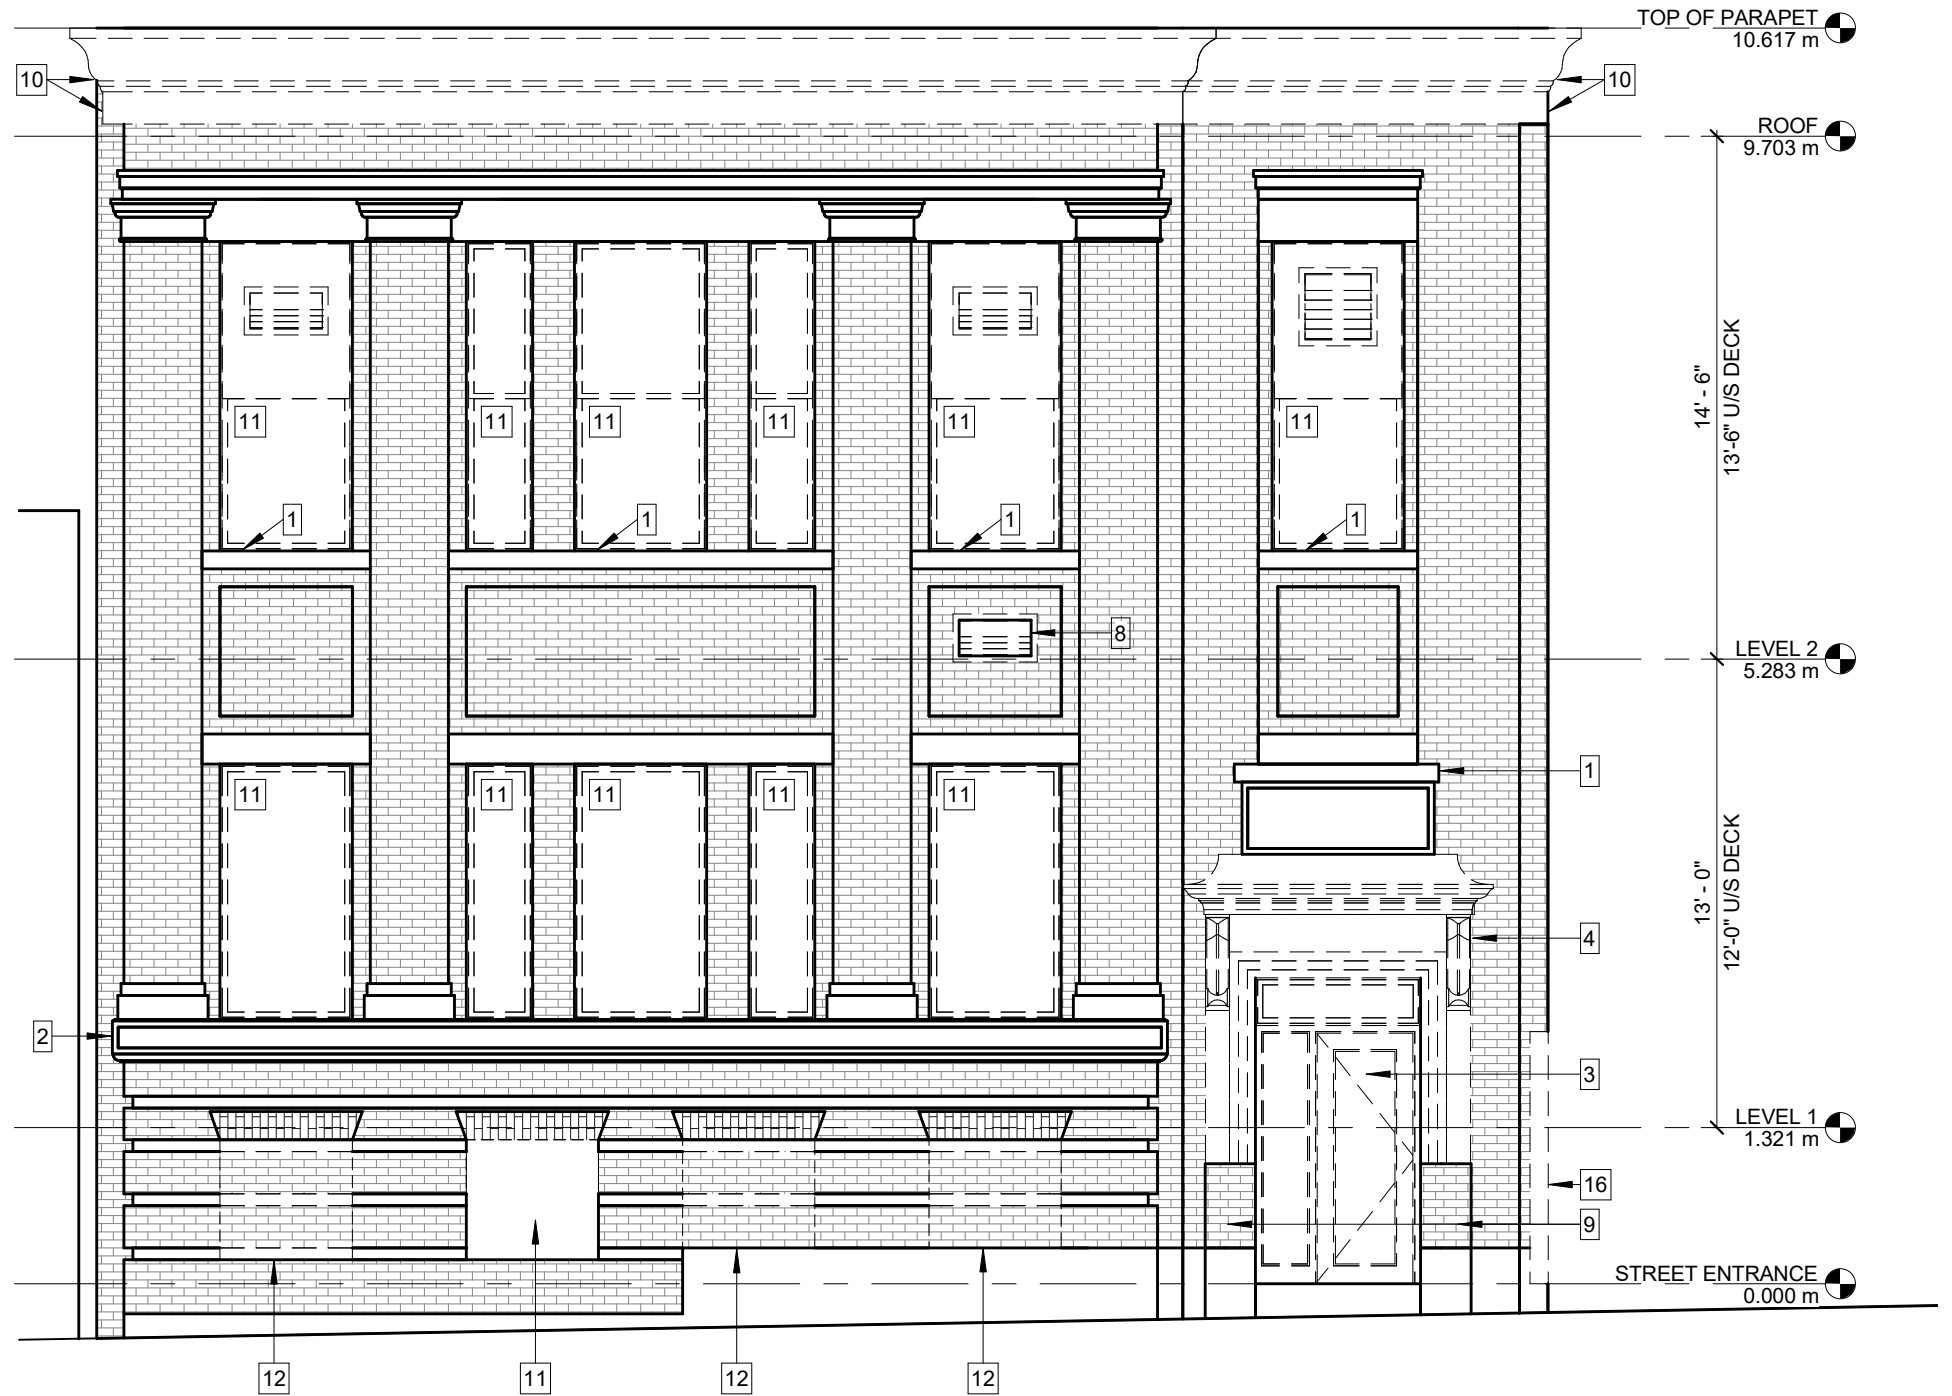
**1** EXISTING ONTARIO STREET ELEVATION  
3/16" = 1'-0"

1. REMOVE EXISTING WINDOW SILL. MAKE GOOD TO RECEIVE NEW PRE-CAST WINDOW SILL.
2. CLEAN AND REPAIR EXISTING BANDING. REPLACE WHERE APPROVED BY HPS.
3. REMOVE EXISTING DOOR AND FRAME. MAKE GOOD TO RECEIVE NEW DOOR AND FRAME. MAINTAIN EXISTING SIZE OF OPENING.
4. REMOVE AND SALVAGE EXISTING MAIN ENTRANCE FEATURES, INCLUDING FRONTISPIECE, SCROLL BRACKETS AND ENTABLATURE. EXISTING FEATURES ARE TO BE USED AS FORMWORK TO MAKE EXACT PRE-CAST REPLICAS. SUBJECT TO APPROVAL BY THE HPS.

5. REMOVE EXISTING BRICK BASE. REPLACE WITH NEW PRE-CAST BASE TO MATCH EXISTING FEATURES REMOVED ABOVE (SEE NOTE NO. 4). SUBJECT TO APPROVAL BY THE HPS.
6. INFILL EXISTING WATERPROOFED OPENING WITH BRICK TO MATCH EXISTING.
7. REMOVE ALL GRATES AND METAL FIXTURES FROM ALL WINDOWS. MAKE GOOD.
8. REMOVE EXISTING VENT. MAKE GOOD TO RECEIVE NEW BRICK INFILL TO MATCH EXISTING FINISHES.
9. RESERVED.
10. REMOVE EXISTING BANDING. USE SALVAGE BANDING TO MOULD NEW BANDING PROFILE. SUBJECT TO APPROVAL BY THE HPS.

11. REMOVE EXISTING WINDOW AND FRAME. REMOVE ANY WINDOW BOARDING AND VENTS. MAKE OPENING GOOD TO RECEIVE NEW WINDOW. MAINTAIN EXISTING SIZE OF OPENINGS.
12. REMOVE EXISTING BRICK. MAKE OPENING GOOD TO RECEIVE NEW WINDOW.
13. REMOVE EXISTING METAL / CLAY PARAPET CAP.
14. RAILING TO BE REMOVED.
15. REMOVE AND MAKE SAFE EXISTING LIGHTING FIXTURE, EXTERIOR WIRES, AND CONDUIT.
16. REMOVE METAL BRICK PROTECTOR. MAKE BRICK GOOD.

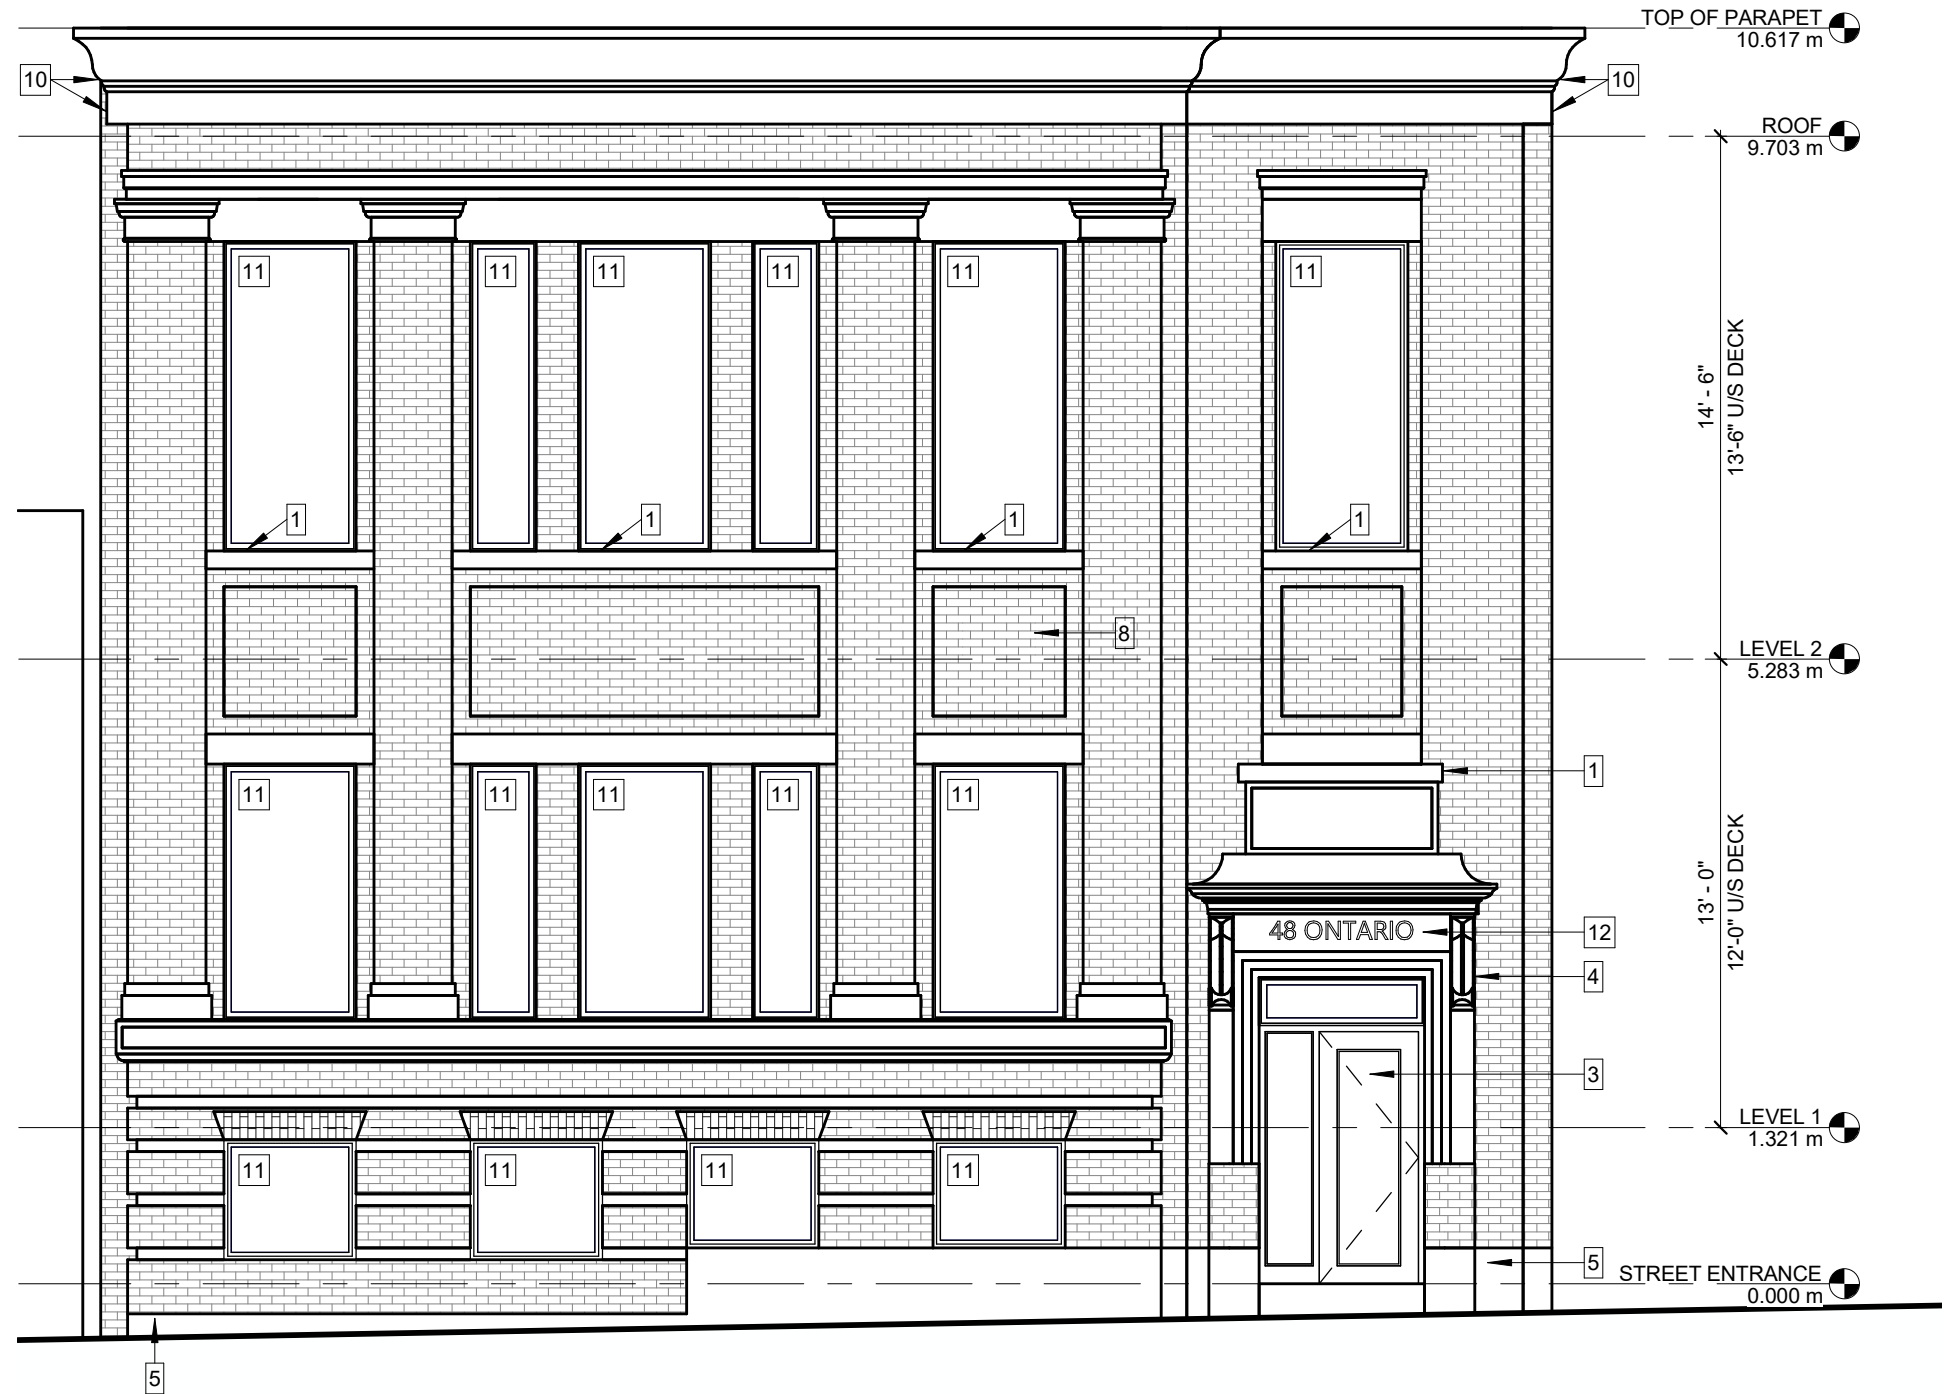
**1 PROPOSED ONTARIO STREET ELEVATION**  
3/16" = 1'-0"

1. NEW PRE-CAST CONCRETE WINDOW SILL. FORM AND COLOUR TO MATCH EXISTING.
2. RESERVED.
3. NEW PREFINISHED ALUMINUM DOOR AND FRAME. COLOUR: GRAPHITE.
4. NEW ENTRANCE FEATURES, INCLUDING FRONTISPIECE, SCROLL BREACKETS AND ENTABLATURE TO BE REPLACED WITH PRE-CAST REPLICAS. EXISTING PROFILES TO BE USED AS MOULDS TO PRODUCE EXACT REPLICAS. COLOUR TO MATCH EXISTING.
5. PARGE EXISTING EXPOSED CONCRETE FOUNDATION TO MATCH EXISTING COLOUR.

6. STAIN ALL NEW MORTAR TO MATCH EXISTING MORTAR COLOUR. ALL MORTAR TO BE STAINED EVENLY ACROSS FRONT FACADE.

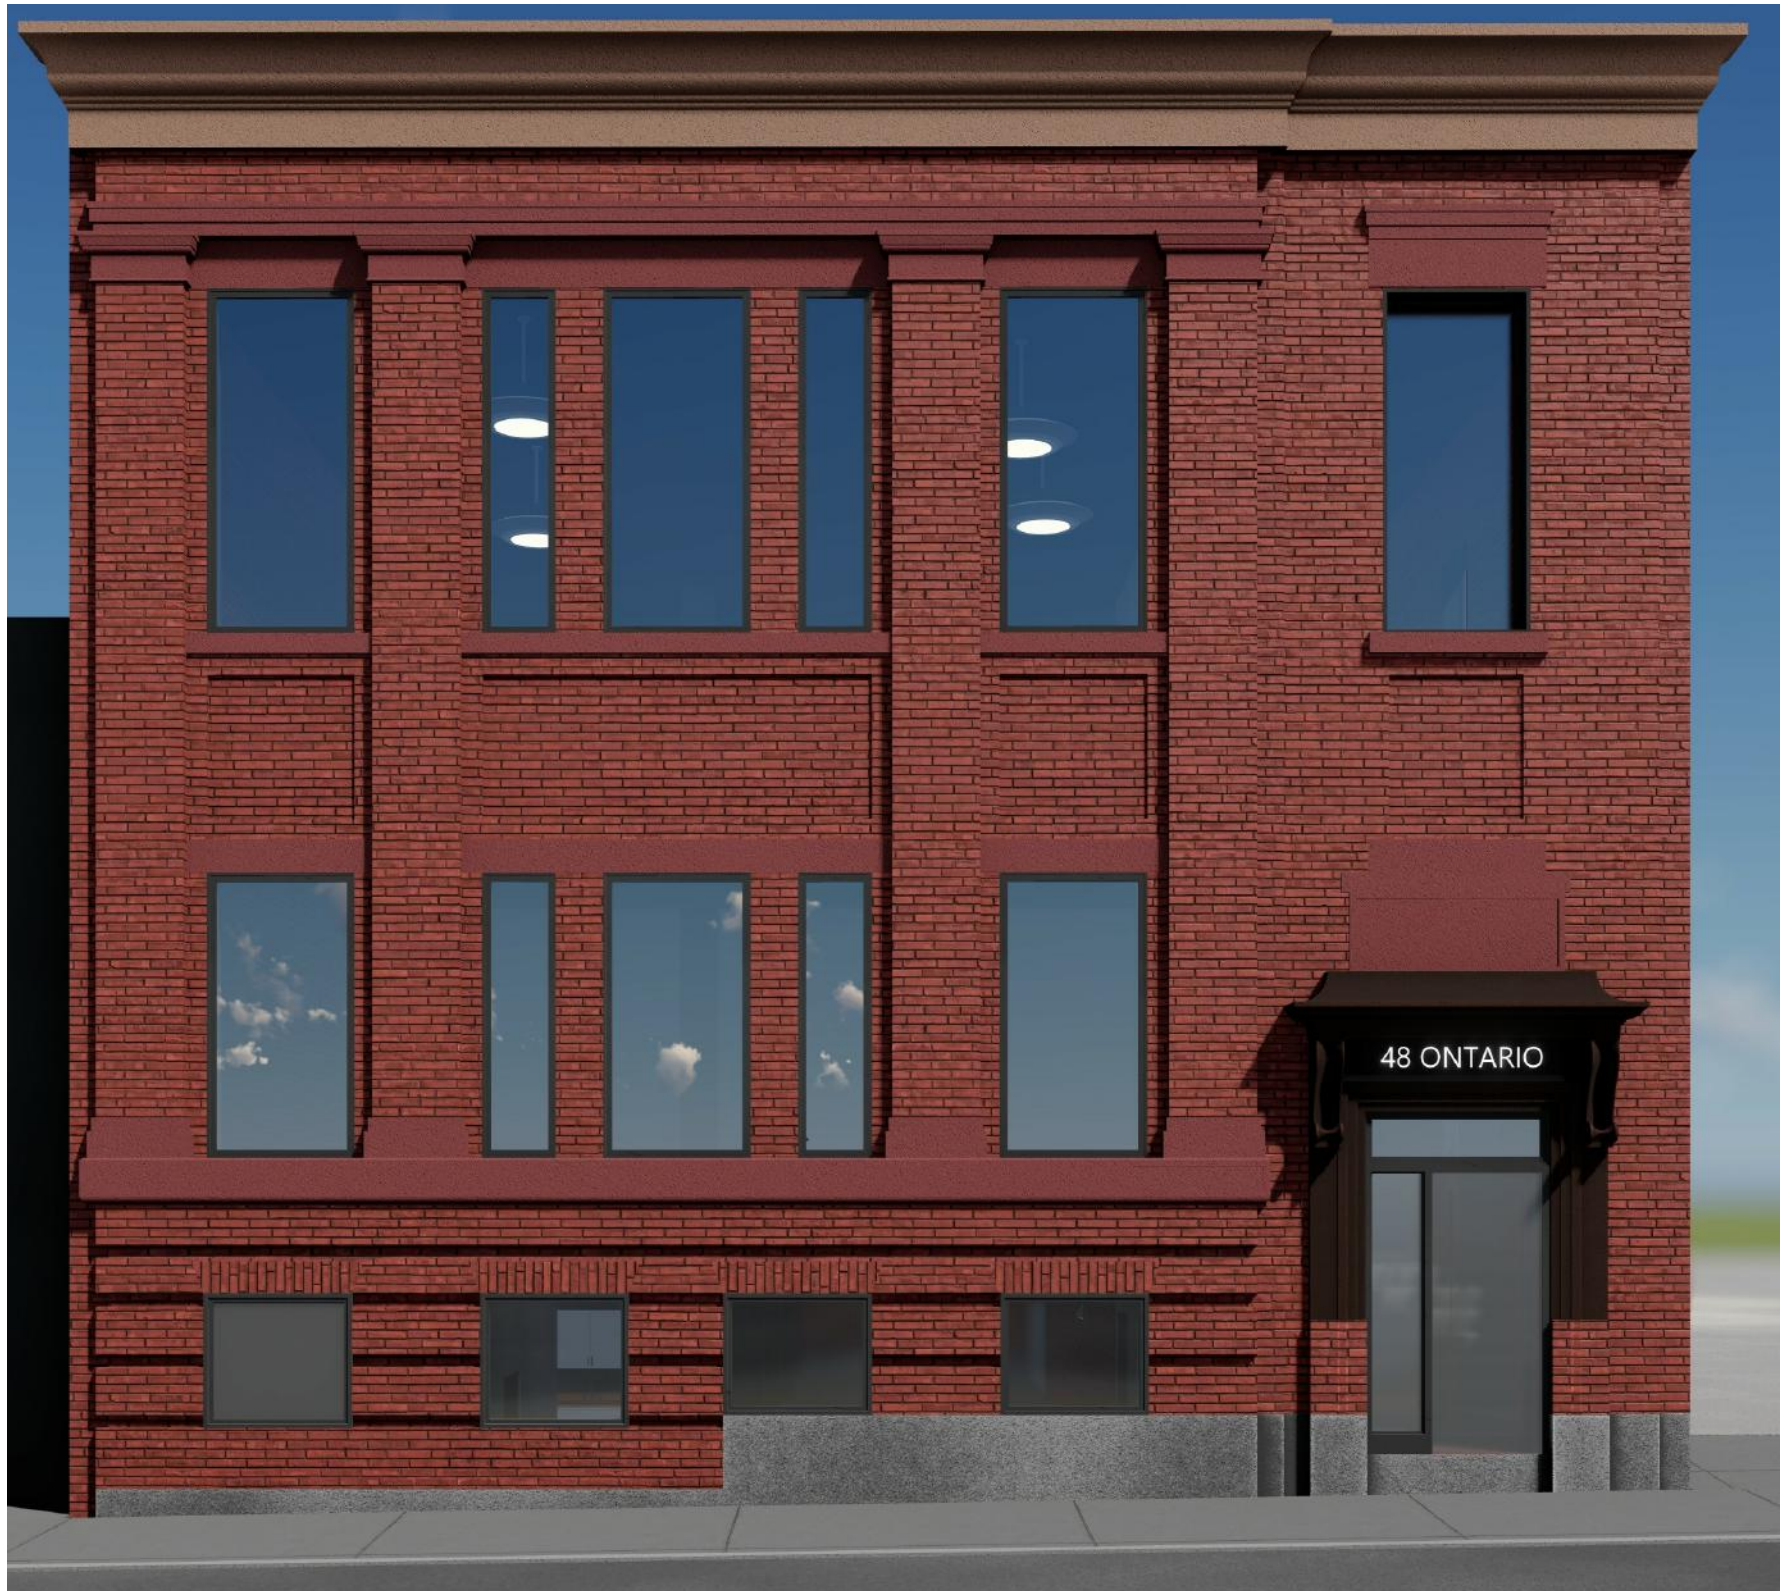
ARTISTIC RENDITION ONLY.  
COLOUR OF EXISTING BUILDING FEATURES ARE TO REMAIN.  
ANY NEW ELEMENTS WILL MATCH COLOUR OF EXISTING BUILDING FEATURES.

# RENDERING OF FRONT ELEVATION 48 ONTARIO STREET NORTH, KITCHENER
