# Heritage Report

48 Ontario Street North

April 27, 2018

## 48 Ontario Street, Kitchener - Heritage Report

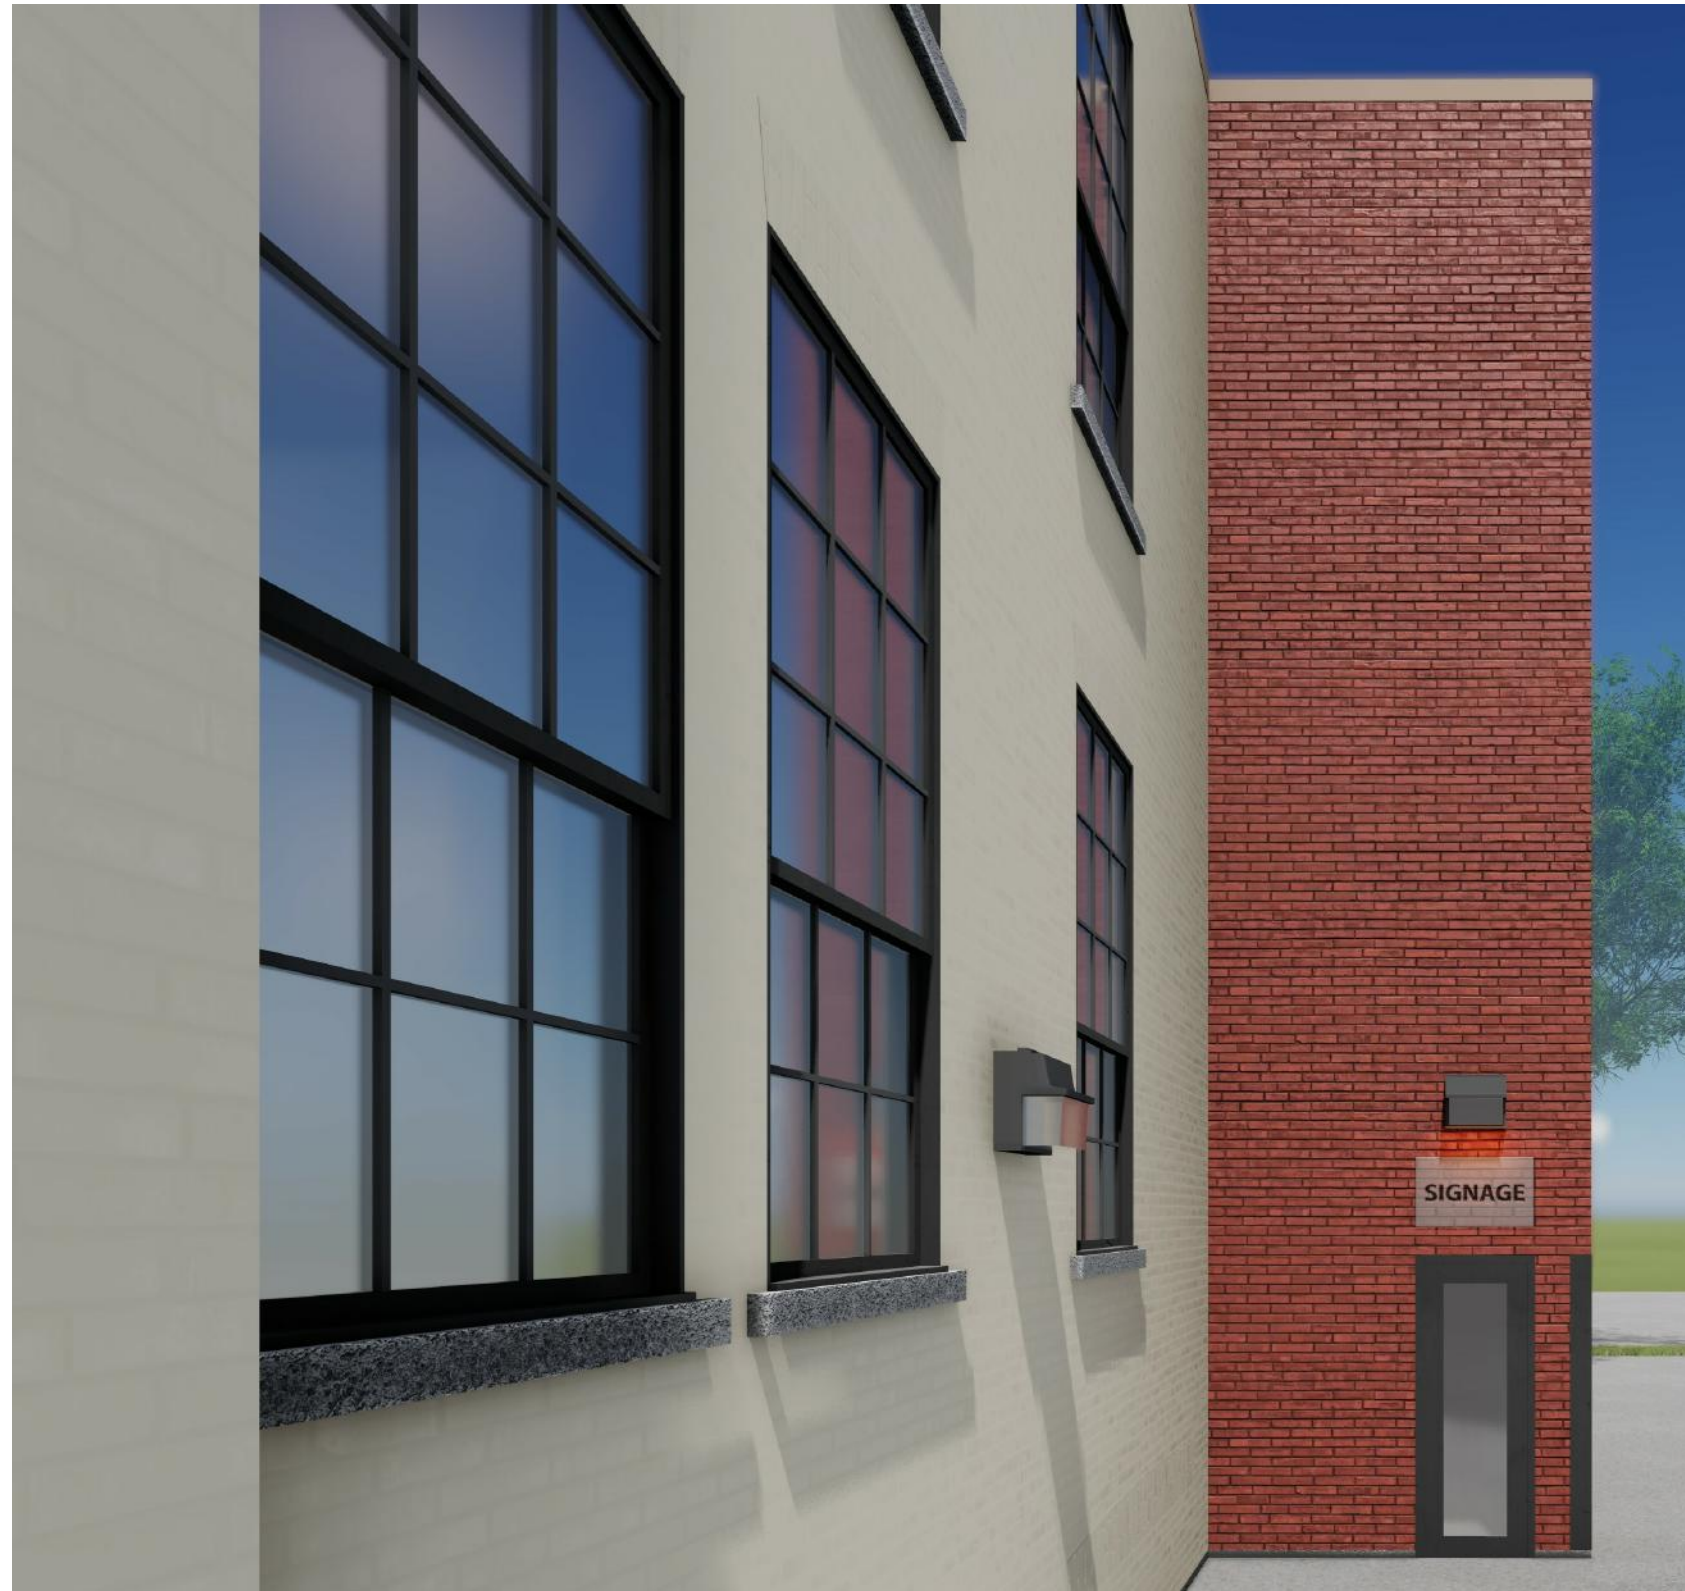
ARTISTIC RENDITION ONLY.  
COLOUR OF EXISTING BUILDING FEATURES ARE TO REMAIN.  
ANY NEW ELEMENTS WILL MATCH COLOUR OF EXISTING BUILDING FEATURES.

**RENDERING OF EAST ELEVATION**  
**48 ONTARIO STREET NORTH, KITCHENER**

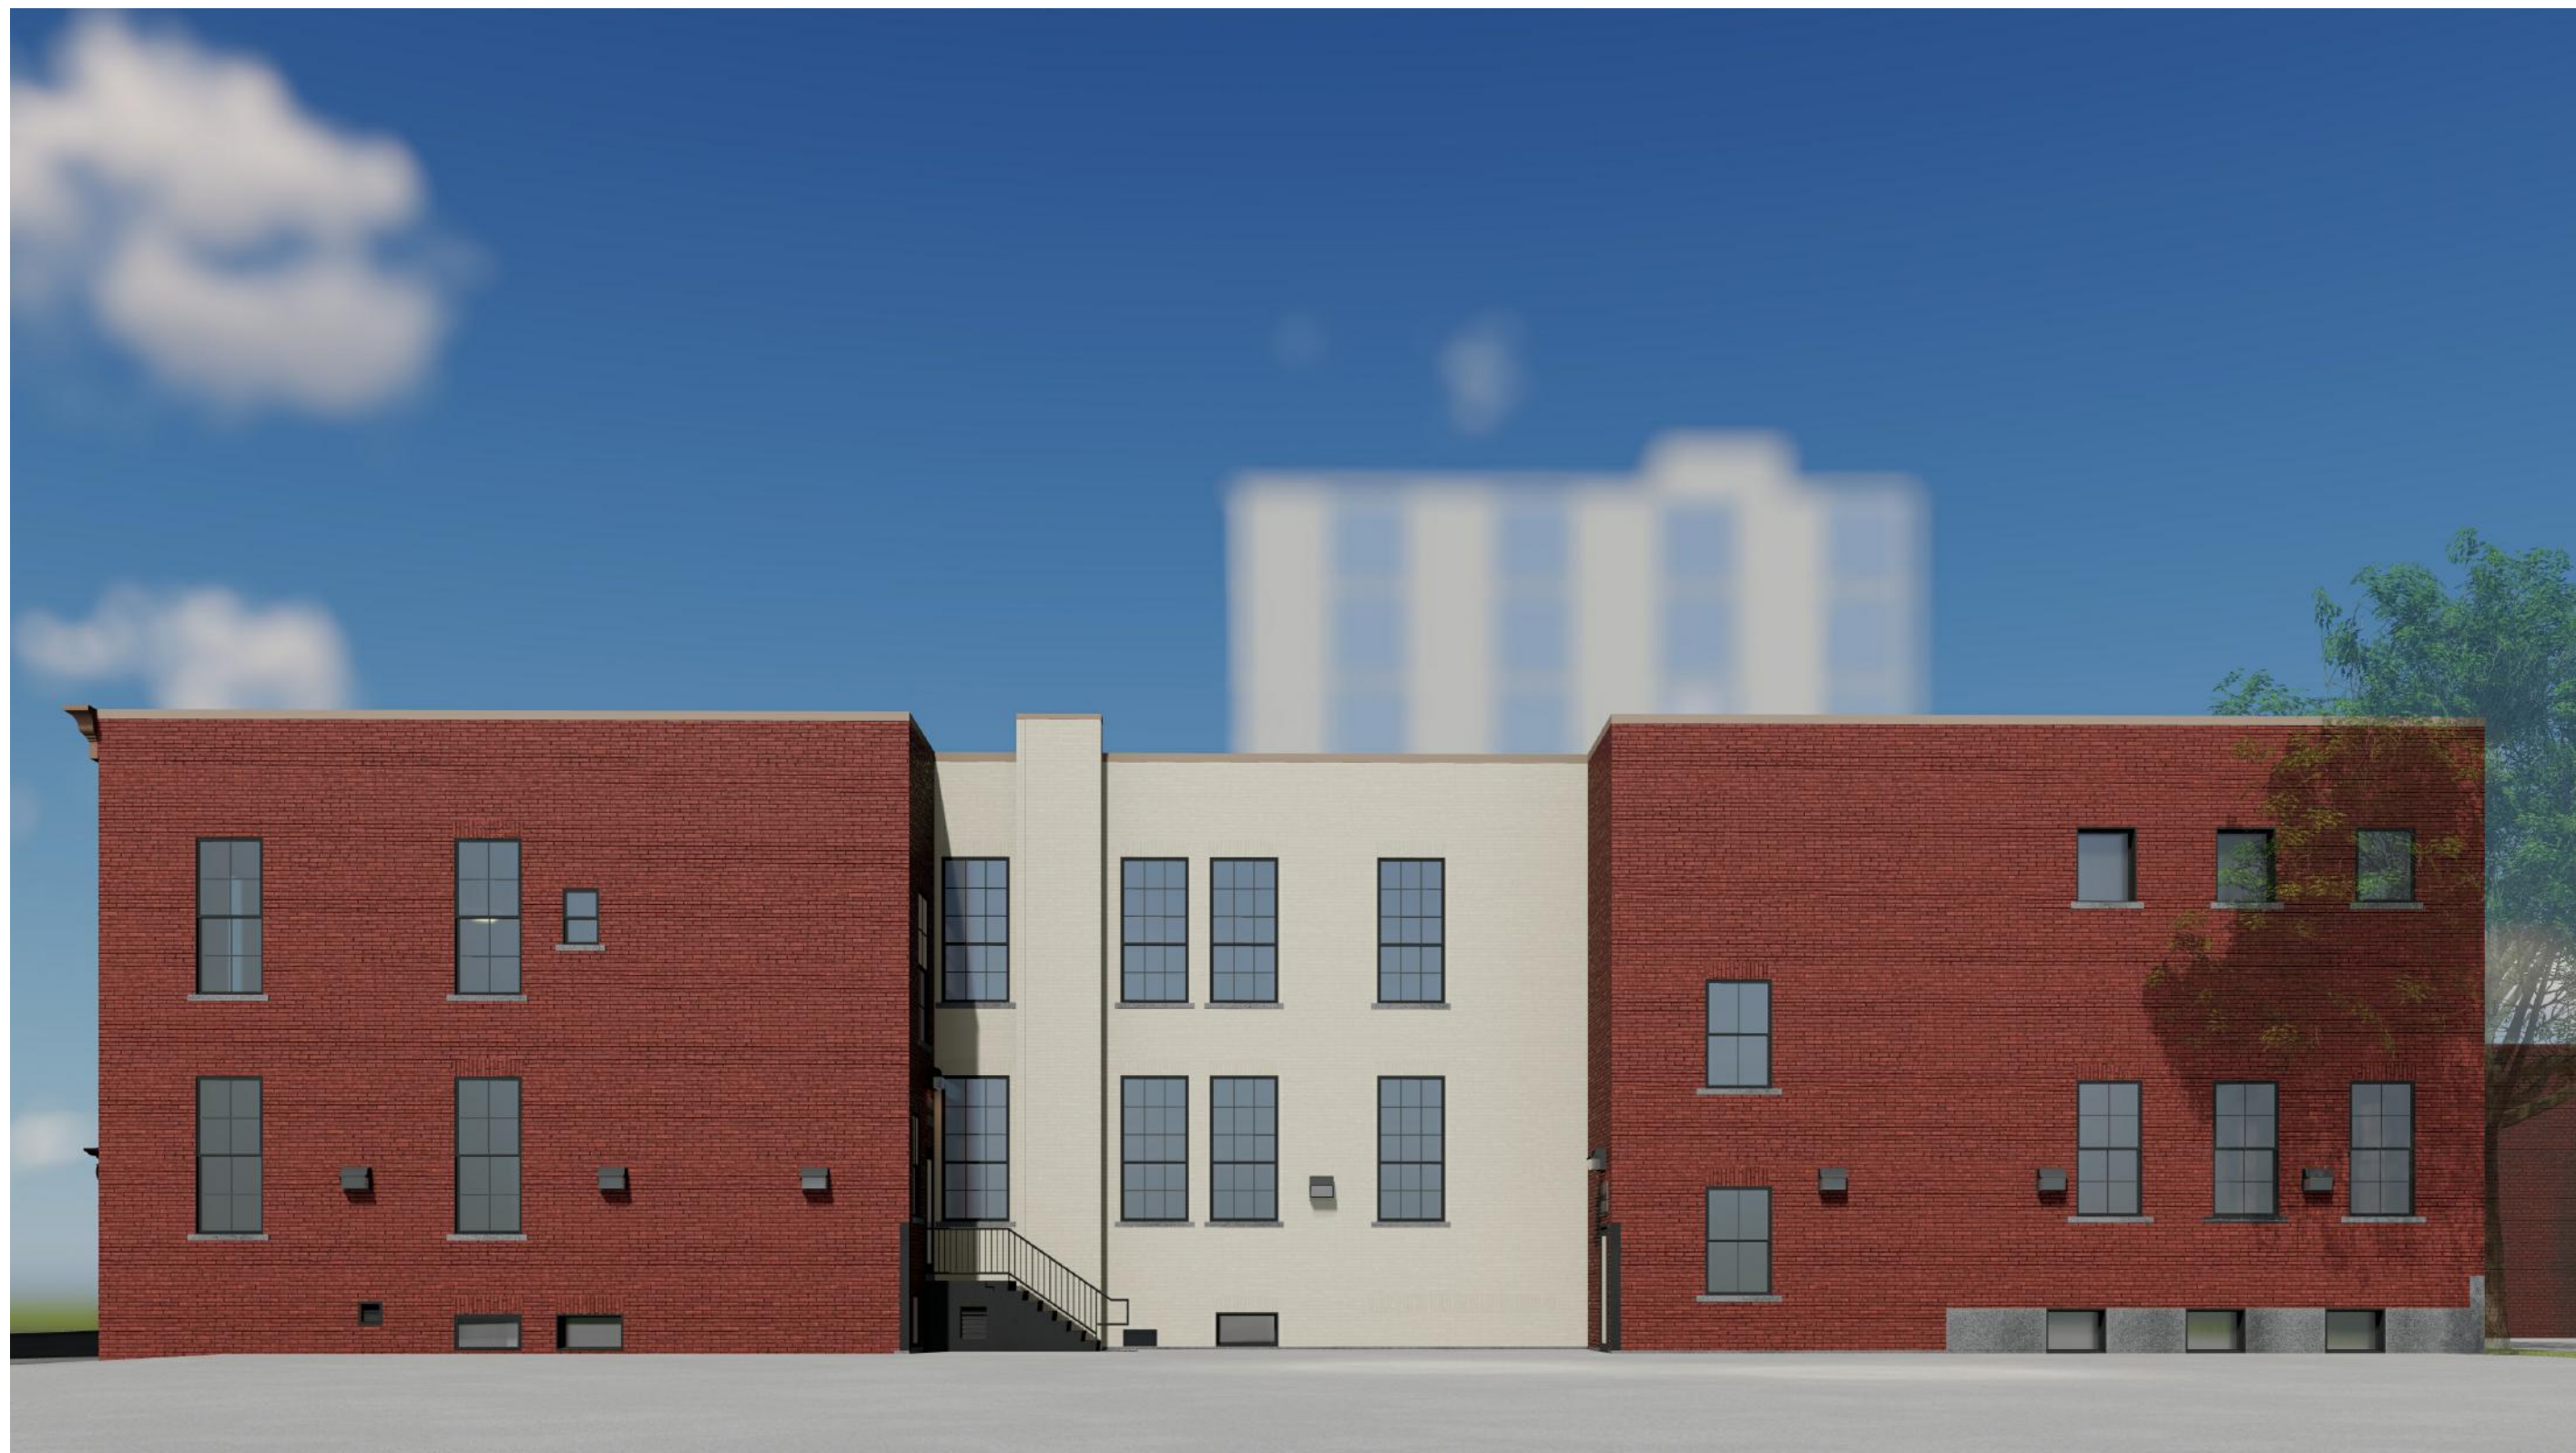
ARTISTIC RENDITION ONLY.  
COLOUR OF EXISTING BUILDING FEATURES ARE TO REMAIN.  
ANY NEW ELEMENTS WILL MATCH COLOUR OF EXISTING BUILDING FEATURES.

**RENDERING OF NORTH ELEVATION**  
**48 ONTARIO STREET NORTH, KITCHENER**

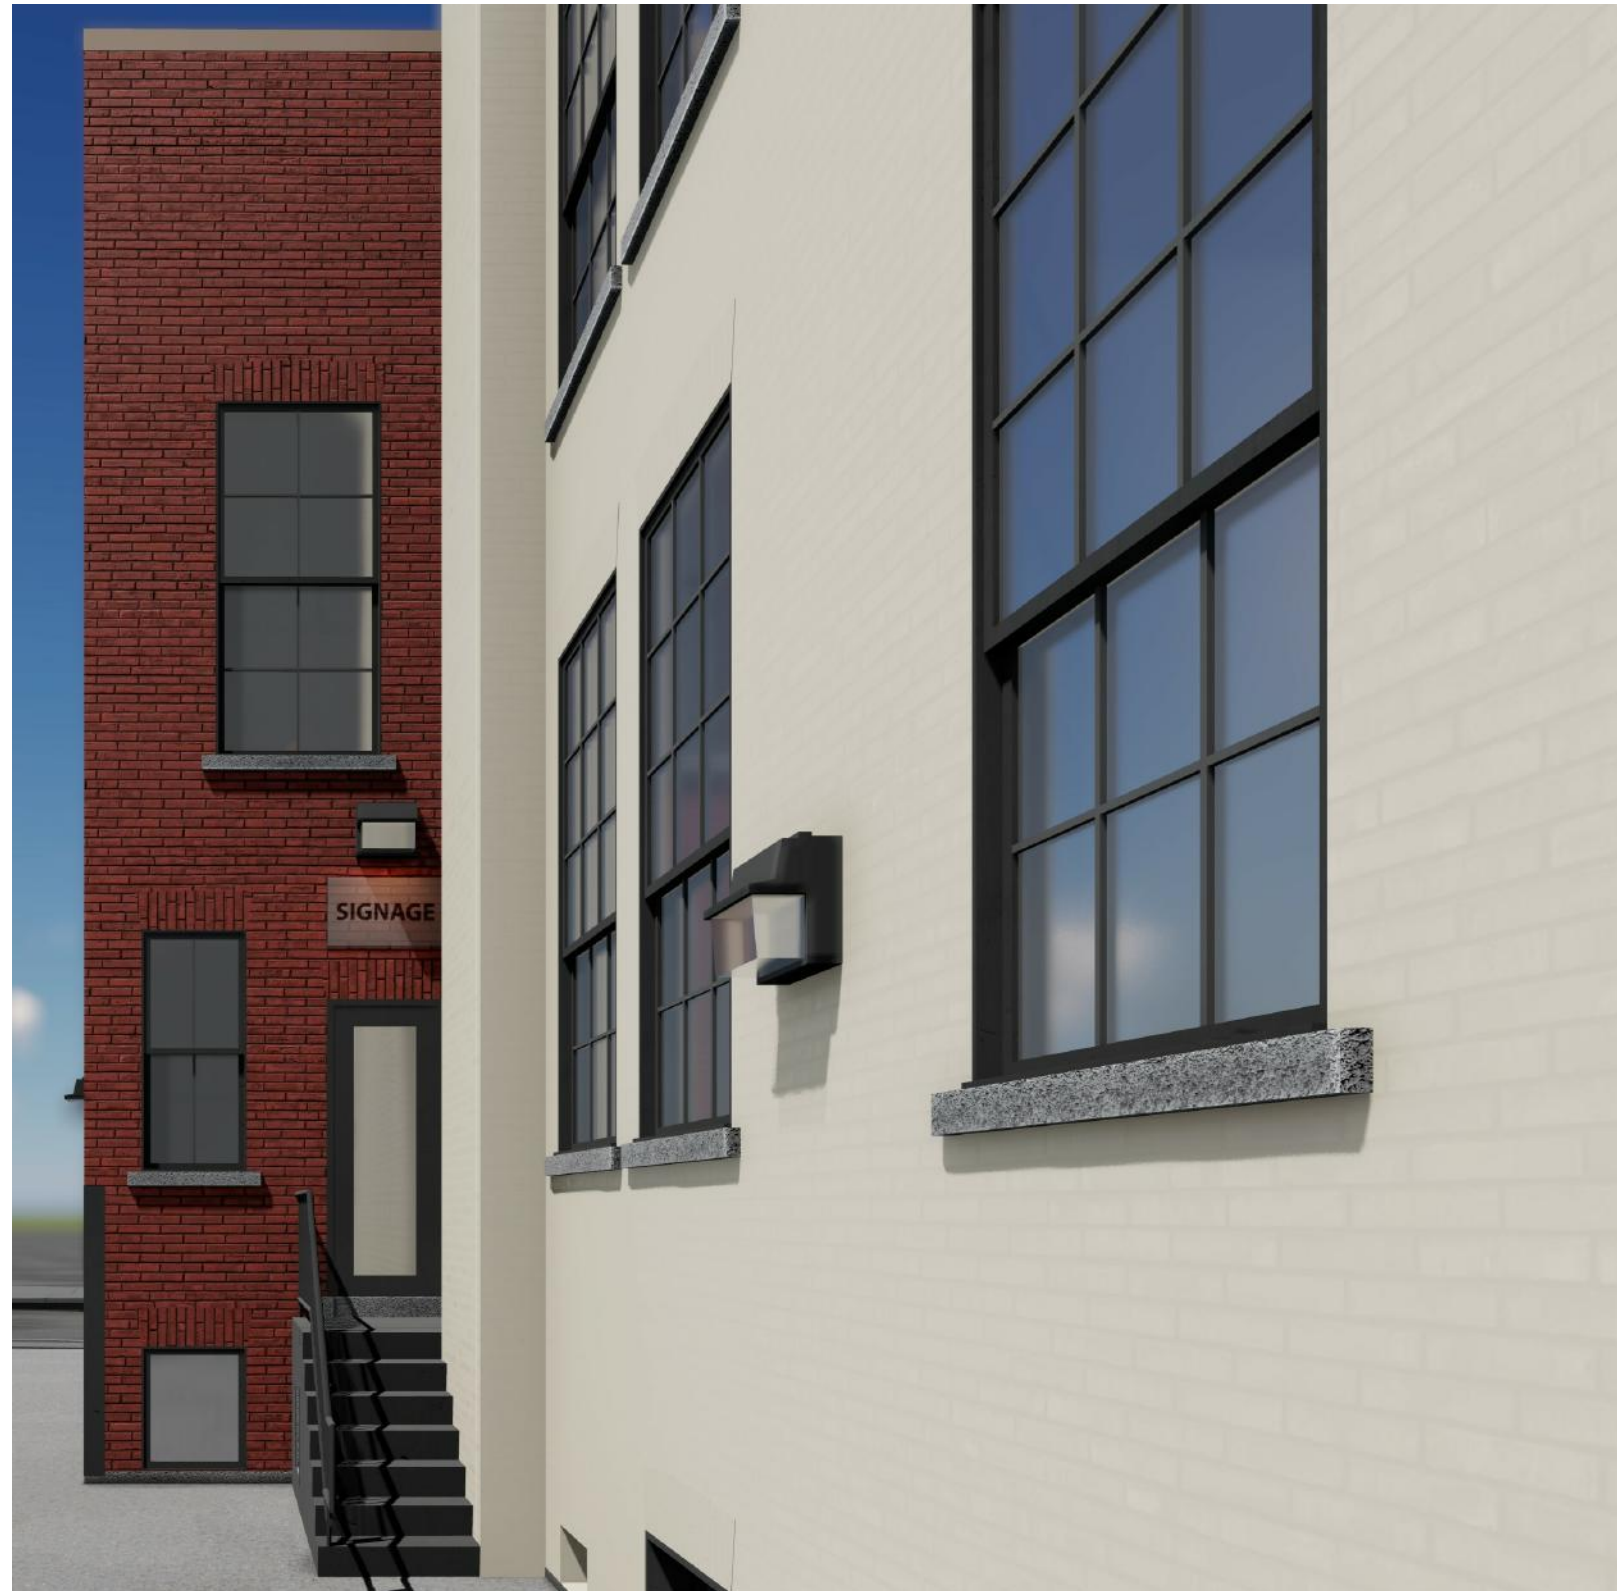
ARTISTIC RENDITION ONLY.  
COLOUR OF EXISTING BUILDING FEATURES ARE TO REMAIN.  
ANY NEW ELEMENTS WILL MATCH COLOUR OF EXISTING BUILDING FEATURES.

# RENDERING OF WEST ELEVATION 48 ONTARIO STREET NORTH, KITCHENER

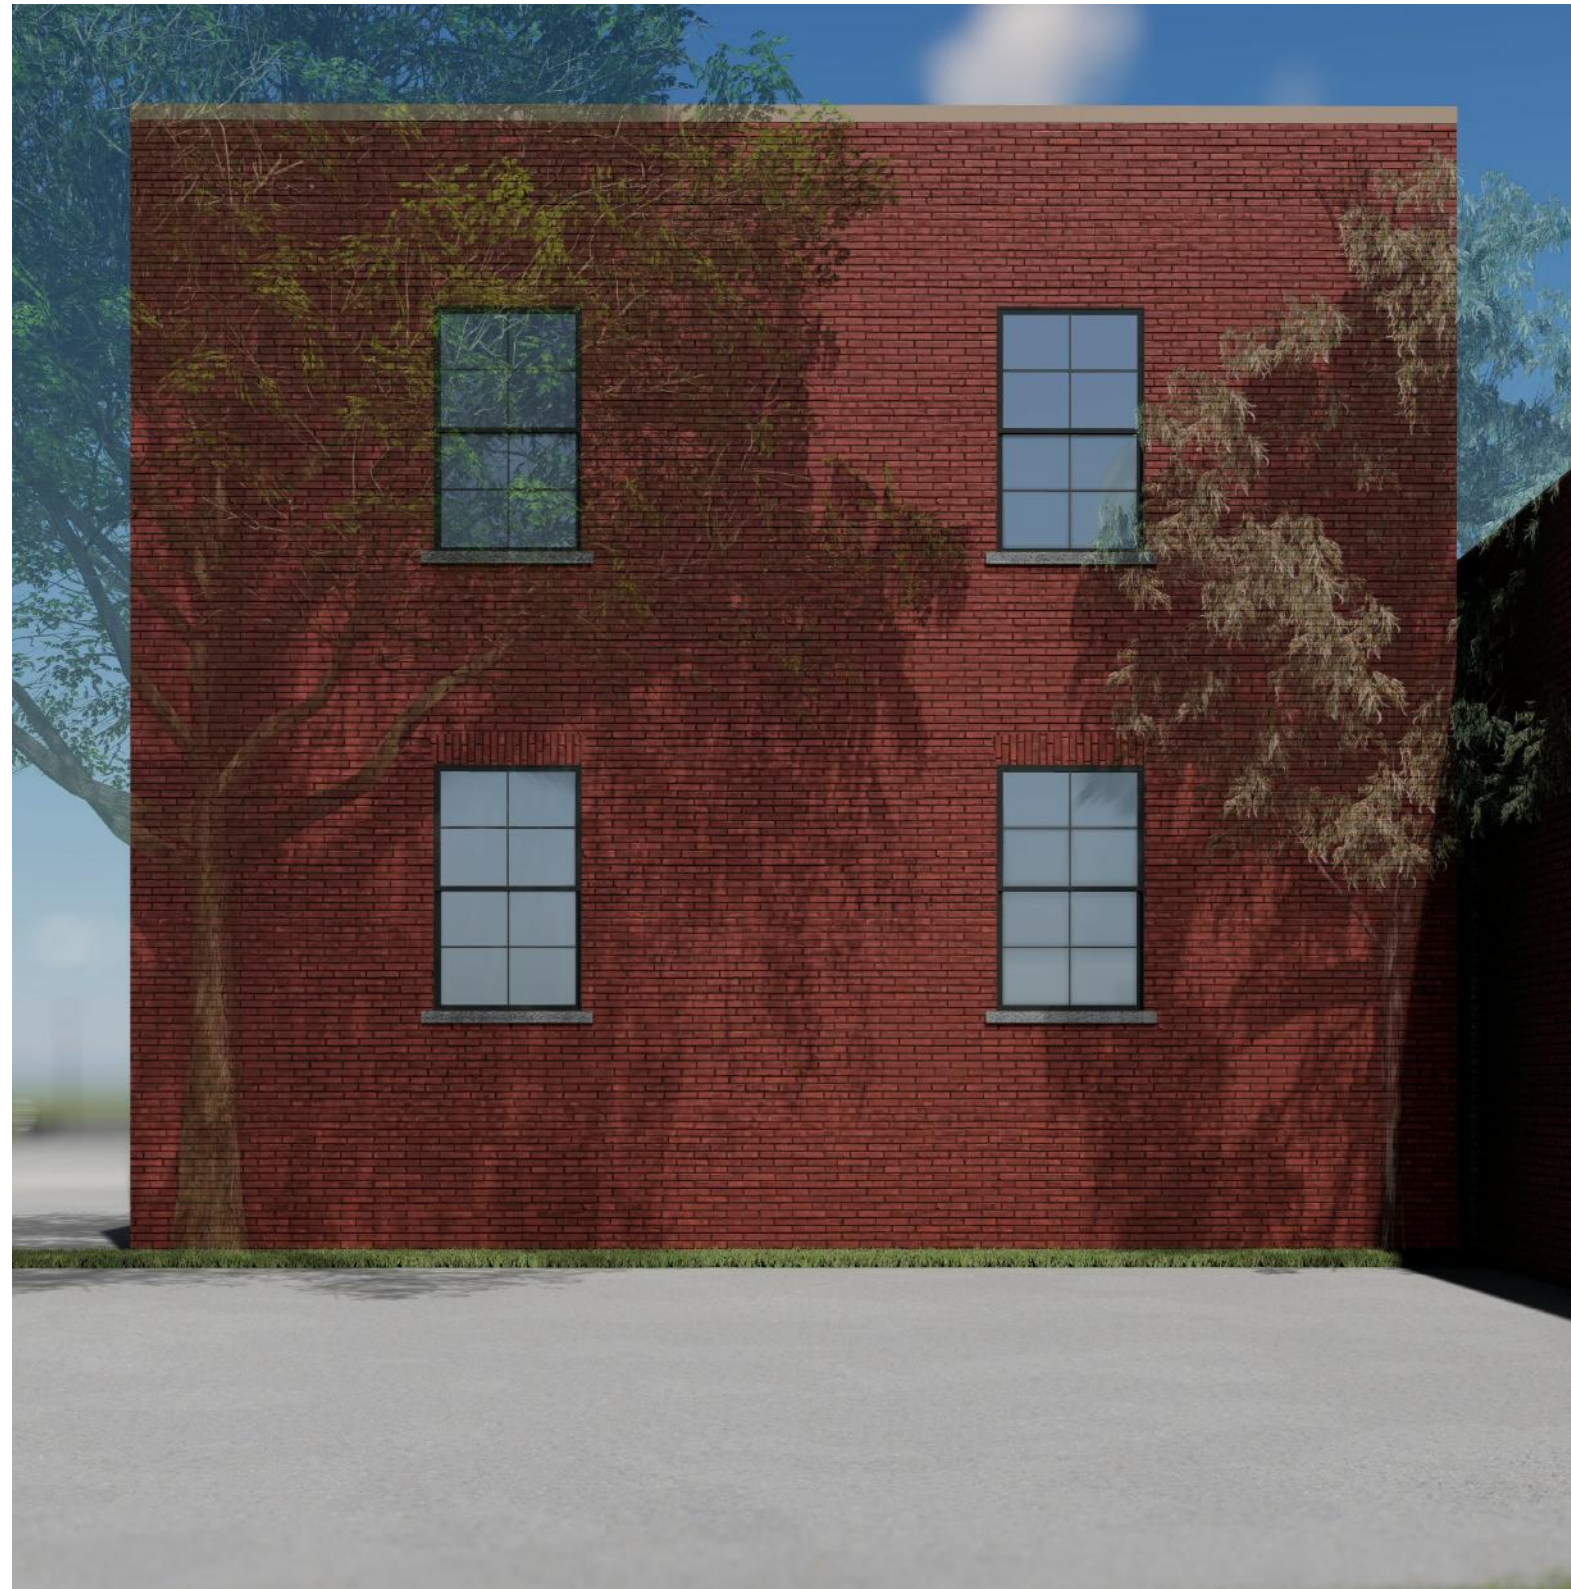
ARTISTIC RENDITION ONLY.  
COLOUR OF EXISTING BUILDING FEATURES ARE TO REMAIN.  
ANY NEW ELEMENTS WILL MATCH COLOUR OF EXISTING BUILDING FEATURES.

## RENDERING OF REAR ELEVATION 48 ONTARIO STREET NORTH, KITCHENER
