STATEMENT OF SIGNIFICANCE

54-68 King Street West

CULTURAL HERITAGE EVALUATION FORM

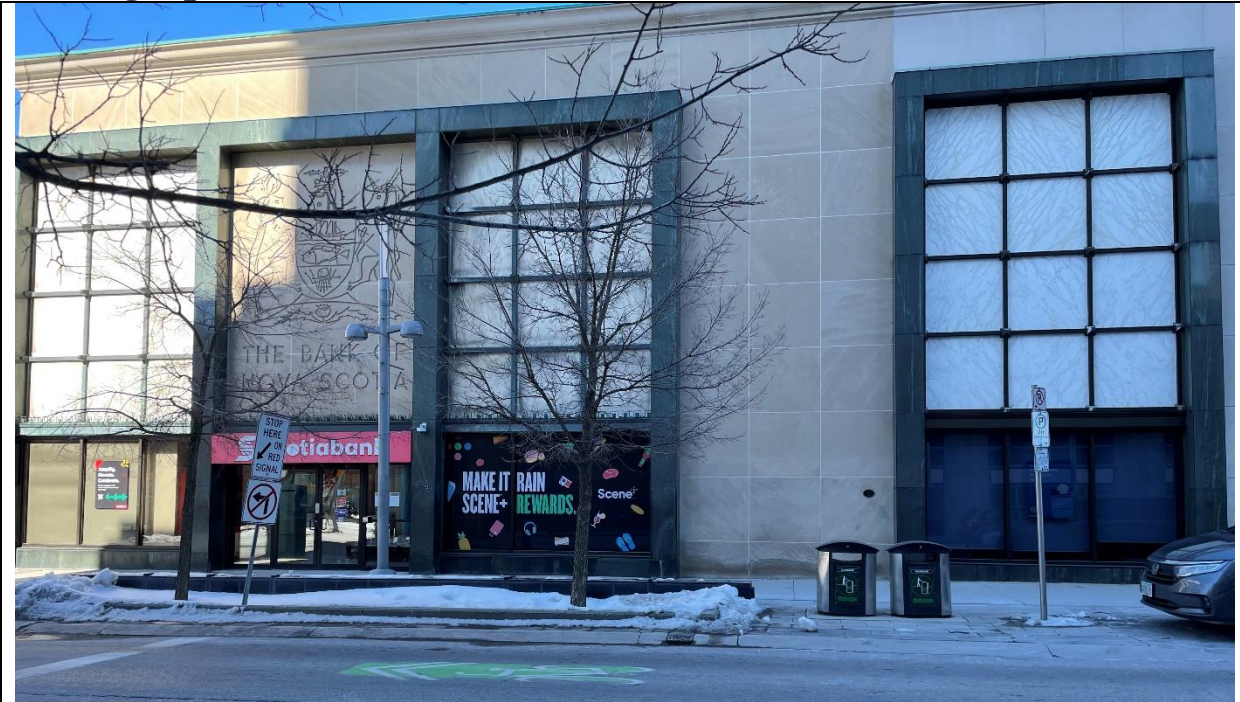
Front Elevation (South Façade)

South Front Façade

The front of the building faces King Street West, and is a limestone façade with five bays. The four bays off-set to the west are original, while the fifth to the east is an addition. The addition is identifiable by the differing colour of the surrounding masonry, and further it visually alters the composition of the front façade. The first and third bay from the west as well as the fifth bay addition are composed of a screen of twelve white marble panels set in bronze mullions, with triple windows below. The marble panels are arranged three across and four high, and where the mullions meet there is a projecting pyramidal decorative element. The second bay from the west contains glazed double-entrance doors flanked by a window and located above the entrance, a limestone slab inscribed with the Bank of Nova Scotia Coat of Arms. The first three bays and the fifth additional bay are framed by green marble. The fourth bay is limestone arranged in an ashlar pattern. A modeled cornice adds further interest to a flat roofline.

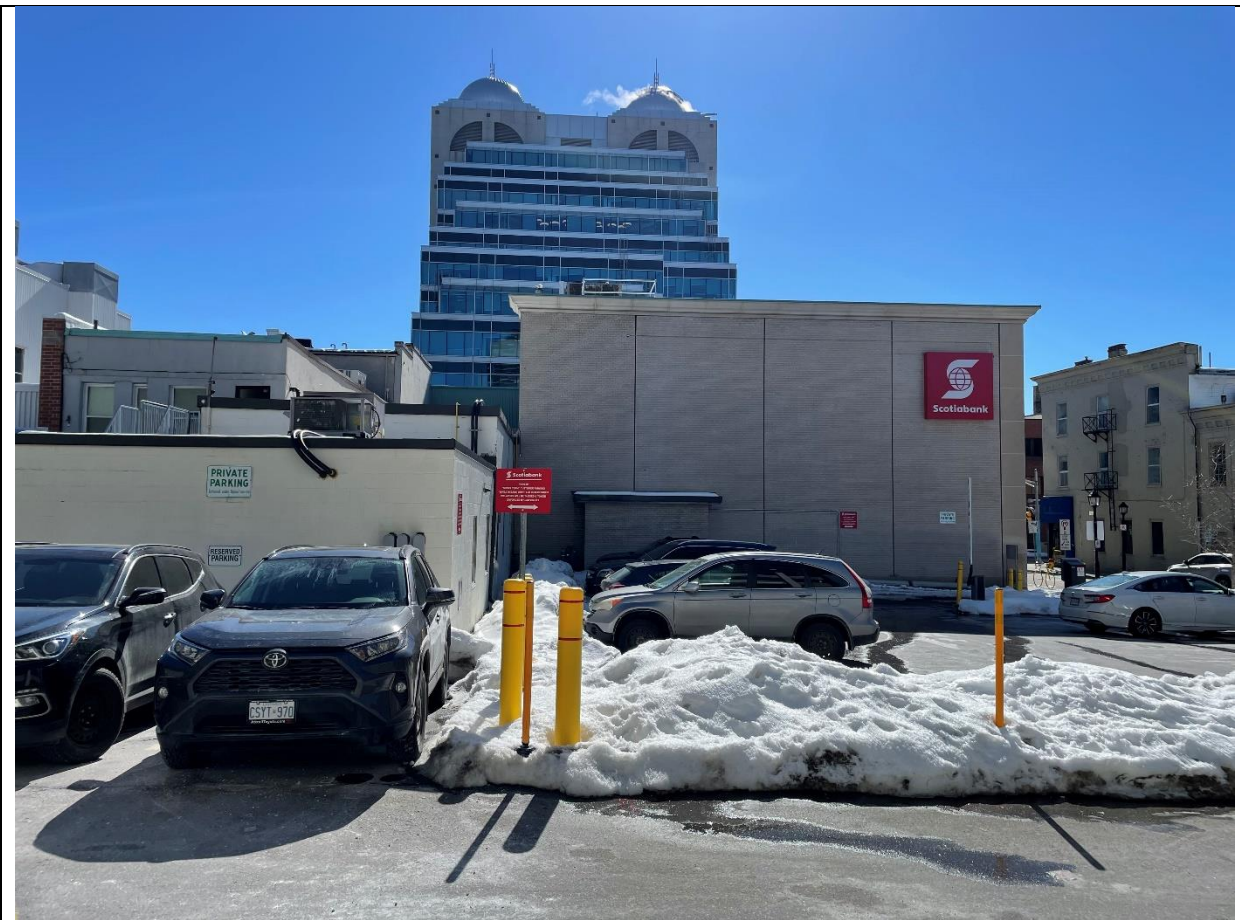
Rear Elevation (North Façade)

North Rear Façade

The rear façade is composed of white brick, except for a narrow vertical strip of limestone on the western side that is arranged in the same ashlar pattern as that of the front and west side façade. The molded cornice continues along the roofline. There is a small brick addition one-storey in height that contains a door – this is the only opening on the rear façade.

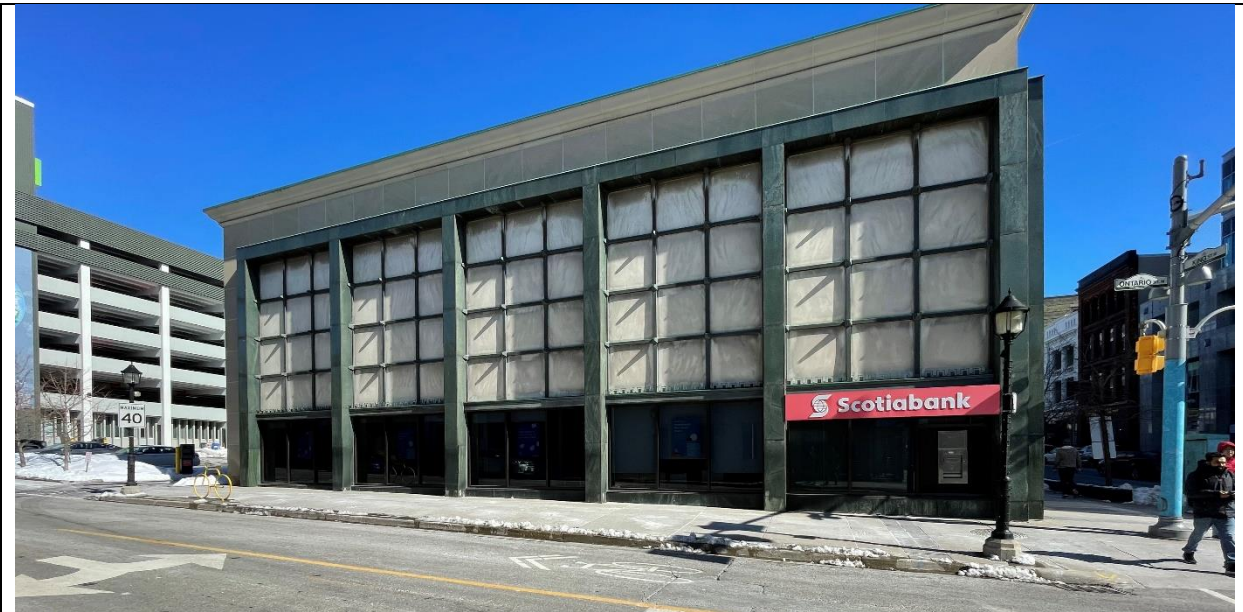
Side Elevation (West Façade)

West Side Façade

The west side façade faces Ontario Street North and is composed of five bays, evenly spaced and similar in appearance to the white marble bays on the front façade, with triple casement windows below. The molded cornice continues along the roofline.
