STATEMENT OF SIGNIFICANCE

28 Burgetz Avenue

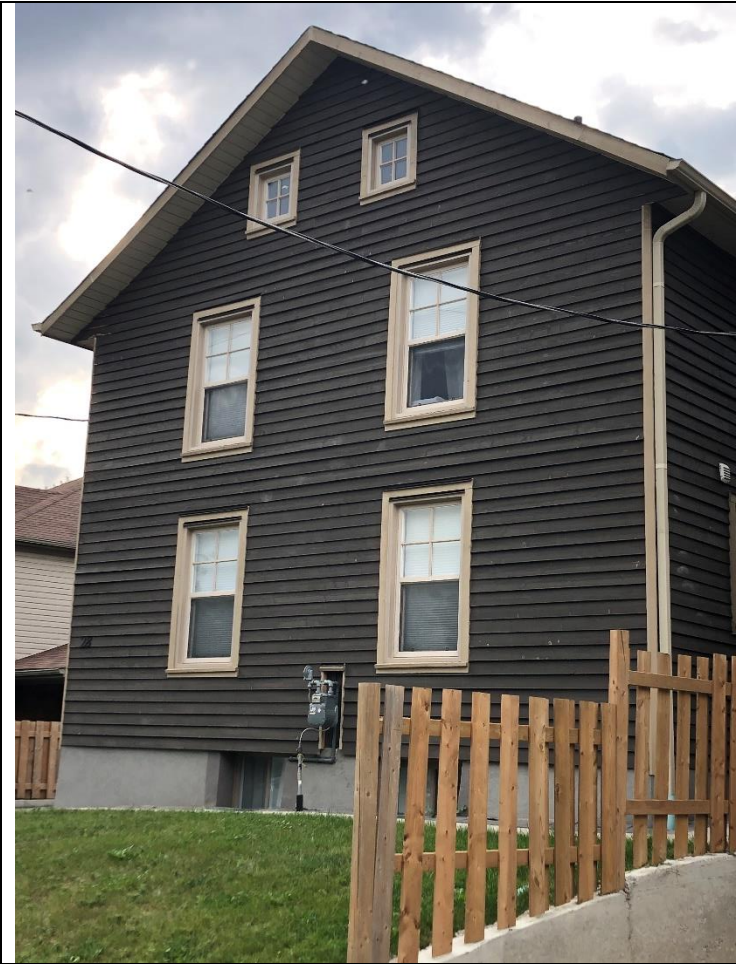
Front Elevation

The property has significant design/physical value as it is a rare, representative, and early example of early 19th century log construction in Waterloo County. The original log house was constructed using hand hewn square logs on top of each other horizontally with mortar and horsehair chinking.

- Overall 2-storey massing;
- Squared-log construction with horsehair and mortar chinking; and
- Original door and window openings.

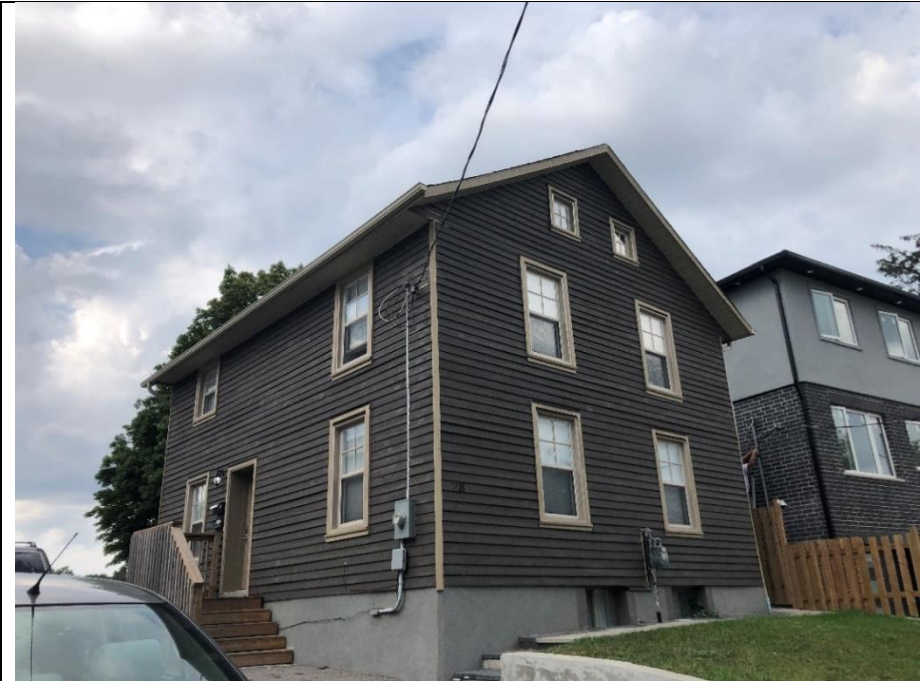
Side Elevation

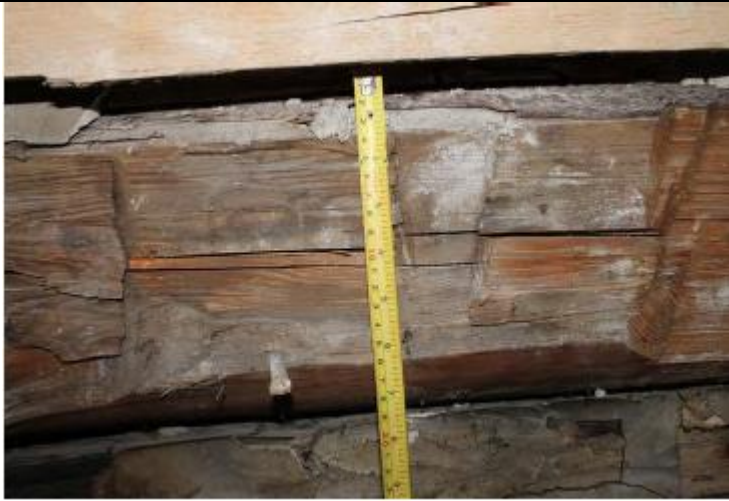
Detailing of typical log (approximately 7.5 inches wide) (source: MHBC Planning, 2018)

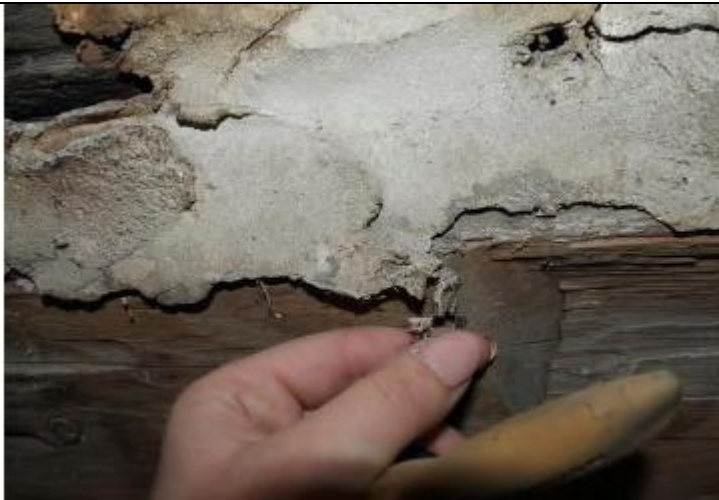
Detailing of chinking between logs (mortar with horsehair) (source: MHBC Planning, 2018)
