Cultural Heritage Conservation Plan & Commemoration Strategy

628 New Dundee Road,
Kitchener ON

Date:
November 2023

Prepared by:
**MacNaughton Hermsen Britton
Clarkson Planning Limited (MHBC)**

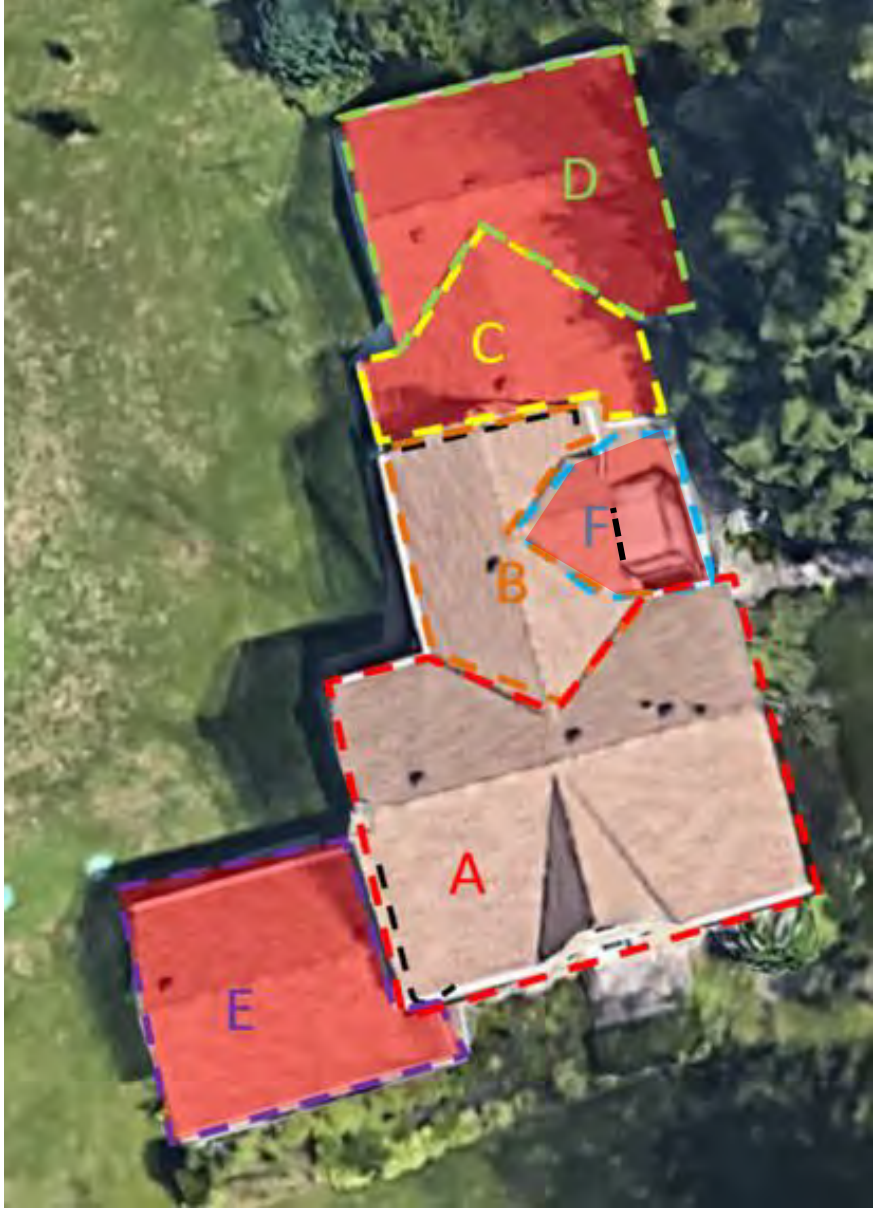
Figure 1: Aerial image of existing dwelling, noting the contemporary additions to the dwelling which are proposed for removal (shaded in red). Elevations which may require alteration following the removal of contemporary additions noted with dashed black line. (Source: MHBC, 2023)

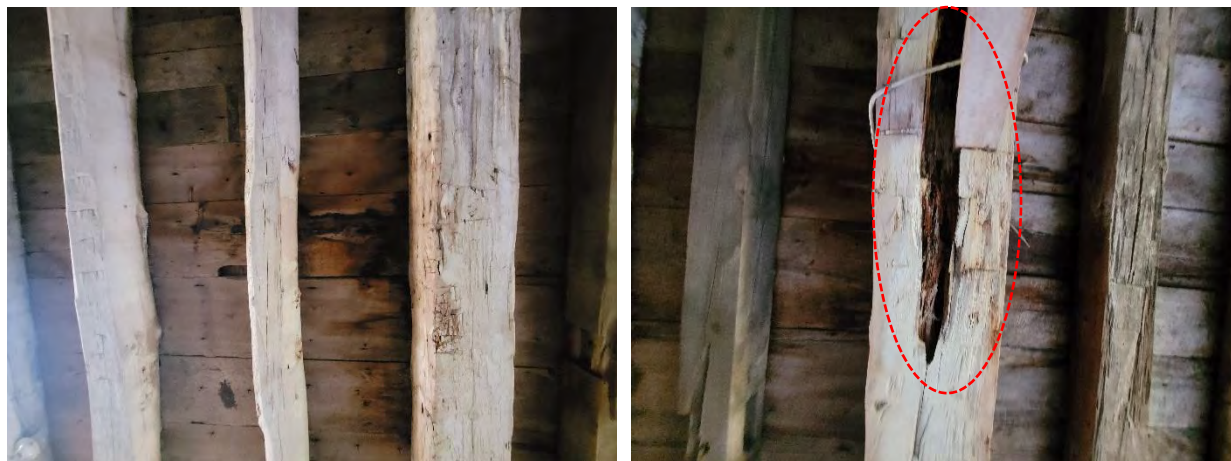
Beams and timbers available for salvage and re-use on site include hand-hewn timbers which are of varying sizes and dimensions, but are generally 7-10" x 6-10" and are 15ft. to 20ft. long (See Figures 4 & 5).

Figures 4 & 5: View of hewn timbers located at the interior of the barn (Source: MHBC, 2023)

Only those timbers which are in good condition are able to be incorporated into a commemorative feature. Those items which are irreparable due to fire, rot, infestation, etc. should not be utilized (example of damaged beam in Figure 5).

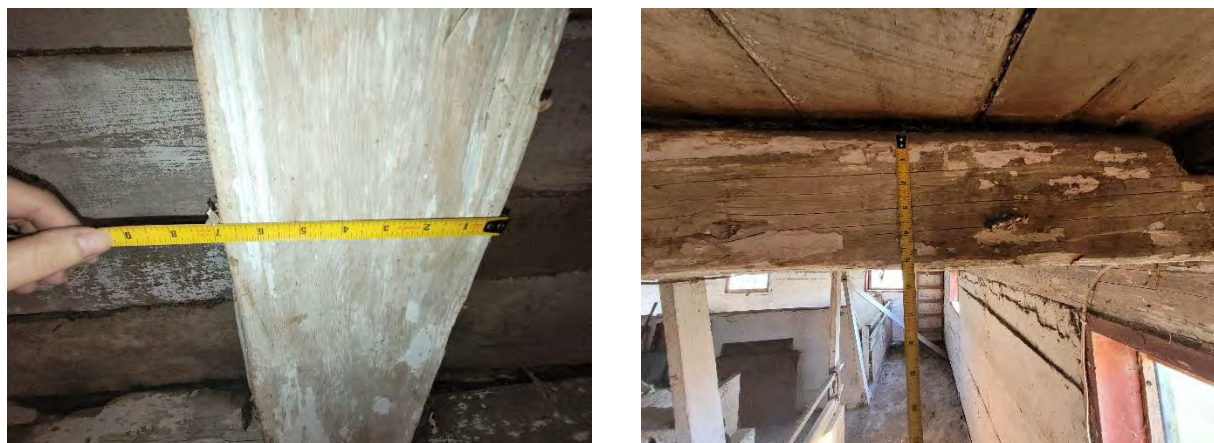
Figures 6 & 7: Dimensions of typical timbers within the barn, (Source: MHBC, 2023)

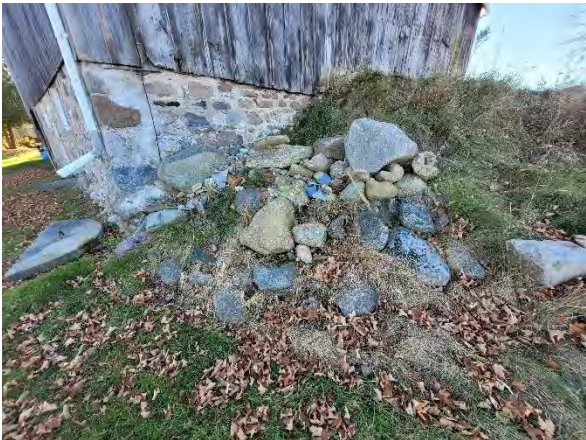
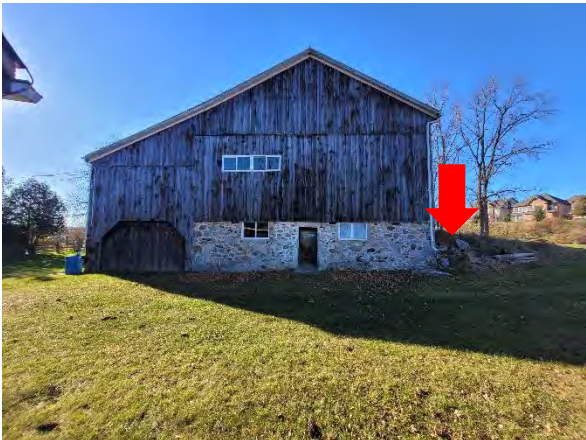
The north-east corner of the barn includes a pile of loose field stones. These stones were likely gathered to create a bank for the barn or were rolled into place when removed from fields and gardens. These stones could be utilized on-site more successfully than existing stones which are integrated into mortar and cement within the barn foundation. A selection of these field stones can be utilized on-site for use as part of a base for the interpretive panel within the proposed amenity area.

Figures 8 & 9: Location of loose field stones at the north-east corner of the barn
(Source: MHBC, 2023)

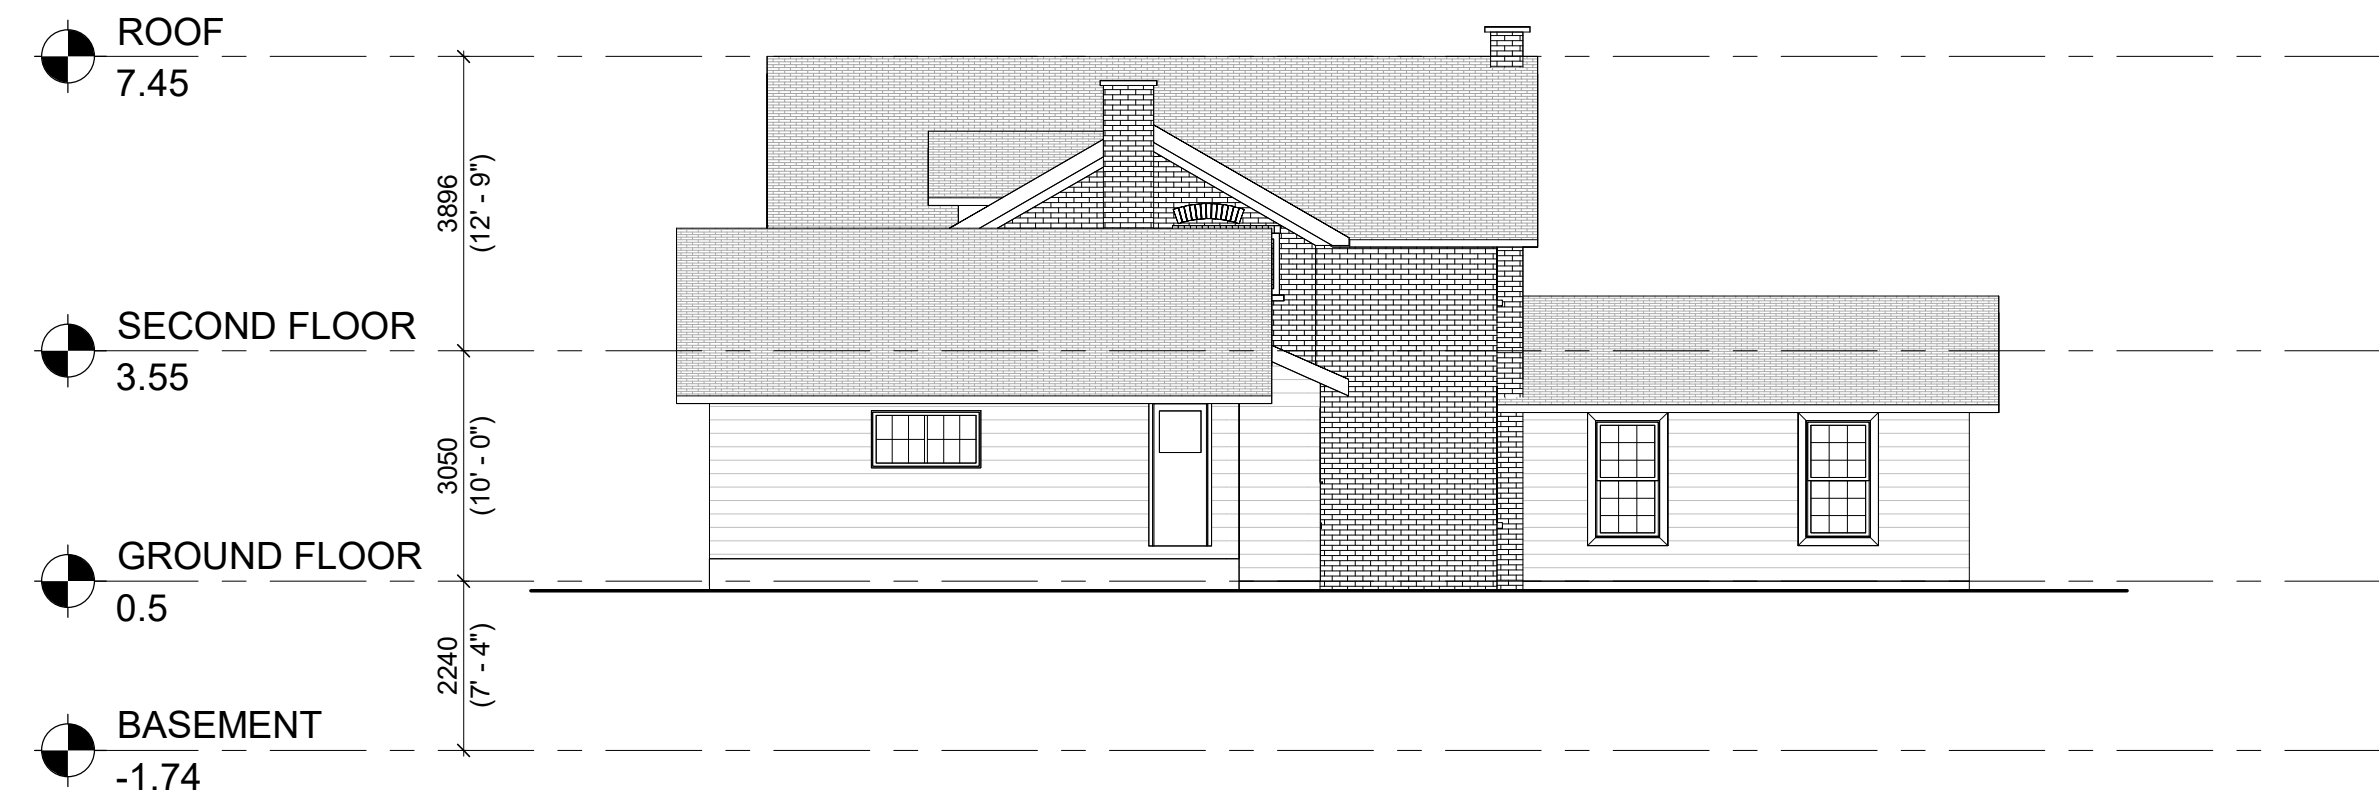
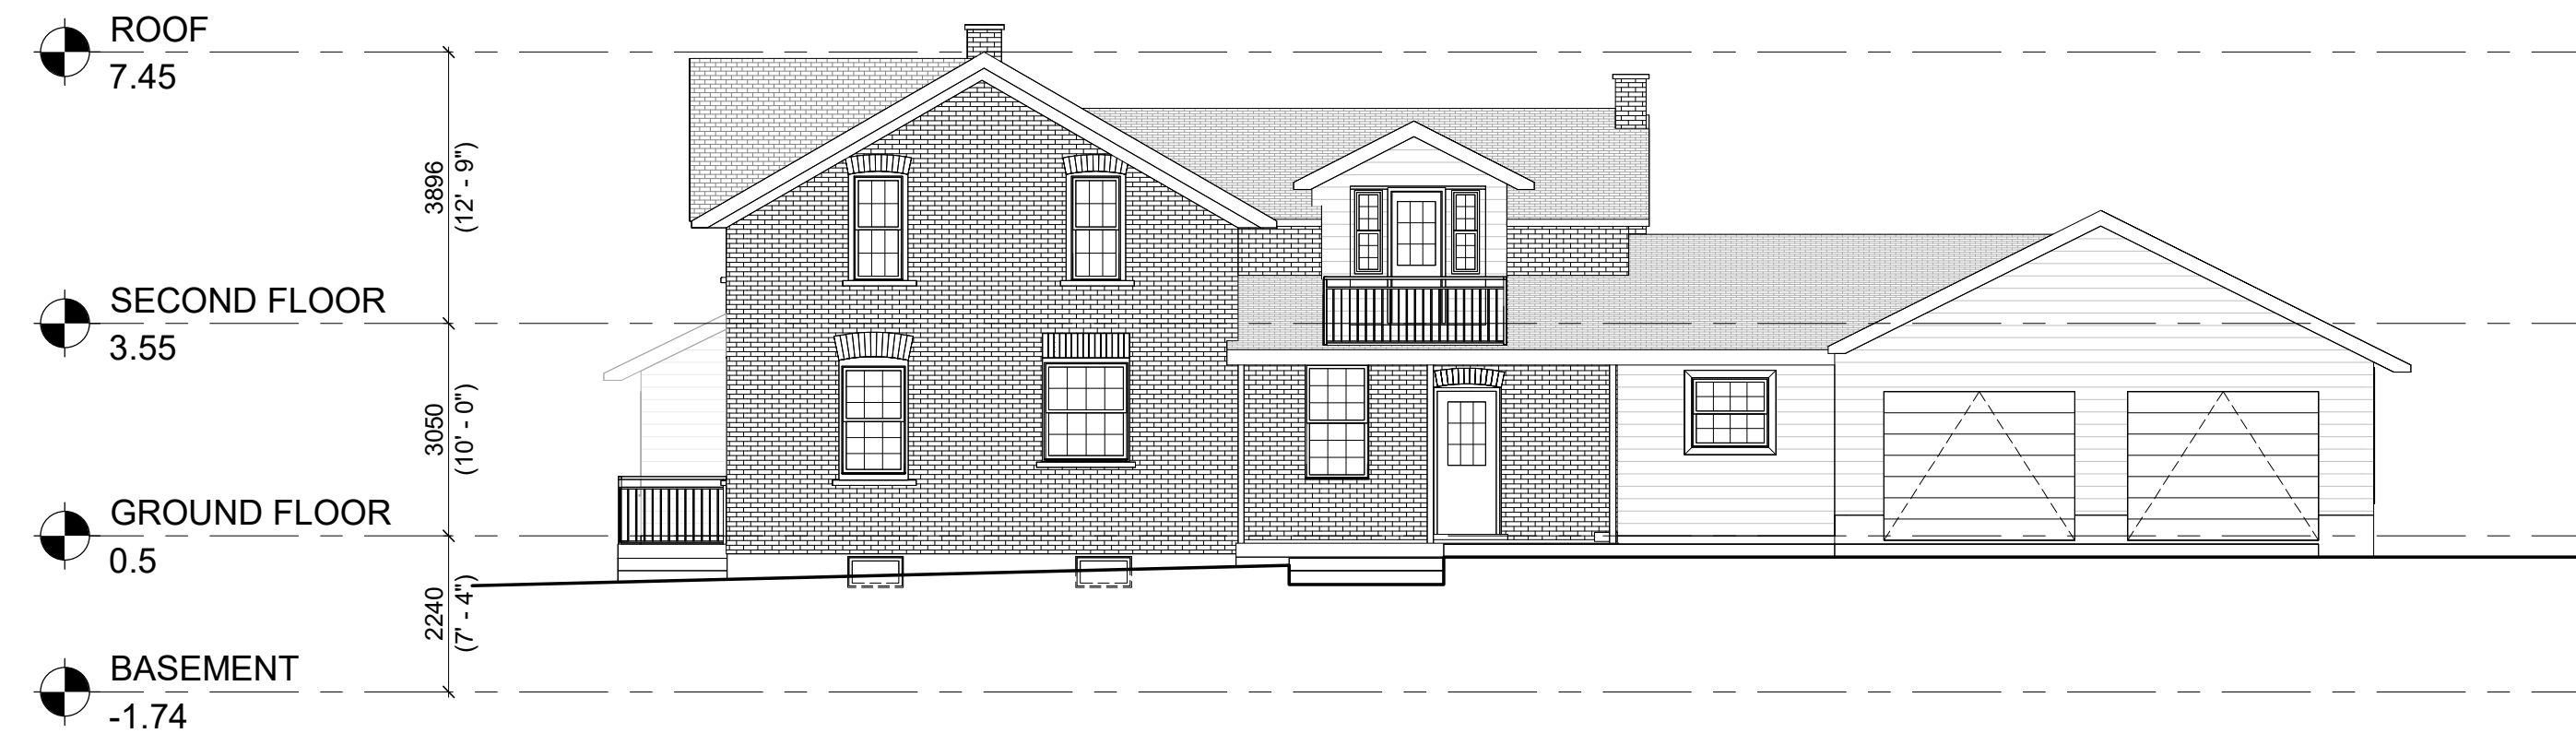
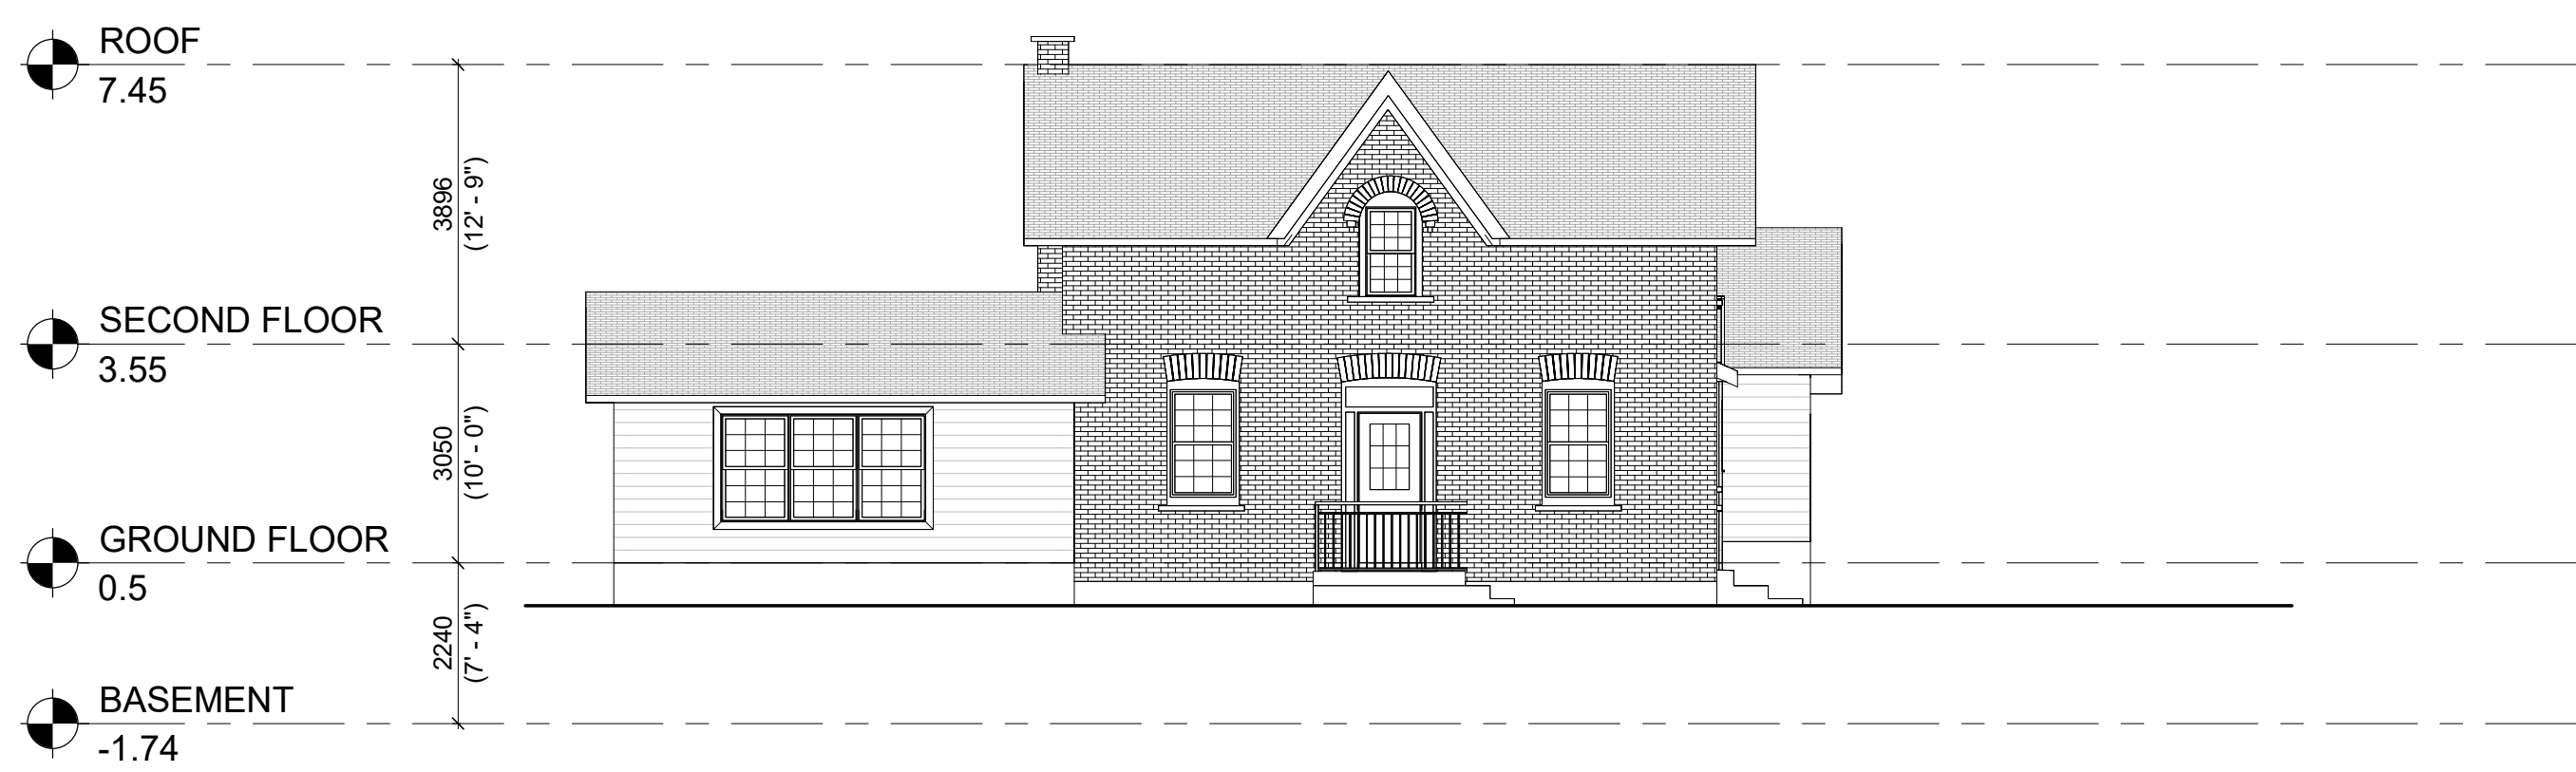
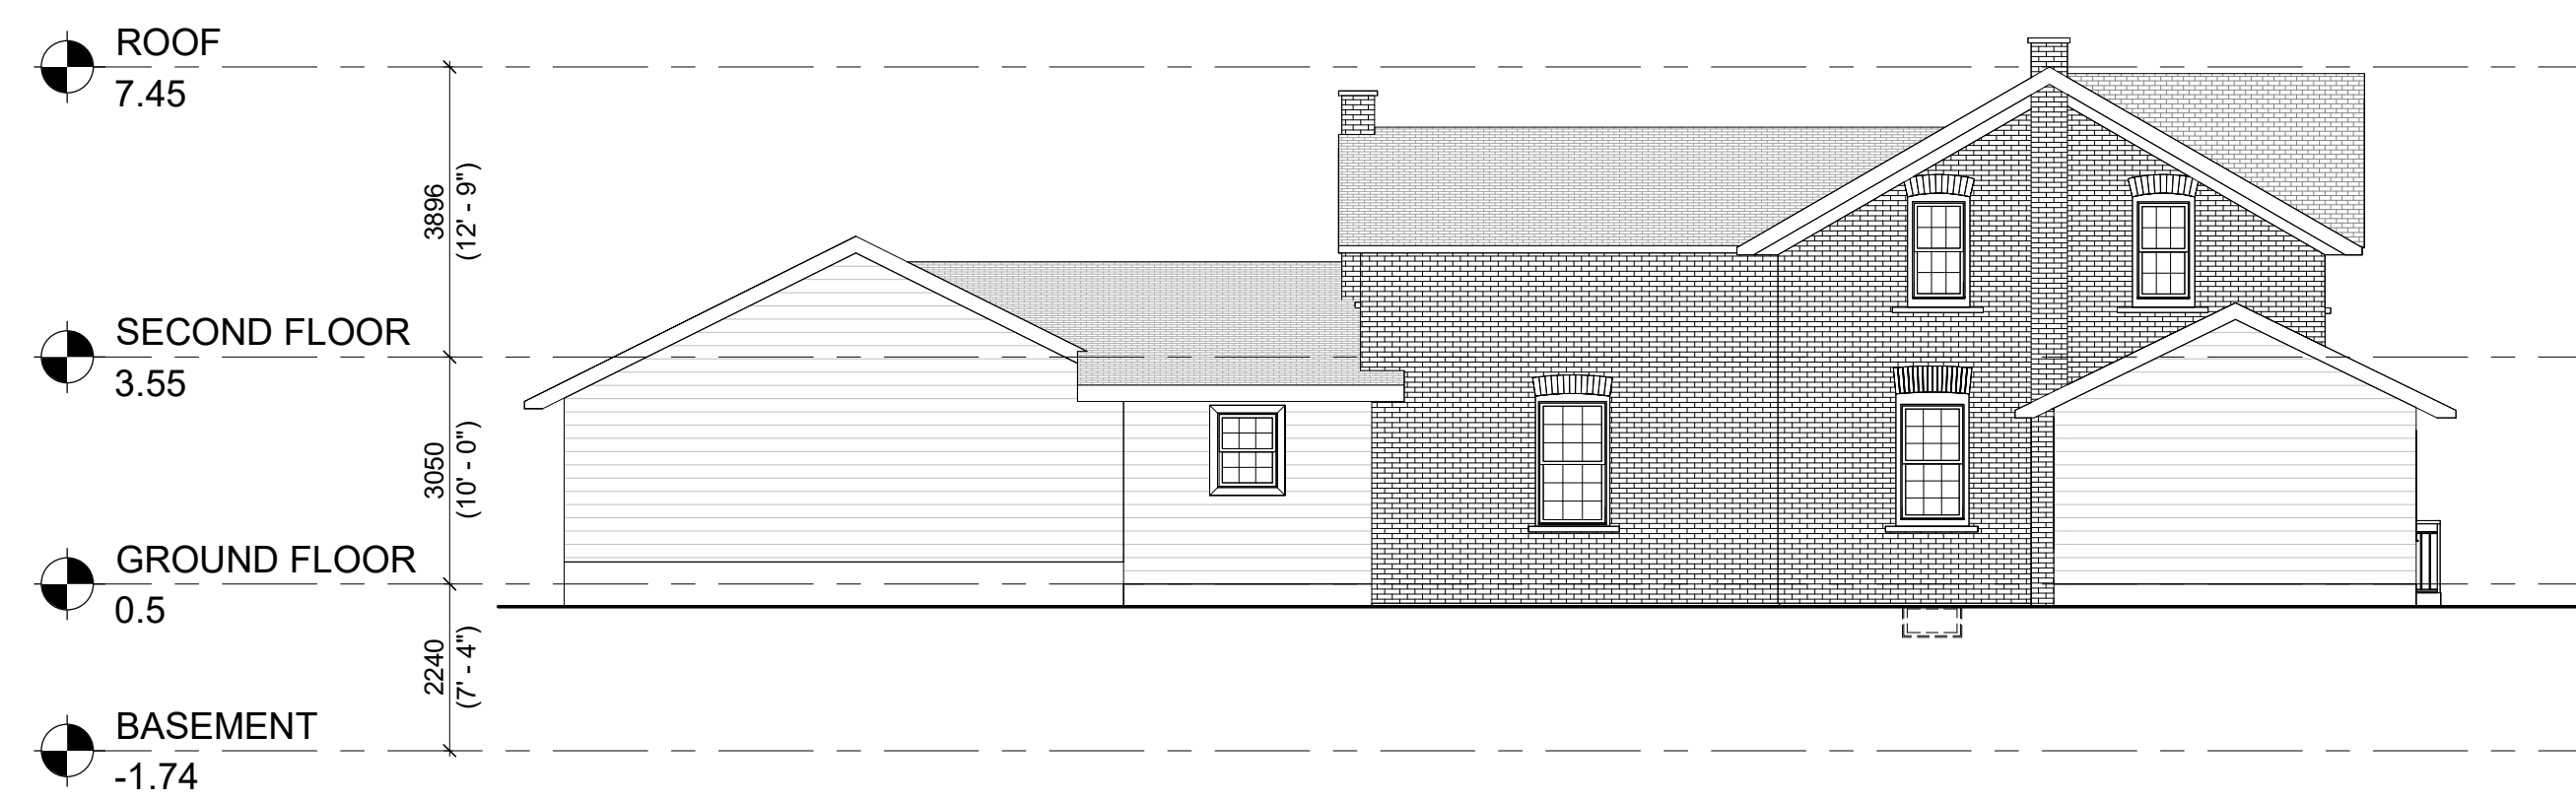
DRAWING NO. SPA301 REV. 1

1 NORTH ELEVATION
SPA301 1: 100

3 EAST ELEVATION
SPA301 1: 100

2 SOUTH ELEVATION
SPA301 1: 100

4 WEST ELEVATION
SPA301 1: 100

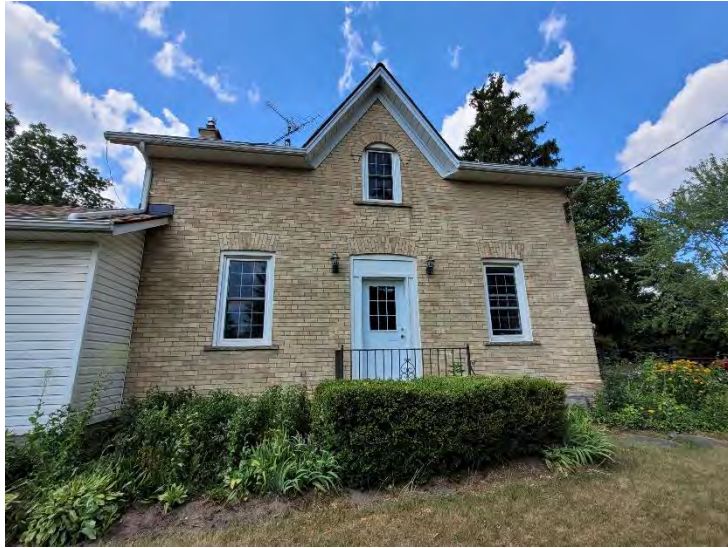
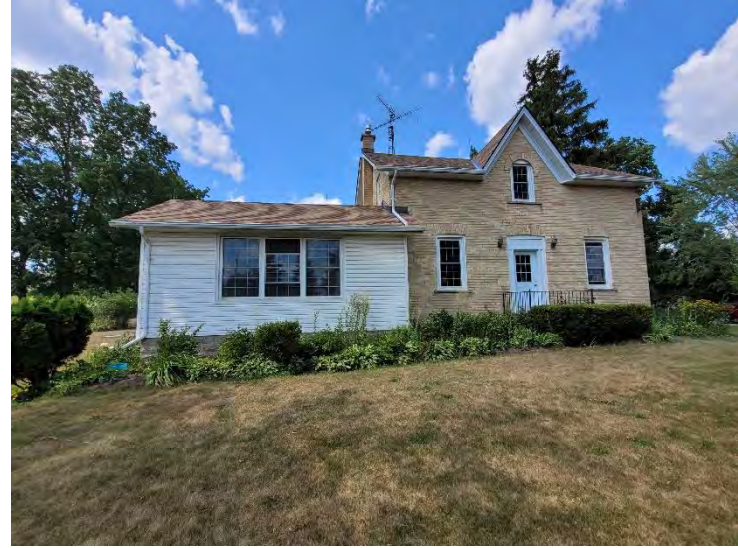
Figures 1 & 2: (left) View of front elevation of dwelling, looking north, (right) View of front elevation of dwelling and contemporary addition, looking north, (Source: MHBC 2022)

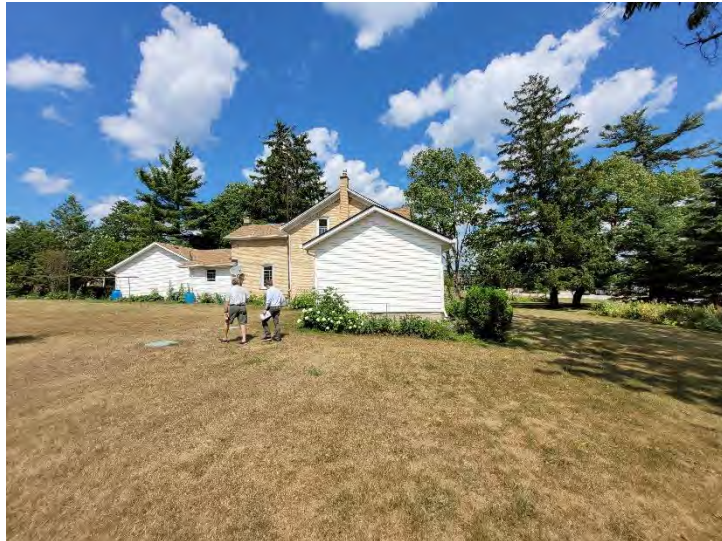
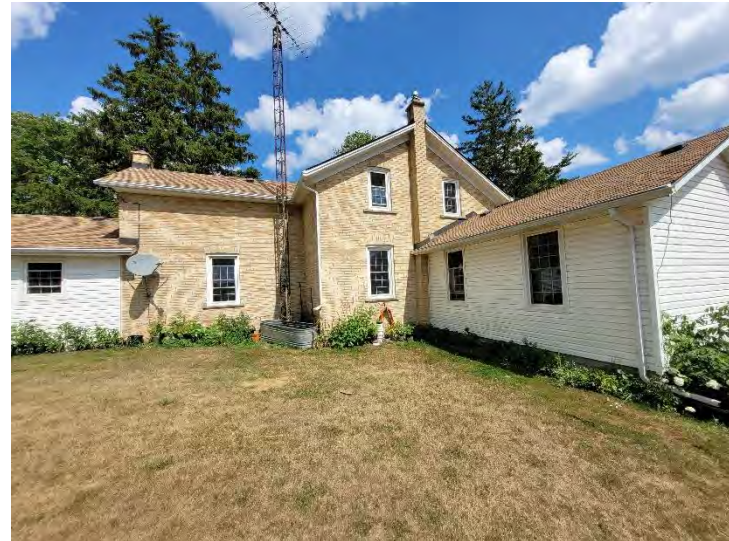
Figures 3 & 4: (left) View of west elevation looking east towards dwelling and contemporary additions, (right) View of west elevations of dwelling, looking south-east (Source: MHBC 2022)

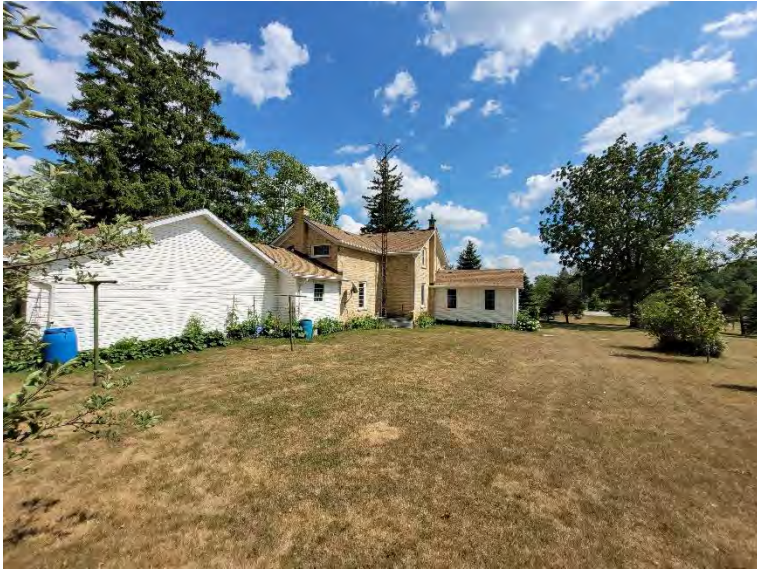
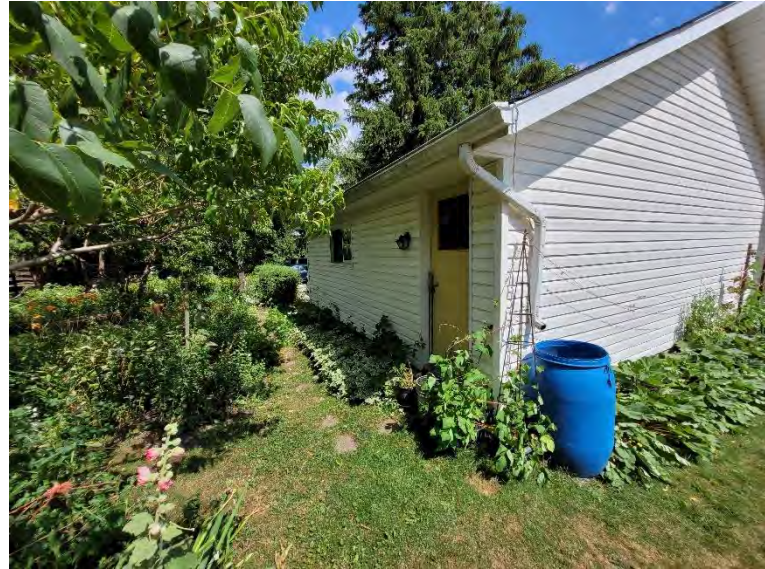
Figures 5 & 6: (left) View of north and west elevations, looking south-east, (right) View of north elevation of garage, looking east, (Source: MHBC 2022)

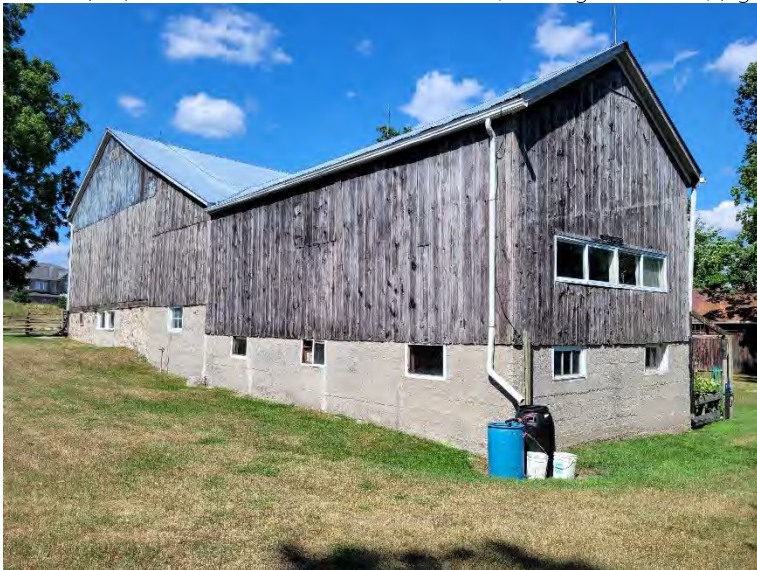
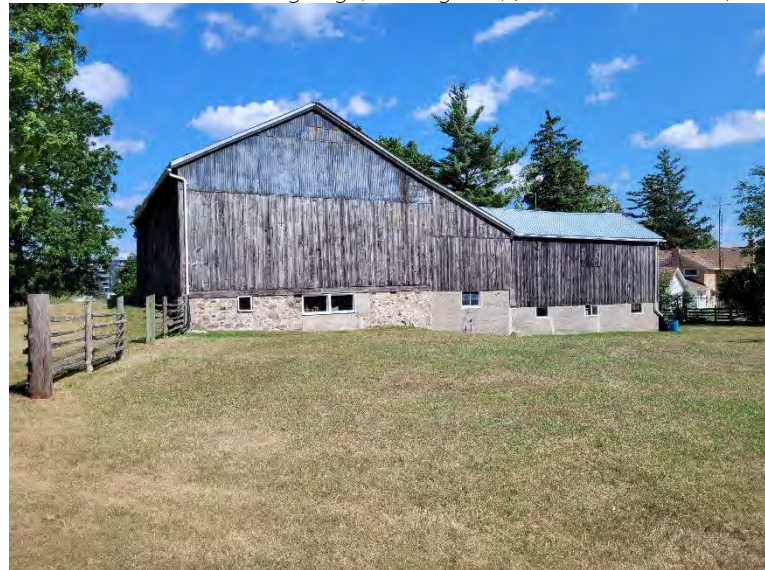
Figures 7 & 8: (left) View of south and west elevations of barn, looking north-east, (right) View of west elevation of barn, looking east, (Source: MHBC 2022)

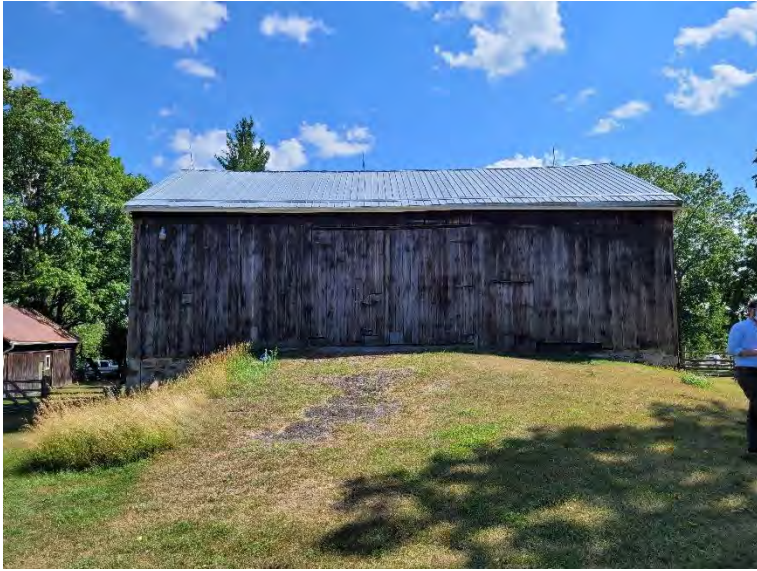
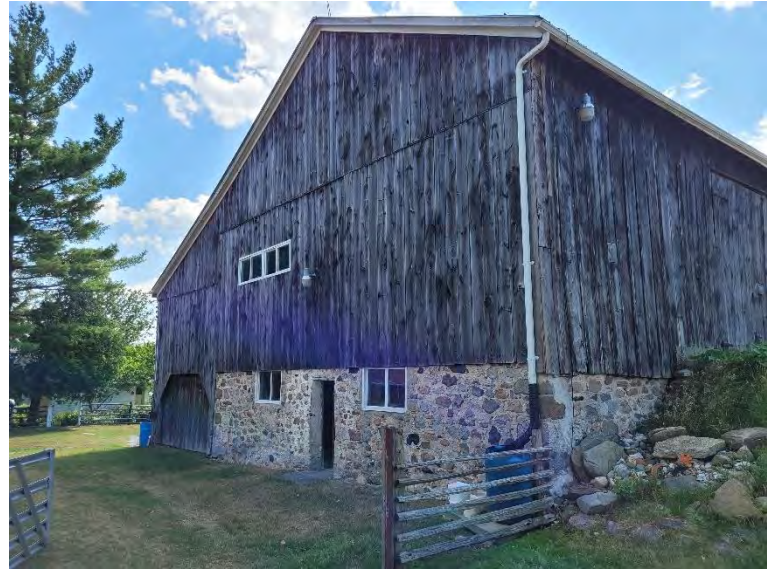
Figures 9 & 10: (left) View of north elevation of barn, looking south, (right) View of west elevation of barn, (Source: MHBC 2022)

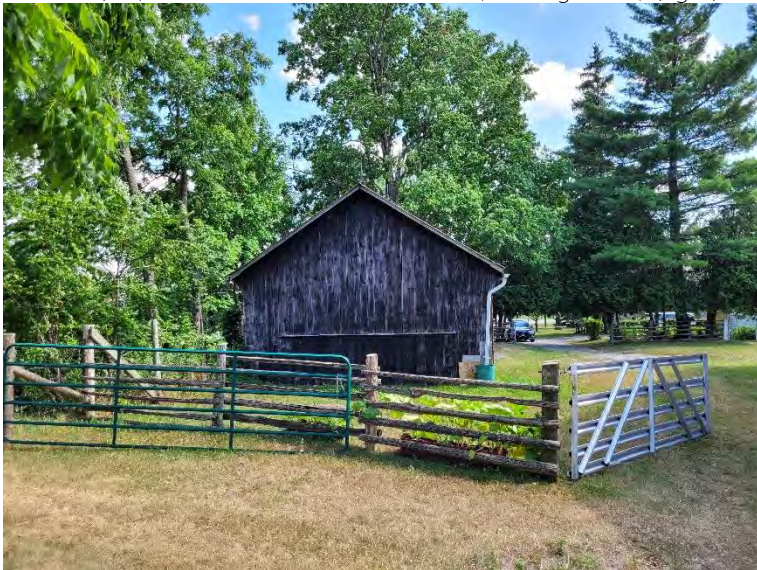
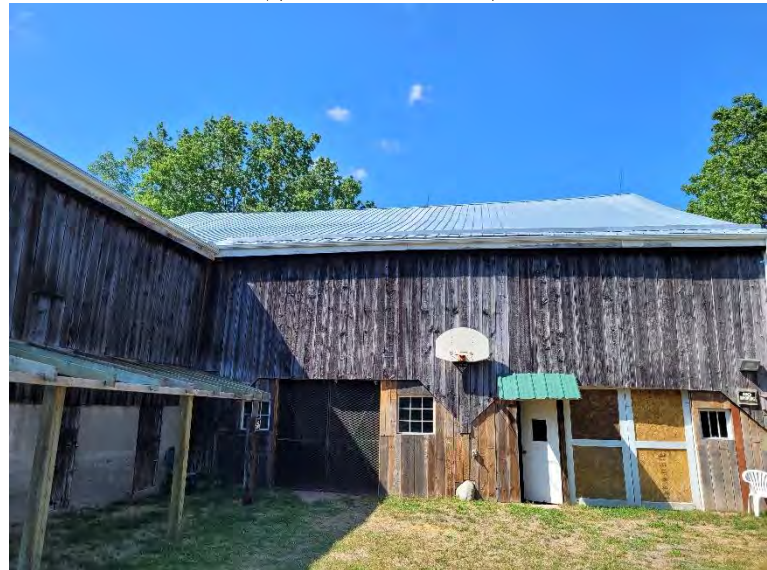
Figures 11 & 12: (left) View of north elevation of wood shed, looking south, (right) View of south elevation of barn, looking north, (Source: MHBC 2022)

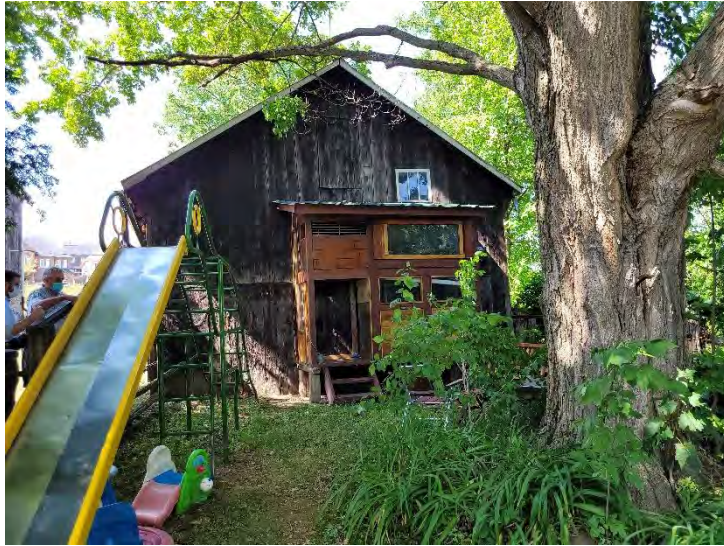
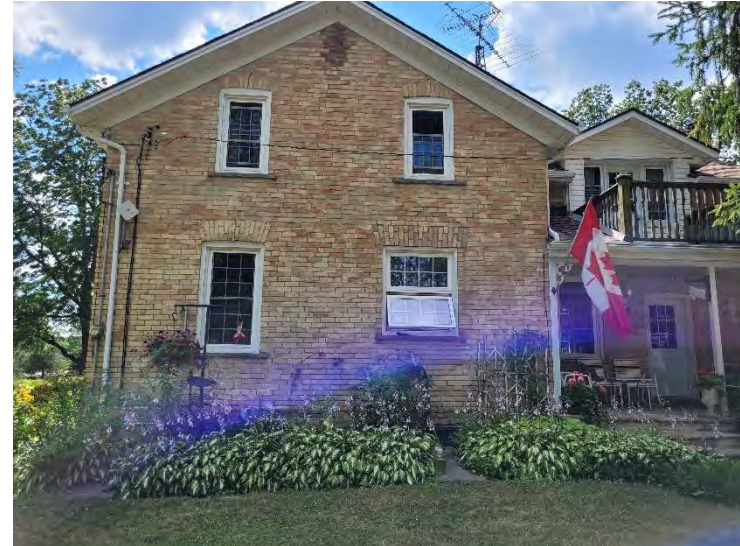
Figures 13 & 14: (left) View of south elevation of wood shed, (right) View of east elevation of dwelling, looking west (Source: MHBC 2022)

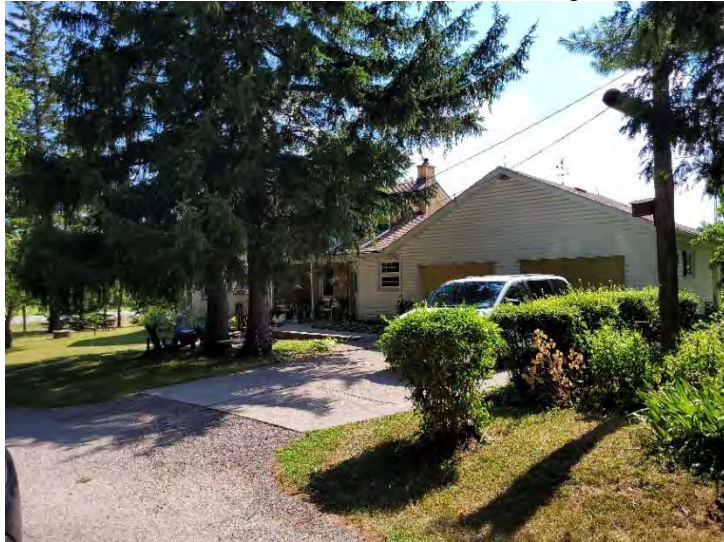
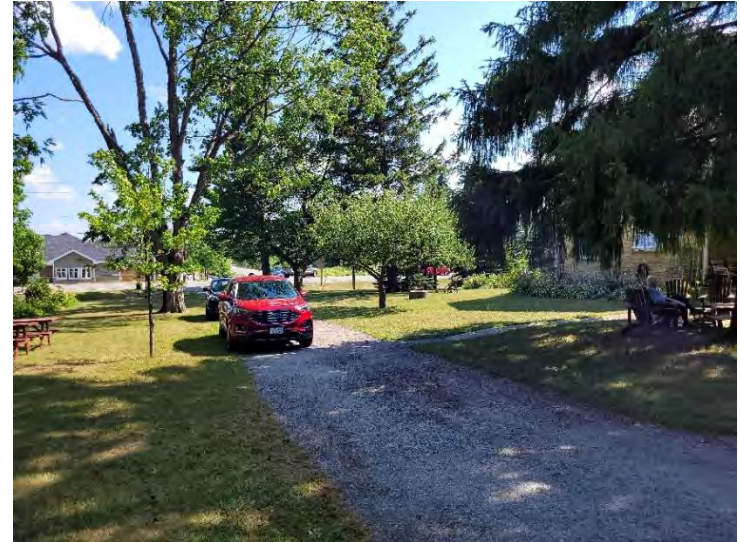
Figures 15 & 16: (left) View of east elevation of dwelling and contemporary additions, looking south-west, (right) View of driveway, looking south towards New Dundee Road, (Source: MHBC 2022)

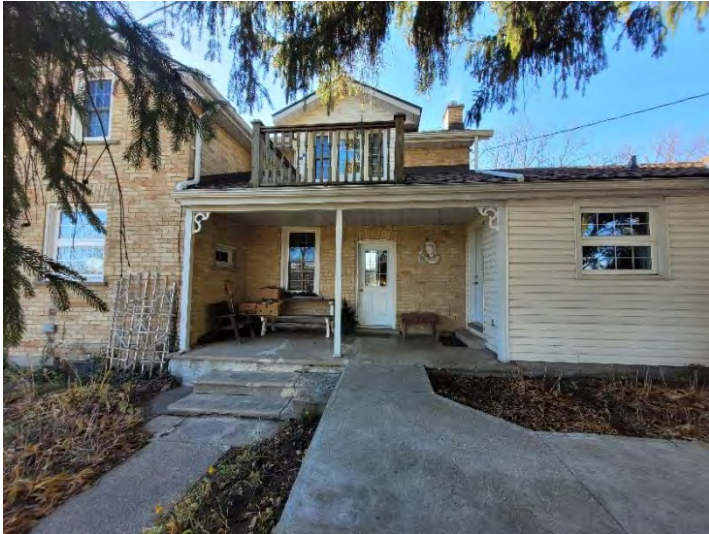
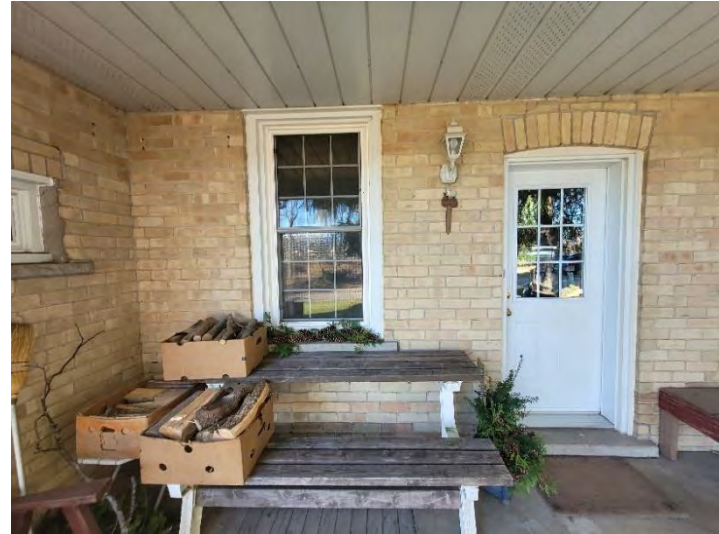
Figures 1 & 2: (left) View of east elevation, looking west, (right) Detail view of east elevation (summer kitchen rear addition) window and entrance at first storey, (Source: MHBC 2023)

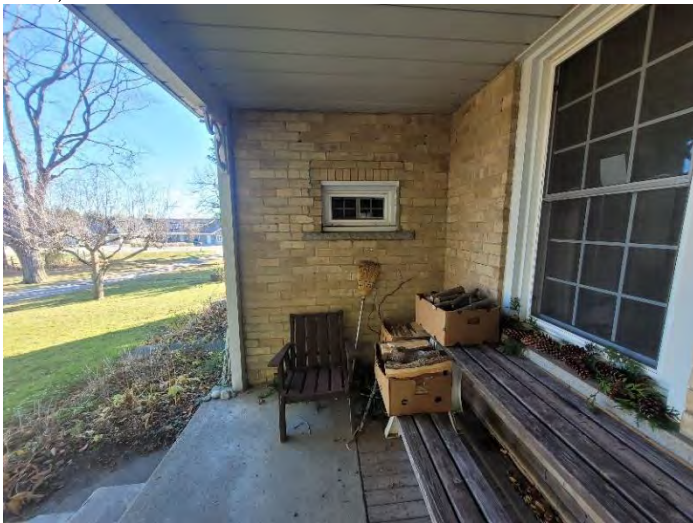
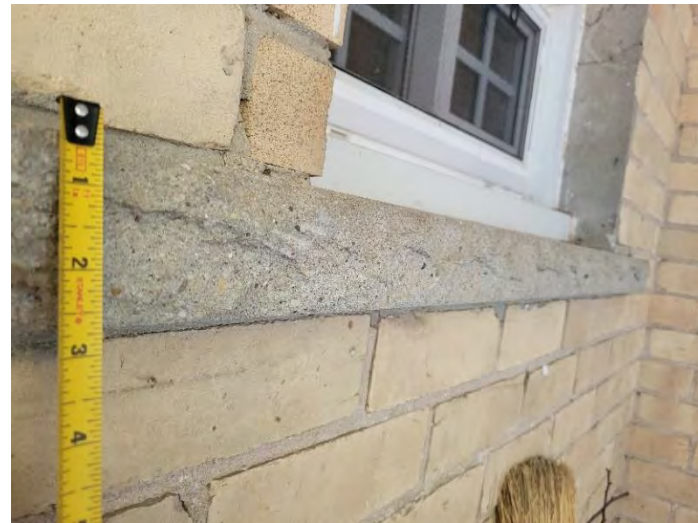
Figures 3 & 4: (left) View of contemporary window opening and contemporary window at south elevation of original portion of the dwelling, (right) Detail view of rusticated concrete sill at south elevation of original portion of the dwelling (contemporary window opening noted in Figure 3), (Source: MHBC 2023)

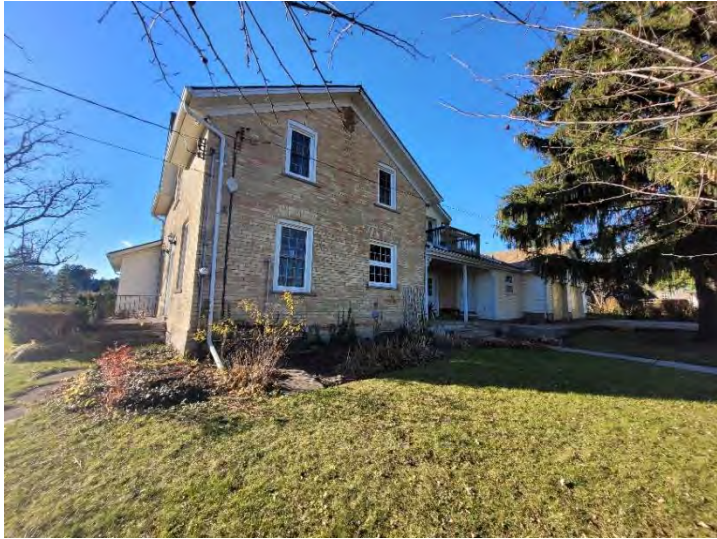
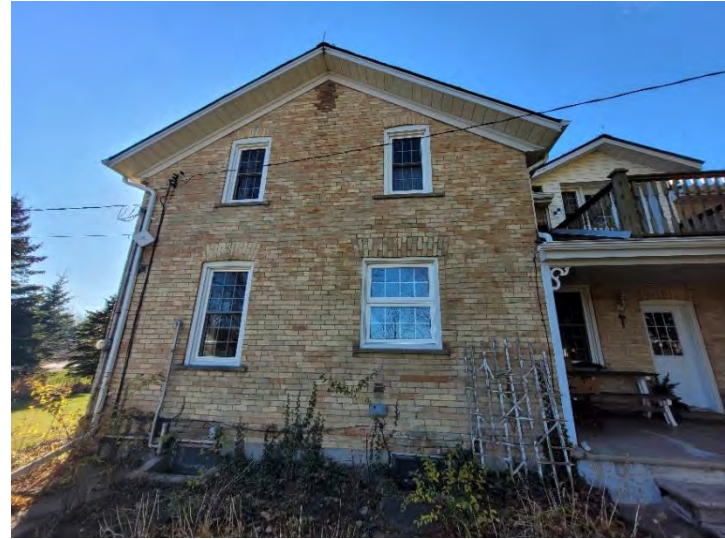
Figures 5 & 6: (left) View of west and south elevations, looking north-east, (right) View of south elevation, looking north, (Source: MHBC 2023)

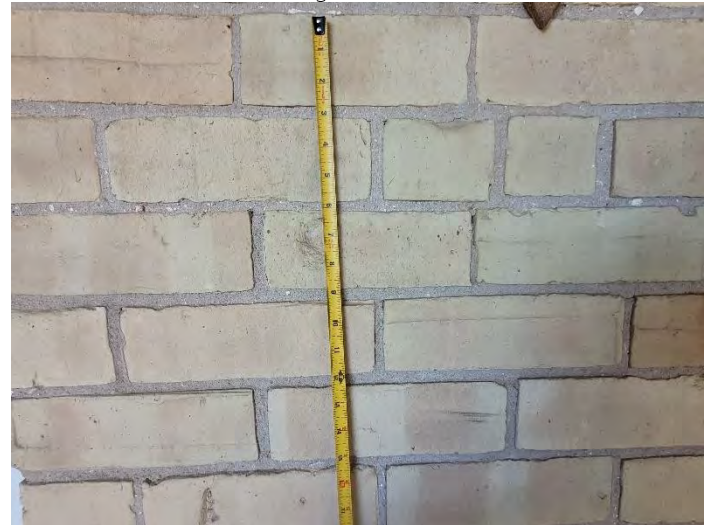
Figures 7 & 8: (left) Detail view of brick dimensions, colour and patina at original portion of the dwelling (noting colour differences (yellow, terra cotta coloured bricks)) (right) Detail view of brick dimensions, colour and patina at rear summer addition (noting colour differences from original portion of the dwelling) (Source: MHBC 2023)

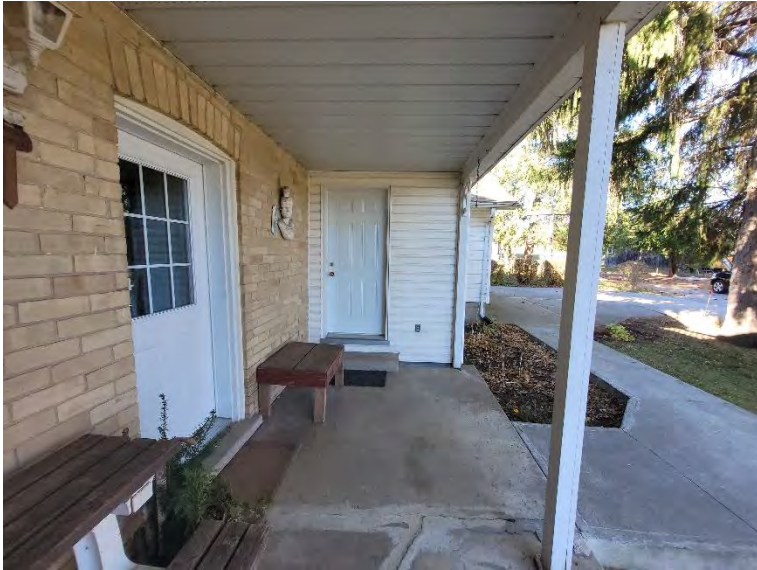
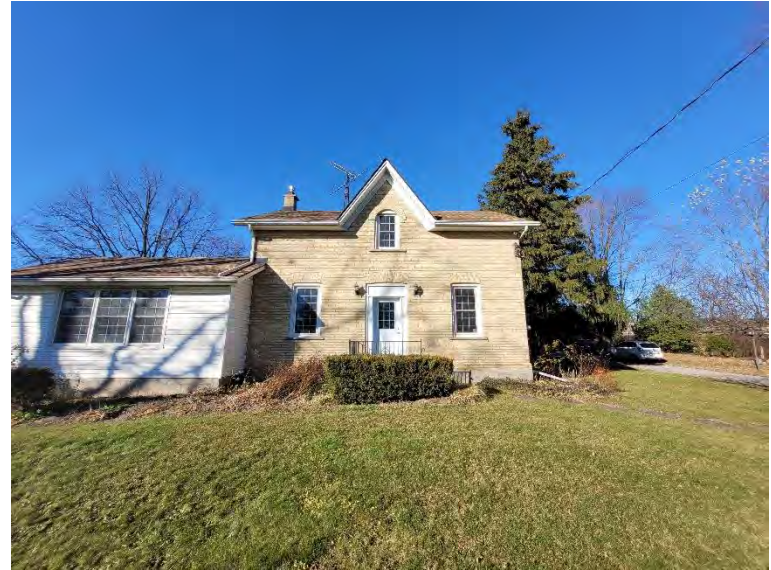
Figures 9 & 10: (left) View of entrance to contemporary addition, looking north along east elevation, (right) View of front (south elevation), (Source: MHBC 2023)

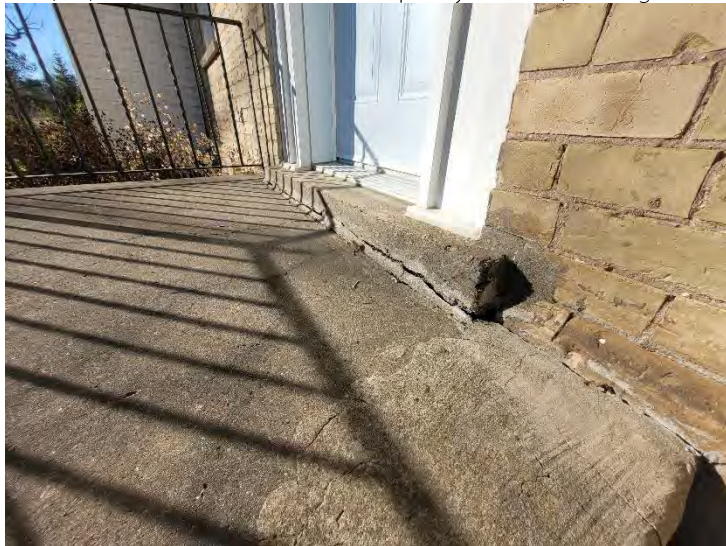
Figures 11 & 12: (left) Detail view of contemporary concrete stairs at front elevation, (right) Detail view of concrete sills at front elevation, (Source: MHBC 2023)

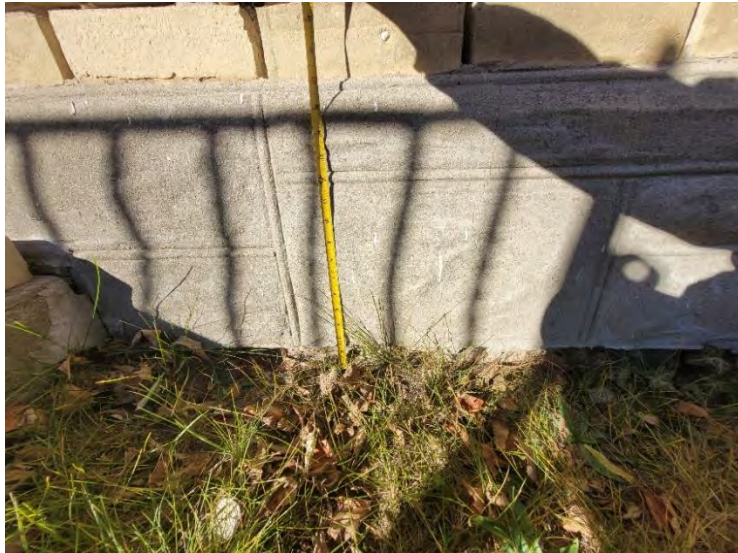
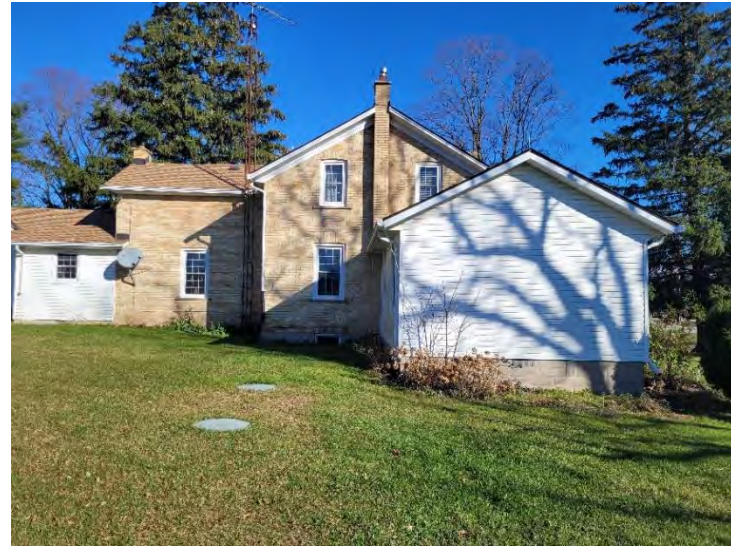
Figures 13 & 14: (left) Detail view of poured foundation at front elevation, (right) View of east elevation, looking west (Source: MHBC 2023)
