Cultural Heritage Conservation Plan & Commemoration Strategy

628 New Dundee Road,
Kitchener ON

Date:
November 2023

Prepared by:
**MacNaughton Hermsen Britton
Clarkson Planning Limited (MHBC)**

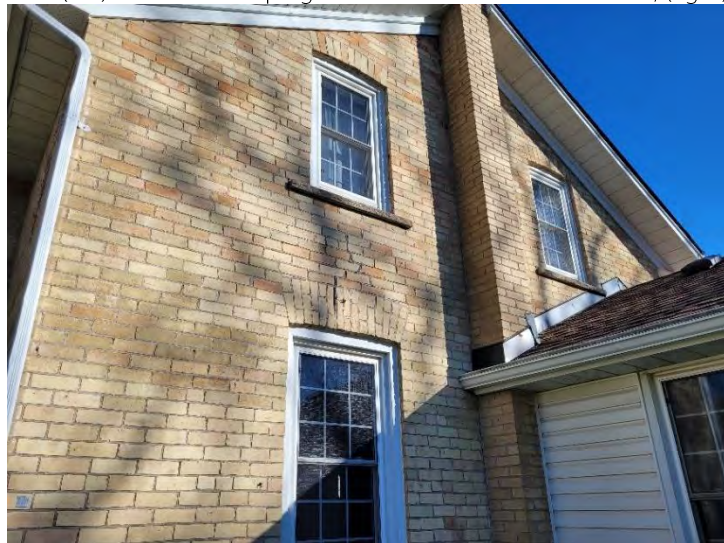
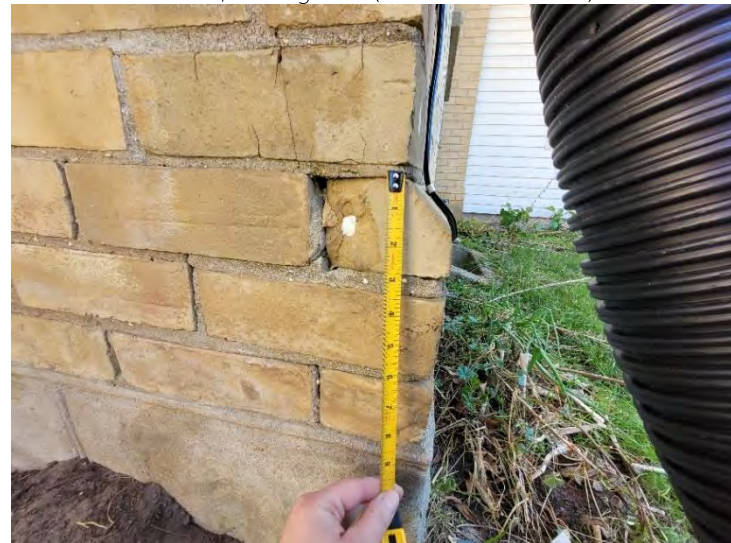
Figures 15 & 16: (left) Detail view of window openings at the east elevation, noting chimney which is not original, (right) Profile of bullnose bricks at east elevation of original portion of the dwelling, looking south (Source: MHBC 2023)

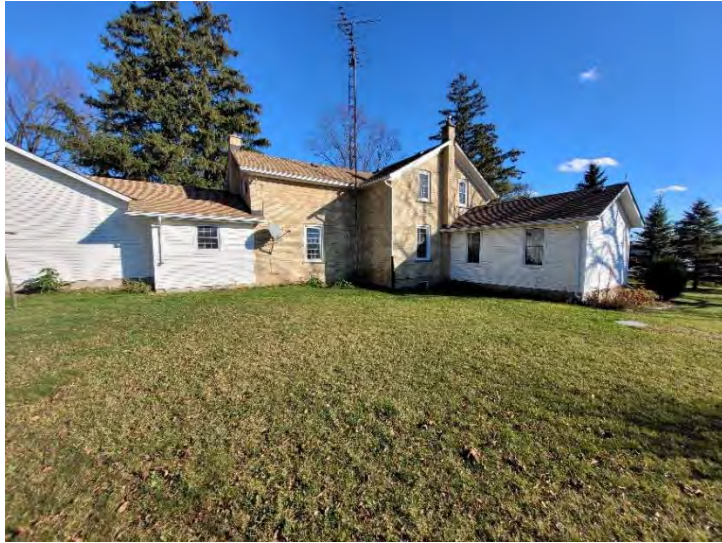
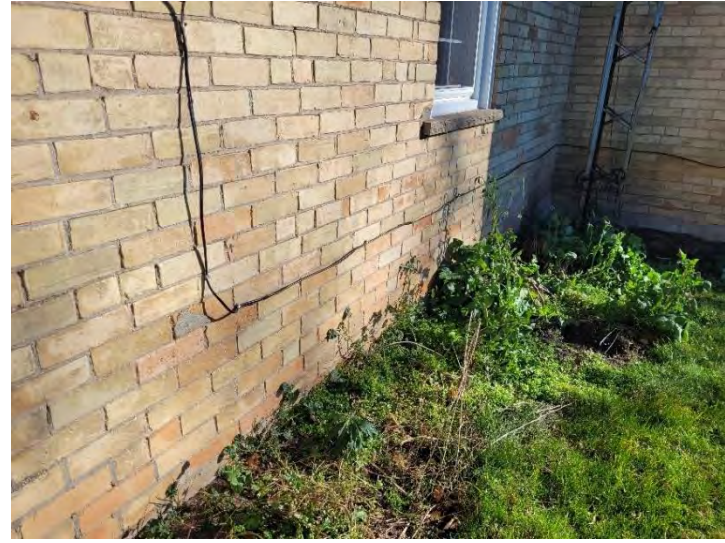
Figures 17 & 18: (left) View of west and south elevations, looking north-west, (right) Detail view of west elevation of rear summer kitchen, noting absence of bullnose brick stringcourse, (Source: MHBC 2023)

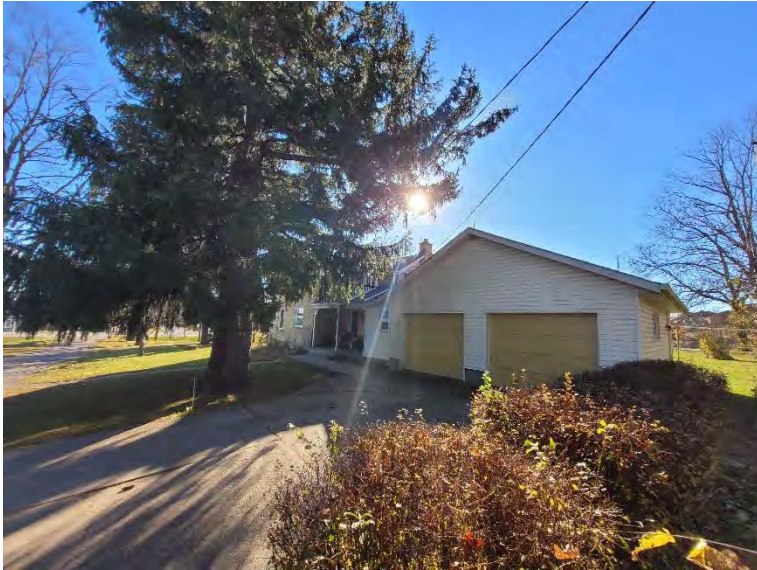
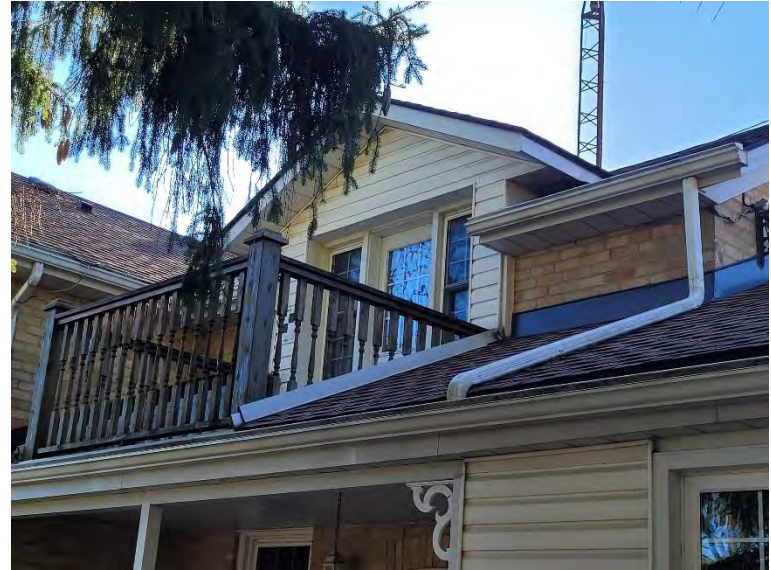
Figures 21 & 22: (left) View of east elevation, looking south-west, (right) Detail view of contemporary alterations and entrance at east elevation of rear summer kitchen, second storey, (Source: MHBC 2023)

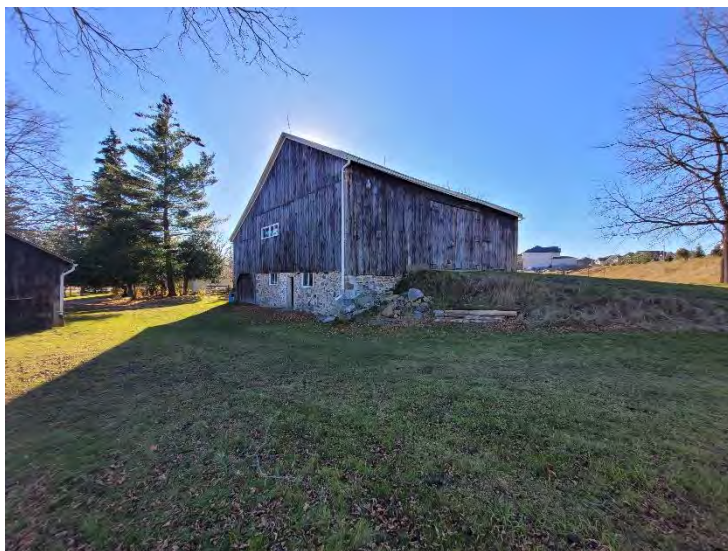
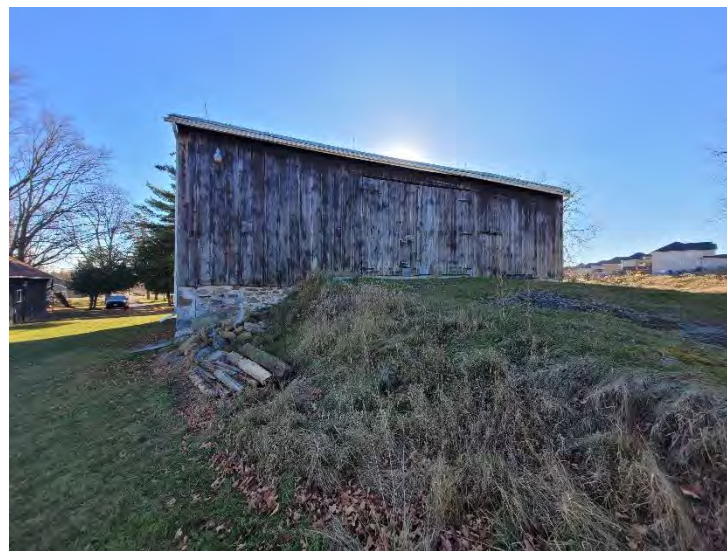
Figures 1 & 2: (left) View of east and north elevations, looking south-west, (right) View of north elevation, looking south along earthen bank, (Source: MHBC 2023)

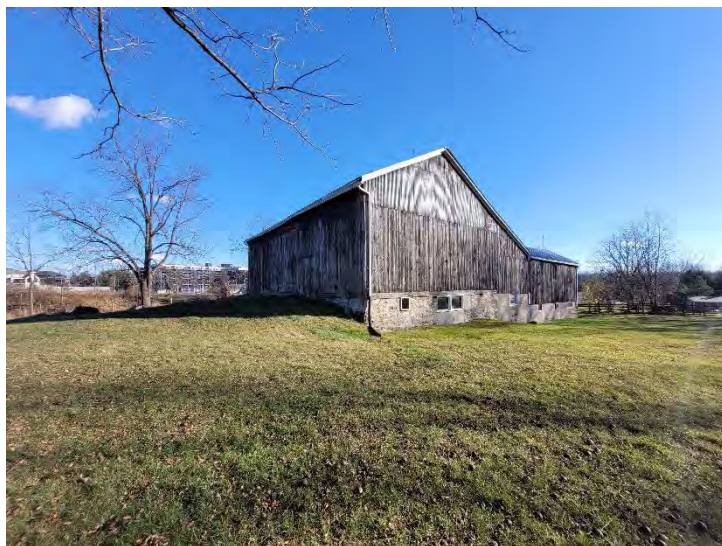
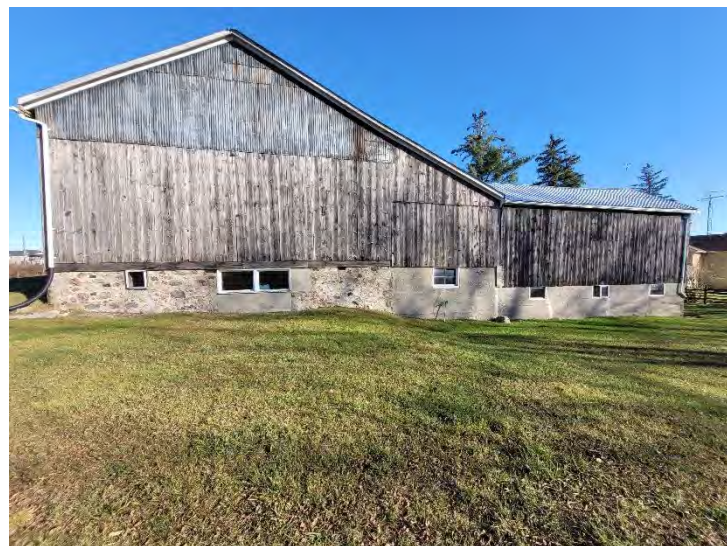
Figures 3 & 4: (left) View of north and west elevations, looking south-east (right) View of west elevation, looking east, (Source: MHBC 2023)

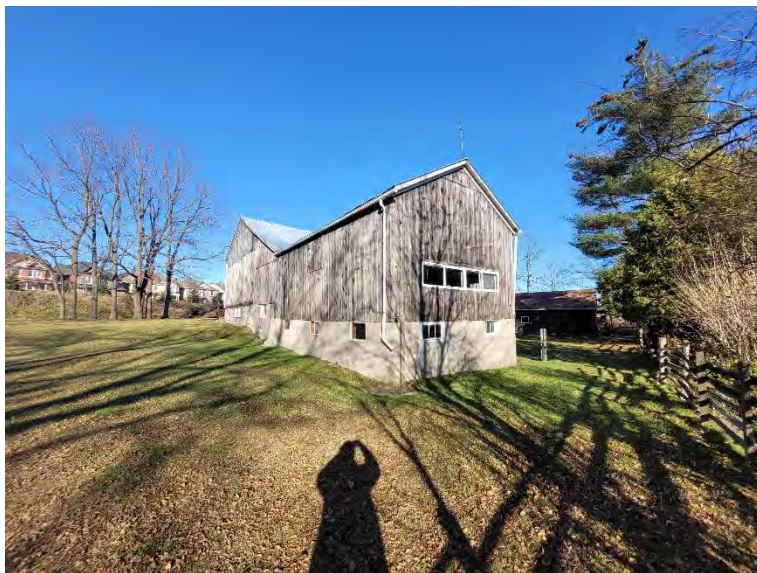
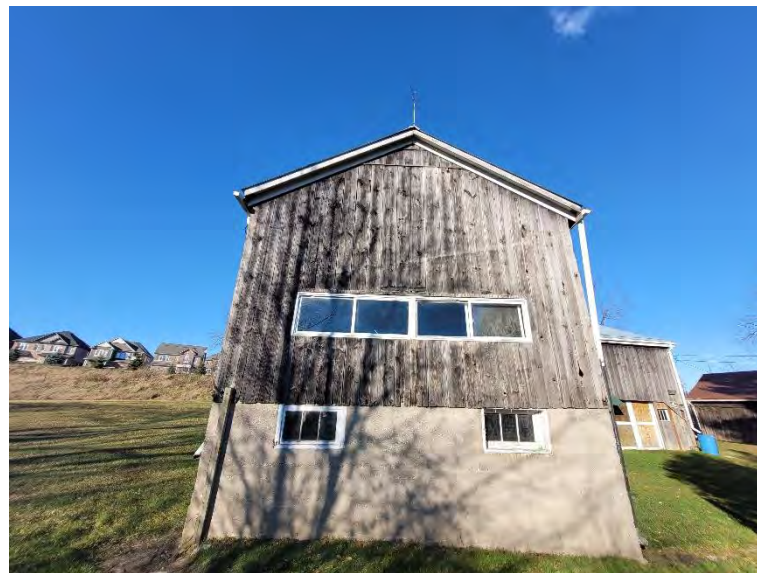
Figures 5 & 6: (left) View of west and south elevations, looking north-east, (right) View of south elevation, looking north, (Source: MHBC 2023)

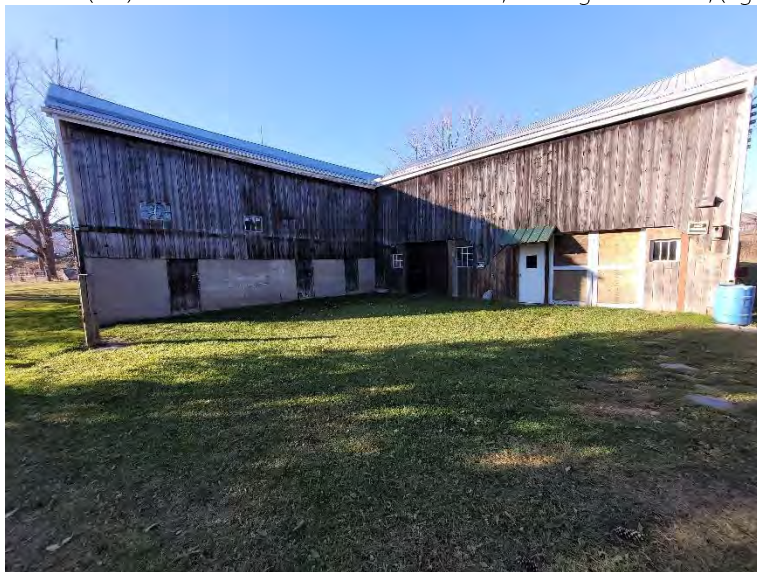
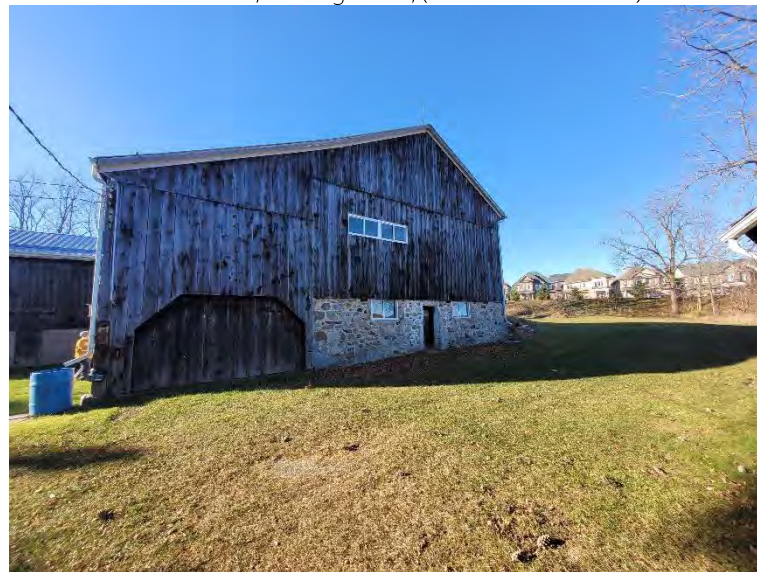
Figures 7 & 8: (left) View of south and east elevations, looking north-west, (right) View of east elevation, looking west, (Source: MHBC 2023)

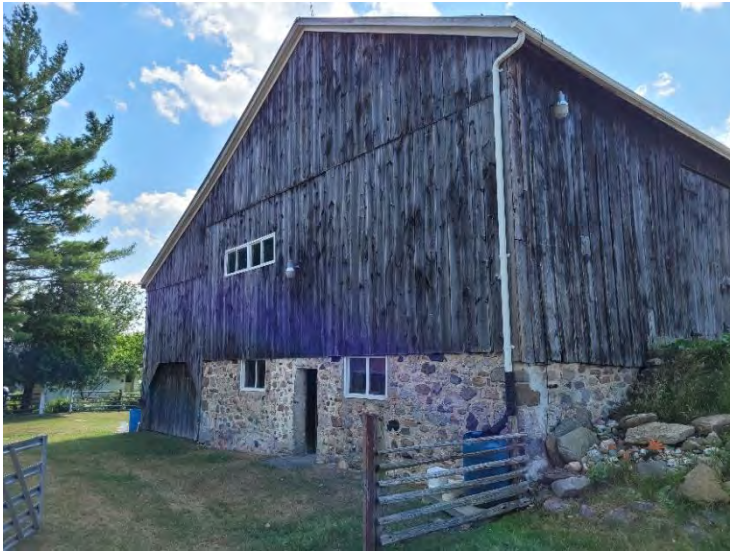
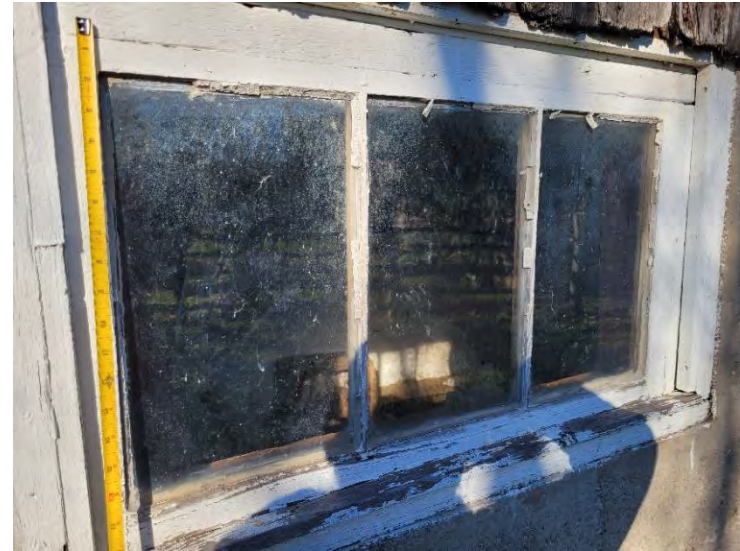
Figures 9 & 10: (left) View of east and partial north elevation, looking south-west, (right) Detail view of 20th century barn window, noting poor conditions,(Source: MHBC 2023)

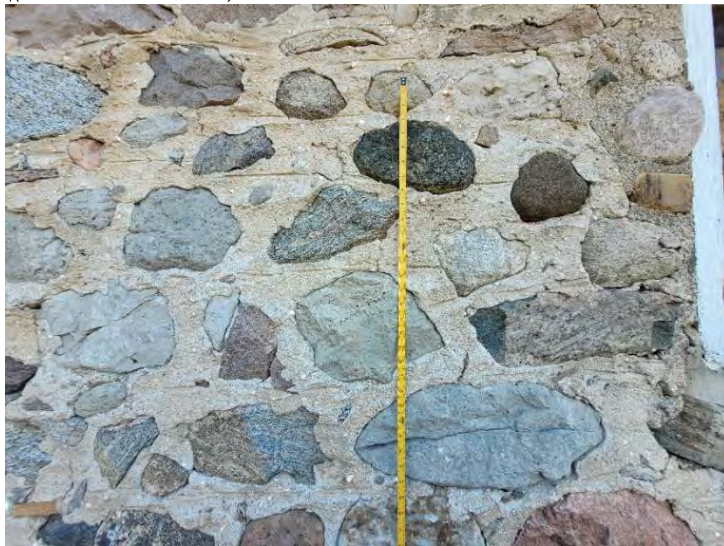
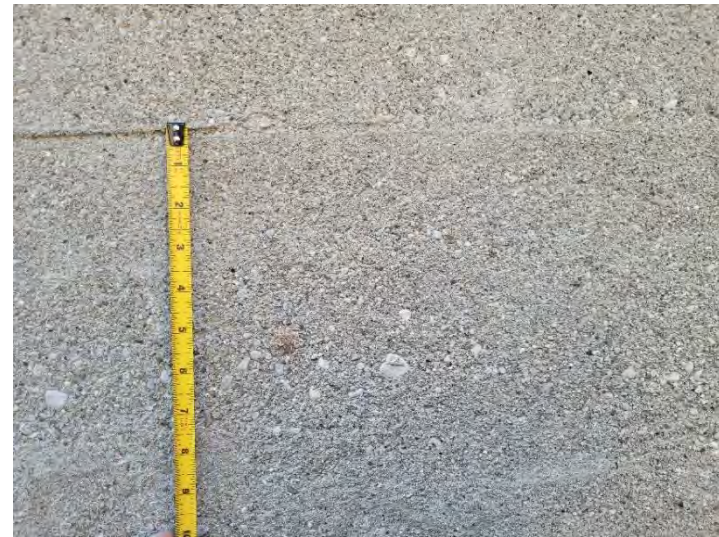
Figures 11 & 12: (left) Detail view of typical barn foundation material and field stones (right) View of concrete foundation at west elevation, (Source: MHBC 2023)

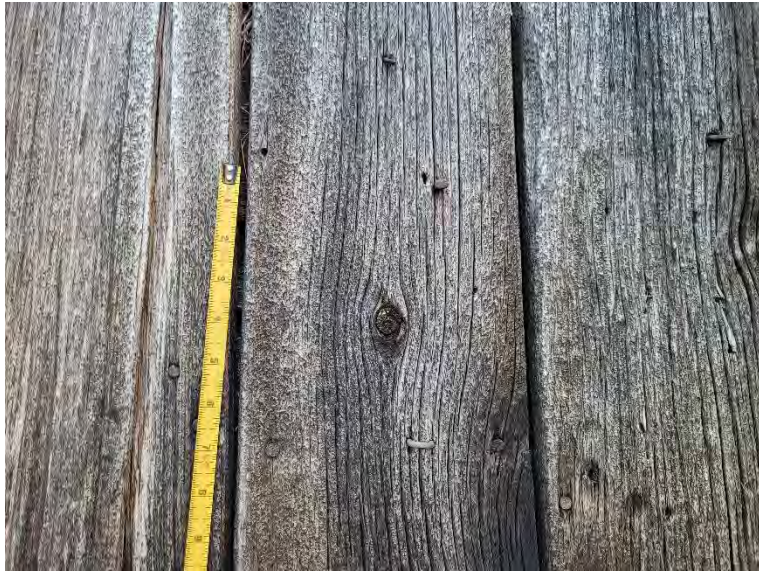
Figures 13 & 14: (left) Detail view of typical barn board cladding at east elevation, (Source: MHBC 2023)

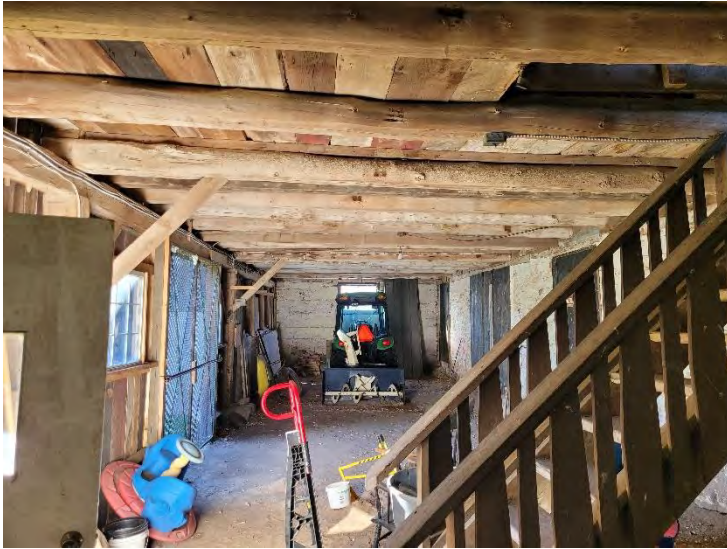
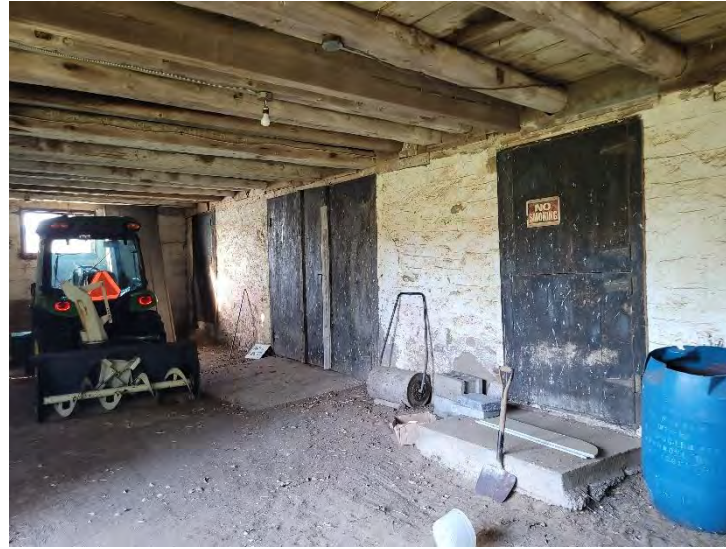
Figures 1 & 2: (left) View of forebay looking west, (right) View of forebay, looking north-west, (Source: MHBC 2023)

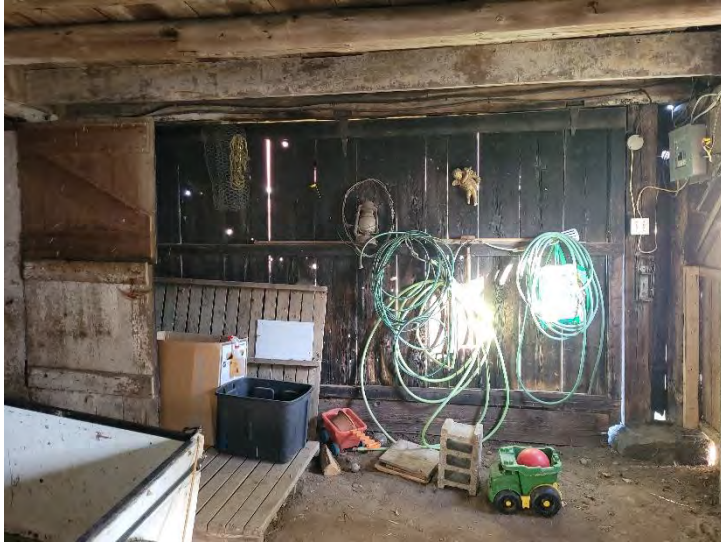
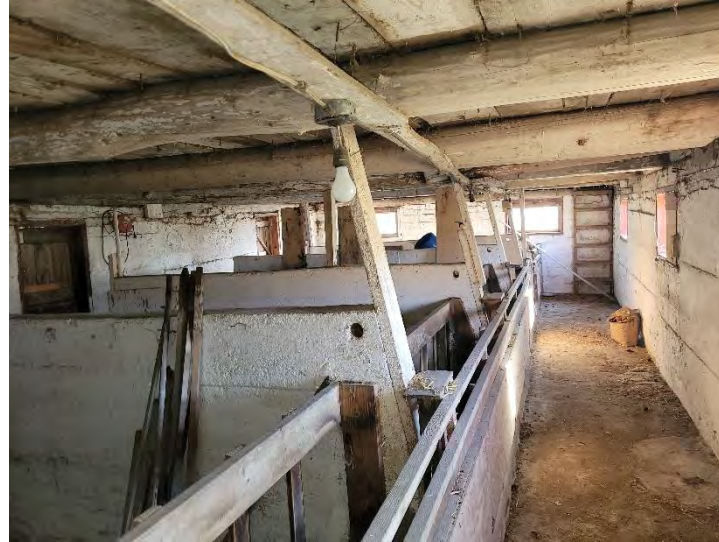
Figures 3 & 4: (left) View of forebay looking east, (right) View of barn, looking south adjacent to stalls, (Source: MHBC 2023)

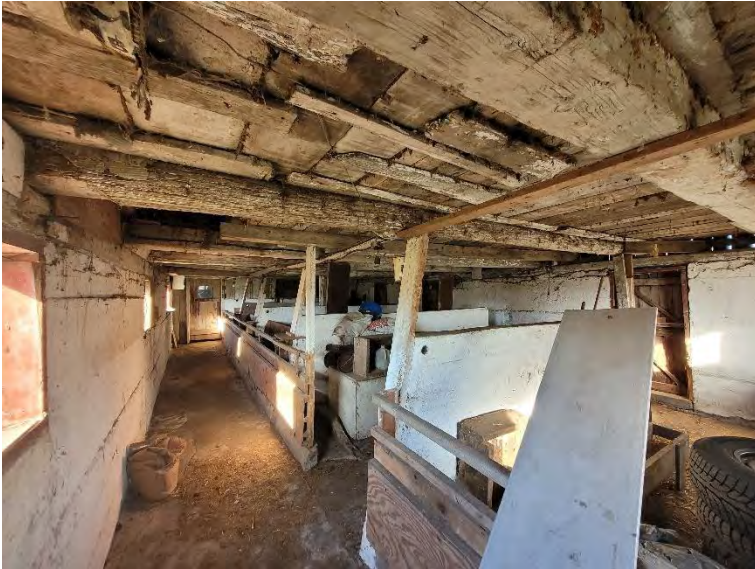
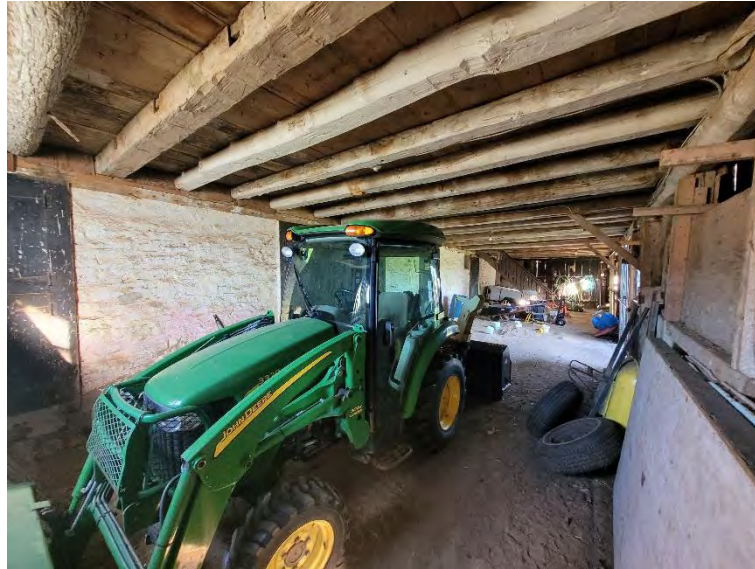
Figures 5 & 6: (left) View of barn, looking north adjacent to stalls, (right) View of barn forebay looking east, (Source: MHBC 2023)

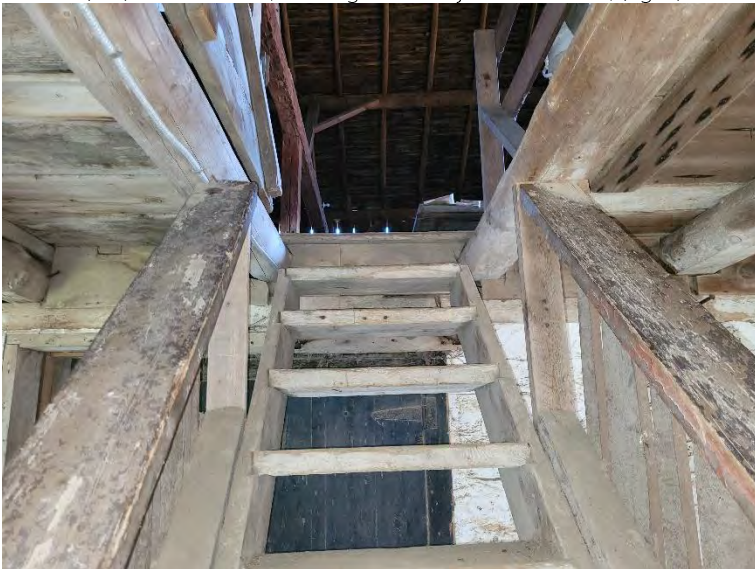
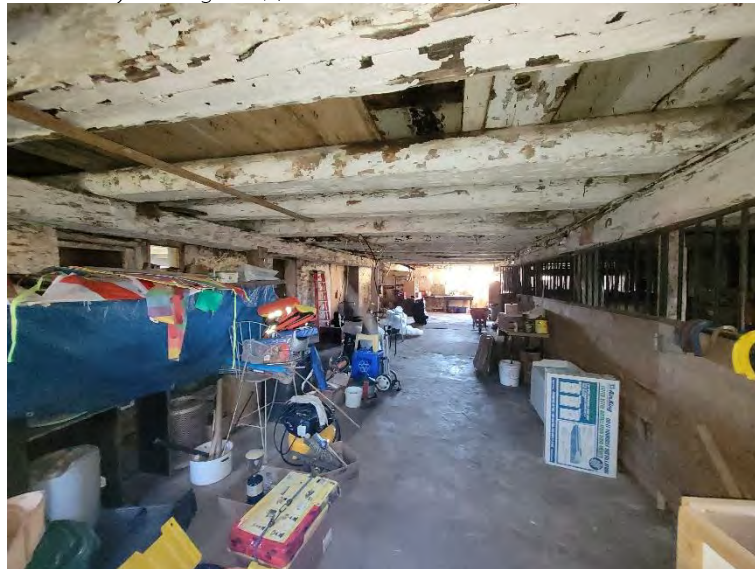
Figures 7 & 8: (left) View of stairs within forebay providing access to second storey, (right) View barn looking west,(Source: MHBC 2023)

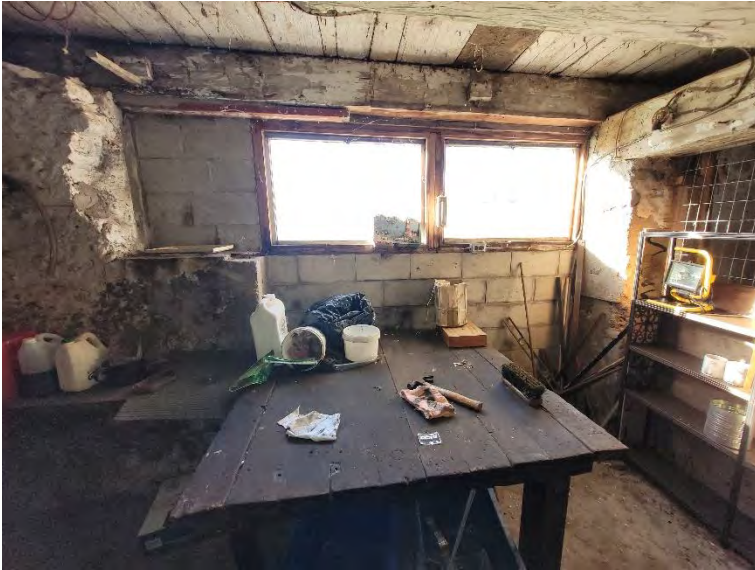
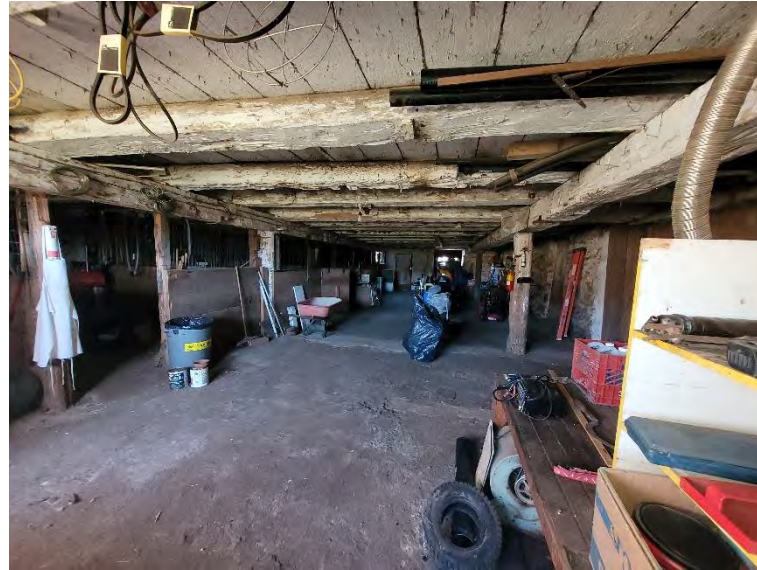
Figures 9 & 10: (left) View of barn (west elevation wall) looking west, (right) View of barn looking east, (Source: MHBC 2023)

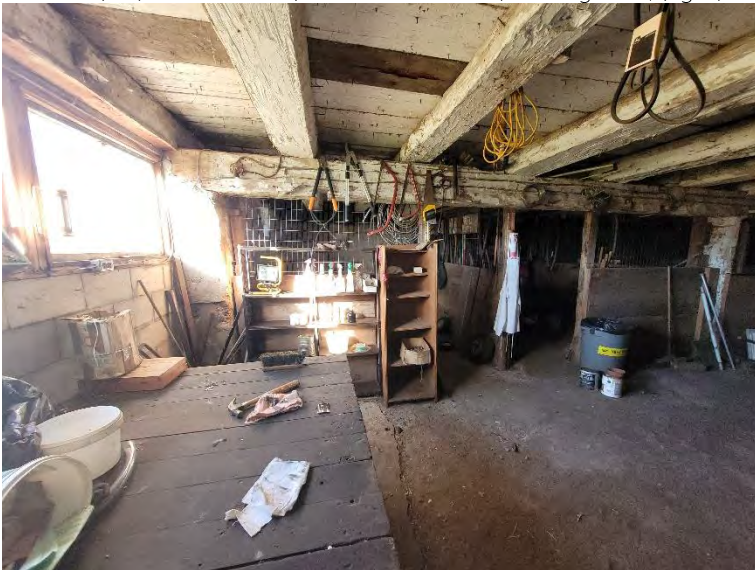
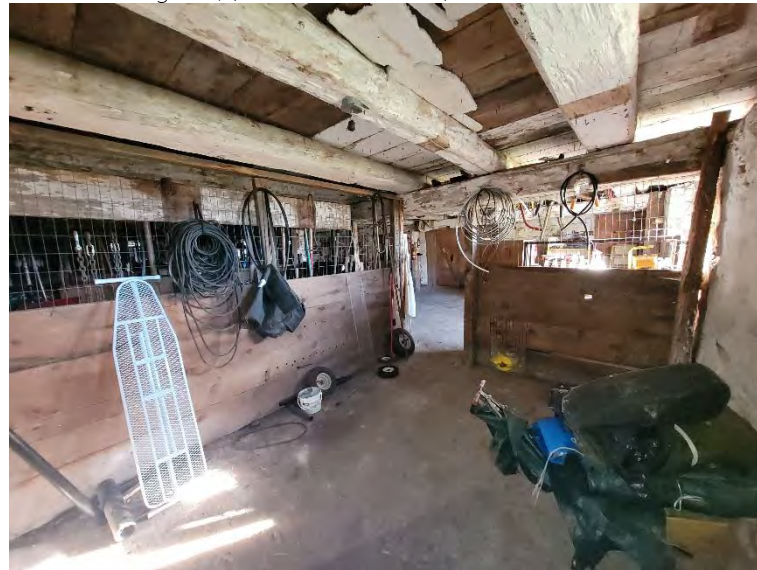
Figures 11 & 12: (left) View of stalls, looking north, (right) View within stall, looking south, (Source: MHBC 2023)

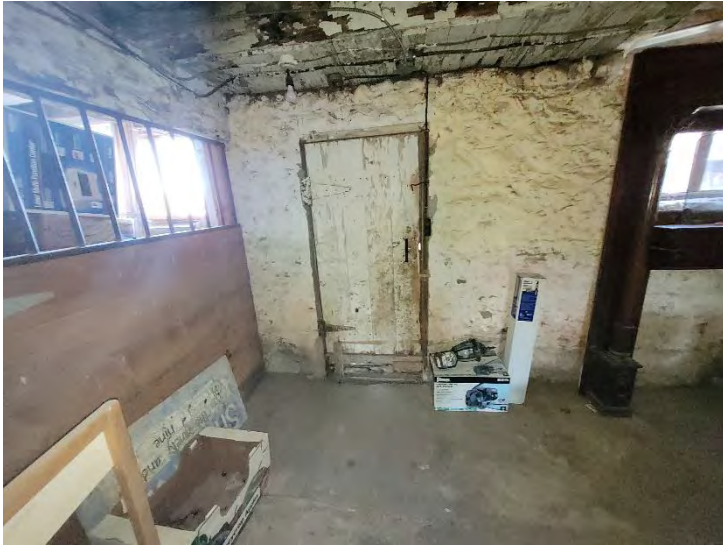
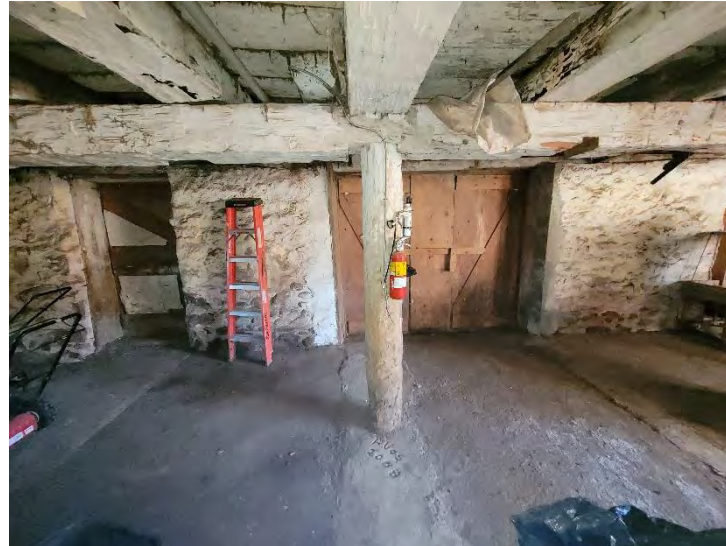
Figures 13 & 14: (left) View of exit at east elevation, (right) View of interior wall, looking south (Source: MHBC 2023)

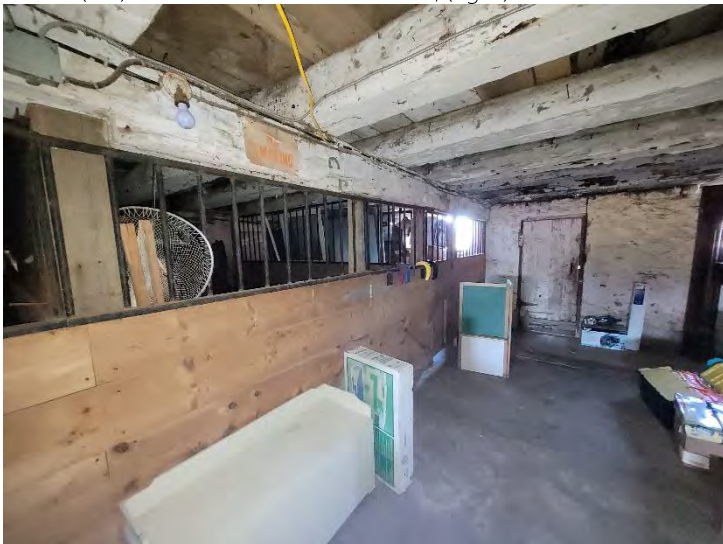
Figure 15: View of stalls at east end of barn, looking north-east, (Source: MHBC 2023)

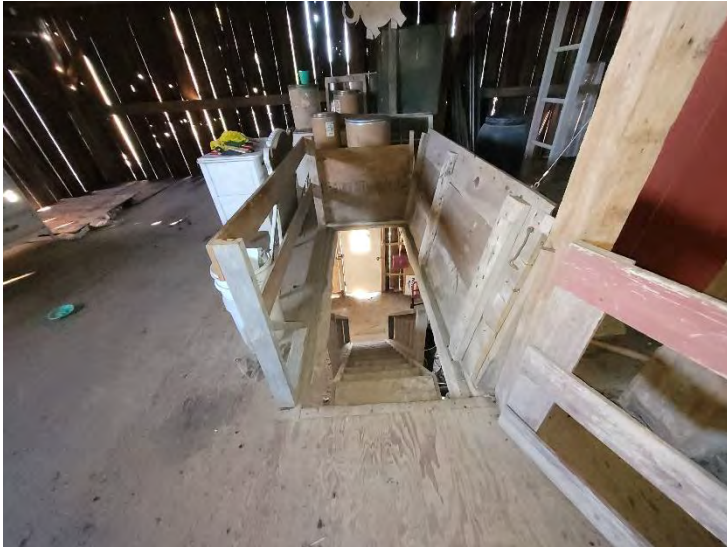
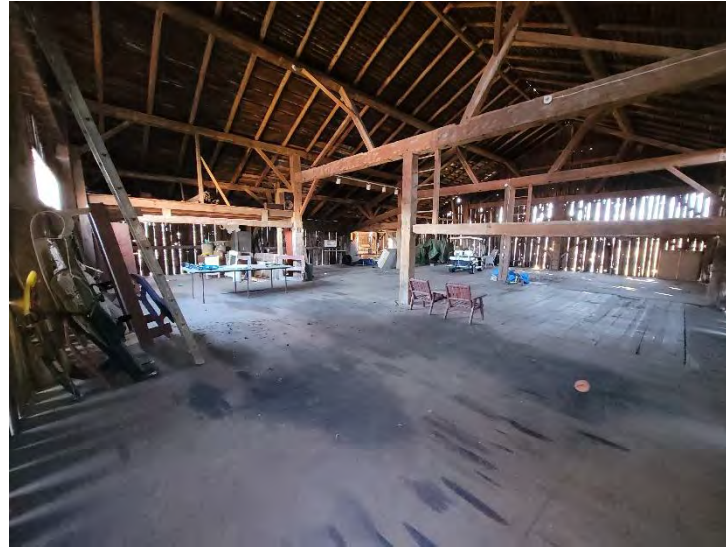
Figures 1 & 2: (left) View of stairs looking down (south) towards the first storey at grade, (right) View of open area, looking south-west, (Source: MHBC 2023)

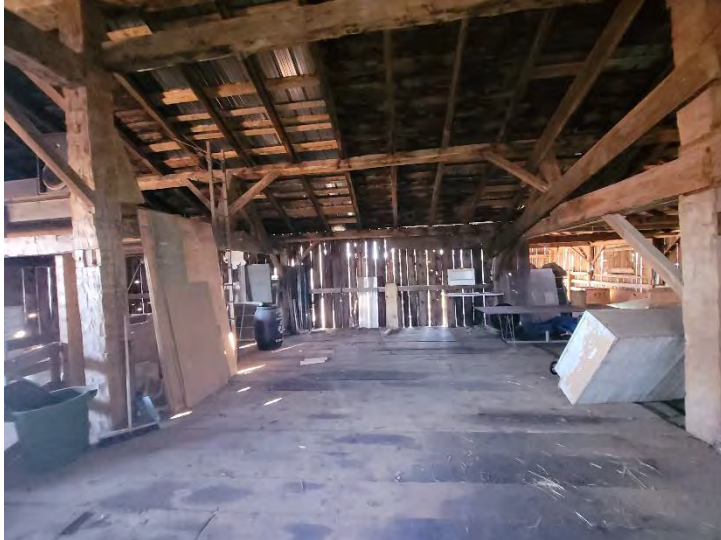
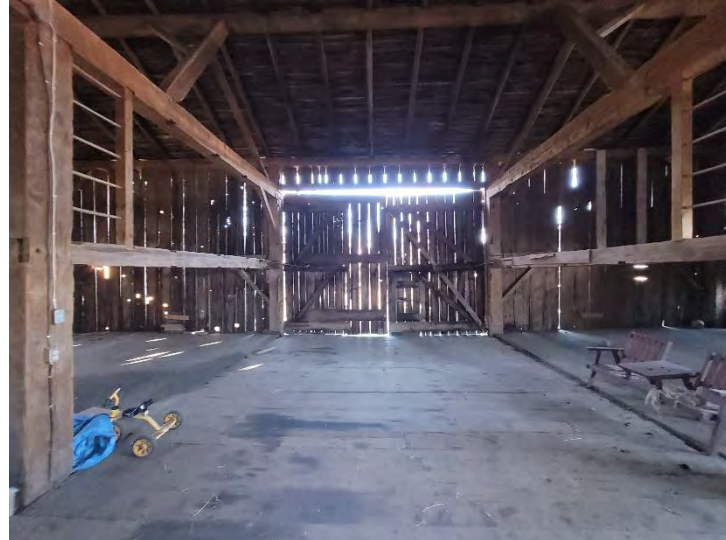
Figures 3 & 4: (left) View of barn looking south, (right) View of barn looking north towards bank, (Source: MHBC 2023)

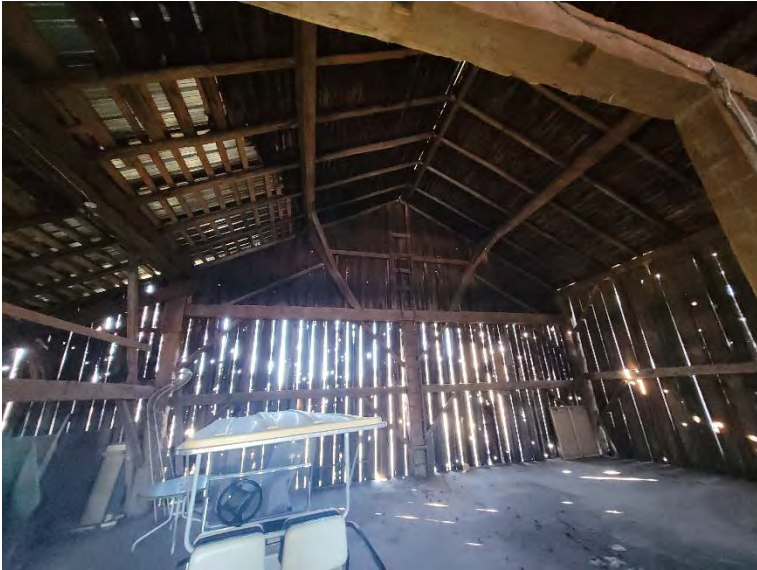
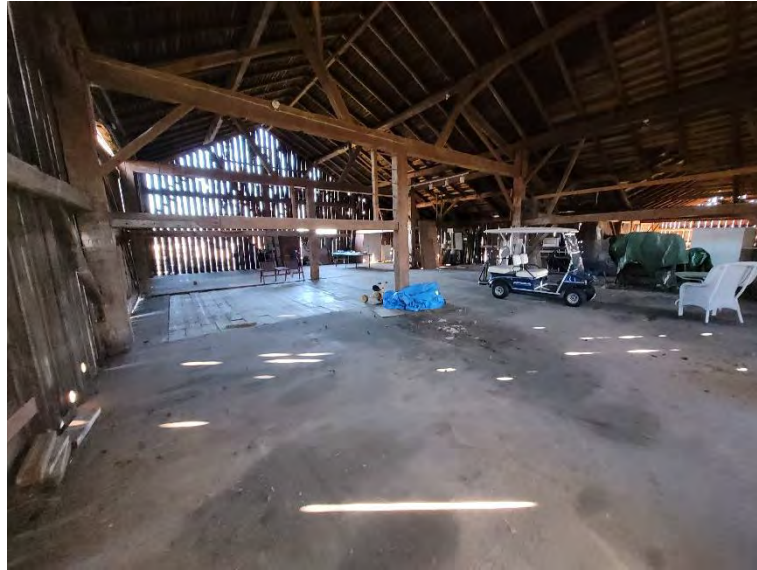
Figures 5 & 6: (left) View of barn looking west, (right) View of barn looking south-east, (Source: MHBC 2023)

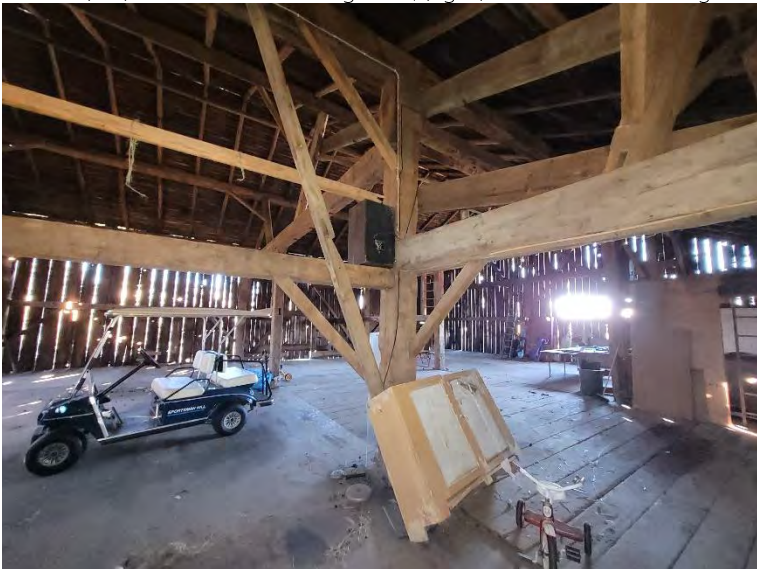
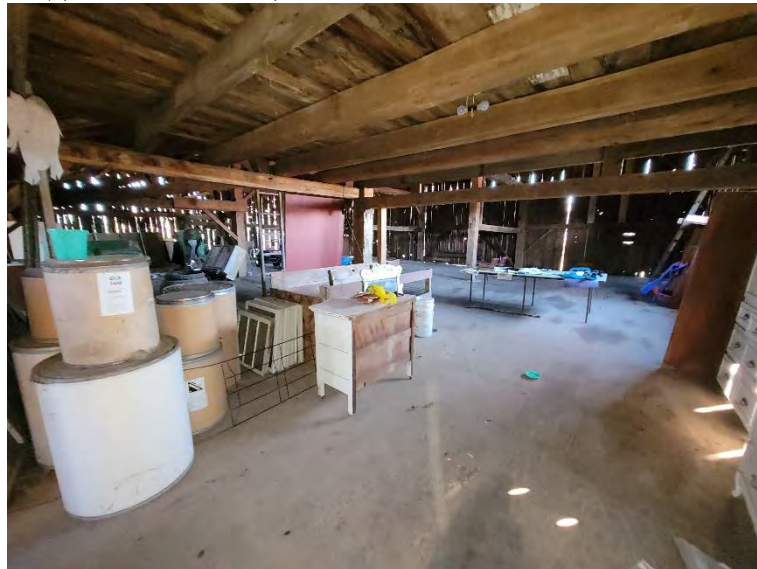
Figures 7 & 8: (left) View of barn looking north-east, (right) View barn looking north-west from under loft area, (Source: MHBC 2023)

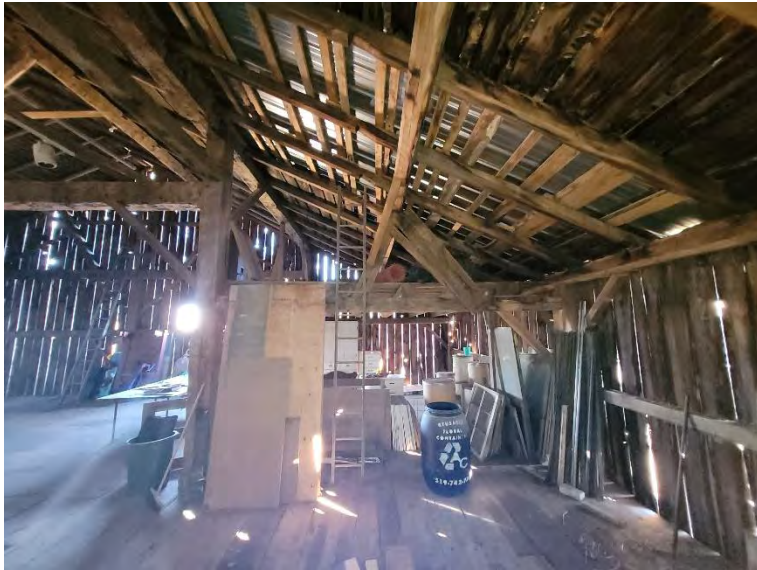
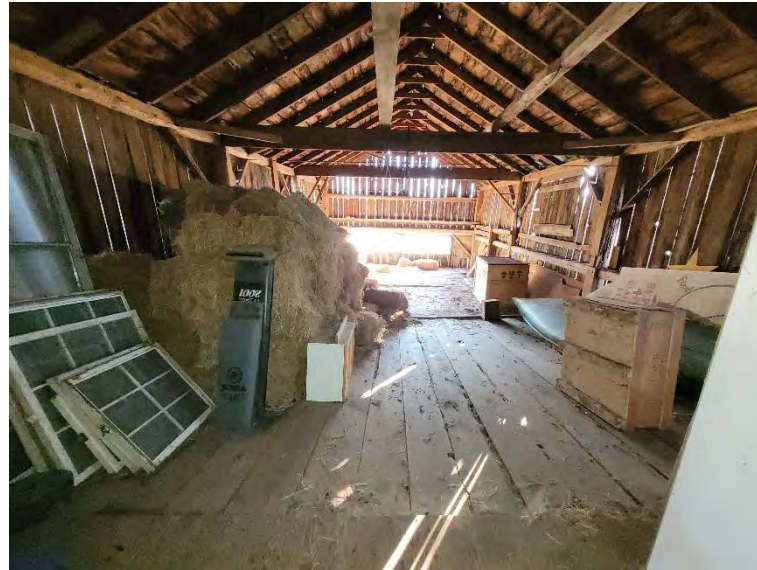
Figures 9 & 10: (left) View of barn looking east towards loft area (right) View of barn looking south, (Source: MHBC 2023)

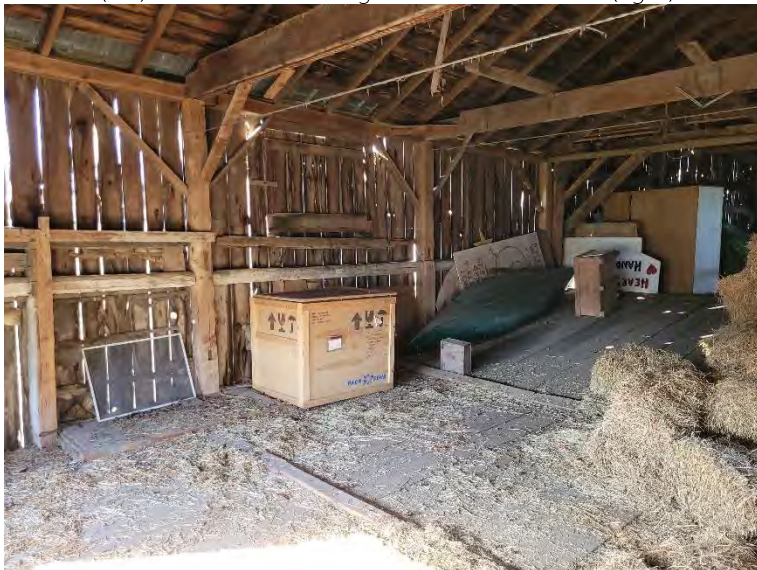
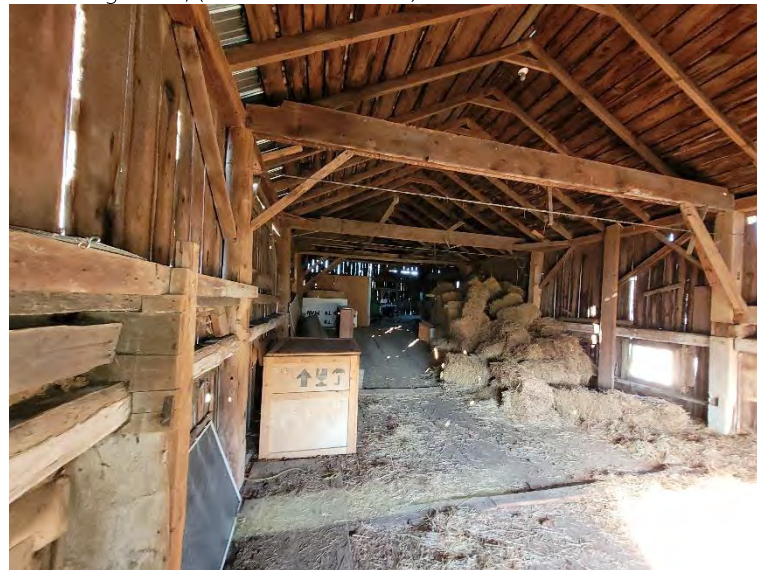
Figures 11 & 12: (left) View of barn looking north-west (note slope) (right) View of barn, looking north, (Source: MHBC 2023)

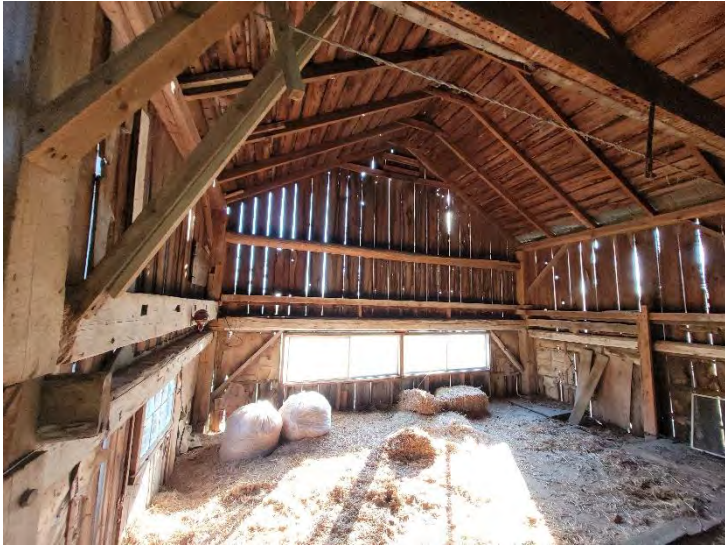
Figures 13: (left) View of barn looking south, (Source: MHBC 2023)

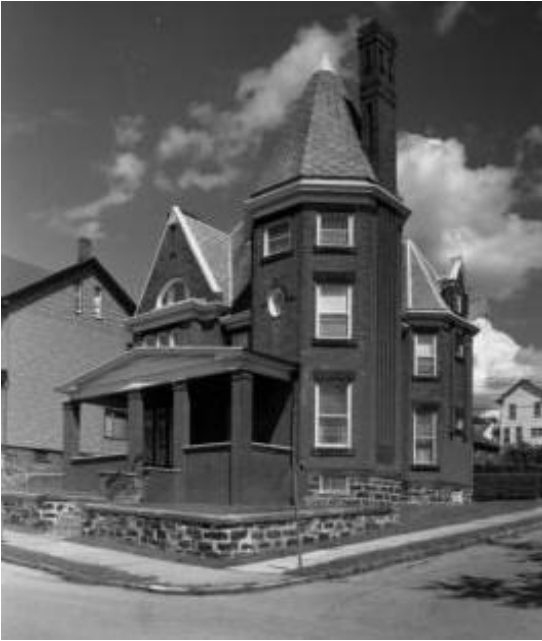
Perspective

Elevation photographs provide the best documentation of shape and proportion of a building while perspective photographs best depict the three-dimensional form of a structure.

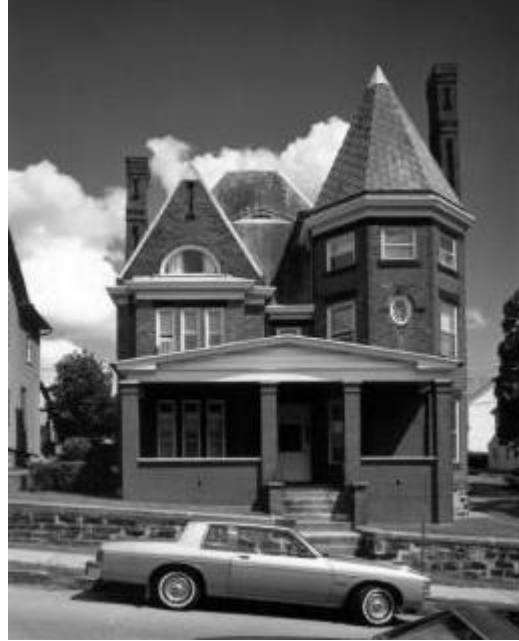
Elevation

An elevation photograph approximates an elevation architectural drawing and is a photograph of one side of a structure taken head on. An elevation is a drawing to scale of the side, front, or rear of a building in which projecting features such as window and door moldings, window sills, steps, and eaves are all rendered as if they were totally flat. The emphasis on one side of a building as two-dimensional surface makes an elevation photograph more axiomatically correct. This means that distances on the photograph are proportional to distances on the building, and approximate measurements can be taken from the photograph. (In elevation photographs, the structure should fill the frame, isolating it from its surroundings.)
