STATEMENT OF SIGNIFICANCE

91 MADISON AVENUE SOUTH

Municipal Address: 91 Madison Avenue South

Year Built: 1924/25

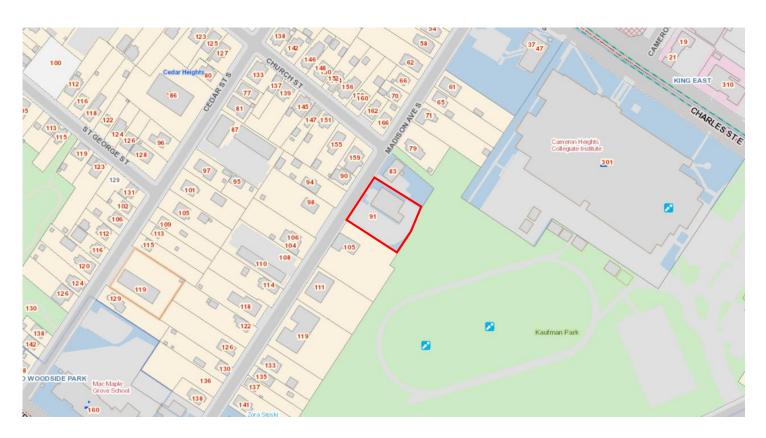
91 Madison Avenue South is a two storey early-20th century religious building constructed in the Colonial Revival architectural style with Byzantine and Moorish influences. The building is situated on a 0.43 acre parcel of land located on the east side of Madison Avenue South between Church Street and Courtland Avenue East. The principal resource that contributes to the heritage value is the religious building.

The front façade of the building is symmetrical in its design and massing. It can be divided into three sections; the northern-most and southern-most sections are each delineated by two pilasters that extend from the raised concrete foundation and beyond the roofline, capped with concrete detailing, The two sections also each contain a third pilaster in the centre above a ground-level door set into the raised concrete foundation. The central pilaster extends approximately three-quarters of the way up the façade and is decorated with further concrete detailing.

The central section contains a set of concrete stairs that lead up to double eight-panel wood doors topped with a semi-circular transom window with stained glass panes and a voussoir. The doors are framed by a semi-circular multi-pane window on each side with decorative concrete headers and sills. The second storey is comprised of two rectangular multi-paned windows with concrete headers and sills and ancentral arched concrete section that contains the symbol of the church.

The north and south side façades possess five pilasters that divide the wall into five bays. The first western-most bay contains four; one square, two semi-arched, and one rectangular. The other four bays contain three windows, one rectangular and two long and semi-arched. The south façade has more of the raised concrete foundation exposed due to the slope of the land, and eight rectangular multi-paned windows are set into it.

The Star of David on the front has been replaced by the logo of the Crkva Božje Church of God.

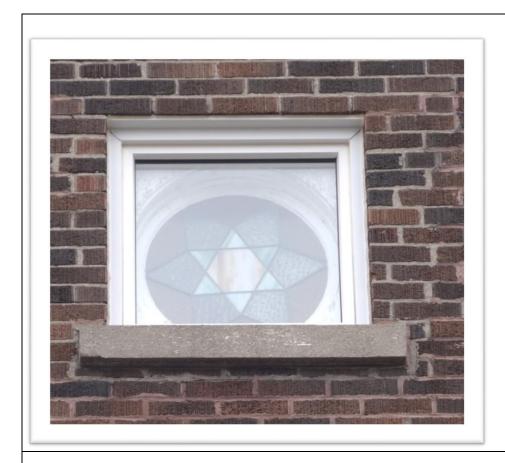
Stained Glass Window

- on the right and left sides are five circular windows with the six pointed Star of David in stained glass.
