**REPORT NO.:** DSD-2024-195

**SUBJECT:** *Notice of Intention to Designate 131 Victoria Street South under  
Part IV of the Ontario Heritage Act*

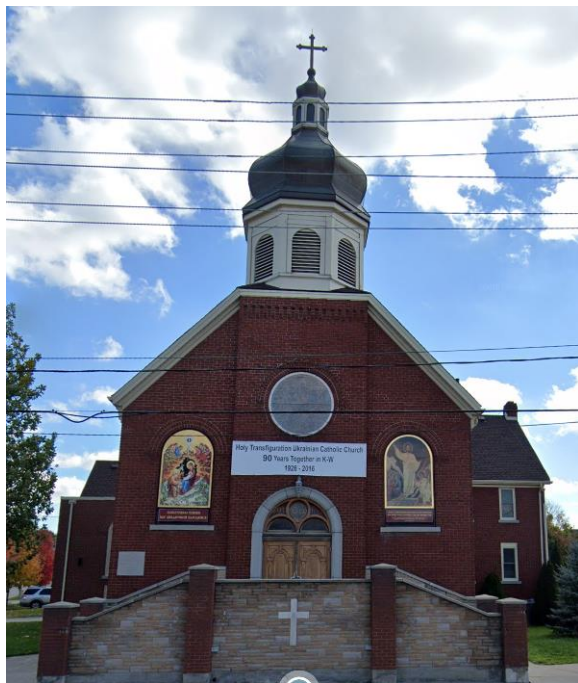
**Figure 2: Front Elevation (West Façade) of the Subject Property – 131 Victoria Street South (Ukrainian Catholic Church of the Transfiguration)**

The front of the building faces Victoria Street South and is comprised of three bays including a centre projecting bay. The most prominent feature of the building is the bronze pear-shaped dome with rooftop cupola topped by a cross. The centre bay features brick dentils

at the roofline, a large round stained-glass window with brick surround, a semi-circular stone door surround, and paneled double doors with a decorative semi-circular transom. The end bays each feature semi-circular window openings, brick voussoirs with drip molds, and stone sills. The windows in these openings have been removed and replaced with Byzantine paintings. The left bay (when looking at the front of the building) also features a 1926 stone datestone. The current exterior stairs were constructed in 1993 and provide access from the north and south. These stairs feature four brick piers of varying heights with stone caps. Between each brick pier is an angel stone wall capped with concrete. Two brick piers with concrete caps have been added to the front of the building along with an angel stone wall capped with concrete. The centre bay of the angel stone wall displays a cross. Four additional brick piers create a brick and iron fence that extends south along the property line (parallel to Victoria Street).
