Staff Report

REPORT NO.: DSD-2024-195

SUBJECT: *Notice of Intention to Designate 131 Victoria Street South under Part IV of the Ontario Heritage Act*

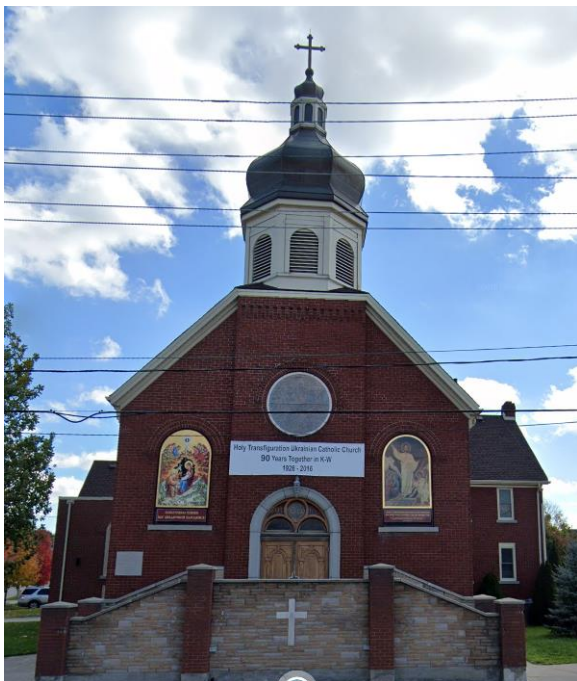
Figure 2: Front Elevation (West Façade) of the Subject Property – 131 Victoria Street South (Ukrainian Catholic Church of the Transfiguration)

Front (West) Façade

The front of the building faces Victoria Street South and is comprised of three bays including a centre projecting bay. The most prominent feature of the building is the bronze pear-shaped dome with rooftop cupola topped by a cross. The centre bay features brick dentils

at the roofline, a large round stained-glass window with brick surround, a semi-circular stone door surround, and paneled double doors with a decorative semi-circular transom. The end bays each feature semi-circular window openings, brick voussoirs with drip molds, and stone sills. The windows in these openings have been removed and replaced with Byzantine paintings. The left bay (when looking at the front of the building) also features a 1926 stone datestone. The current exterior stairs were constructed in 1993 and provide access from the north and south. These stairs feature four brick piers of varying heights with stone caps. Between each brick pier is an angel stone wall capped with concrete. Two brick piers with concrete caps have been added to the front of the building along with an angel stone wall capped with concrete. The centre bay of the angel stone wall displays a cross. Four additional brick piers create a brick and iron fence that extends south along the property line (parallel to Victoria Street).
