STATEMENT OF SIGNIFICANCE

236 Gehl Place

Description of Cultural Heritage Resource

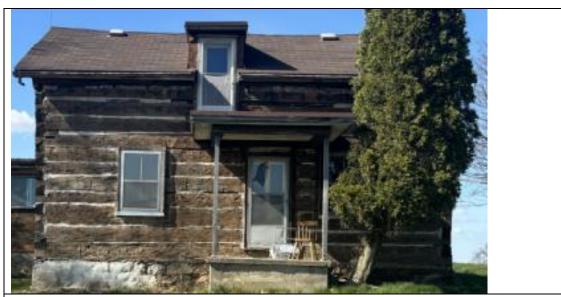
Front Elevation (South Façade)

Front (South Elevation) Façade

The front façade displays a slightly off-centre (towards the right/east) front door with wood trim. A 2/2 flat headed double hung wood window with a wood sill is located on each side of the front door. A two-storey basic porch was a later addition. The shed roof dormer was added to facilitate access to the upper porch.

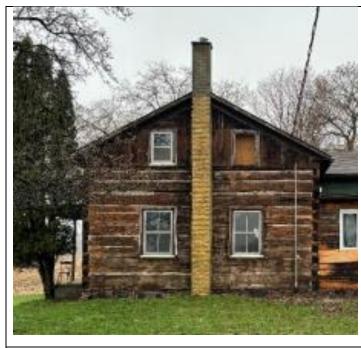
Side Elevation (East Façade)

Side (East Elevation) Façade

The side façade displays a symmetrical façade with a central chimney built of yellow brick flanked by windows on both sides at the basement level and on the first- and second storey. The basement windows are flat headed rectangular windows with wood sills. Some of the basement windows, which may be original, feature three-lites. The first storey features two 2/2 flat headed double hung wood windows with wood sills. The second-storey window openings are slightly smaller given the gable roof design and appear to be original; however, the one opening contains a flat-headed 1/1 hung window with wood sill, while the other opening is missing the window and currently covered by plywood.

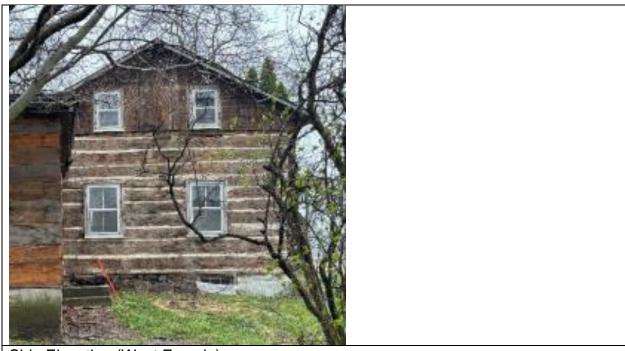
Side Elevation (West Façade)

Side (West Elevation) Façade

The side façade displays a symmetrical façade. The two basement windows are flat headed rectangular windows with wood trim and sills. Some of the basement windows, which may be original, feature three-lites. The first-storey features two 2/2 flat headed double hung wood windows with wood sills. The second-storey window openings are slightly smaller given the gable roof design and appear to be original; however, the two openings contain a flat-headed 1/1 hung window with wood sill.
