STATEMENT OF SIGNIFICANCE

1738 Trussler Road

1738 Trussler Road, GCT Pt Lt 149 RP 58R8498 Part 1

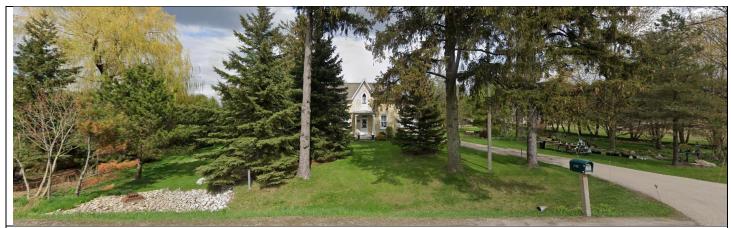
The contextual values relate to how the property helps to maintain and support the rural character of the area. The farmhouse remains on its original location. A board and batten front gable garage contributes to the character of the property along with the cedar hedges delineating three sides of the property. The farmhouse is visually and historically linked to its surroundings, especially the rural farm property on the corner of Huron Road and Trussler Road where the original barn and driveshed still stand. This property is addressed off Huron Road (outlined in green on page 1) and legally described as Plan 585 Lots 18, 19, and 20 Part Lots 5, 6, 7, 8, 15, 16, and 21 SS Huron Road German Company Tract Part Lot 149.

Wide Angle View of the Frontage of the Property, including the Front Elevation (West Façade) of the Farmhouse – 1738 Trussler Road

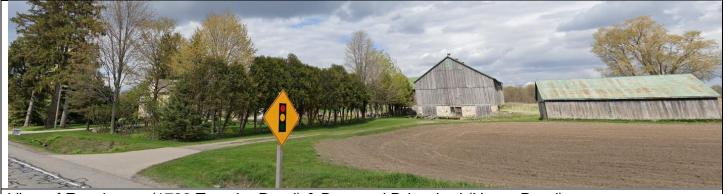
The original barn with gable roof, vertical board siding, original hardware and stone foundation is located south of the house on a separate parcel of land. A new garage was constructed in 1999 that does not detract from the character of the farmhouse, barn or immediate surroundings.

View of Farmhouse (1738 Trussler Road) & Barn and Driveshed (Huron Road)
