STATEMENT OF SIGNIFICANCE

107 Courtland Avenue South

Municipal Address: 107 Courtland Avenue East

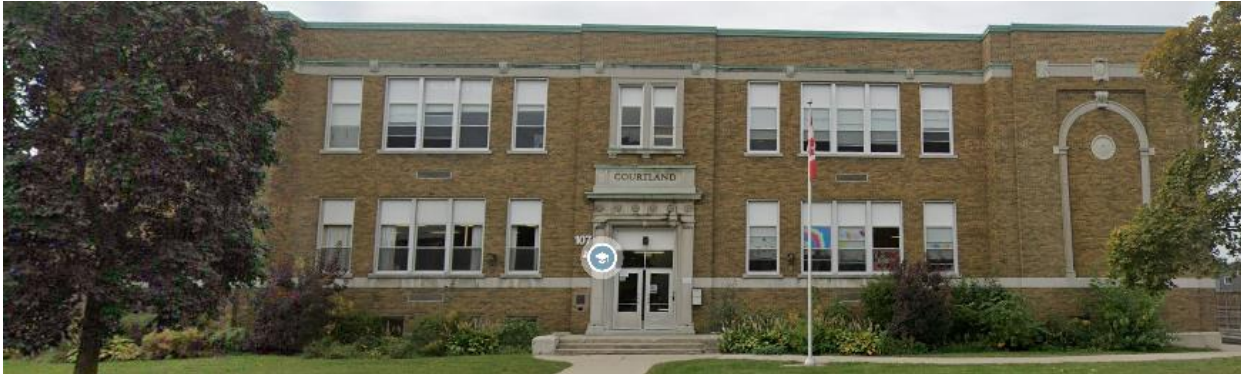
Front Elevation (North Façade) – 107 Courtland Avenue East

Front (North Elevation) Façade

The front façade faces Courtland Avenue East and features a symmetrical façade with five bays and a flat roof.

The central bay features: yellow brick and stone materials; a classical frontispiece that is raised from the ground features smooth pilasters with simple moulded base and a crown cap topped by an entablature; the entablature features a plain architrave, a decorative frieze with round reliefs, and a moulded cornice with dentils; above the entablature sits a stone sign that reads “*COURTLAND*”; copper flashing is used above the entablature, the stone sign, the second floor stone belt course, and the roof; stone belt courses are located below the first floor windows and above the second floor windows; a pair of window openings with a stone surround; and, a bronze plaque that reads “*Courtland Senior Public School 1890 – 1990 to Commemorate One Hundred Years in Education.*”

The two bays on either side of the central bay feature: four flatheaded basement windows; yellow brick and stone materials; a stone belt course below the first floor windows and above the second floor windows; the belt course above the second floor windows feature decorative stone reliefs; a window pattern on both the first and second floor that features a single flatheaded 1/1 window with enclosed transom and a stone sill, a ribbon of three flatheaded 1/1 windows with enclosed transom and a stone sill, and another single flatheaded 1/1 window with an enclosed transom and a stone sill; and, copper flashing on the entablature, stone sign, second floor belt course, and roof.

The two end bays feature: yellow brick and stone materials; three flatheaded basement windows; a stone belt course that aligns with the bottom of the first floor windows and a broken stone belt course

that aligns with the top of the second floor windows; blind stone semi-circular arches with decorative central keystones (agraffe) supported by fluted pilasters with plain bases and crown caps; stone cartouches above the blind concrete arches; and, stone medallions with brick surrounds.

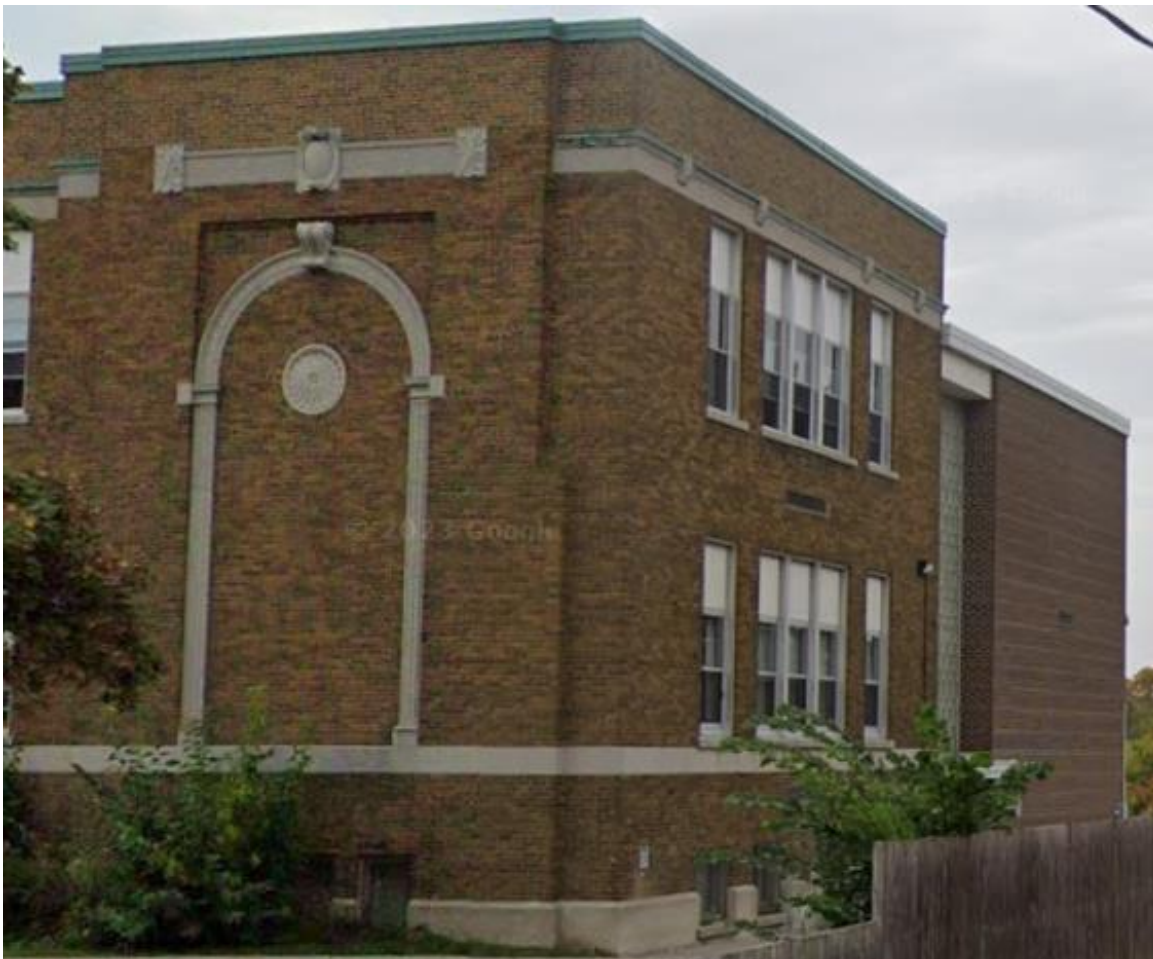
Side Elevation (West Façade) – 107 Courtland Avenue East

Side (West) Façade

The side façade faces West and features: yellow brick and stone; four flathead basement windows with stone sills; a stone belt course below the first-floor windows and above the second-floor windows; a ribbon of three 1/1 flatheaded windows with enclosed transom and stone sills bookended by a single 1/1 window with an enclosed transom and stone sills on both the first- and second-storey; and, copper flashing on the roof.

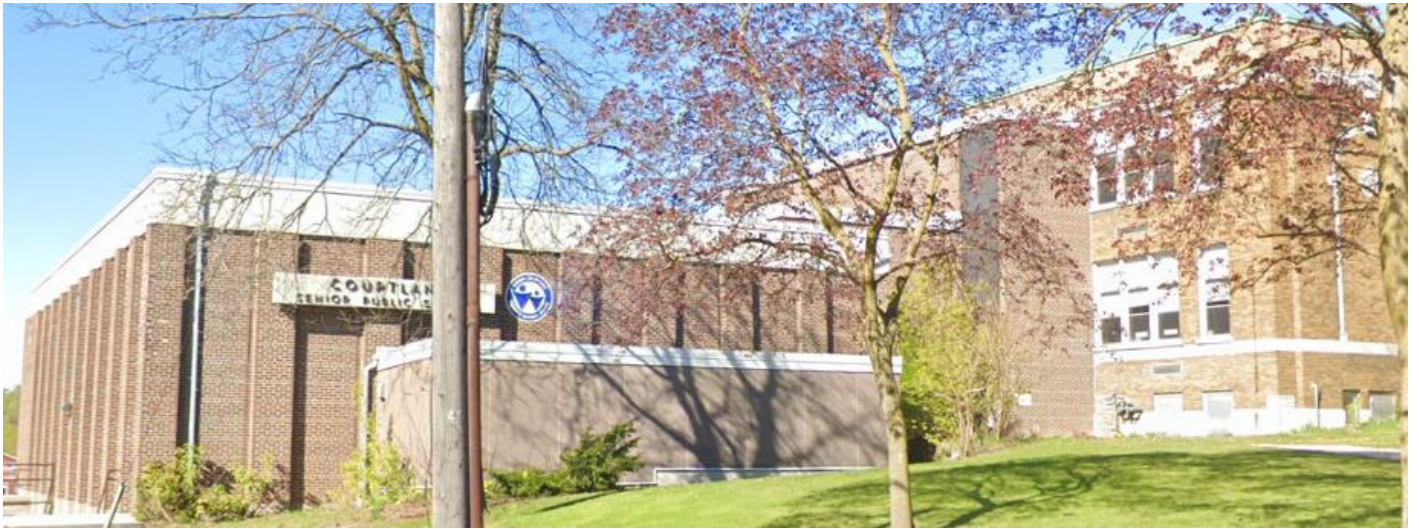
Side Elevation (East Façade) – 107 Courtland Avenue East

Side (East) Façade

The side façade faces East but only a portion of the circa 1928 façade is visible because the 1964 addition was built on to the East façade. The portion of the circa 1928 building that can be seen features: yellow brick and stone materials; two flathead enclosed basement windows; a stone belt course below the first-floor windows and above the second floor windows; a single flatheaded 1/1 window with an enclosed transom and a stone sill on both the first- and second-storey; a ribbon of three flatheaded 1/1 windows with enclosed transoms and a stone sill on both the first- and second-storey; and, copper flashing on the roof.

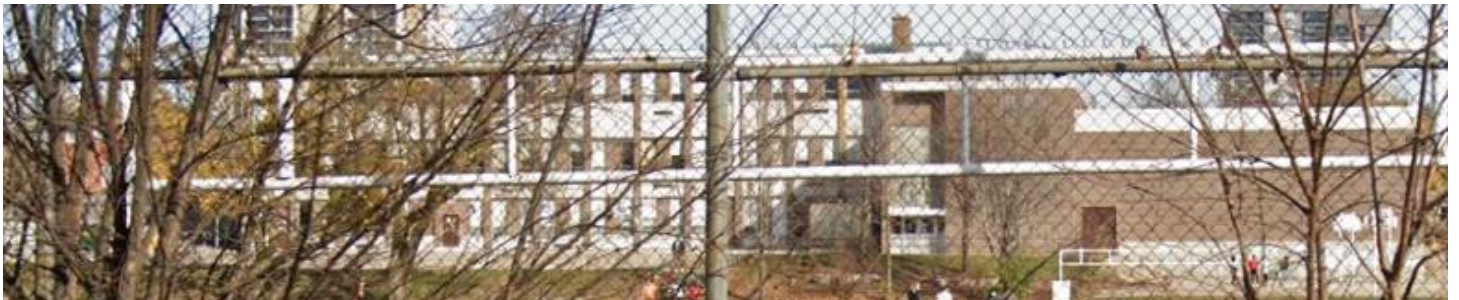
Rear Elevation (South Façade) – 107 Courtland Avenue East

Rear (South) Façade

The rear façade faces South and consists entirely of the 1964 addition.

Addition (1964)

A one storey addition was built of the south façade of 107 Courtland Avenue East. The addition is set back behind the frontline of the circa 1928 building. The addition is constructed of brown brick and features the school's name "COURTLAND SENIOR PUBLIC SCHOOL" as well as the Waterloo Region District School Board logo. The addition does not detract from the character of 107 Courtland Avenue, or the character of the Courtland Avenue East streetscape as it is setback from the original façade, lower in height, and situated on a lower elevation of land.
