**Addendum to Heritage Impact Assessment  
for  
1385 Bleams Road  
Lot 5, Registrar's Compiled Plan 1469, Hiestand Tract  
in the City of Kitchener, ON**

**Addendum to Heritage Impact Assessment  
1385 Bleams Road, Kitchener, ON**

**Re: Preliminary Construction Vibration Assessment  
1385 Bleams Road  
Proposed Stacked Townhouse Block  
City of Kitchener  
Our File No. 23355**

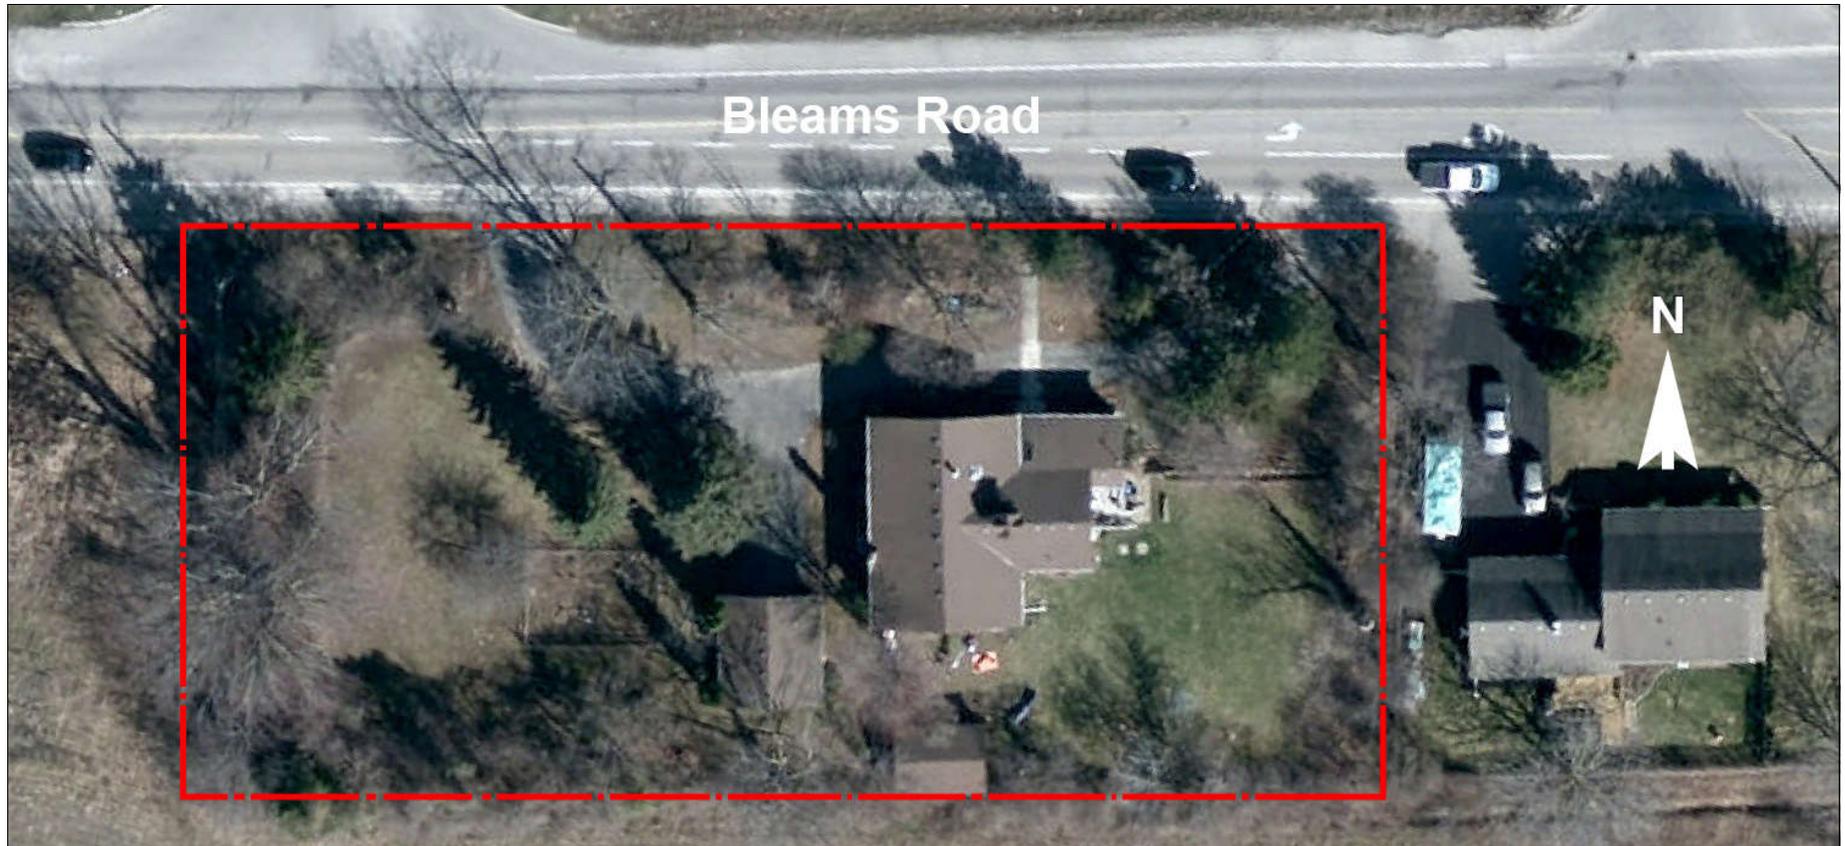
Figure 1

The heritage resources on the subject property are located near the middle of the property, with the eastern and western portions being open lawn and the original playgrounds for the school (Figure 1).

1385 Bleams Road - GRCA mapping

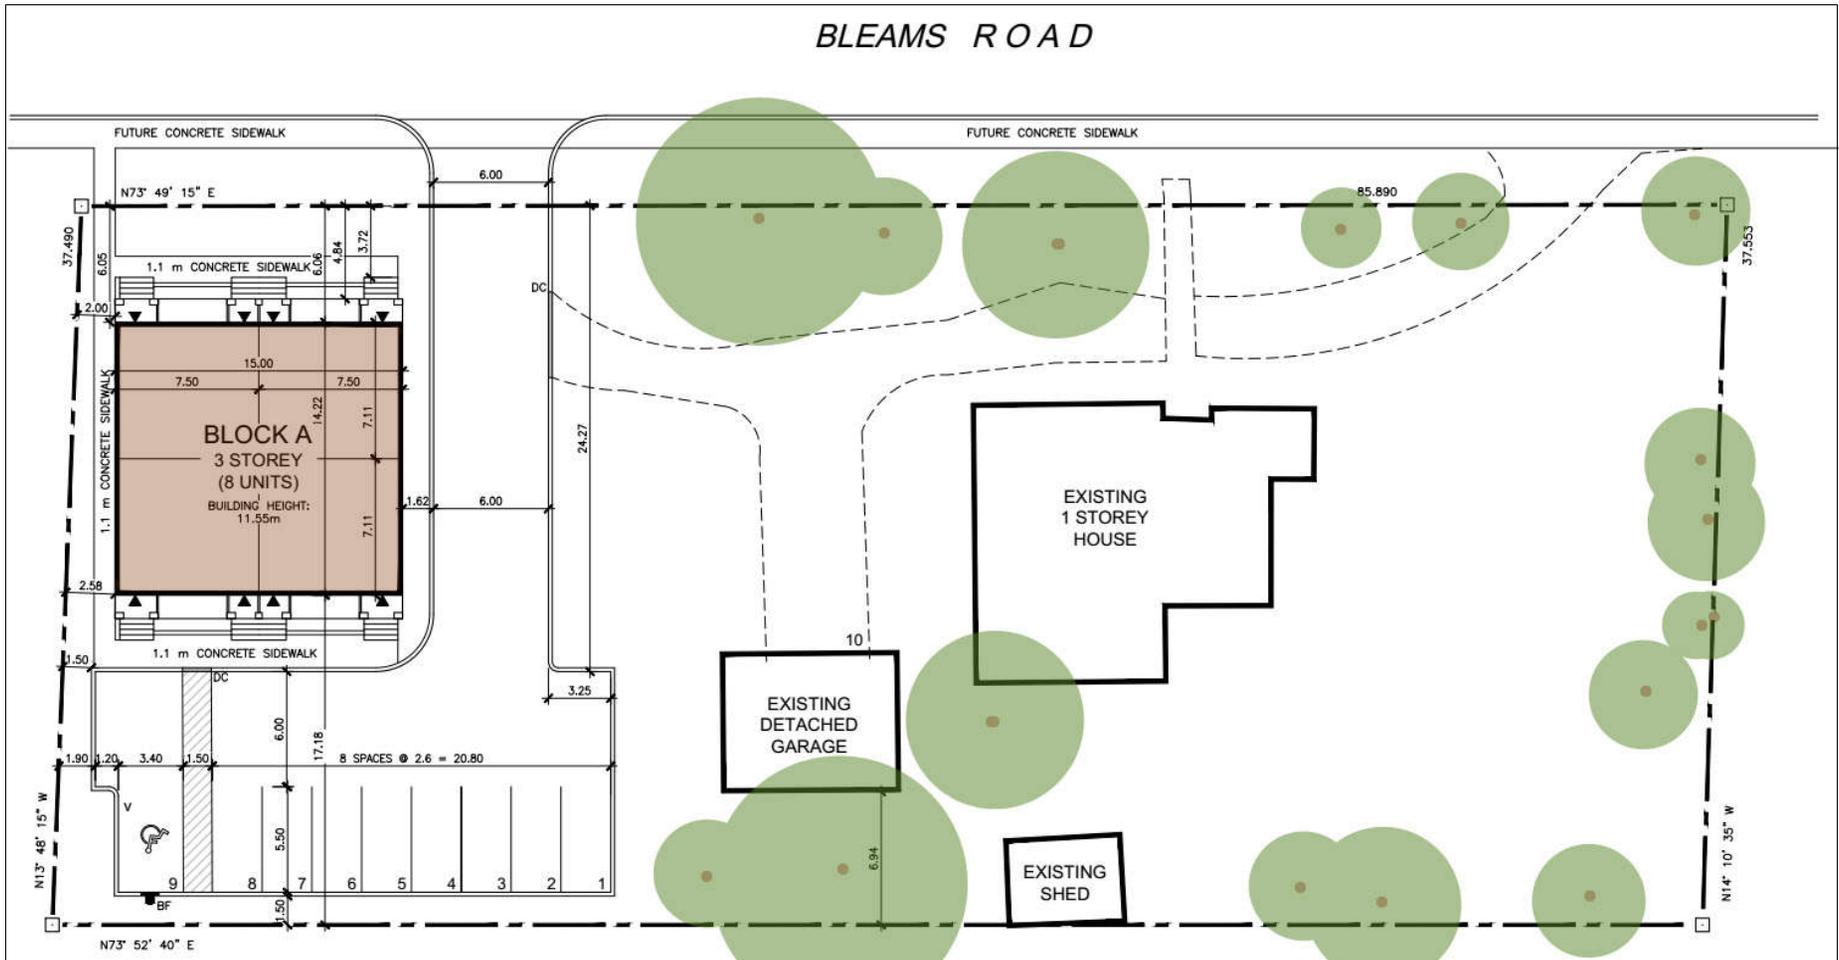
Figure 2

The western open lawn portion was proposed to be redeveloped with eight, three-storey townhomes in the June 2023 HIA. The change in plans now proposes to develop that western open lawn portion as shown on the site plan in Figure 2. The proposed 3-storey stacked townhouse unit is set near the street with parking behind the building accessed by a driveway on the east. The building is approximately 30 metres from the westerly facade of the former schoolhouse.

site plan - Orchard Design, August 14, 2024

Public views of the schoolhouse are not impeded. The former schoolhouse is in complete public view from the street (Figure 2). The facades of the stacked townhouse unit are illustrated in Figures 3 - 6.

The architecture of the proposed stacked townhouses is contemporary and in keeping with that of the neighbouring residential architecture. It does not overwhelm the adjacent heritage resource, mainly as a result of its location on the lot, being set back some 30 metres from the west wall of the former schoolhouse (Figure 2).

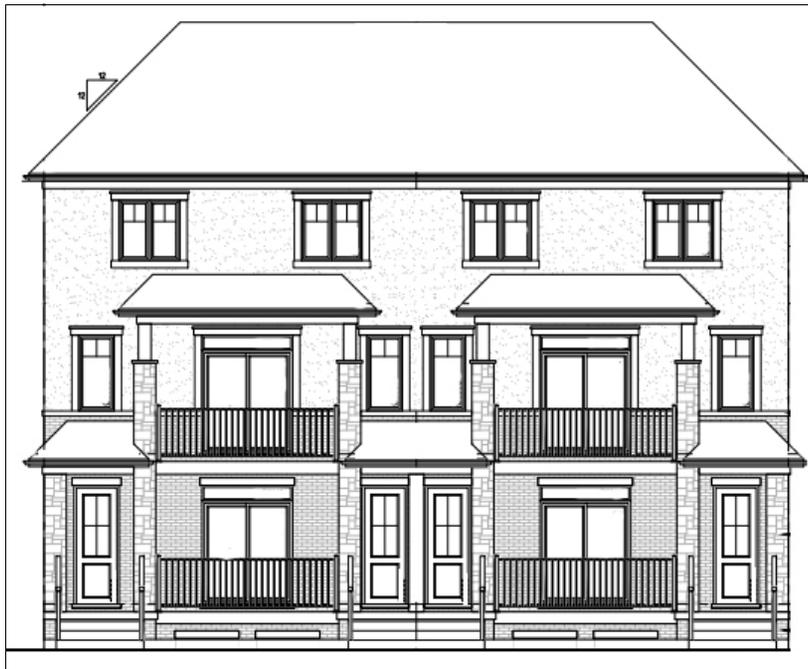
Figure 3 front elevation - Orchard Design, June 24, 2024

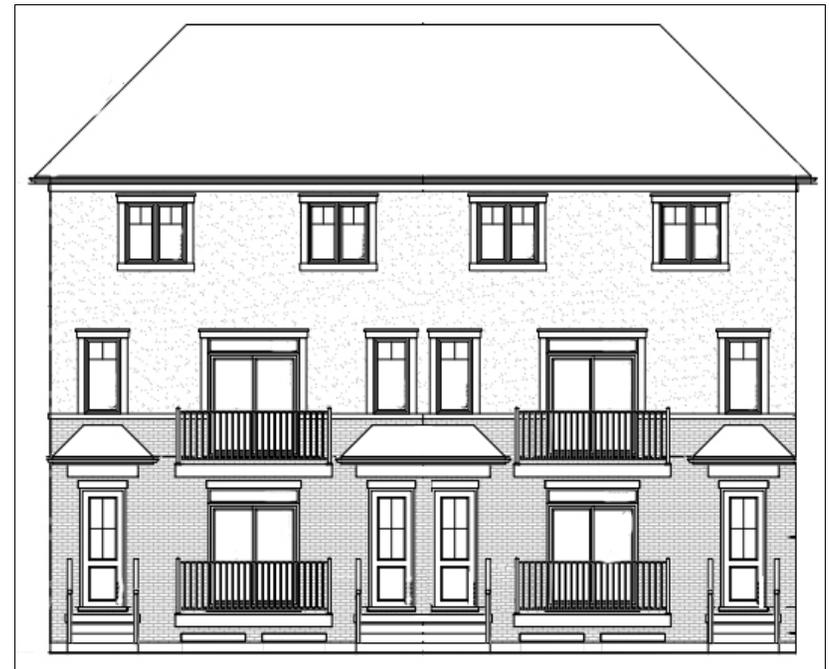
Figure 4 rear elevation - Orchard Design, June 24, 2024

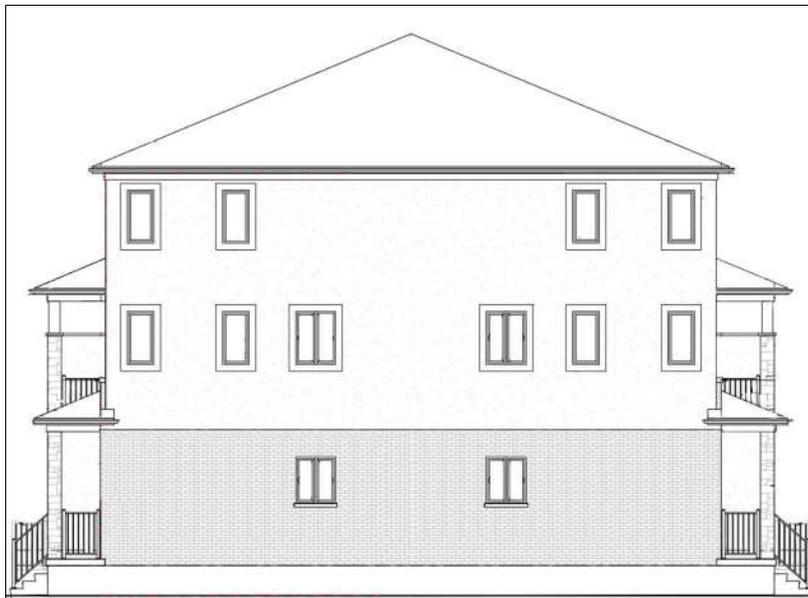
Figure 5 west side elevation - Orchard Design, August 20, 2024

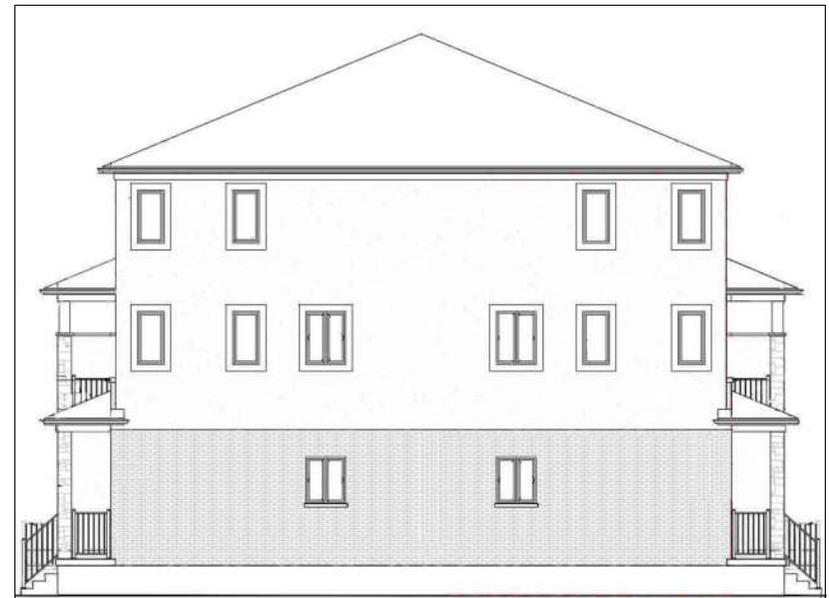
Figure 6 east side elevation - Orchard Design, August 20, 2024
