HERITAGE KITCHENER MEETING

Meeting Date: October 1st, 2024

4.1 Draft Heritage Impact Assessment 169-183 Victoria Street South / 59 Park Street

4.2 Heritage Permit Application HPA-2024-IV-023

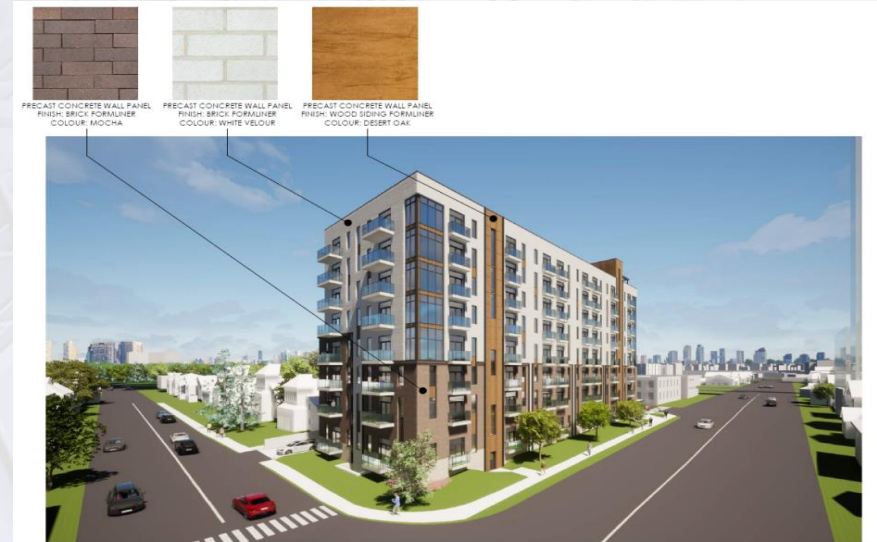
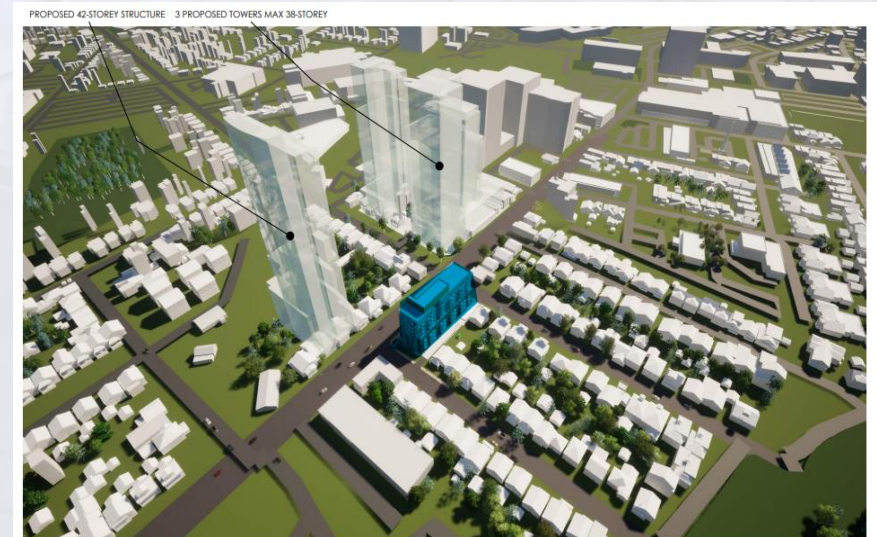
- Impacts to be reduced through building stepbacks/articulation, use of appropriate materials, landscape buffers
- Intended to create transition from high-rises proposed along Victoria St
- Construction controls, protection plan, monitoring plans to be implemented to avoid damages to adjacent heritage properties
- Salvage and reuse materials where feasible from the five buildings to be demolished along Victoria Street South

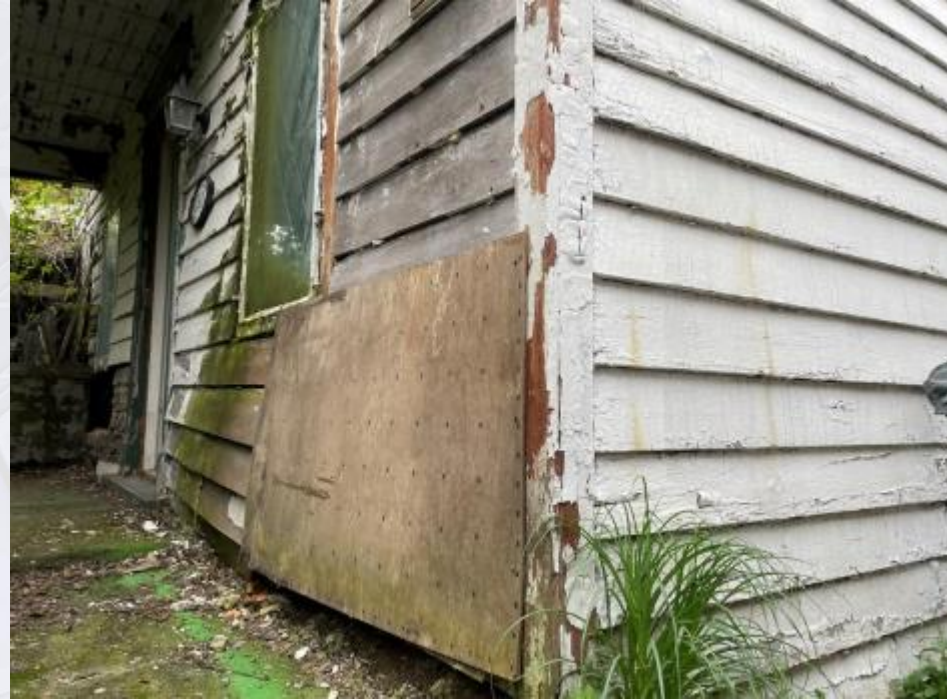
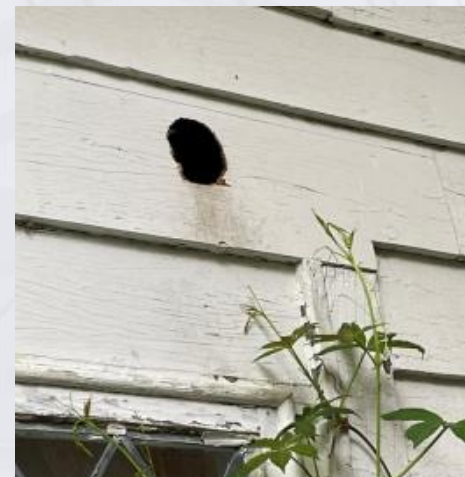
- Property Standards Order to Comply (June 2020)
 - Identified several deficiencies that required repair and/or replacement (e.g., cladding, soffits, fascia, windowsills)
 - Deadline for owner to complete the work lapsed
 - By-Law Enforcement initiated steps to bring the property into compliance
 - A structural assessment was required to inform the necessary exterior repairs

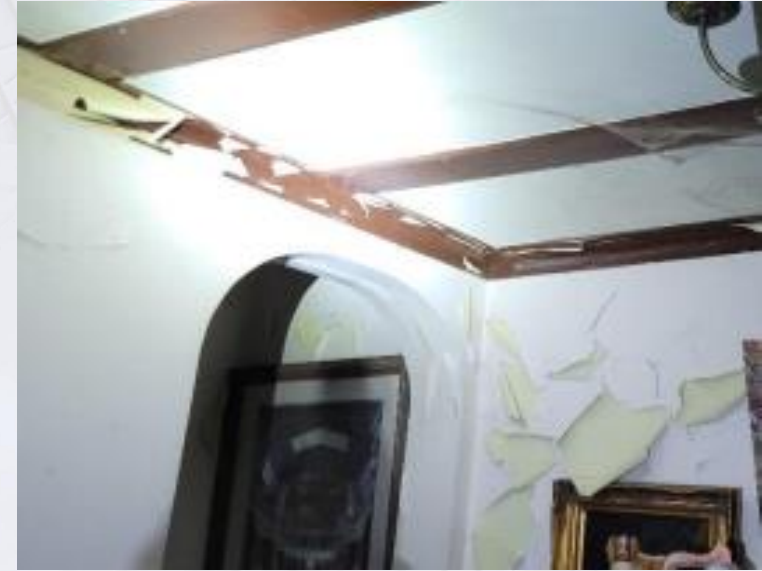
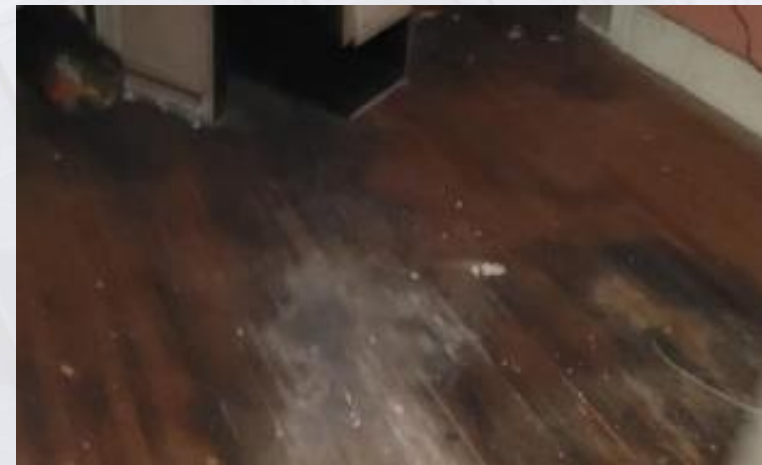
- Structural Condition Assessment prepared by Tacoma Engineers (2024)
 - The assessment identified interior issues including:
 - peeling paint,
 - high relative humidity,
 - mould,
 - roof and wall leaks,
 - buckled hardwood floors,
 - evidence of rodents,
 - fair condition of rubblestone foundation mortar,
 - fair condition of timber floor joists, and
 - potential compromised basement foundation.

- Structural Condition Assessment prepared by Tacoma Engineers (2024)
 - Recommended that the following interior items be repaired, reinforced and/or replaced:
 - roof structure;
 - all interior finishes;
 - deteriorated structural members;
 - framing; and,
 - basement foundation.
 - Interior work will also require mould abatement.

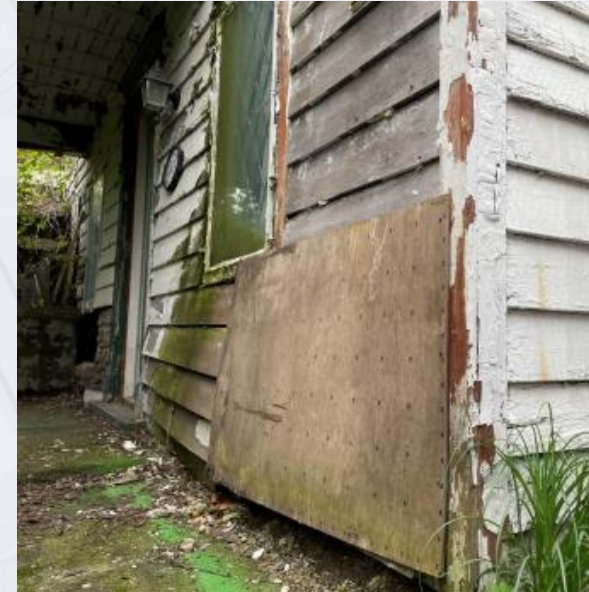
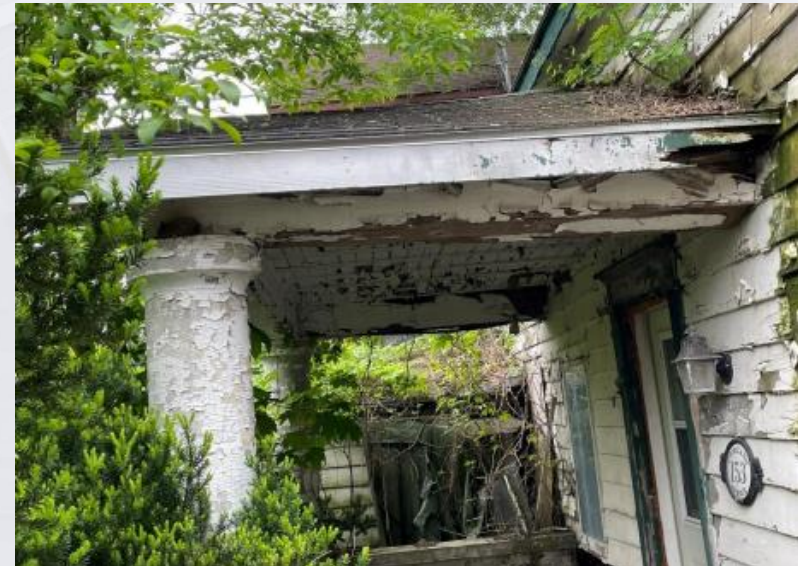
- Structural Condition Assessment prepared by Tacoma Engineers (2024)
 - Identified exterior issues including:
 - bowing/missing/deteriorated clapboard siding,
 - deteriorated wall studs,
 - deteriorated porch beams posing a life safety hazard,
 - missing fascia,
 - hole in roof, and
 - no eavestroughs or downspouts.

- Structural Condition Assessment prepared by Tacoma Engineers (2024)
 - Recommended that the following exterior items be repaired, reinforced, replaced and/or added:
 - roof;
 - fascia;
 - front porch;
 - clapboard siding;
 - wall studs;
 - front wall;
 - rear wall; and,
 - eavestroughs and downspouts.

- Structural Condition Assessment prepared by Tacoma Engineers (2024)
 - The life safety concerns with the front porch have been temporarily addressed with the installation of security fencing.
 - With respect to the front and rear wall, the assessment concluded that reframing of large sections of these walls is required.
