# HERITAGE KITCHENER MEETING

Meeting Date: October 1<sup>st</sup>, 2024

# Agenda

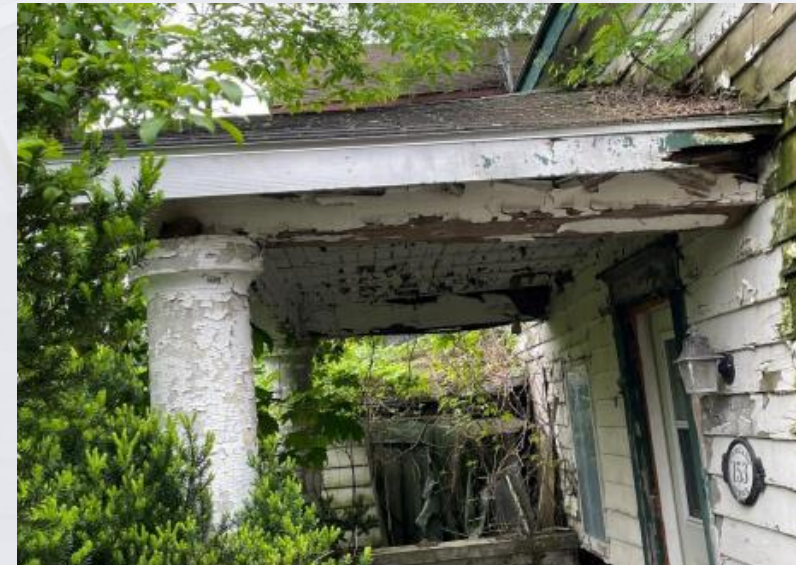
- Structural Condition Assessment prepared by Tacoma Engineers (2024)
  - Identified exterior issues including:
    - bowing/missing/deteriorated clapboard siding,
    - deteriorated wall studs,
    - deteriorated porch beams posing a life safety hazard,
    - missing fascia,
    - hole in roof, and
    - no eavestroughs or downspouts.

- Structural Condition Assessment prepared by Tacoma Engineers (2024)
  - Recommended that the following exterior items be repaired, reinforced, replaced and/or added:
    - roof;
    - fascia;
    - front porch;
    - clapboard siding;
    - wall studs;
    - front wall;
    - rear wall; and,
    - eavestroughs and downspouts.

- Structural Condition Assessment prepared by Tacoma Engineers (2024)
  - The life safety concerns with the front porch have been temporarily addressed with the installation of security fencing.
  - With respect to the front and rear wall, the assessment concluded that reframing of large sections of these walls is required.
