HERITAGE KITCHENER MEETING

Meeting Date: October 1st, 2024

4.1 Draft Heritage Impact Assessment 169-183 Victoria Street South / 59 Park Street

4.2 Heritage Permit Application HPA-2024-IV-023

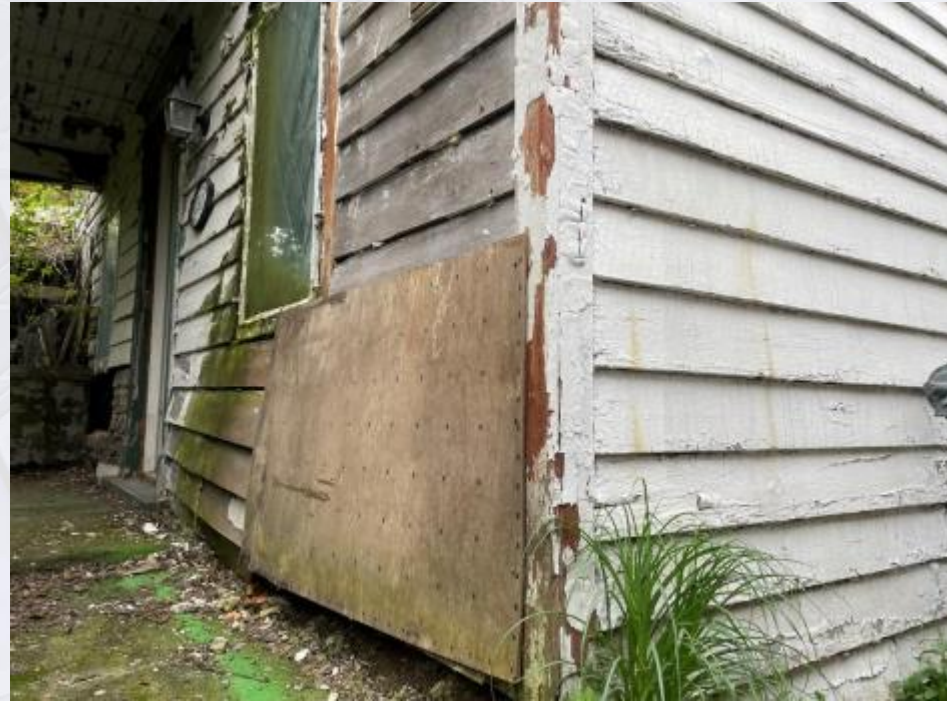
- Property Standards Order to Comply (June 2020)
 - Identified several deficiencies that required repair and/or replacement (e.g., cladding, soffits, fascia, windowsills)
 - Deadline for owner to complete the work lapsed
 - By-Law Enforcement initiated steps to bring the property into compliance
 - A structural assessment was required to inform the necessary exterior repairs

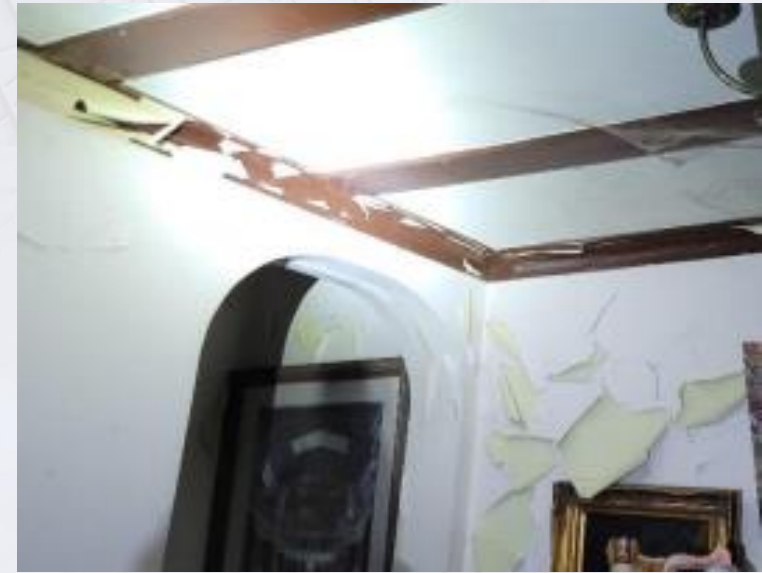
- Structural Condition Assessment prepared by Tacoma Engineers (2024)
 - The assessment identified interior issues including:
 - peeling paint,
 - high relative humidity,
 - mould,
 - roof and wall leaks,
 - buckled hardwood floors,
 - evidence of rodents,
 - fair condition of rubblestone foundation mortar,
 - fair condition of timber floor joists, and
 - potential compromised basement foundation.

- Structural Condition Assessment prepared by Tacoma Engineers (2024)
 - Recommended that the following interior items be repaired, reinforced and/or replaced:
 - roof structure;
 - all interior finishes;
 - deteriorated structural members;
 - framing; and,
 - basement foundation.
 - Interior work will also require mould abatement.

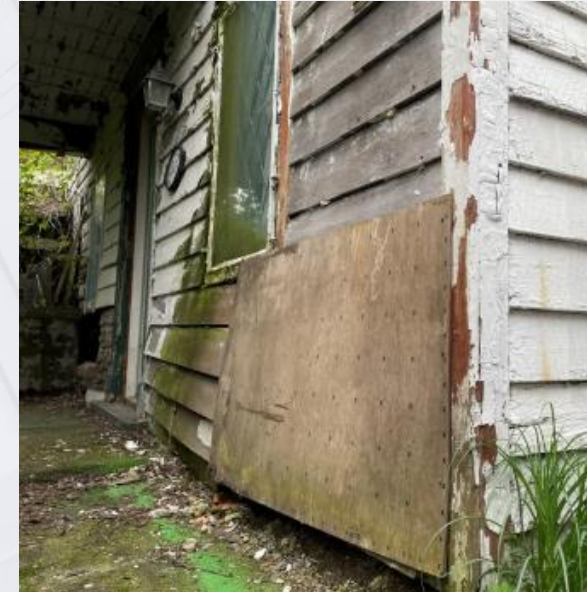
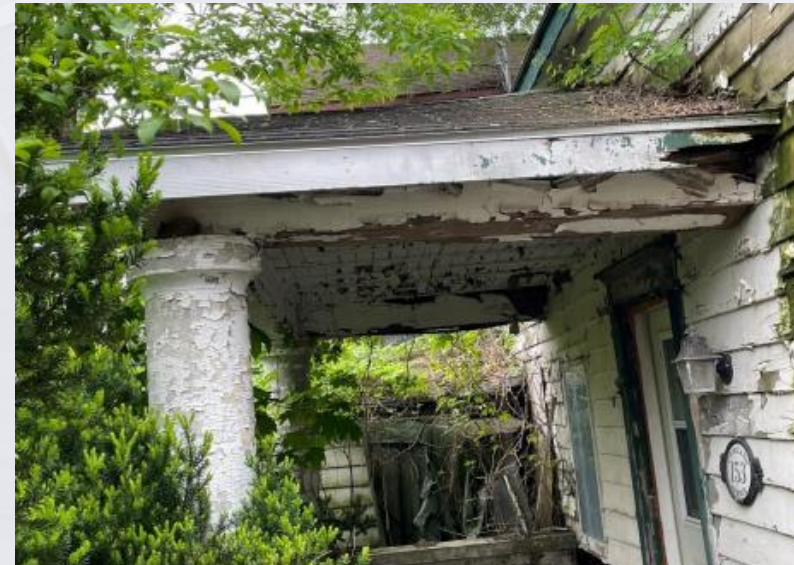
- Structural Condition Assessment prepared by Tacoma Engineers (2024)
 - Identified exterior issues including:
 - bowing/missing/deteriorated clapboard siding,
 - deteriorated wall studs,
 - deteriorated porch beams posing a life safety hazard,
 - missing fascia,
 - hole in roof, and
 - no eavestroughs or downspouts.

- Structural Condition Assessment prepared by Tacoma Engineers (2024)
 - Recommended that the following exterior items be repaired, reinforced, replaced and/or added:
 - roof;
 - fascia;
 - front porch;
 - clapboard siding;
 - wall studs;
 - front wall;
 - rear wall; and,
 - eavestroughs and downspouts.

- Structural Condition Assessment prepared by Tacoma Engineers (2024)
 - The life safety concerns with the front porch have been temporarily addressed with the installation of security fencing.
 - With respect to the front and rear wall, the assessment concluded that reframing of large sections of these walls is required.
