STATEMENT OF SIGNIFICANCE

83 Benton Street

CULTURAL HERITAGE EVALUATION FORM

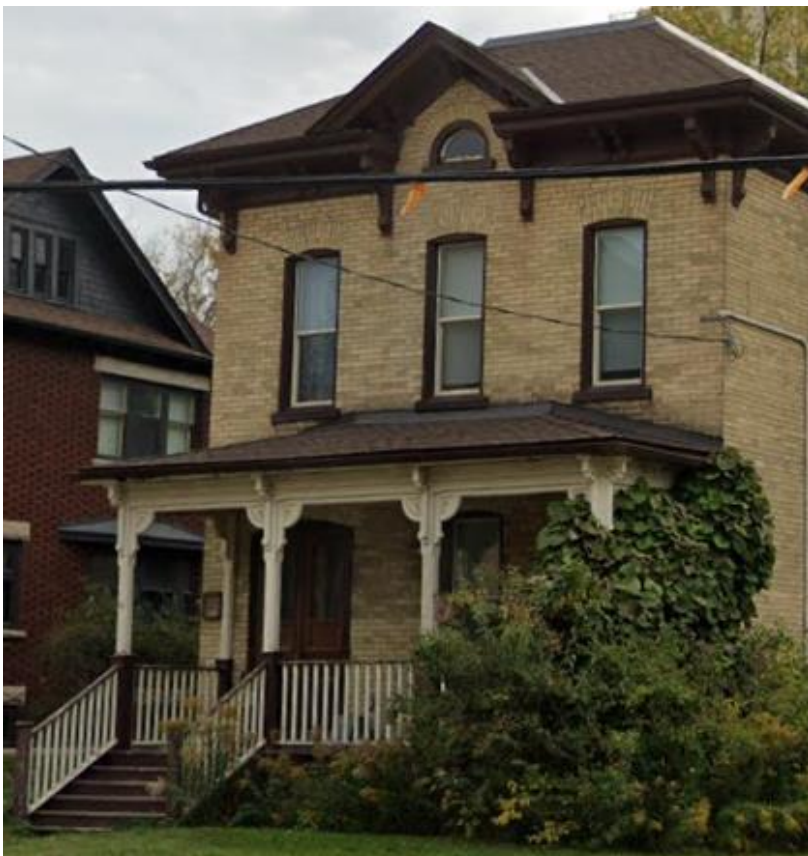
Front Elevation (North Façade) – 83 Benton Street

The front façade of the building is three bays wide and faces Benton Street.

The prominent centre bay features buff (yellow) brick construction; a low-pitched hipped roof with the remnants of a cupola or tower; a front-facing centred gable containing a lunette window with brick surround and wood sill; wide overhanging eaves supported by large (not paired) decorative brackets and small (paired) decorative modillions; fascia, soffit and frieze board; segmentally arched window openings with brick voussoirs and wood sills; full-width hipped roof one-storey verandah with square beveled corner posts and decorative woodwork; and, a double entrance segmentally arched wood door with lower panels and upper lites.

The two end bays are setback approximately 16 feet from the centre bay, are about 6 feet wide, and the ridge of their cross-hipped roofline aligns with the rear of the main hip roof. These bays feature buff (yellow) brick construction; a low-pitched cross-hipped roof; wide overhanging eaves supported by large (not paired) brackets; fascia, soffit and frieze board; rubble stone foundation and, the eastern bay displays segmentally arched false window openings with brick voussoirs and wood sills while the western bay displays segmentally arched window openings with brick voussoirs and wood sills.

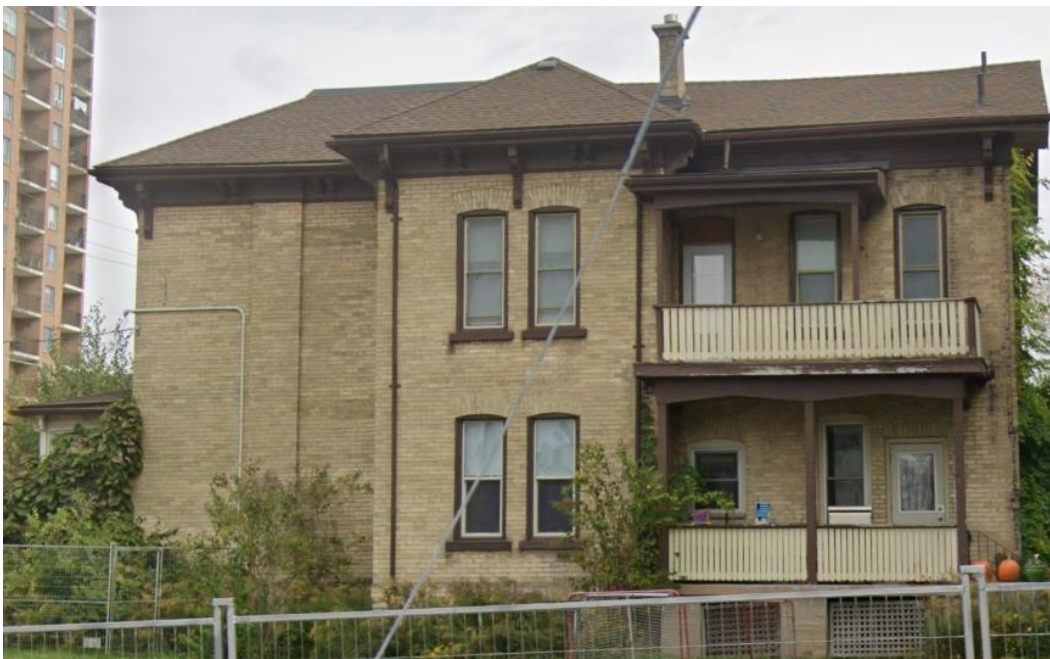
Side Elevation (West Façade) – 83 Benton Street

The side façade of the original building is three bays wide. The bay closest to Benton Street features buff (yellow) brick construction; a low-pitched hipped roof with the remnants of a cupola or tower; wide overhanging eaves supported by large (not paired) decorative brackets and small (paired) decorative modillions; fascia, soffit and frieze board; evidence of an original chimney; and, rubble stone foundation. The middle bay features buff (yellow) brick construction; a low-pitched cross-hipped roof; wide overhanging eaves supported by large (not paired) decorative brackets and small (paired) decorative modillions; fascia, soffit and frieze board; paired segmentally arched window openings with brick voussoirs and wood sills on both the first- and second-storey; and, rubble stone foundation. The end bay is visible from St. George Street and features: buff (yellow) brick construction; gable roofline; wide overhanging eaves supported by large (not paired) decorative brackets and small (paired) decorative modillions; fascia, soffit and frieze board; segmentally arched window openings with brick voussoirs and wood sills on both the first- and second-storey; a door opening on both the first- and second-storey; and, rubble stone foundation. This façade also features a non-original two-storey verandah.
