STATEMENT OF SIGNIFICANCE

51 Breithaupt Street

CULTURAL HERITAGE EVALUATION FORM

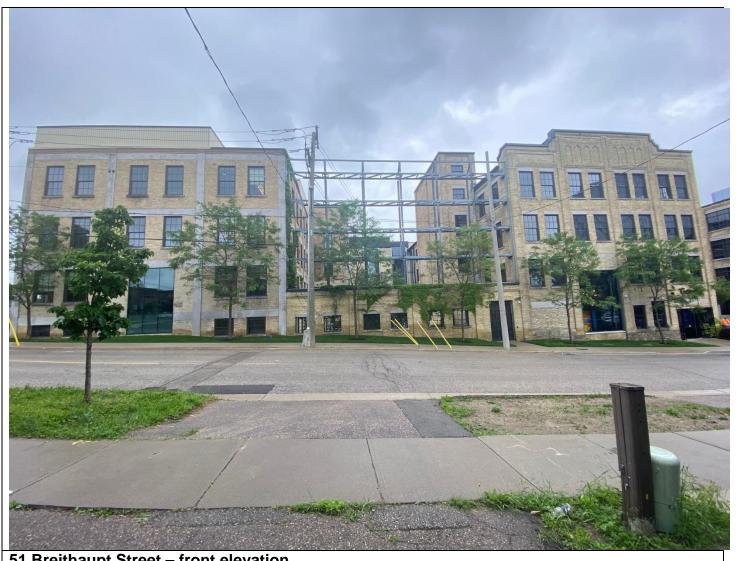
51 Breithaupt Street – front elevation

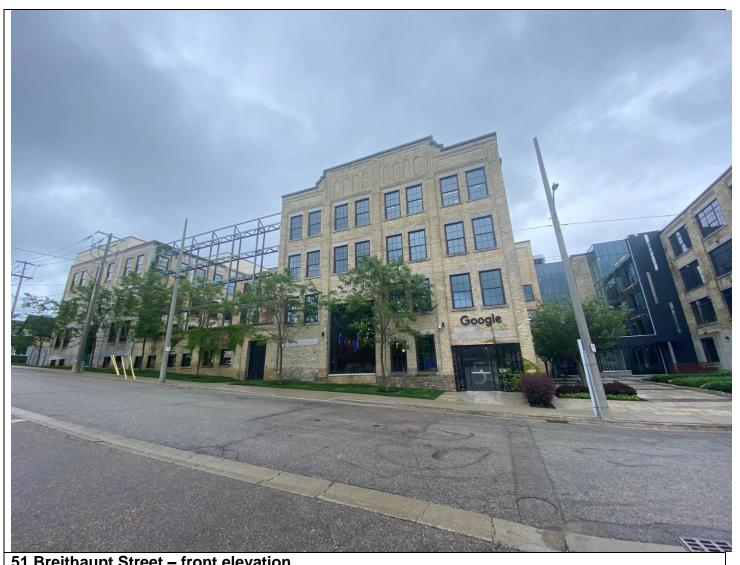
The building at the corner of Breithaupt Street and Waterloo Street (Fig. 3) was built in 1908 in the Industrial Vernacular architectural style. It is three storeys in height, with a flat roof and is of buff white brick construction. There are concrete pilasters dividing the front façade into 3 bays and the side façade into 9 bays. Each bay contains two 6 over 6 double hung windows with concrete sills on each storey, except for the central bay on the main storey of this building. The windows on the third storey have brick lintels.

51 Breithaupt Street - front elevation

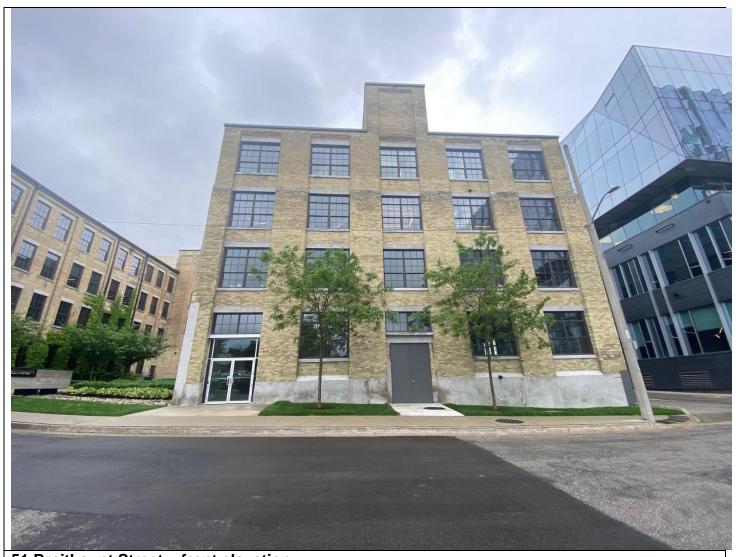
The last building of the original complex was built in 1918, and is four (4) storeys in height (Fig 4). This building has a flat roof with a central tower which has decorative brick moulding. This building also has brick pilasters which divide the front façade in two five (5) bays. Each bay of the upper three storey has a double 6 over 6 hund window with concrete lintels. Above the concrete lintels of each fifth storey window is decorative brick detailing. The building has two door openings on this façade, one in the centre, and one on the corner.

51 Breithaupt Street - front elevation
