STATEMENT OF SIGNIFICANCE

69 AGNES STREET

Description of Cultural Heritage Resource

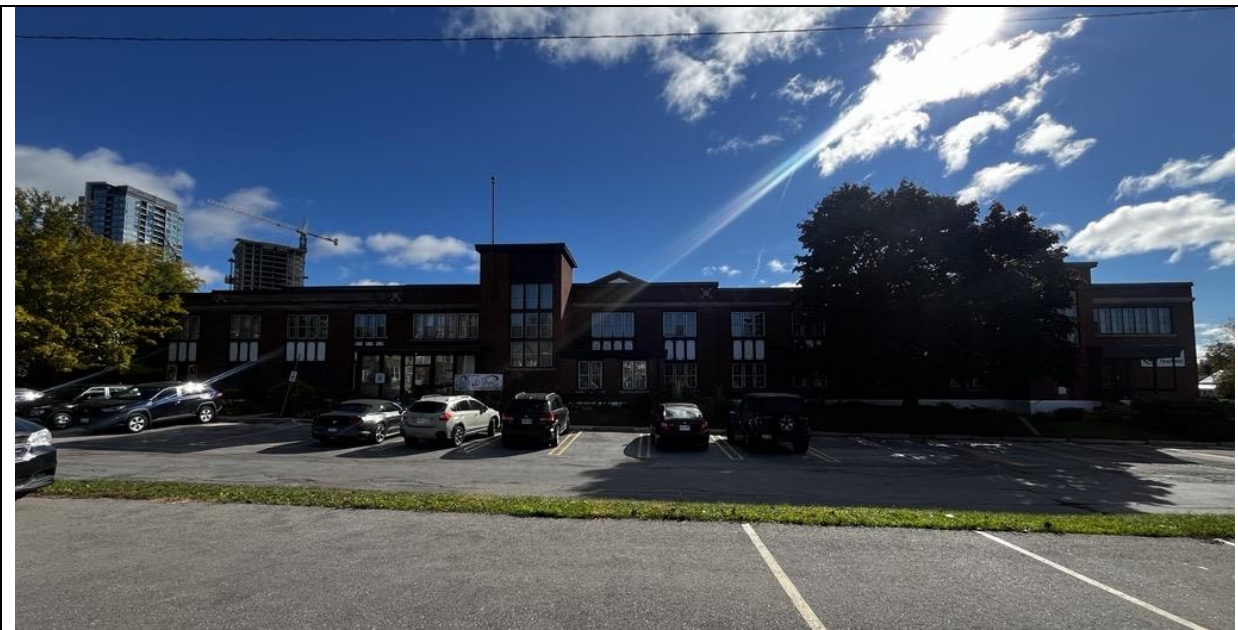
Front Façade of Subject Building

The front façade of the building is asymmetrical in its design and massing, though many of the architectural features make use of symmetry and repetition. There are two projecting towers which vertically divide the building into three major sections; the first section is north of the first tower, the central section is between the two towers, and the third section is to the south of the second tower.

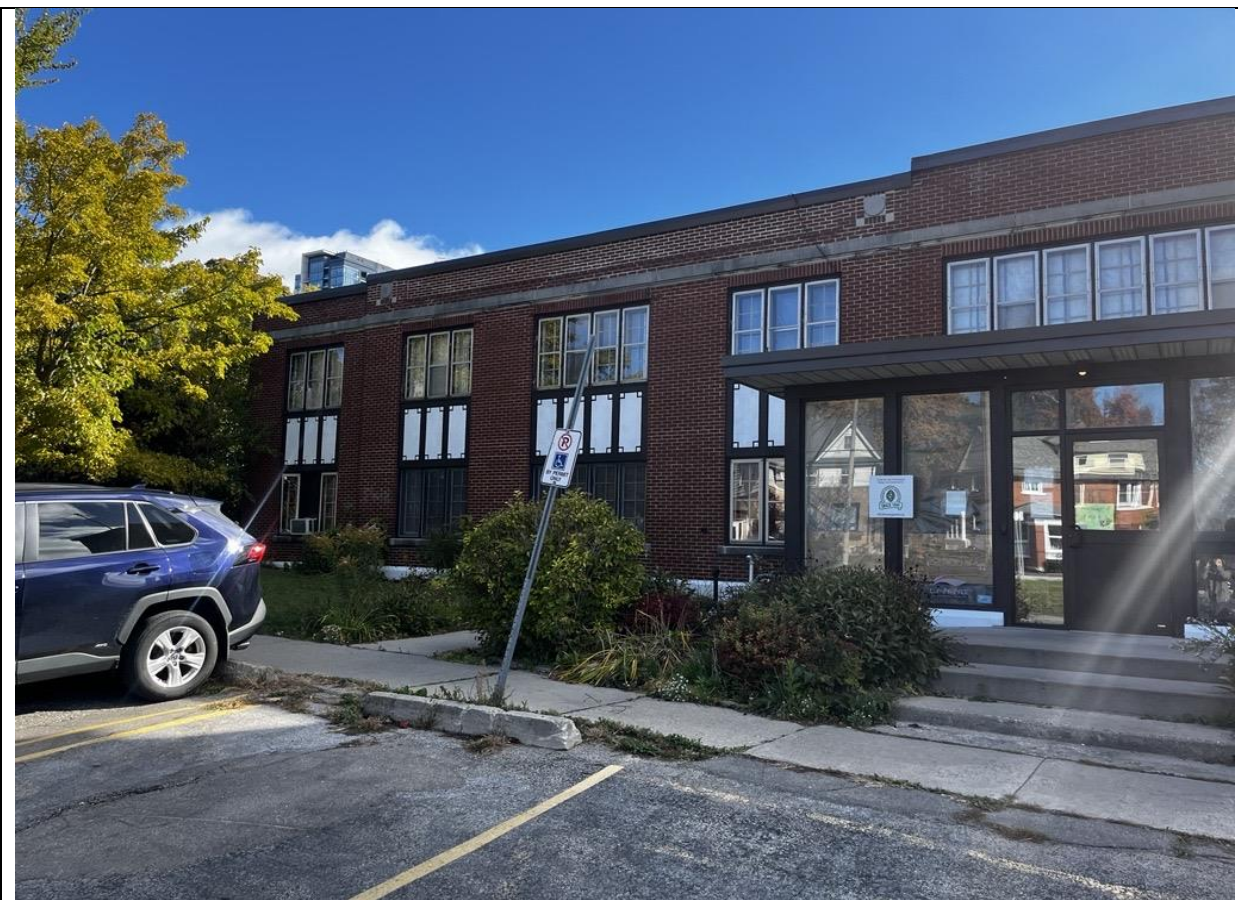
Northern End Section (Front Façade)

The northern end section can be further divided vertically into five parts. The first four are comprised 4/4 and 1/1 windows arranged into groups of three or four, with the ground floor windows having concrete sills and being separated from the second-storey windows by decorative panels above. There is a parapet with two concrete motifs and concrete banding, and the roofline is flat and staggered. A one-storey glass vestibule projects out from the northern end sections and abuts the first tower. Above the glass vestibule there is a group of seven windows with a concrete sill.

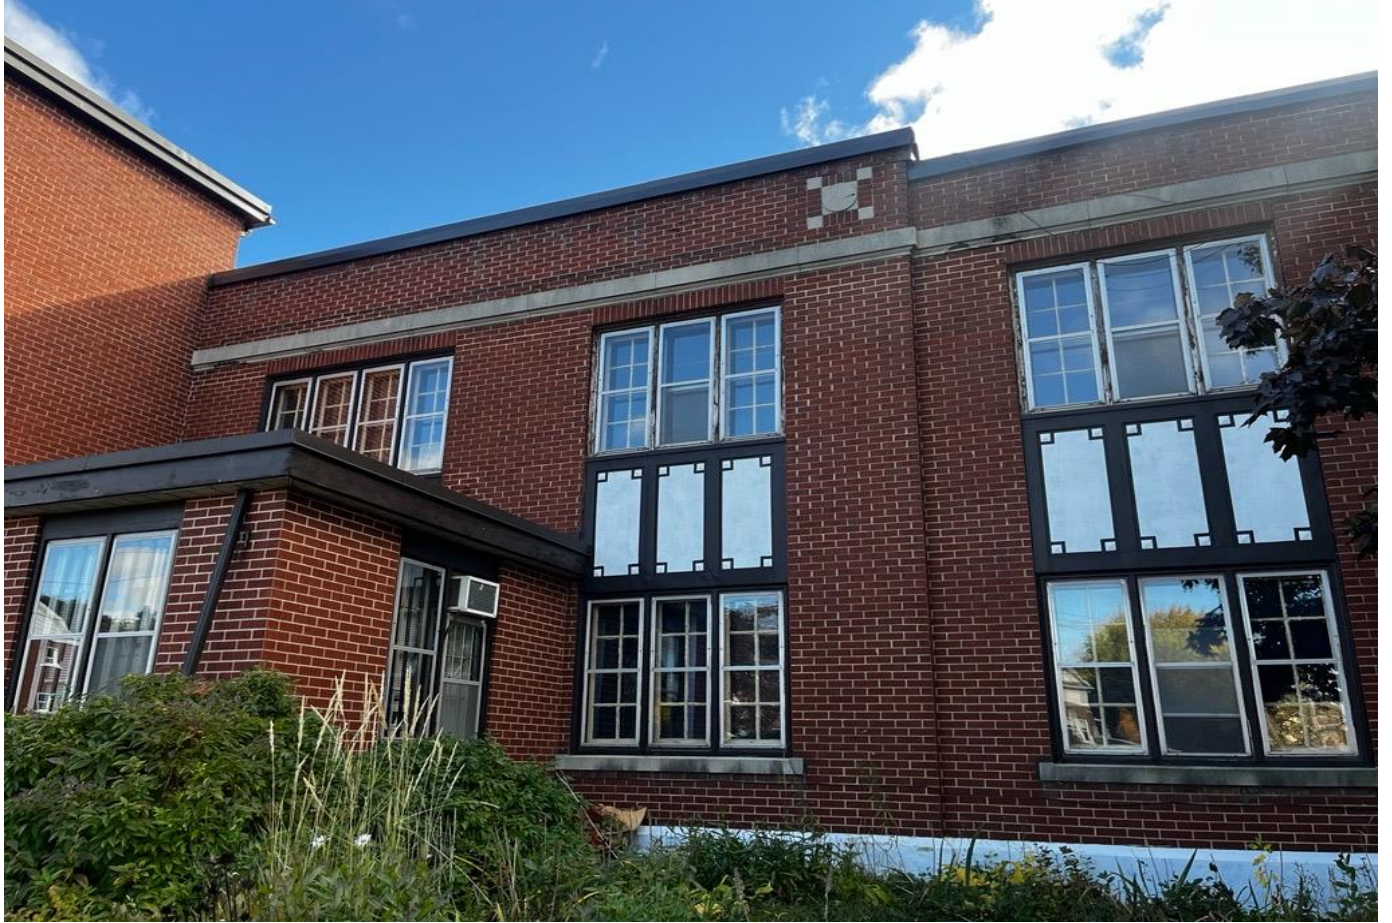
Close-up of Architectural Detailing on Central Section Including Concrete Motifs and Decorative Panels

The central recessed section can be vertically divided into six parts, five of which are comprised of groups of 3 4/4 and 1/1 windows. As with the northern end section, the ground floor windows have concrete sills and there are decorative panels underneath the second-floor windows. The parapet in this section possesses the same concrete banding and one concrete motif, and the roofline again has some variation in its height. There is a one-storey brick addition that abuts the first tower, and it contains two groups of two 1/1 windows with concrete sills on the front and one group of two 1/1 windows on the side.

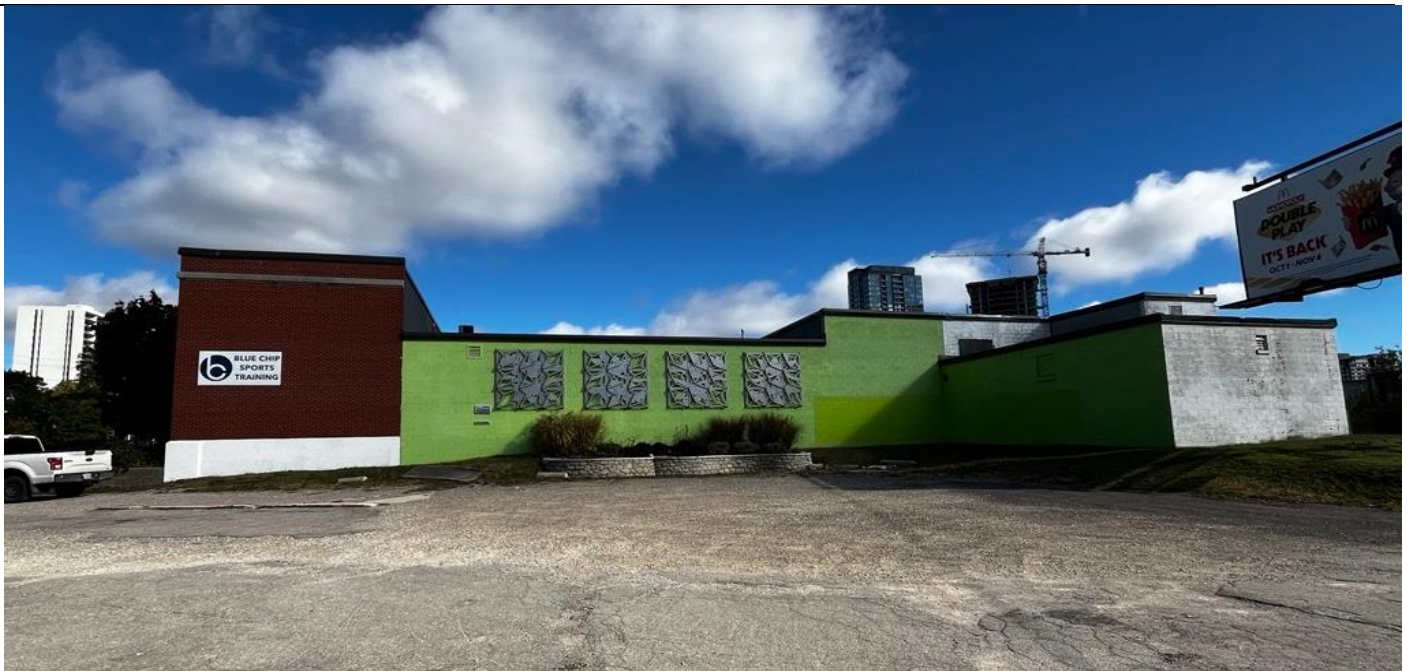
South-Side Façade (1927 Portion and new addition)

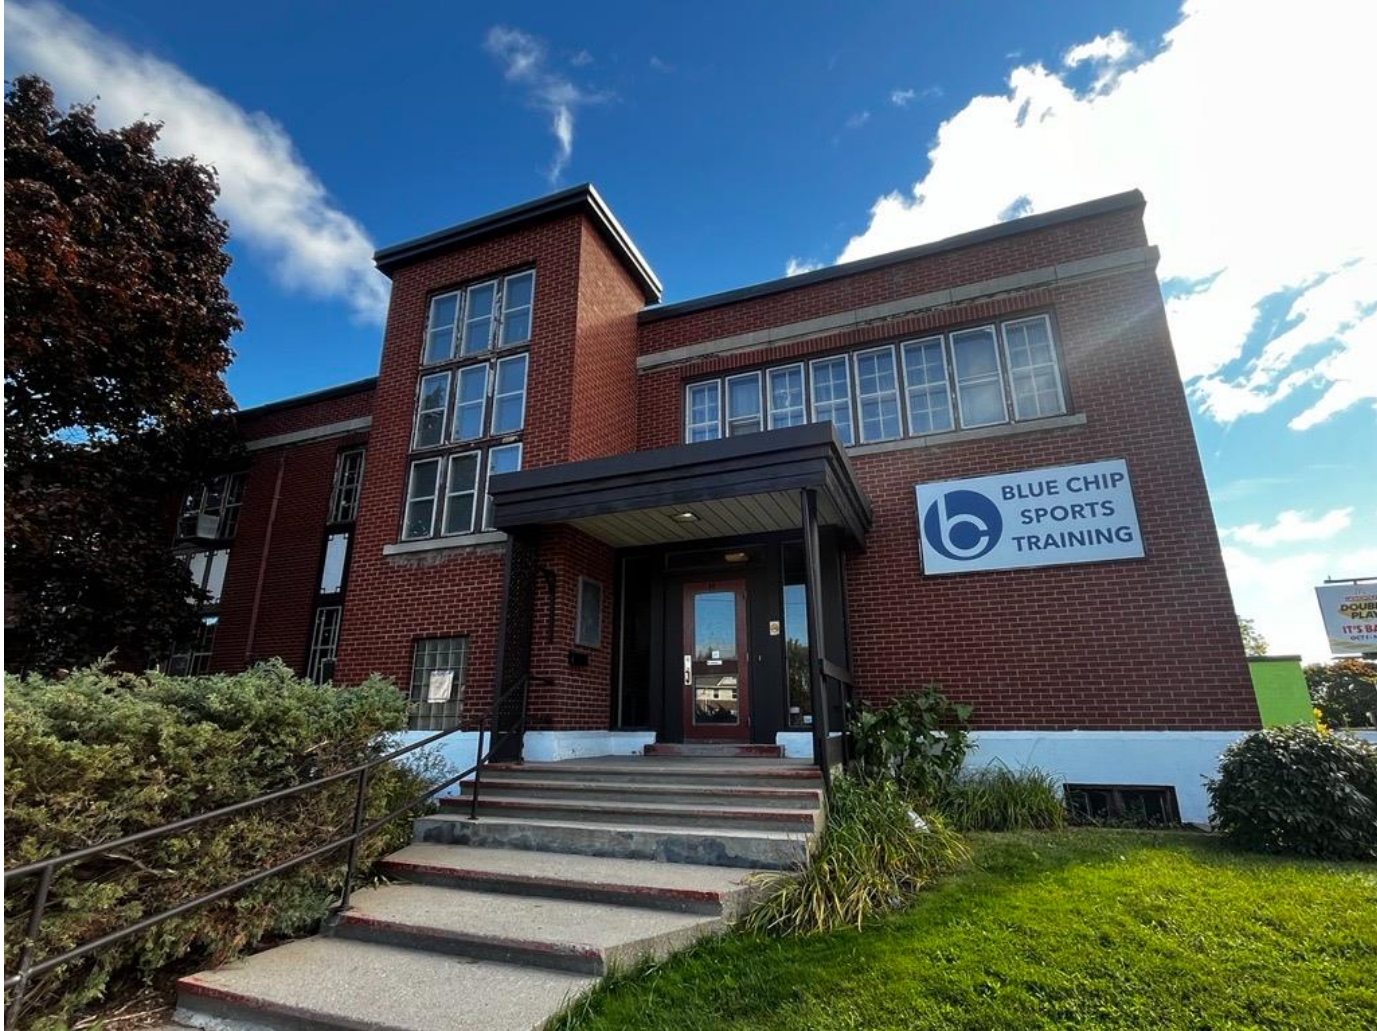
Second Tower and Southern End Section (Front Façade)

The second tower is similar in appearance to the first, possessing the same grouping of three-by-three 1/1 windows with the bottom row having a concrete sill. The second tower lacks the vertical cladding that can be found in the first tower, and contains one window of glass blocks on the ground floor.

The southern end section of the 1927 portion of the building contains a covered entranceway with a flat roof on the ground floor, and a single group of eight windows with concrete sill on the second. The parapet contains the concrete banding but no additional motifs.
