HERITAGE IMPACT ASSESSMENT REPORT

Wallaceton (Stage 6 Lands)
Haldimand Street & Broadacre Drive,
City of Kitchener

November 2024

**MacNaughton Hermsen Britton Clarkson Plan-
ning Limited (MHBC)**

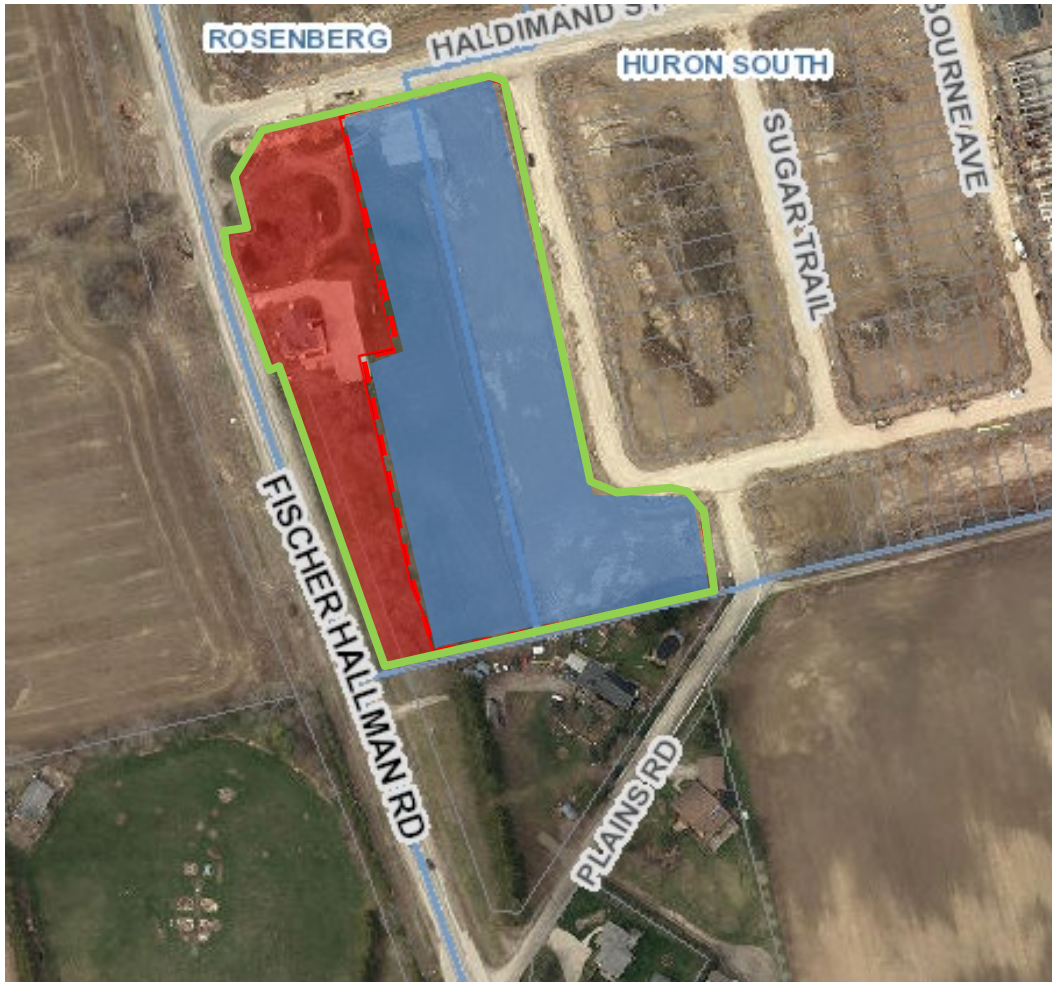
Figure 1: Aerial photo noting the location of the subject property. The Stage 6 lands proposed for development are indicated in blue and the Stage 8 lands (which contain the dwelling at 1940 Fischer-Hallman Road) are indicated in red. (MHBC, 2024)

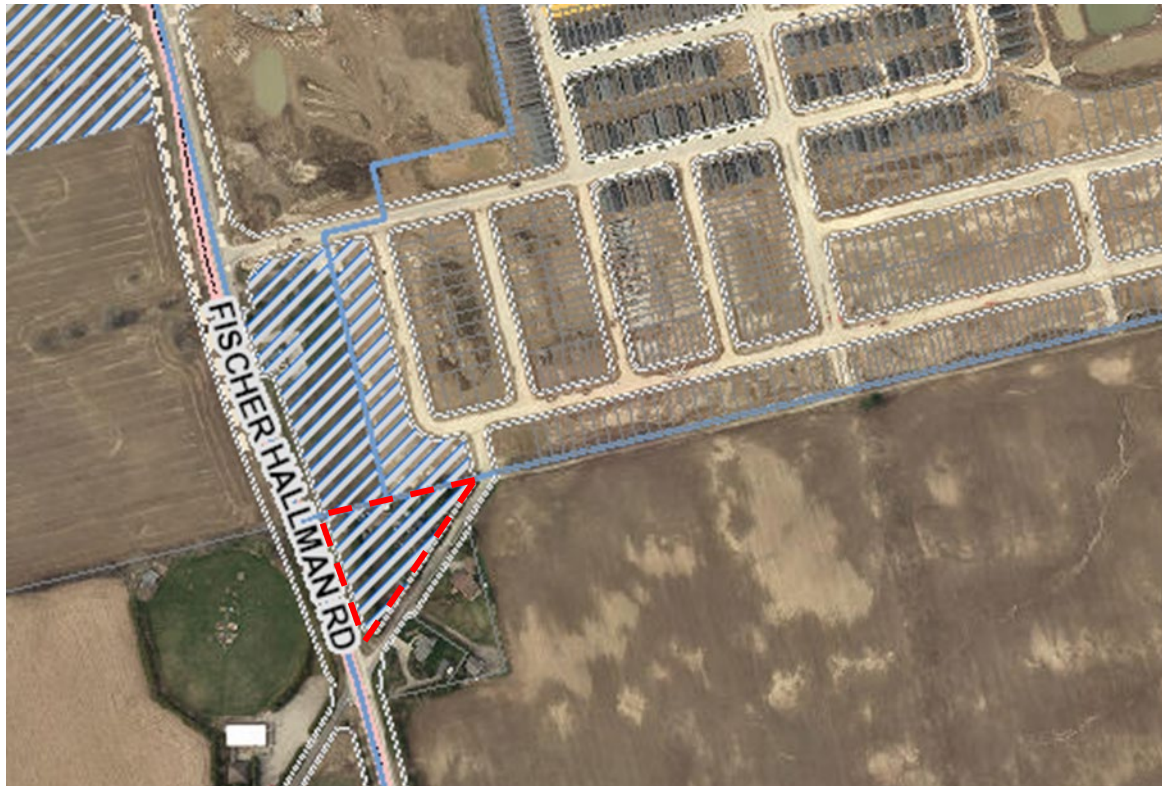
Figure 5: Excerpt of the City of Kitchener Interactive Map showing the listed status of the adjacent property at 1970 Fischer-Hallman Road, which is noted with a red dashed line. (Source: City of Kitchener Interactive Map, 2024)

The Stage 6 lands are located adjacent (contiguous) to the property at 1970 Fischer-Hallman Road, which is listed (non-designated) on the City of Kitchener Heritage Register (see **Figure 5**).

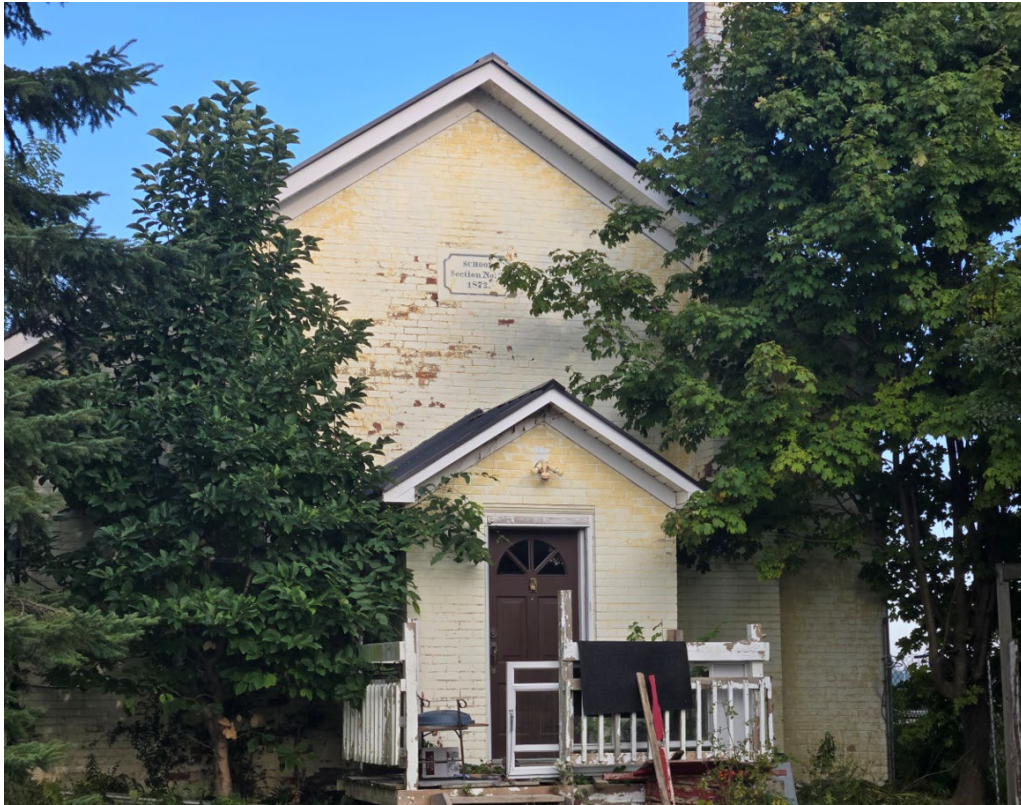
Figure 7: View of the structure on the listed property located at 1970 Fischer-Hallman Road. (MHBC, 2024)

The architectural features of the former schoolhouse include a symmetrical one-storey brick construction with a gable roof and a gable vestibule at the south elevation. There is a brick chimney on the southeastern corner of the structure. The building includes a number of later rear additions to the north.

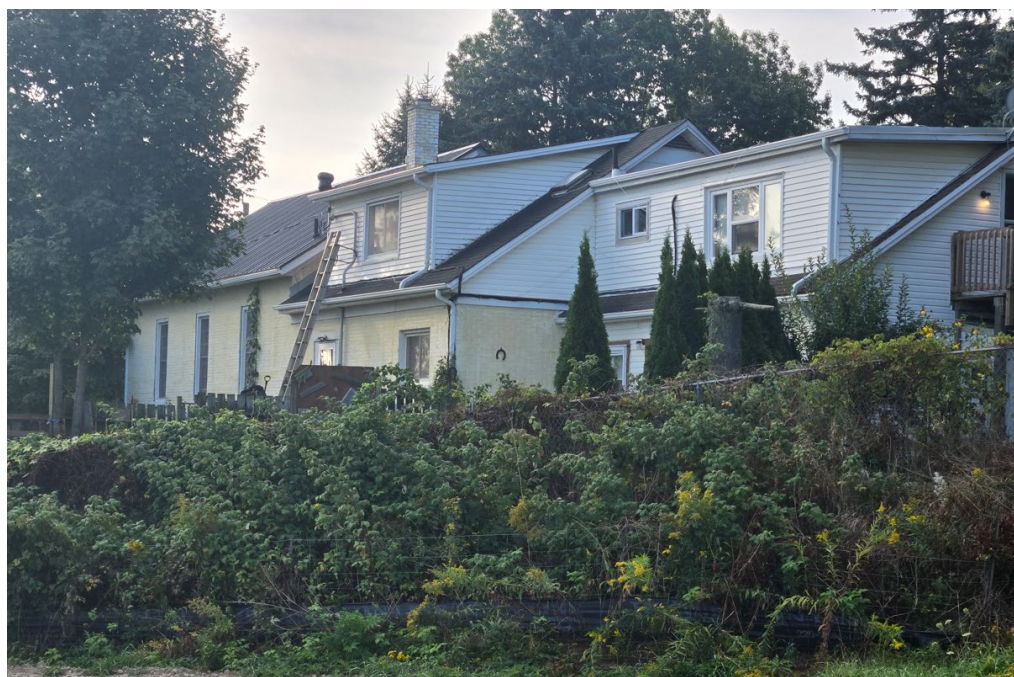
Figure 8: View of the rear of the rear of the listed property located at 1970 Fischer-Hallman Road as seen from the Stage 6 lands. (MHBC, 2024)

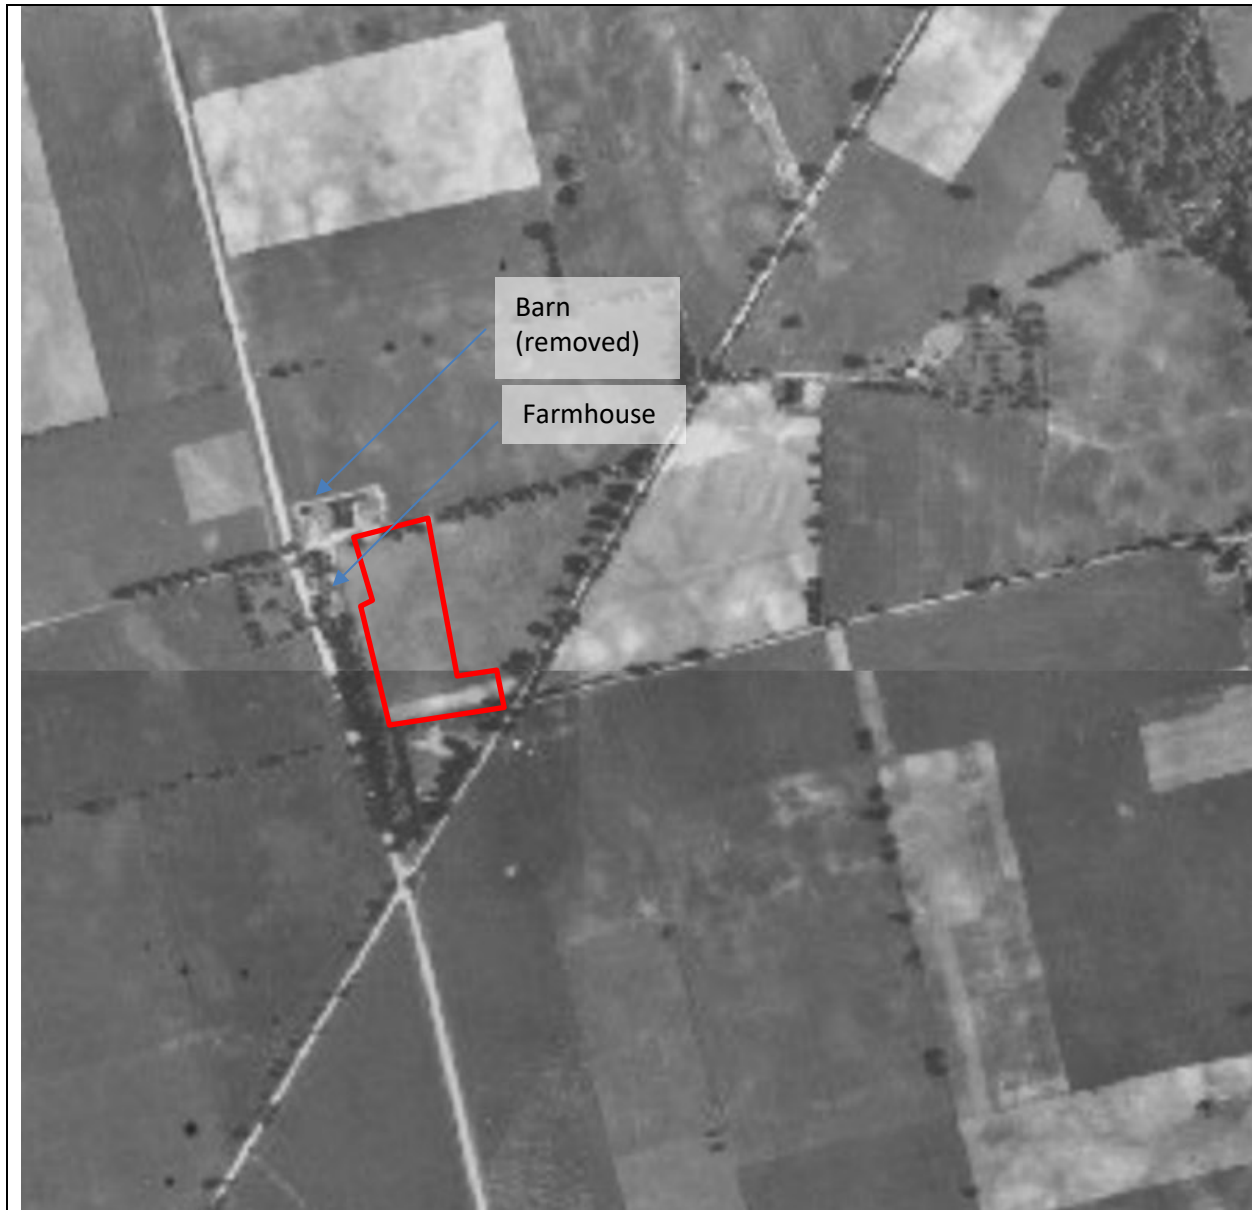
Figure 12: Excerpt of the 1946/1947 aerial photo noting the approximate location of the Stage 6 lands in red (Source: University of Waterloo)

According to the 1946 aerial photograph, the surrounding context was rural and agricultural (see **Figure 12**). While the photo is not clear, the barn and farm complex on the Stage 8 lands can be seen at this time, as well as tree rows along Fischer Hallman Road, Plains Road, and the northern edge of the property. The Stage 6 lands contained farm fields.

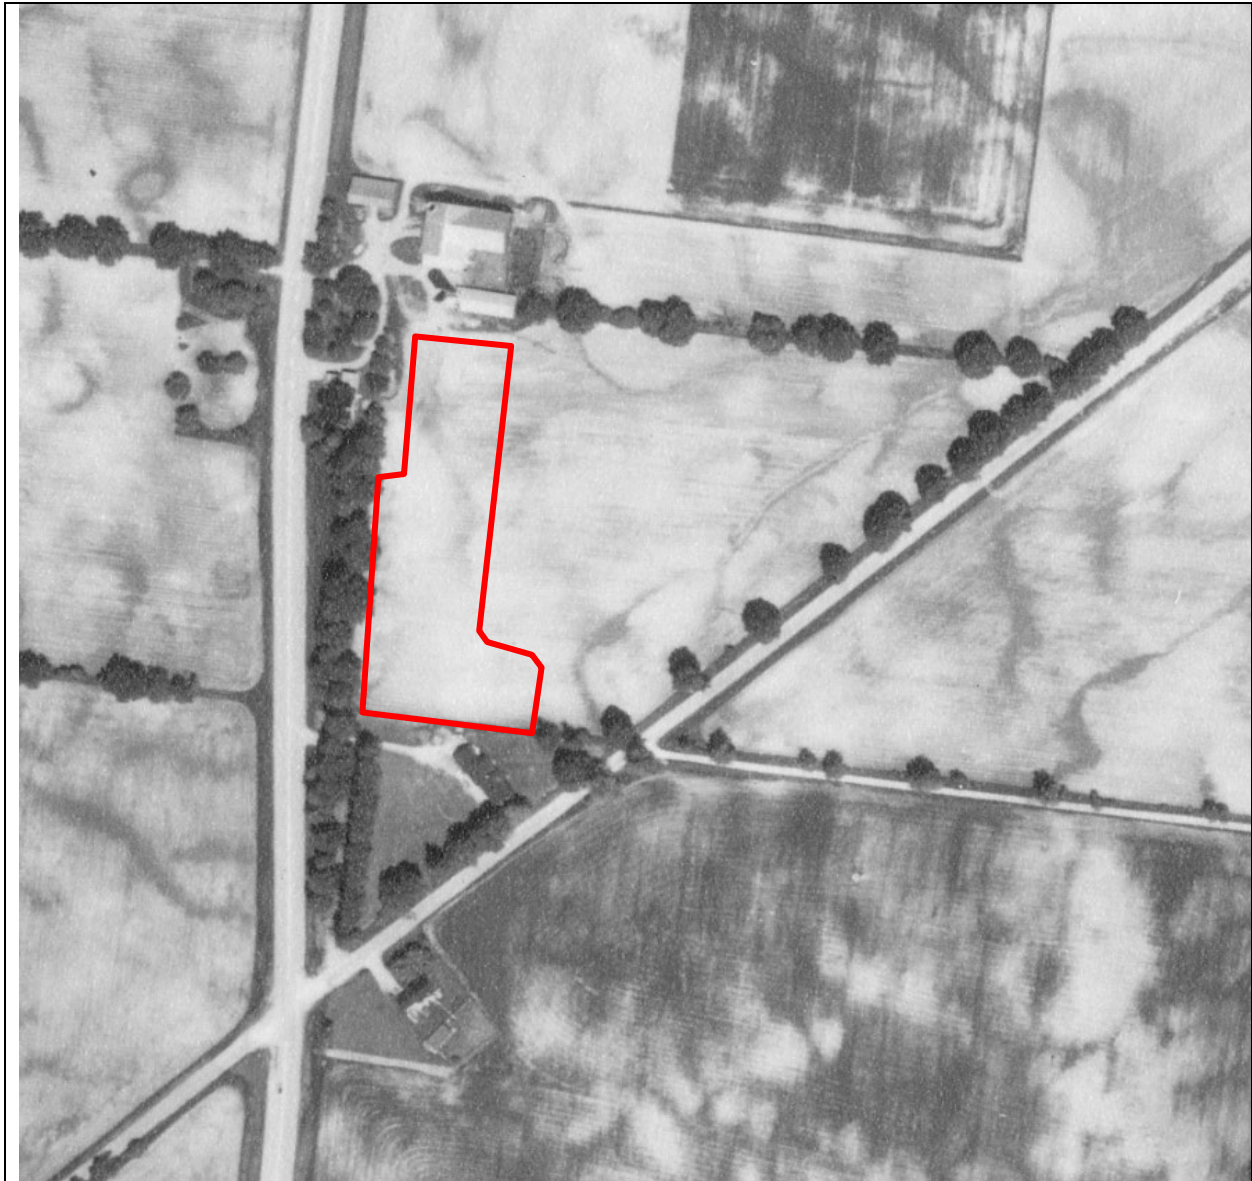
Figure 15: Excerpt of the 1971 aerial photo noting the approximate location of the Stage 6 lands in red. (Source: Canadian National Air Photo Library)

According to the 1971 aerial photograph below, the Stage 6 lands and surrounding area remained largely unchanged at this time (see **Figure 14**).

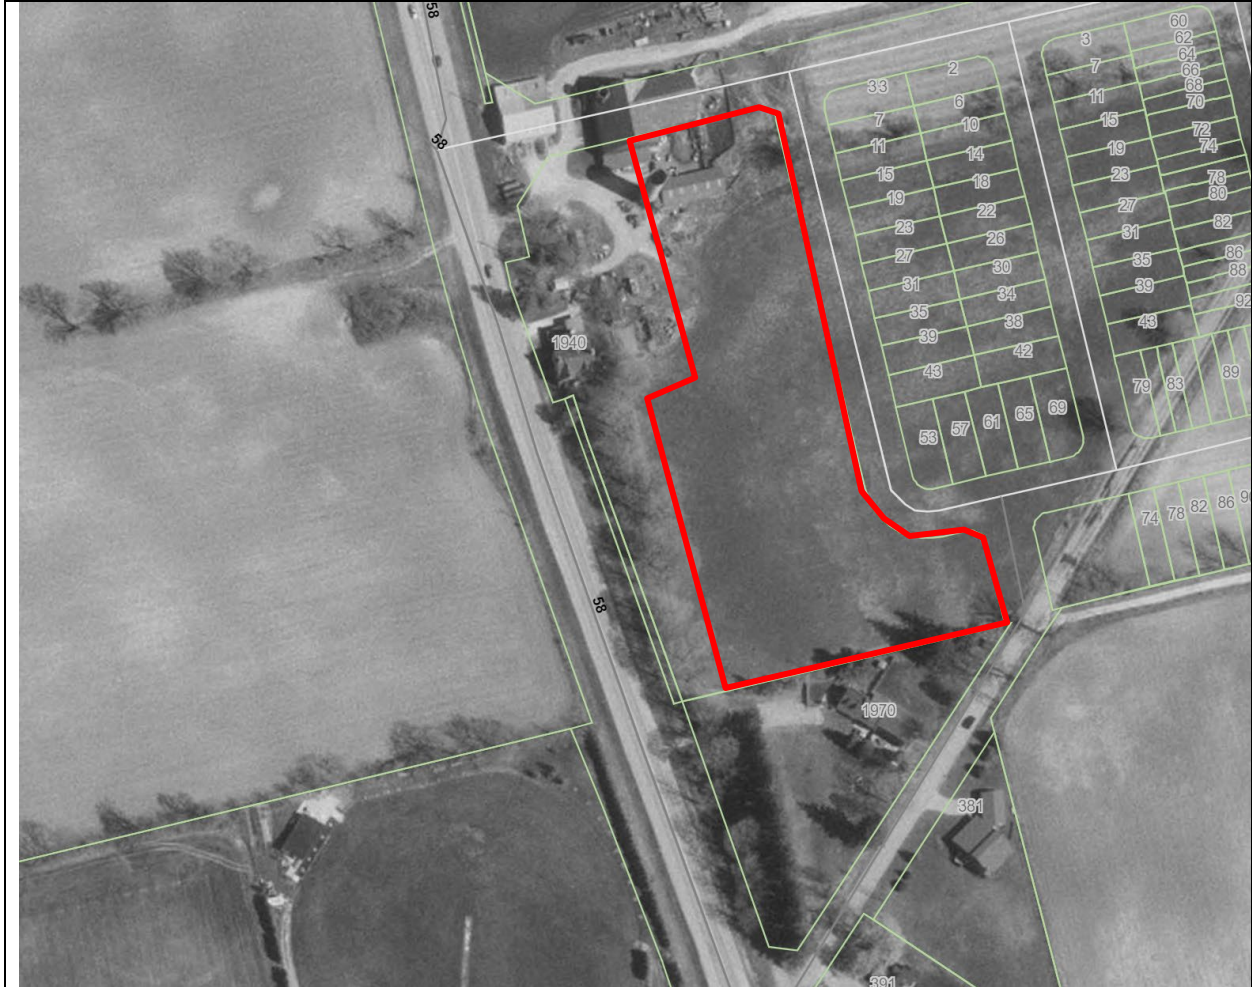
Figure 16: Excerpt of the 2000 aerial photo noting the location of the Stage 6 lands in red (Source: Region of Waterloo Interactive Map)

According to the 2000 aerial photograph below, some mature trees appear to have been removed from the Stage 8 lands, and additional structures have been constructed across Plains Road as well as across Fischer-Hallman Road to the southwest (see **Figure 16**).

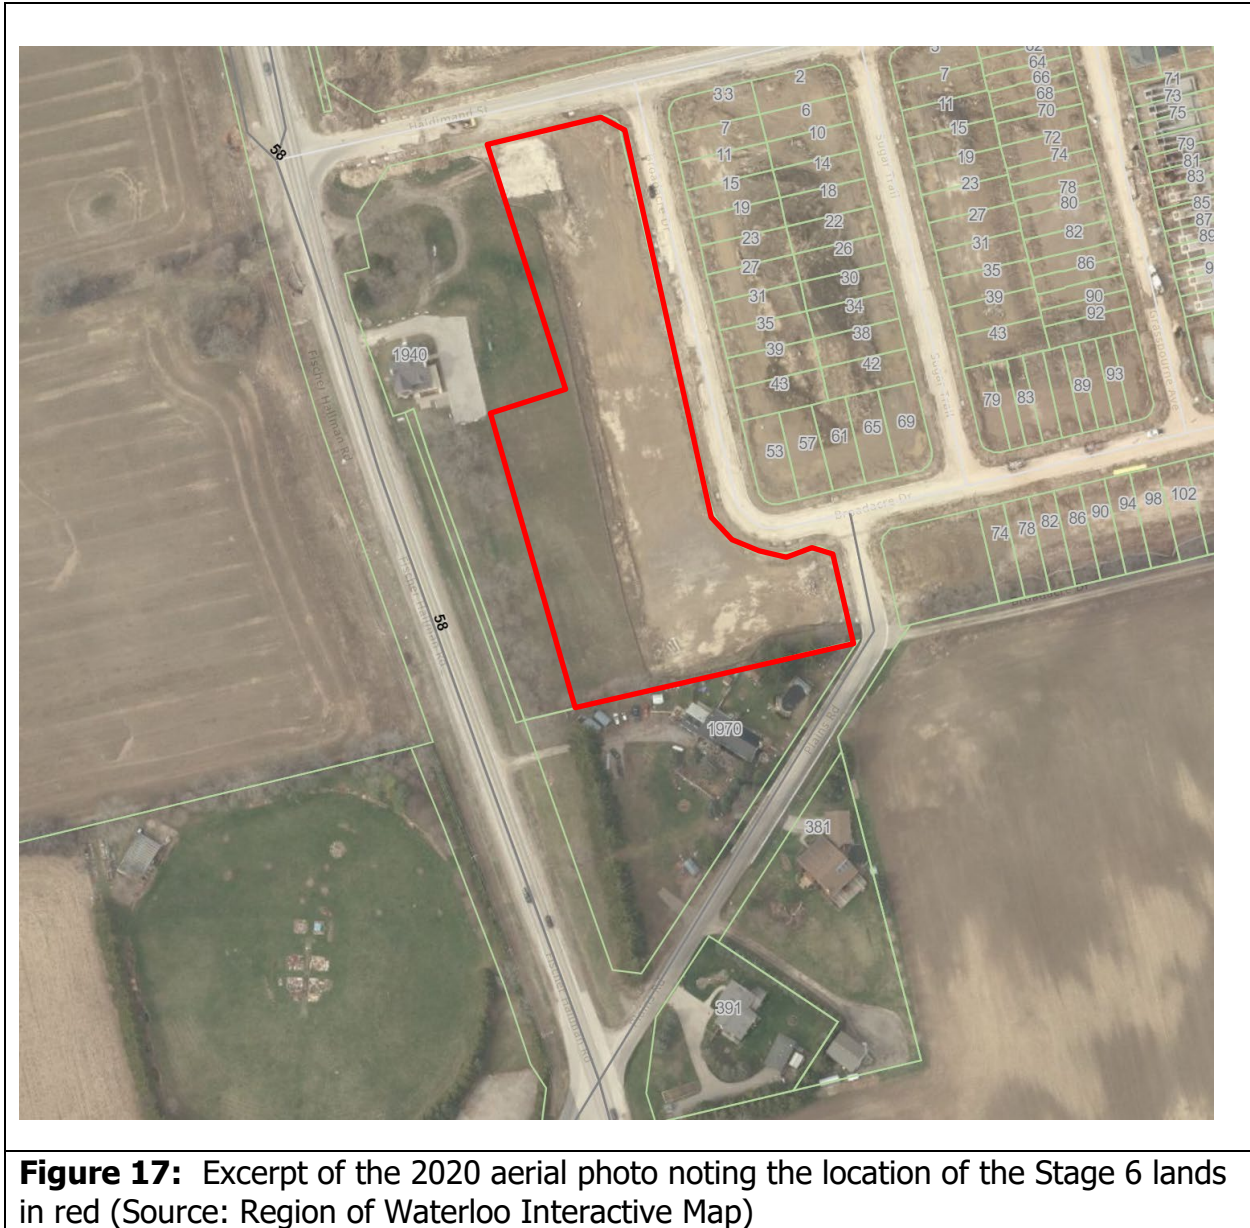
According to the 2020 aerial photograph, the barn and other outbuildings have been demolished at this time (see **Figure 17**). Some land grading appears to have taken place on the Stage 6 lands at this time and additional mature trees appear to have been removed from the Stage 8 lands.

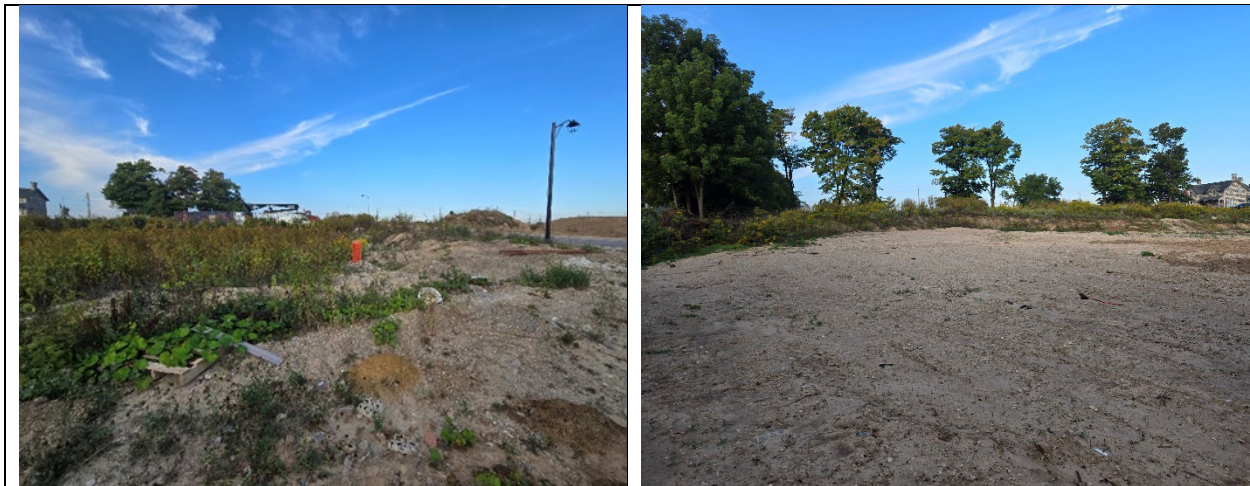
Figures 18 & 19: (left) View of the Stage 6 lands looking west towards Fischer-Hallman Road from Broadacre Drive (right) View of the Stage 6 lands looking north-west towards Fischer-Hallman Road (MHBC, 2024)

The Stage 6 lands comprising the eastern portion of 1940 Fischer-Hallman Road are currently vacant and include no natural or built features at this time (see **Figures 18** and **19**).

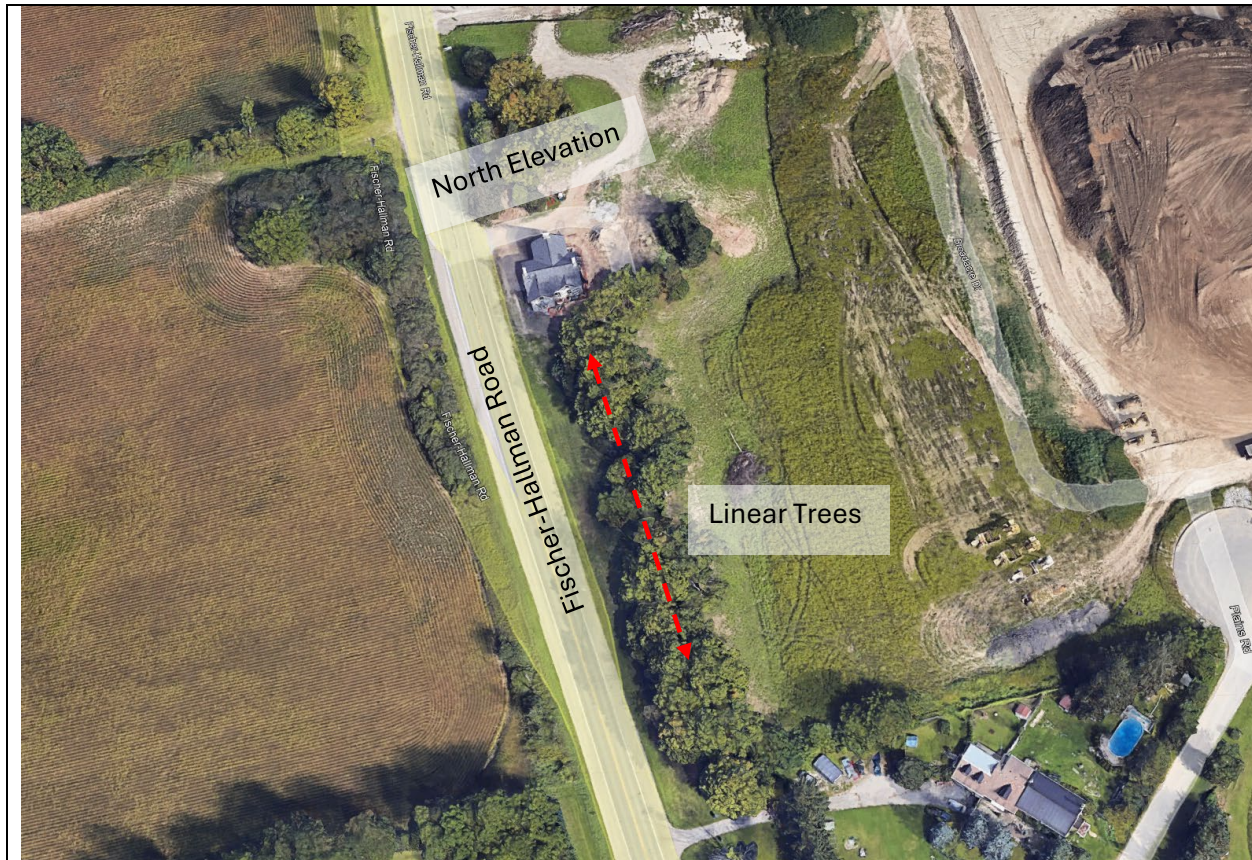
Figure 20: Aerial image noting location of existing farmhouse and linear trees on the lands to be retained (Source: Google Earth Pro, 2024)

The Stage 8 lands comprising the western portion of the property located at 1940 Fischer-Hallman Road can be described as an irregular-shaped lot with access to the north and east via Broadacre Drive. It currently includes a stone dwelling constructed c. 1870, remnants of the “old lane” in the form of a mature tree row extending south from the dwelling, landscaping and additional mature trees (see **Figure 20**).

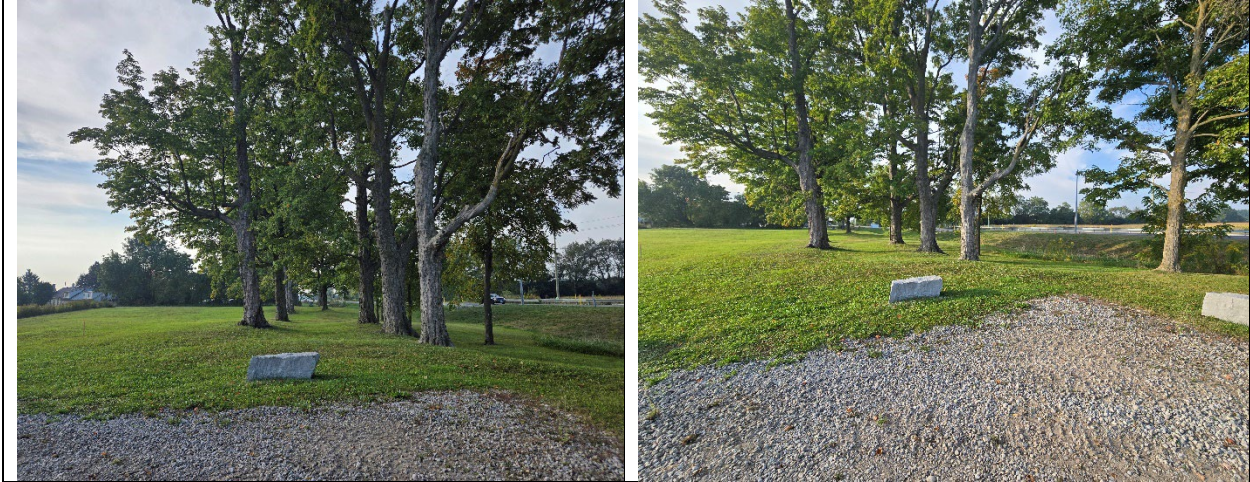
Figures 21 & 22: (left) View of linear trees looking south from south elevation of farmhouse, (right) View of linear trees looking south-west from parking area. (Source: MHBC, 2024)

Remnant features of the former agricultural farm complex are limited to the existing linear trees located south of the existing farmhouse along Fischer-Hallman Road (see **Figures 21 & 22**). Farmyards, fields, and accessory structures noted in the previous Architectural Analysis and Heritage Impact Assessment are no longer present on the property.

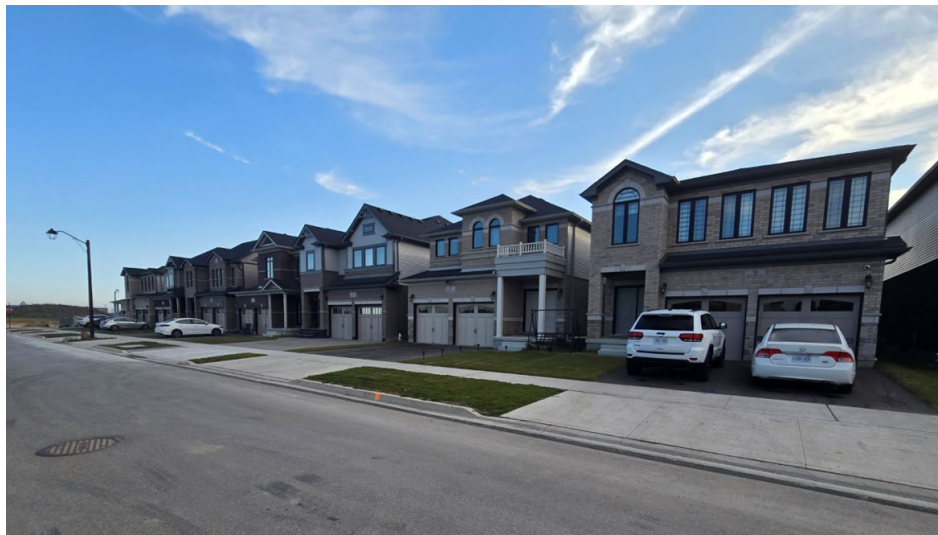
Figure 23: View of the subdivision to the east of the Stage 6 lands looking east. (MHBC, 2024)

The Stage 8 lands are located within a transition area which was once agricultural and rural in context. The area is currently subject to development applications where residential subdivisions are being constructed east of Fischer-Hallman Road, south of Huron Road (see **Figures 23 & 24**).

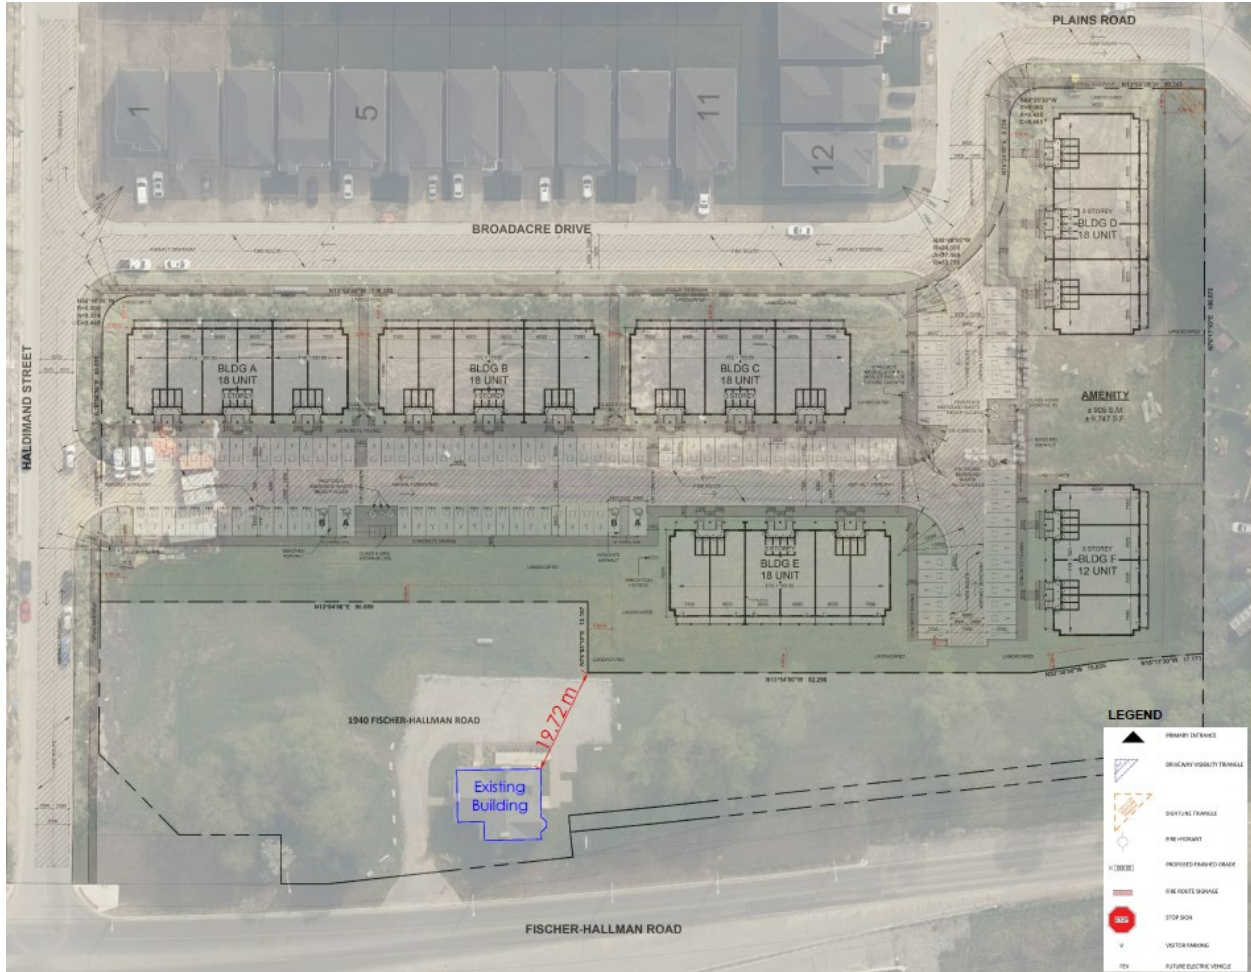
Figure 26: Location of the site plan with respect to the adjacent Stage 8 lands containing the existing building and adjacent existing development to the east across Broadacre Drive. (MHBC, 2024)

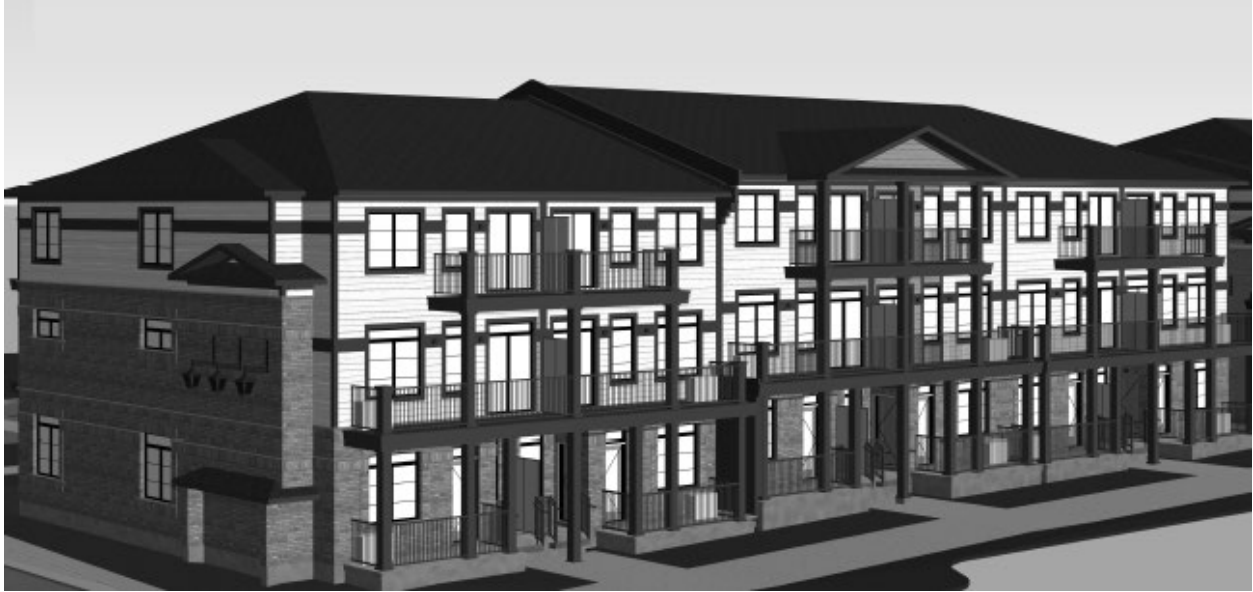
Figure 27: Conceptual render of the proposed townhouses. (Source: Fusion Homes, 2023)

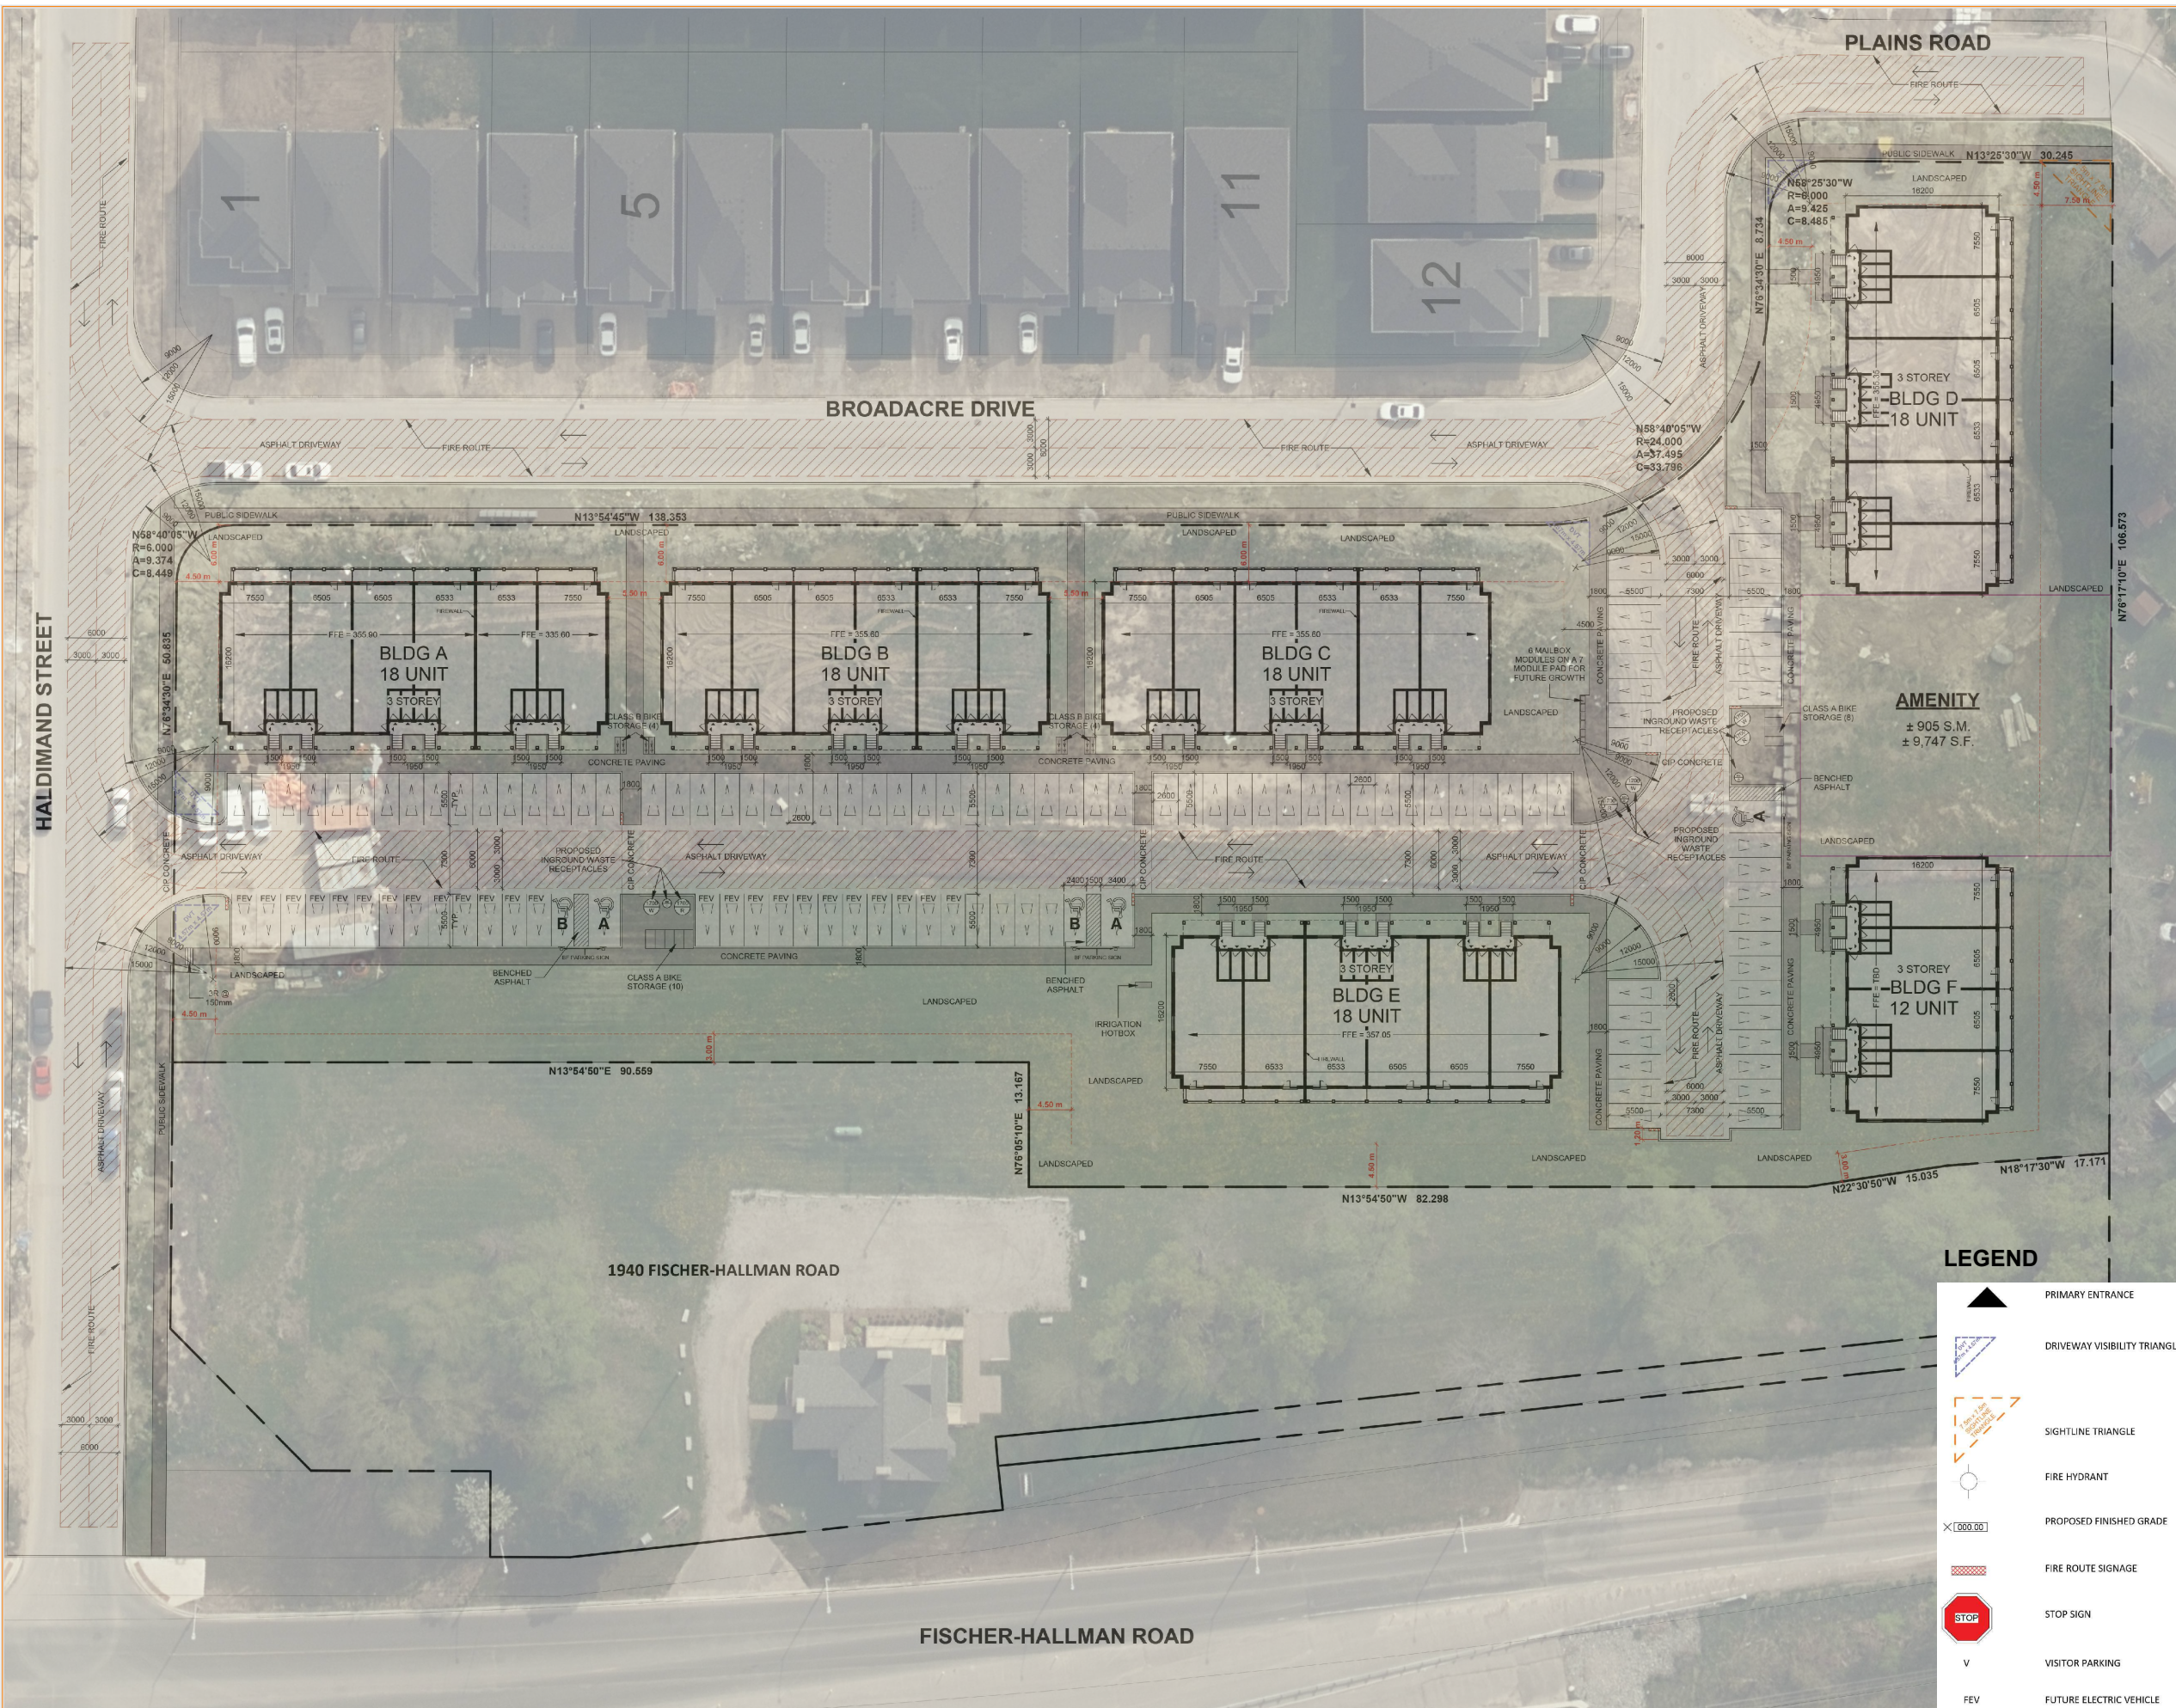
Required Amenity = 2m² x #units + 2.5m² x (#bedrooms - #units)
= 519 m²
Provided Amenity = 914 m²

Note: Snow removal to occur off site.
