REPORT TO: Heritage Kitchener

REPORT NO.: DSD-2025-173

SUBJECT: Heritage Permit Application HPA-2025-IV-010
60 Victoria Street North
Demolition of Additions with Retention in Full of 1913 Building

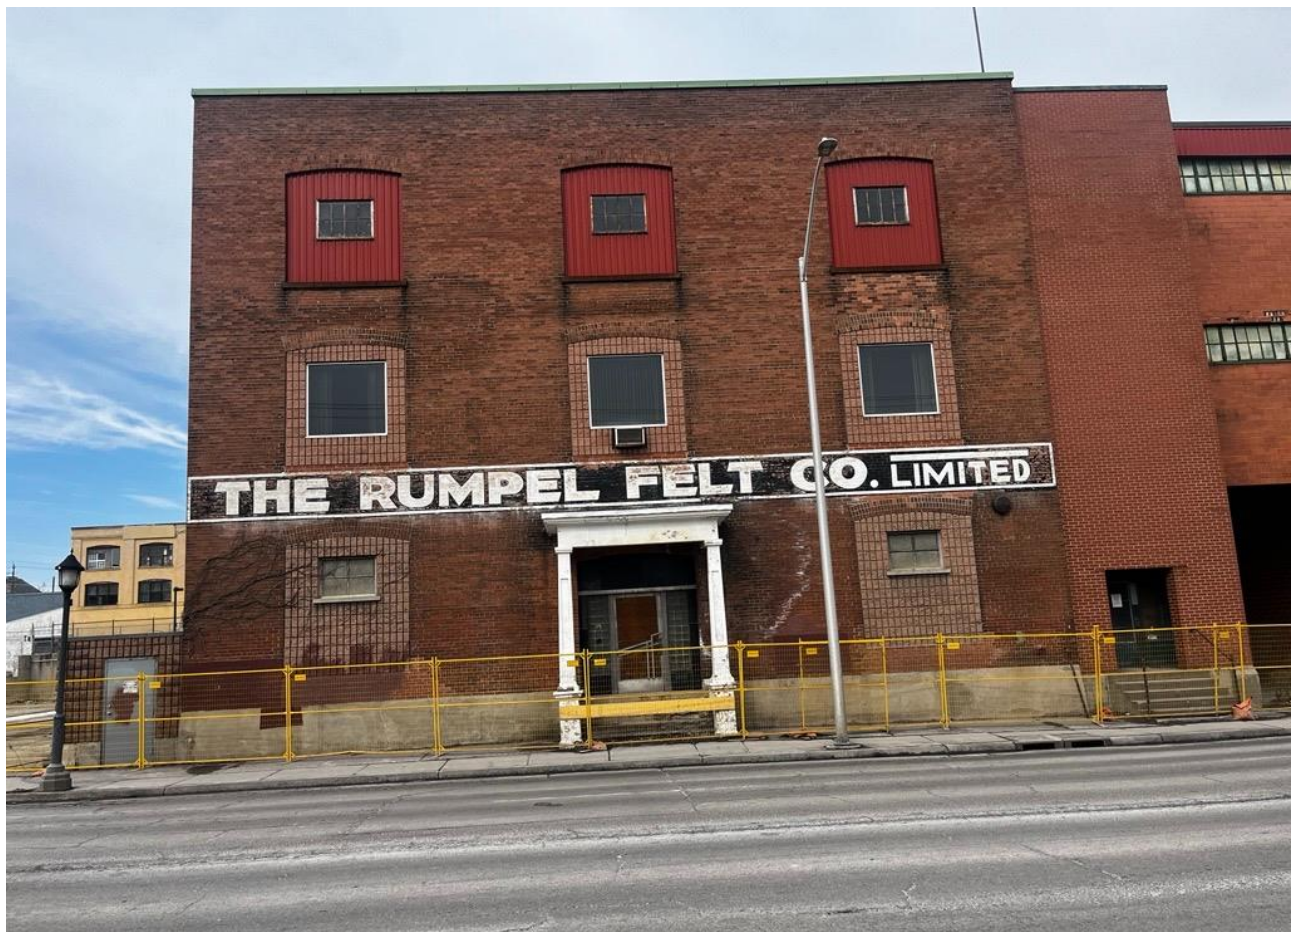
Figure 2: Front Facade of Subject Property

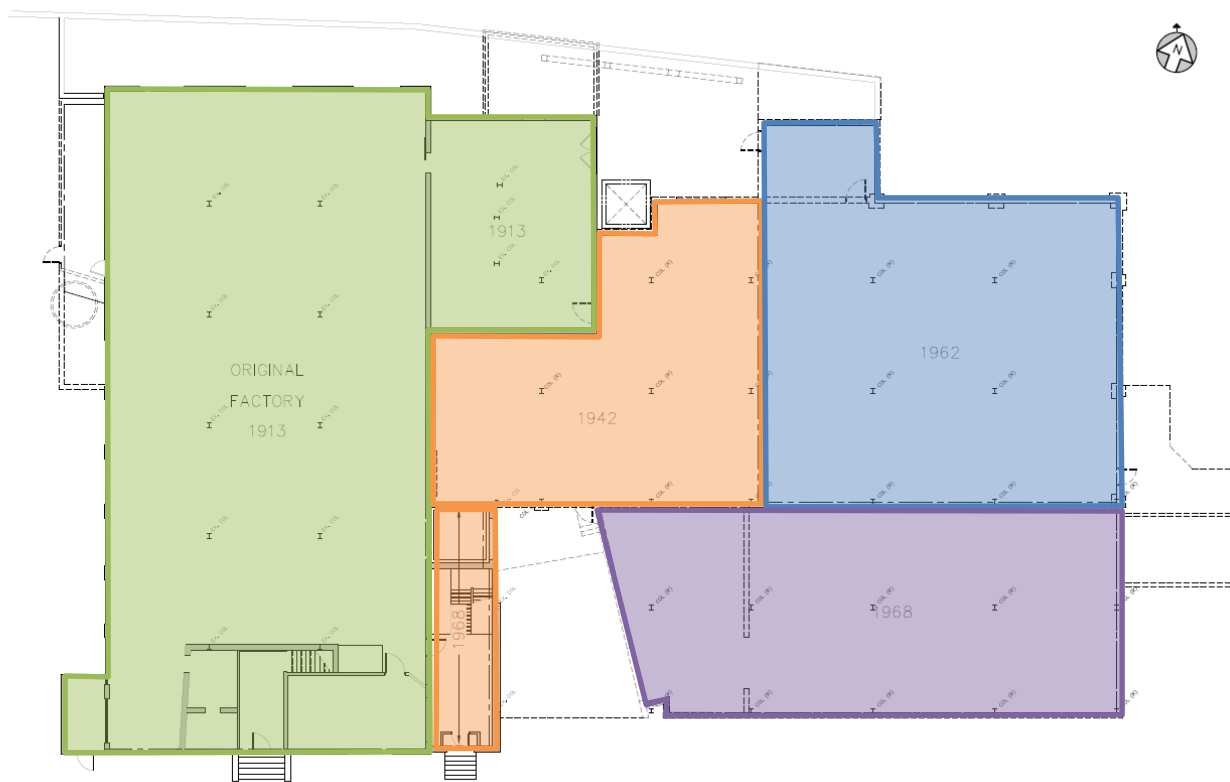
Figure 3: Additions (1913 in Green, 1942 in Orange, 1962 in Blue, 1968 in Purple)

60 Victoria Street North is located on the northwestern corner of the Victoria Street North and Duke Street West intersection. The subject property is designated under Part IV of the *Ontario Heritage Act* and contains an original 1913 three-storey brick factory with three contemporary additions constructed in 1942, 1962, and 1968 respectively.
