STATEMENT OF SIGNIFICANCE

69 AGNES STREET

Summary of Significance

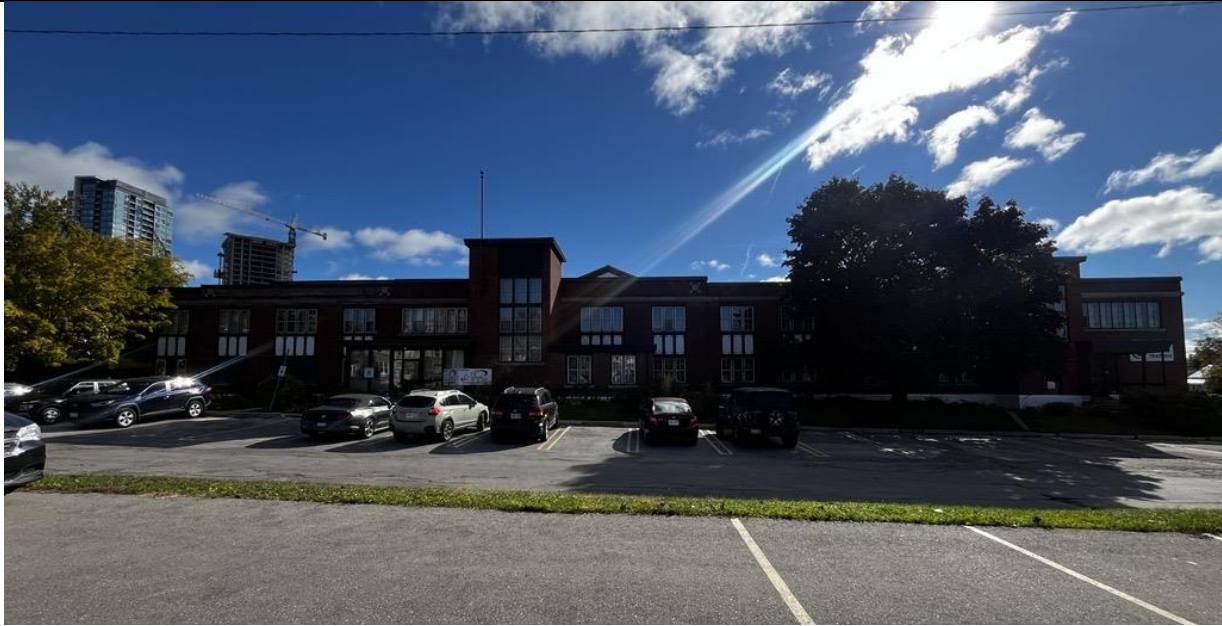
Front Façade of Subject Building

The front façade of the building is asymmetrical in its design and massing, though many of the architectural features make use of symmetry and repetition. There are two projecting towers which vertically divide the building into three major sections; the first section is north of the first tower, the central section is between the two towers, and the third section is to the south of the second tower.

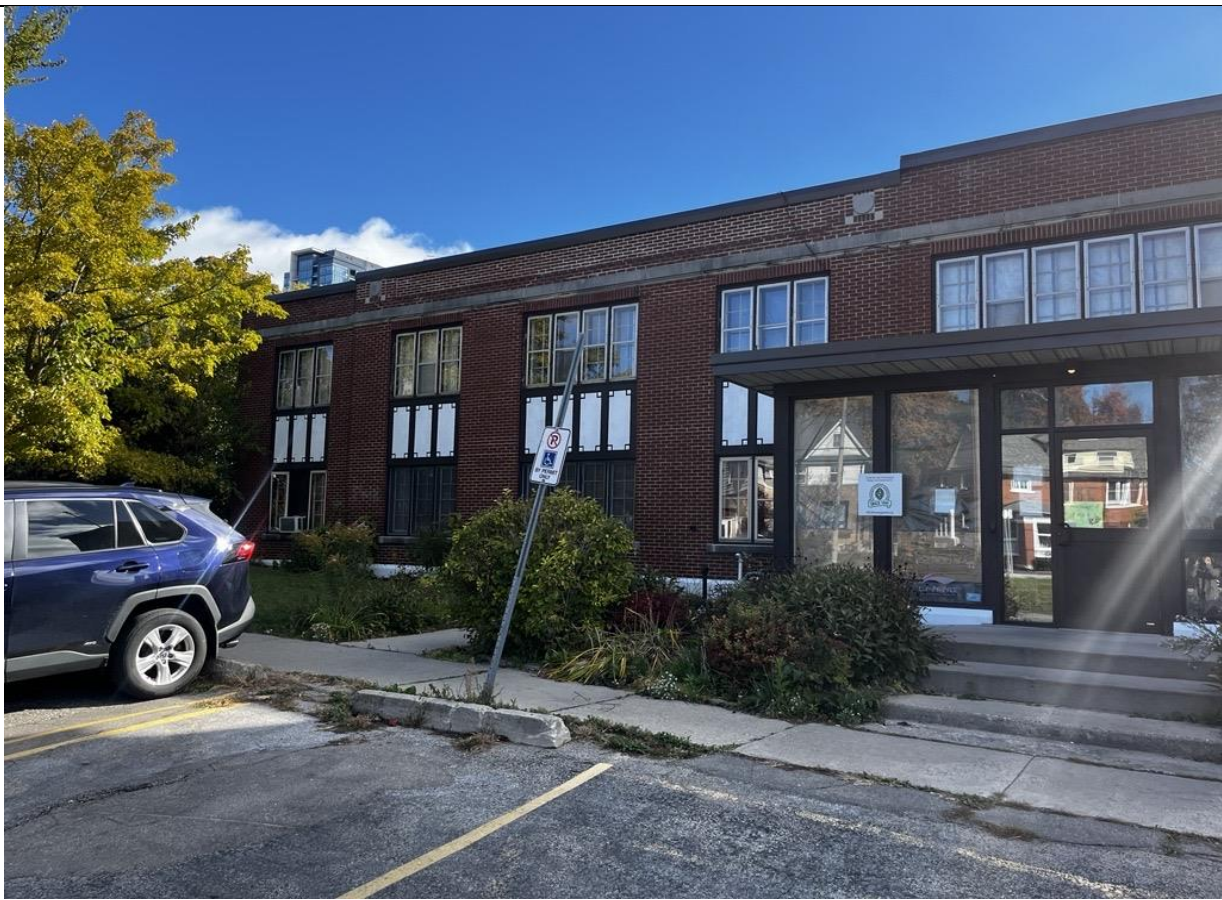
Northern End Section (Front Façade)

The northern end section can be further divided vertically into five parts. The first four are comprised 4/4 and 1/1 windows arranged into groups of three or four, with the ground floor windows having concrete sills and being separated from the second-storey windows by decorative panels above. There is a parapet with two concrete motifs and concrete banding, and the roofline is flat and staggered. A one-storey glass vestibule projects out from the northern end sections and abuts the first tower. Above the glass vestibule there is a group of seven windows with a concrete sill.

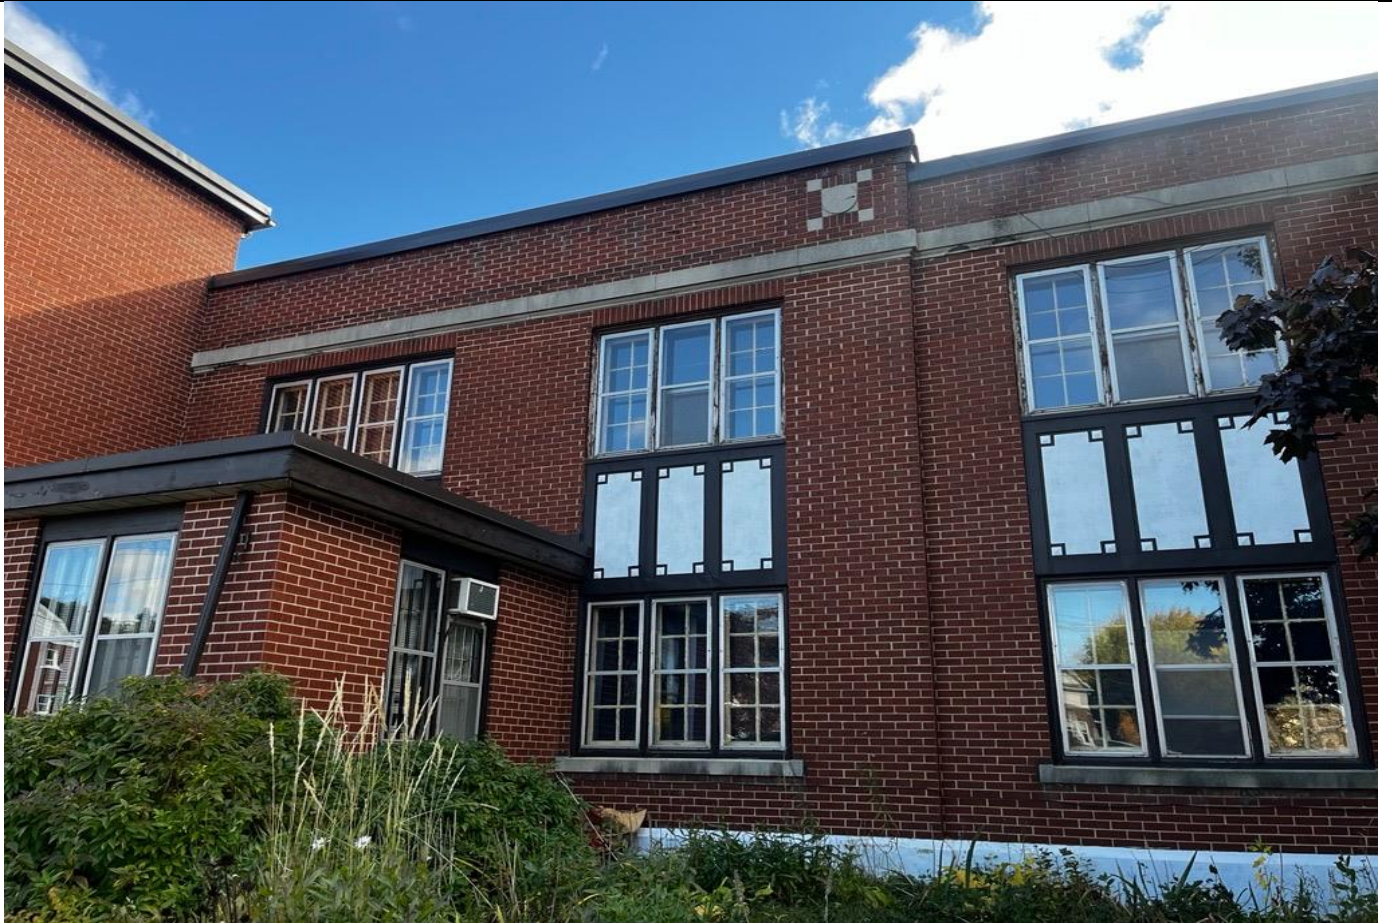
Close-up of Architectural Detailing on Central Section Including Concrete Motifs and Decorative Panels

The central recessed section can be vertically divided into six parts, five of which are comprised of groups of 3 4/4 and 1/1 windows. As with the northern end section, the ground floor windows have concrete sills and there are decorative panels underneath the second-floor windows. The parapet in this section possesses the same concrete banding and one concrete motif, and the roofline again has some variation in its height. There is a one-storey brick addition that abuts the first tower, and it contains two groups of two 1/1 windows with concrete sills on the front and one group of two 1/1 windows on the side.

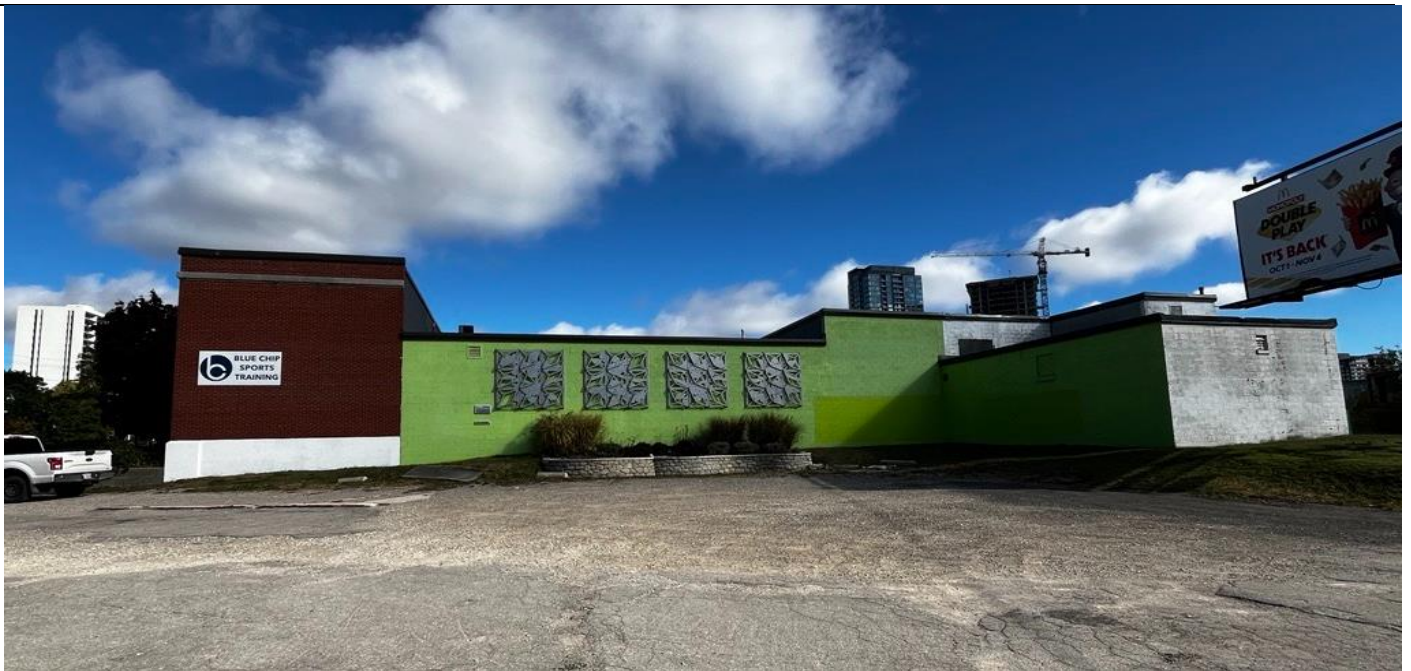
South-Side Façade (1927 Portion and new addition)

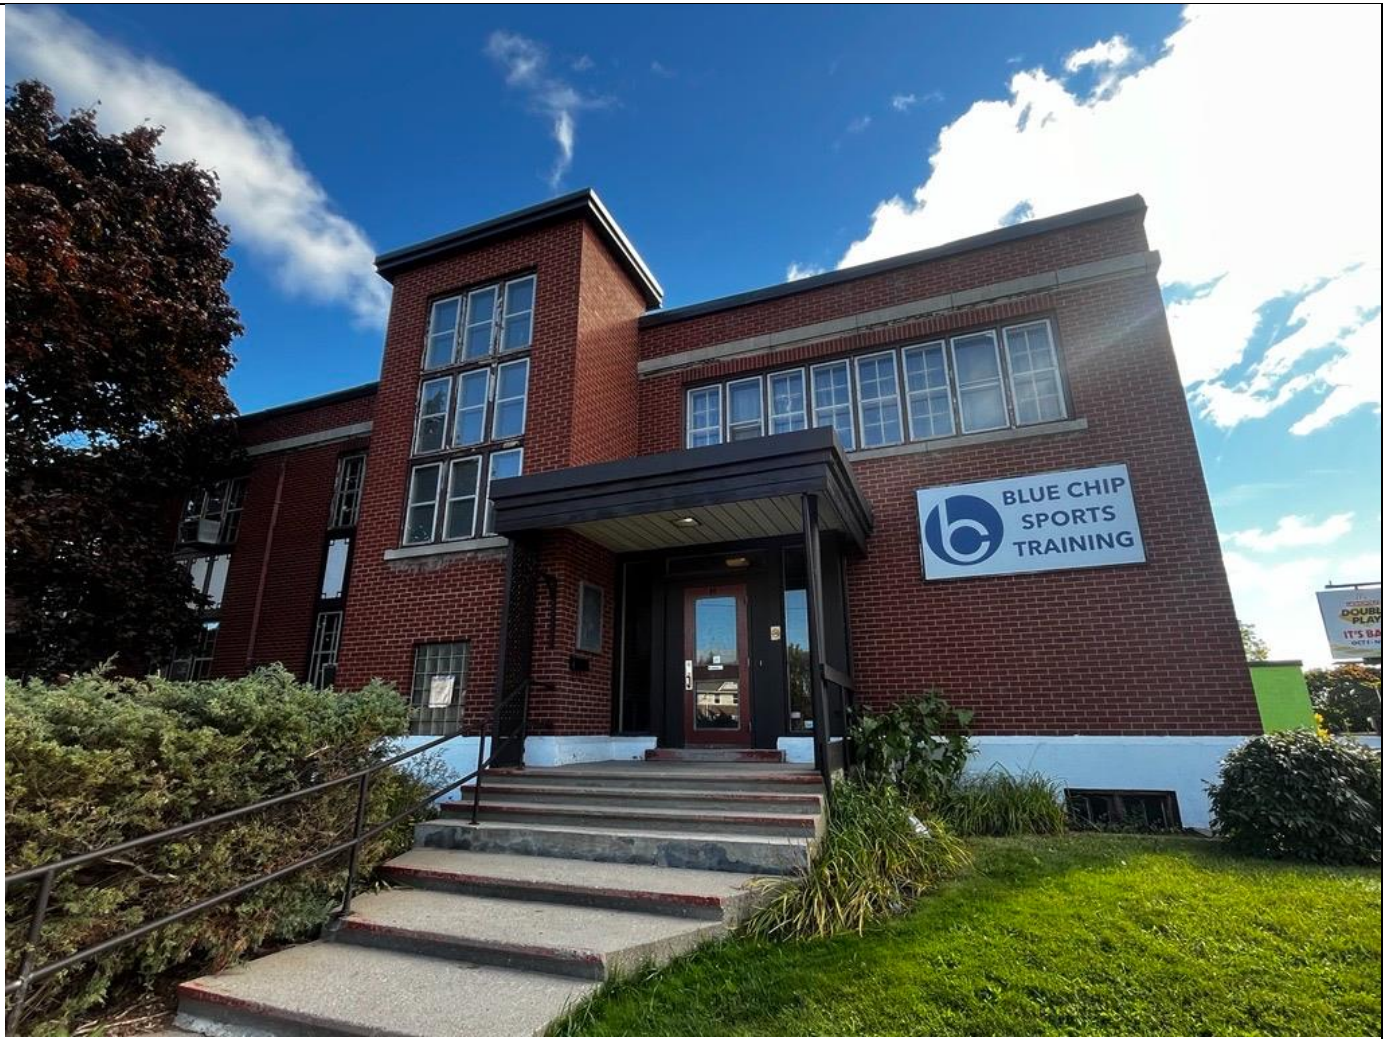
Second Tower and Southern End Section (Front Façade)

The second tower is similar in appearance to the first, possessing the same grouping of three-by-three 1/1 windows with the bottom row having a concrete sill. The second tower lacks the vertical cladding that can be found in the first tower and contains one window of glass blocks on the ground floor.

The southern end section of the 1927 portion of the building contains a covered entranceway with a flat roof on the ground floor, and a single group of eight windows with concrete sill on the second. The parapet contains the concrete banding but no additional motifs.
