Statement of Significance 4336 King Street East

Municipal Address: 4336 King Street East

Year Built: c. 1889

Architectural Style: Georgian

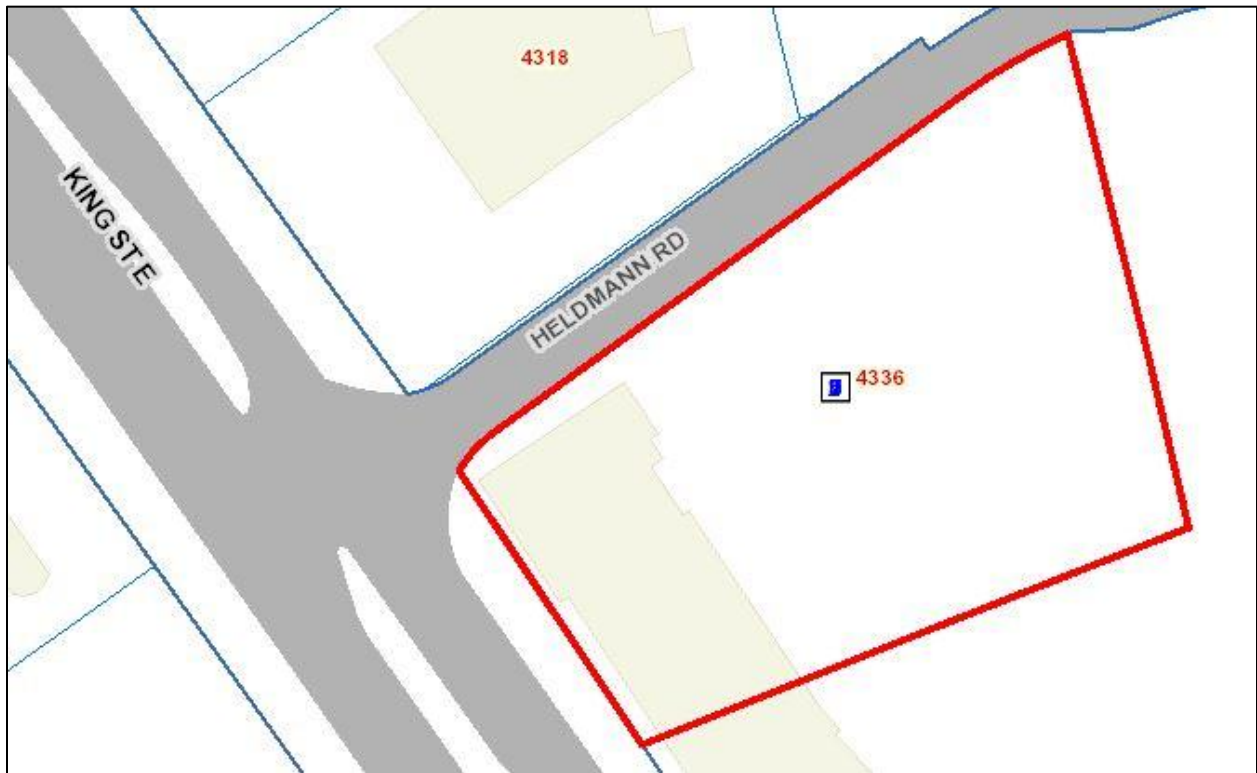
4336 King Street East is a one storey late-19th century former school house built in the Georgian architectural style. The building is situated on a 1.40 acre parcel of land located on the corner of King Street East and Heldmann Road in the Pioneer Tower East Planning Community of the City of Kitchener within the Region of Waterloo. The principal resource that contributes to the heritage value is the former school house building.

The design and physical value of the subject property relates to the architecture of the old schoolhouse. The design, composition, craftsmanship and details of the building result in a representative example of Georgian architectural style. The building is in good condition and is one of only four remaining one-room schoolhouses in the City of Kitchener. As such, it is considered a rare example of a one-room schoolhouse. The existing building is one-storey in height, is constructed of buff-brick in a common bond and Flemish bond, with a gable roof and a fieldstone foundation.

- All elements related to the Georgian architectural style of the original portion of the building, including:
- The location, height, and massing of the original schoolhouse
 - one storey height;
 - front gable roof;
 - buff brick;
 - segmentally arched window openings with brick voussoirs;
 - flat headed basement window openings with brick voussoirs;
 - circular vent (former window) with brick voussoirs;
 - remnants from former school name plate; and,
 - fieldstone foundation.
 - Brick chimney
 - Former date/school name insert in gable peak.

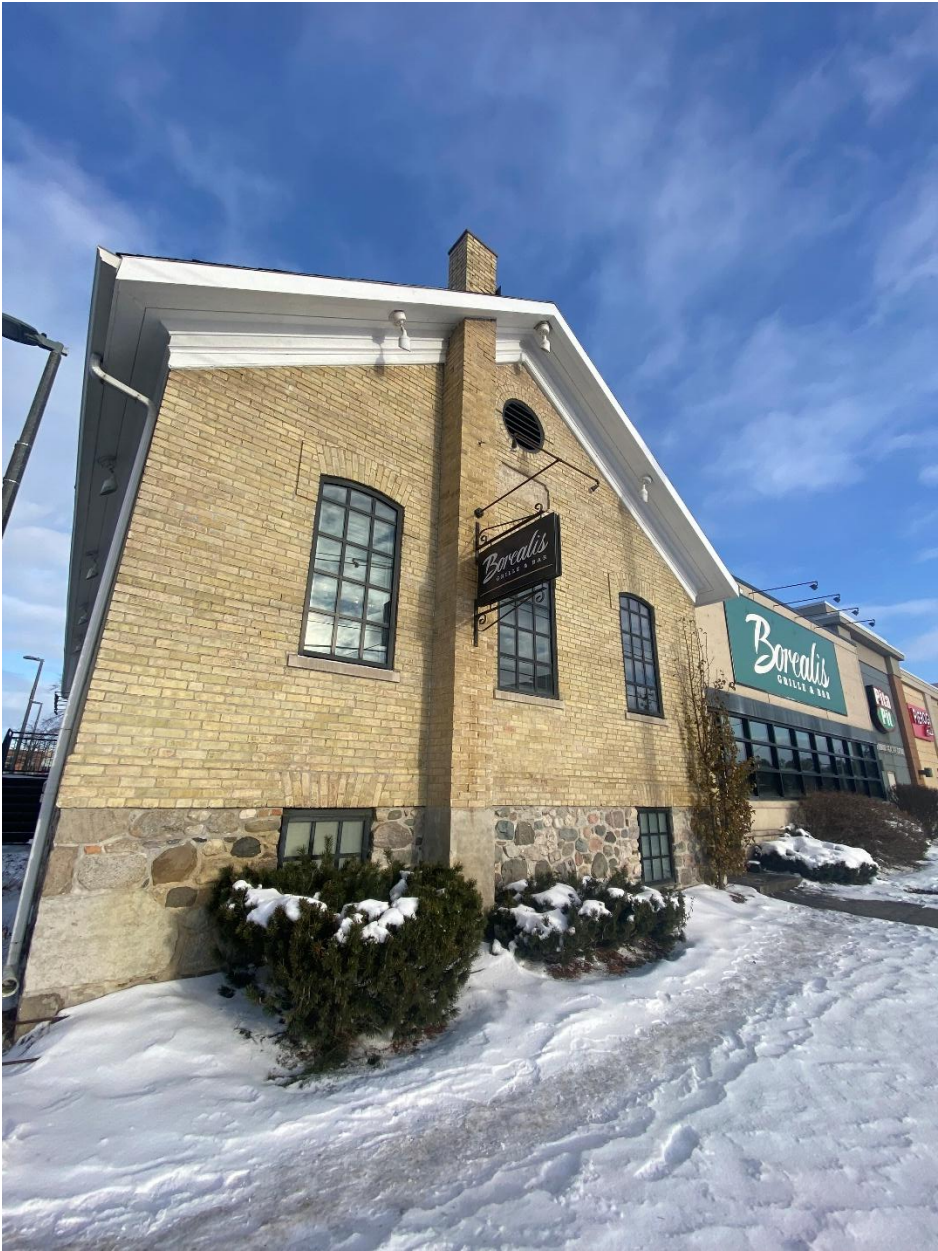
4336 King Street East: Front Facade

The front elevation of 4336 King Street east consists of a gable end of the north addition to the former Pine Grove Schoolhouse. West of the former schoolhouse, there is an attached flat roof commercial building that has been divided into multiple units.

The gabled roof addition to the former schoolhouse is three bays wide, and is designed similar to the original portion of the Pine Grove Schoolhouse. From the exterior, the addition appears to be two-storeys in height, but on the inside it is one-storey. The elevation foundation is concrete, clad in a stone veneer, and the walls consist of buff-brick laid in a running bond pattern with grey mortar. On either side of the door, there are two large rectangular windows with brick lintels. Above these door and window openings are three segmentally arched window openings with brick lintels and concrete sills. Each of these window openings has a modern window divided into 12 lites. Underneath the gable peak on this elevation there is a central round vent opening with a brick surround.

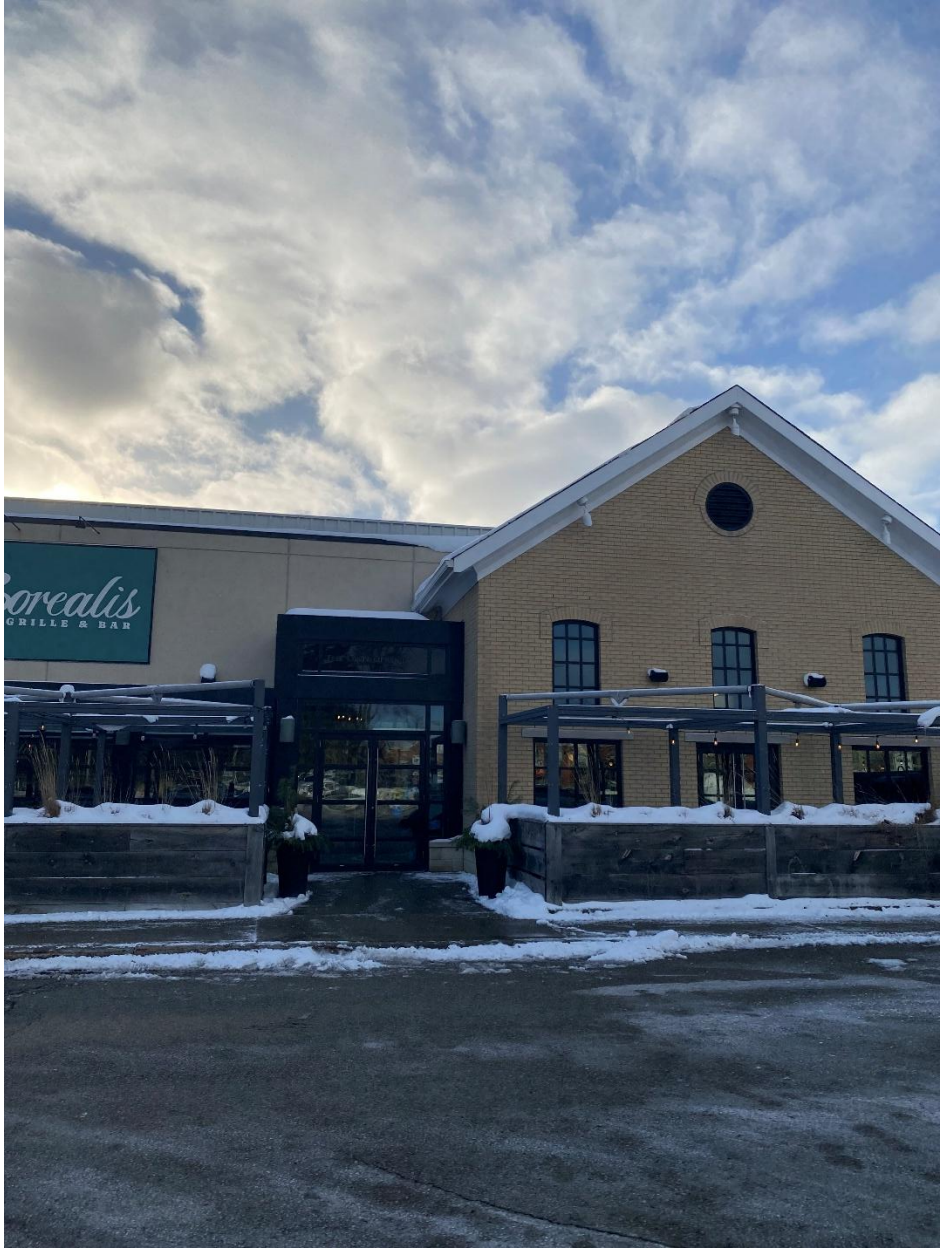
4336 King Street East: Rear Addition Facade

Rear (South) Elevation

The rear (south) elevation faces King Street East and is the rear elevation of the Former Pine Grove Schoolhouse. This elevation also includes the buff-brick construction and the fieldstone foundation. There are two rectangular windows on the foundation, consisting of 12 lites. This elevation is three bays wide, consisting of segmentally arched windows with brick lintels with concrete sills. Each window opening has a modern window divided into 12 lites. The gable peak has a circular window with brick surround. This elevation also has a projecting chimney.

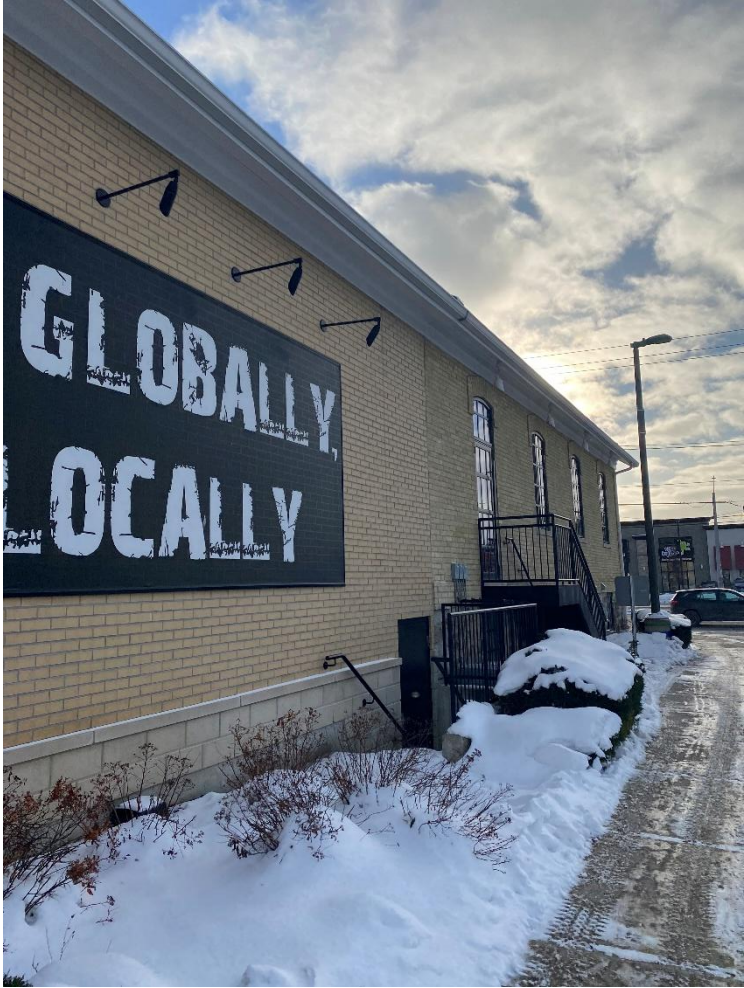
4336 King Street East: West Façade (Showing the seam between the original schoolhouse and the addition)

West Elevation

The modern addition and the former schoolhouse are both visible on this elevation. The original portion of the schoolhouse contains three segmentally arched windows with brick voussoirs and concrete sills with a segmentally arched door. The window openings all have modern windows with 12 lites. The fieldstone foundation has two rectangular window openings. These window openings have modern windows with 9 lites with brick lintels. The addition has a gable roof with brick veneer, gable roof, and is one-storey in height.
