RE: Updated Heritage Impact Assessment (HIA) and Notice of Intention to Demolish under Part IV Section 27 (9) of the *Ontario Heritage Act*, 63 Courtland Avenue East, Kitchener  
OUR FILE: 2144D

**63 Courtland Avenue East**

MHBC was retained to undertake a Heritage Impact Assessment (HIA) for the property located **at 63 Courtland Avenue East, Kitchener hereinafter noted as the “subject property”**. This HIA is required given that the subject property is listed (non-designated) on the City of Kitchener’s *Municipal Heritage Register* under Section 27 of the *Ontario Heritage Act*. The purpose of this Heritage Impact Assessment is to determine whether or not the proposed development will result in adverse impacts to cultural heritage resources located on-site and adjacent. The subject property currently includes three buildings (identified in this report as Buildings 1, 2, and 3) as well as surface parking. While some building fabric located on-site demonstrates Cultural Heritage Value or Interest (CHVI), others do not. This Heritage Impact Assessment concludes that the subject property meets 2 criteria under *Ontario Regulation 9/06*. A Statement of Significance and list of herit

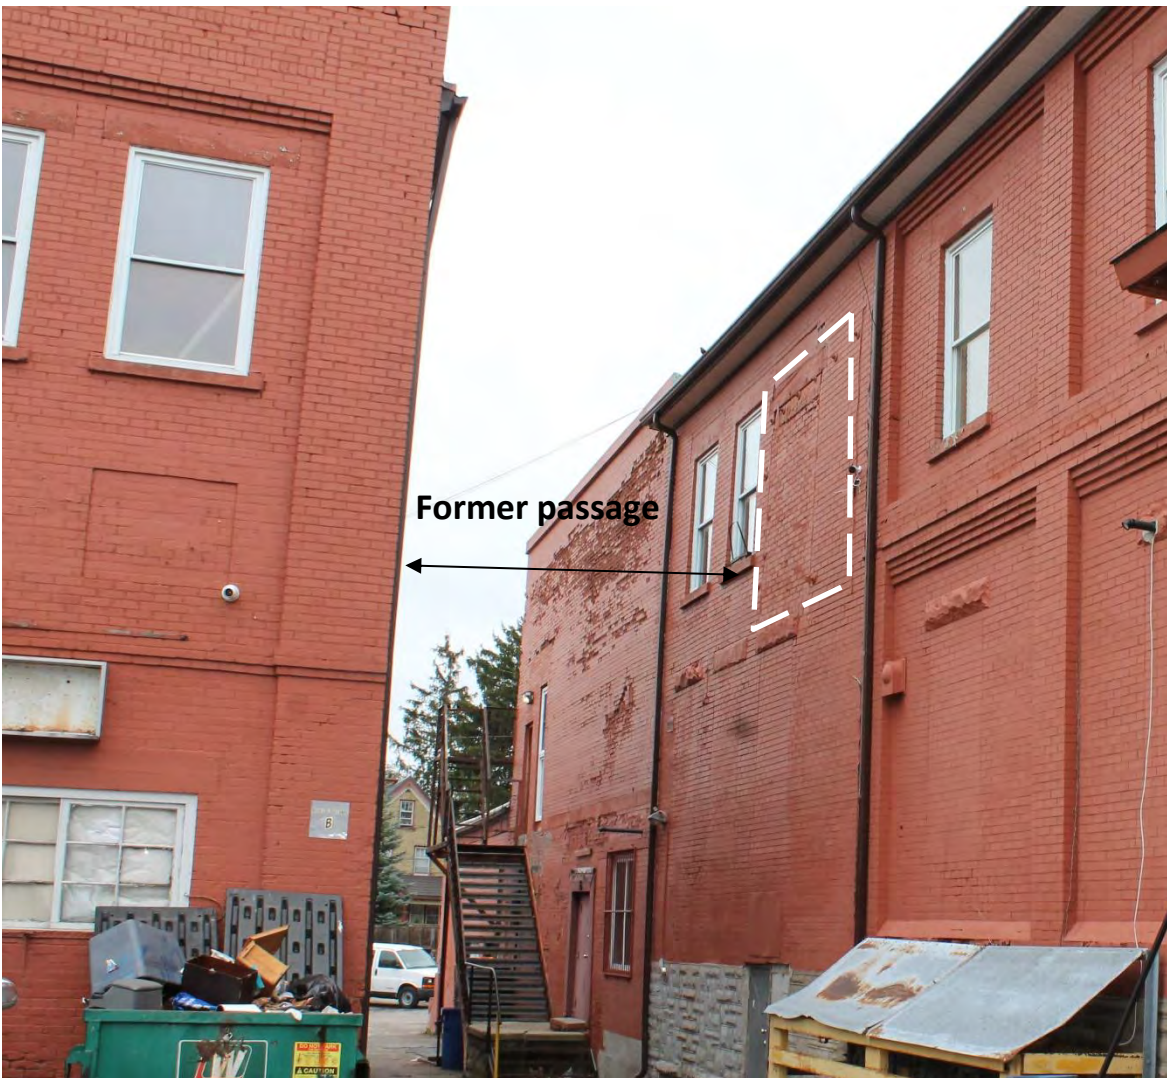
The 1925 Fire Insurance Plan indicates a second storey passage between buildings. The photograph below indicates the location of the passage between the two buildings. Both entrances have since been bricked-over and enclosed.

Figure 19: View of former passage, as noted in the 1925 Fire Insurance Plan (Source: MHBC, 2024)

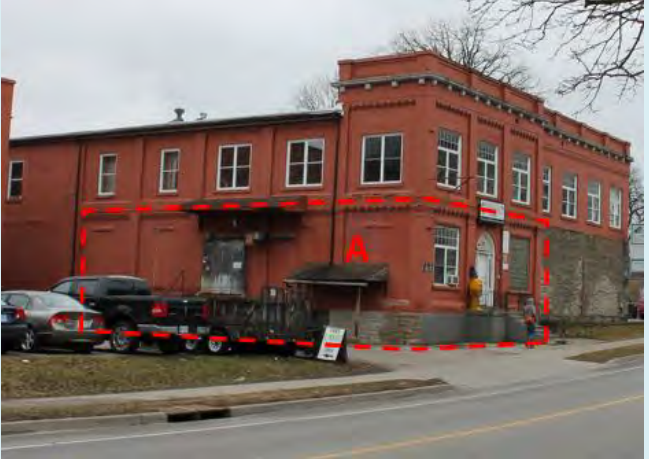
<i>Legend: Building 1: Sections A - G</i>			
Identifier	Description	Construction Date	Photo
A	Original single storey brick addition to former J.M. Schneider home/factory. All original windows and doors have been replaced. Some window and door openings have been enclosed.	c. 1909

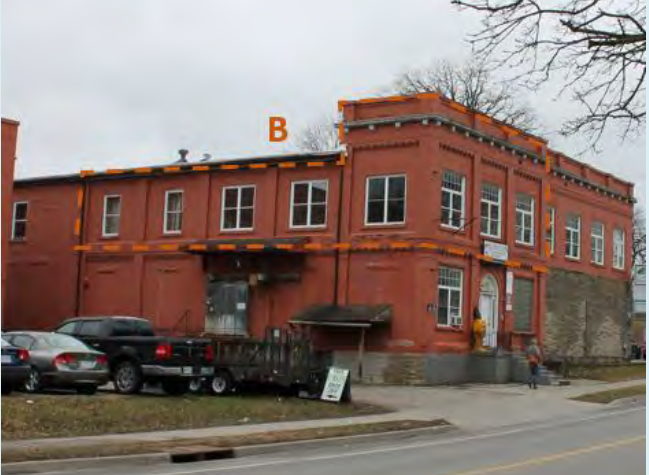
B	Second storey addition above Section "A". All original windows and doors have been replaced.	Bet. 1909 and 1914

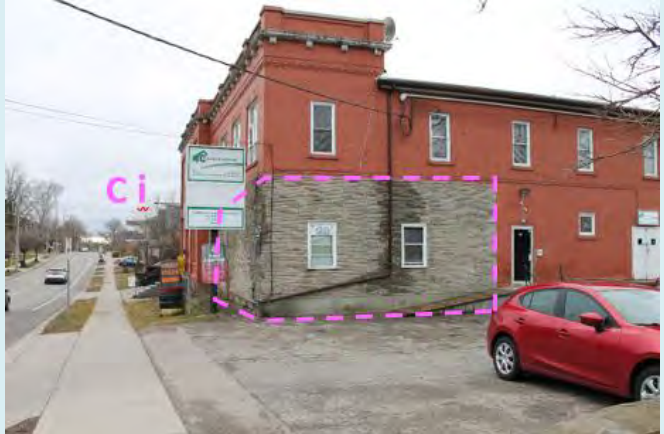
<p>C i</p>	<p>First storey of a 2-storey addition fronting Courtland Avenue East. The entire portion of this building has been clad with contemporary materials.</p>	<p>Bet. 1909 and 1914</p>

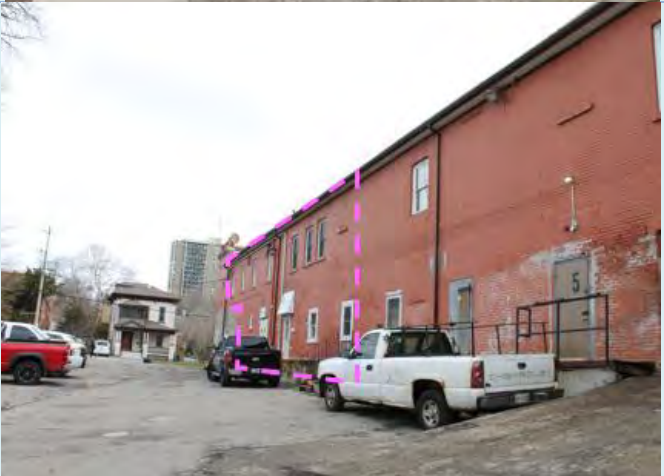
<p>C ii</p>	<p>Second portion of brick addition at west elevation. All original windows and doors have been replaced.</p>	<p>Bet. 1909 and 1914</p>

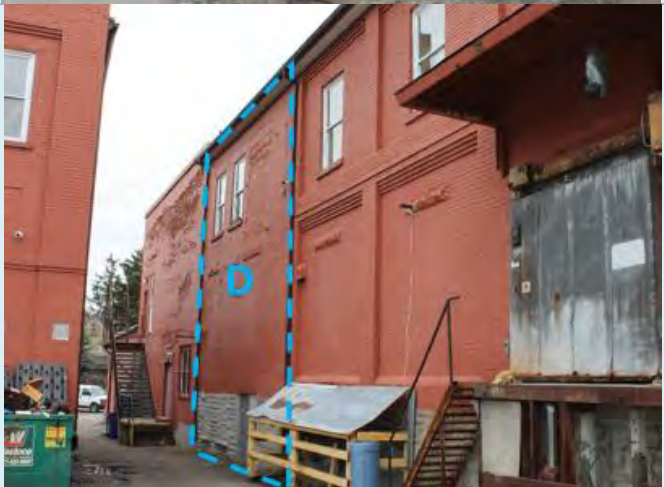
<p>D</p>	<p>Rear brick addition. All original windows and doors have been replaced. Some window and door openings have been enclosed.</p>	<p>Bet. 1909 and 1914</p>

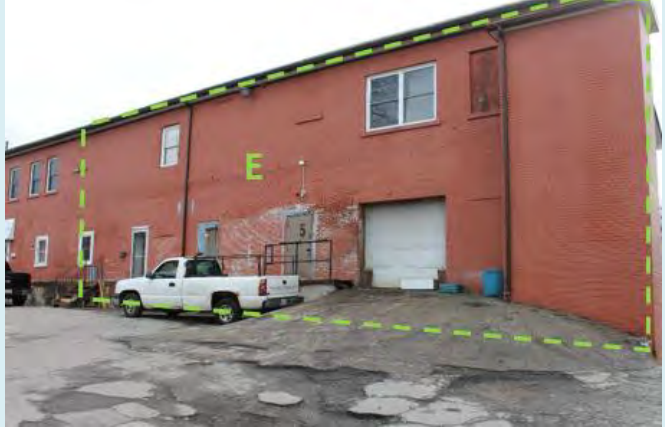
E	Rear brick addition. All original windows and doors have been replaced. Some window and door openings have been enclosed.	Bet. 1917 and 1925

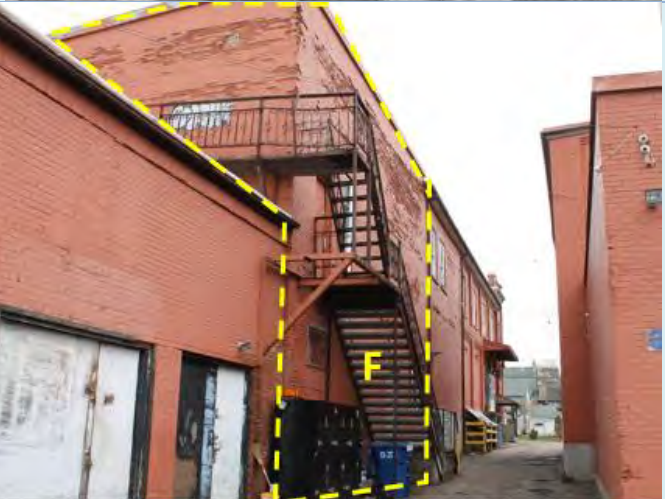
F	Rear brick addition. All original windows and doors have been replaced. Some window and door openings have been enclosed.	Bet. 1917 and 1925

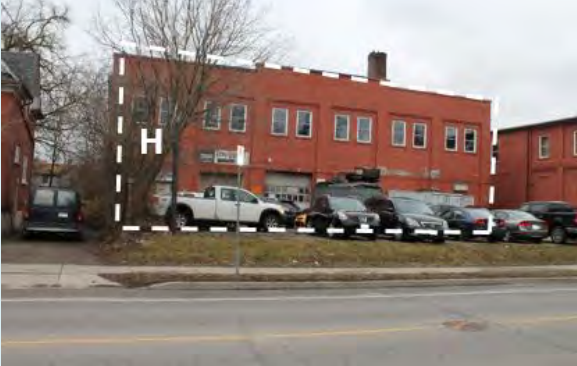
Legend: Building 2: Sections H - J			
Identifier	Description	Construction Date	Photo
H	2 storey brick building fronting Courtland Ave. East. Includes brick chimney stack. Original windows and doors have either been replaced or are in a deteriorated condition. Some window and door openings have been enclosed.	Bet. 1917 & 1925

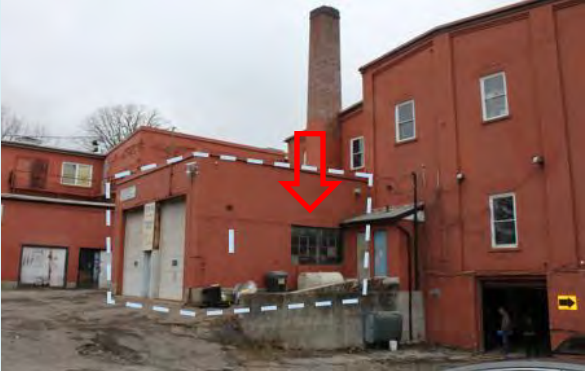
I	Rear brick addition with garage doors. One 20 <sup>th</sup> century metal frame window is located at the east elevation (noted with red arrow).	Bet. 1925 and 1947

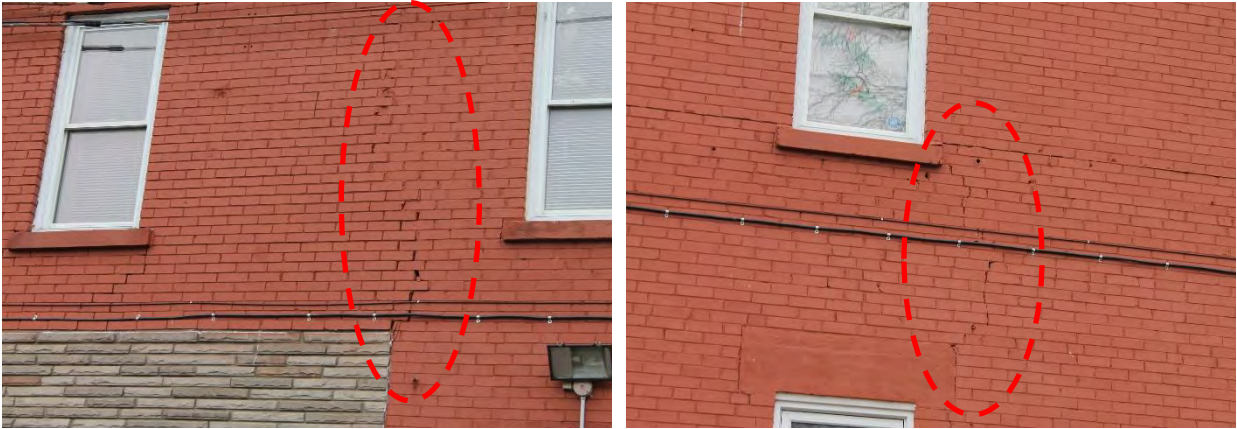
Figures 38 & 39: Photos of settlement cracks at the exterior of Building 1, (MHBC, 2024)

A condition assessment has been completed by Tacoma Engineers in May 2024 in order to determine the structural stability of Building 1. The report confirmed that the building has some issues but is generally in fair condition and the building is currently structurally stable. The report concludes that it is feasible to remove portions of Building 1 while avoiding any adverse impacts to portions which are of heritage value and are proposed to be retained.

A supplementary structural condition report was undertaken in December 2024. The supplementary report confirms the following:

- The building was constructed with a combination of wood and steel framing supported on exterior masonry walls;
- Foundation walls are a combination of rubblestone mass masonry (earlier portions of the building) as well as later concrete (later additions);

- No original building fabric remains at the interior of the building, which has been extensively modified over time;
- **The building is in “fair condition”, with “...no observed damages that would cause concern for structural stability.”;**

- Exterior masonry shows signs of distress from lack of or improper maintenance;
- Damages may be accelerated with lack of water management (i.e. damaged downspouts, roof flashings);

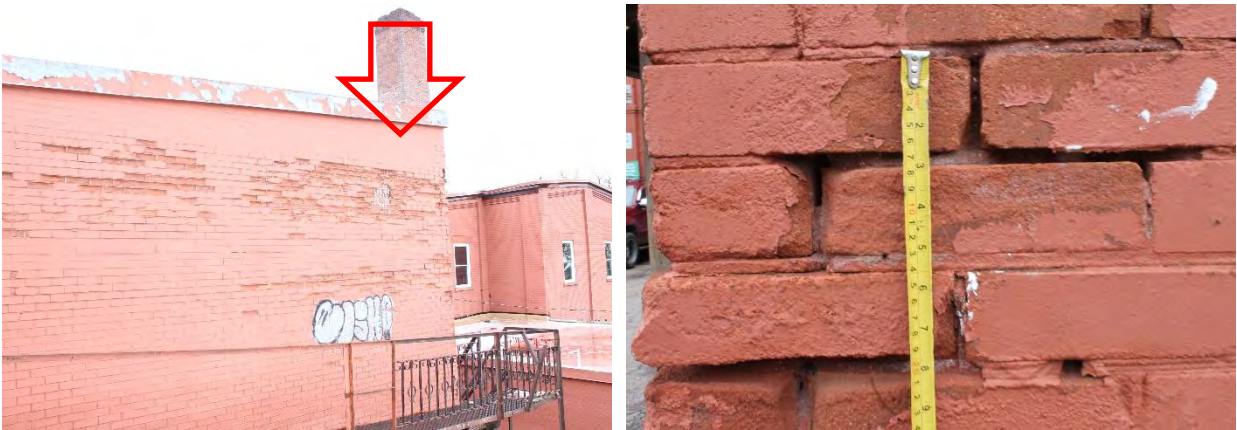
Figures 40 & 41: (left) View of spalling bricks at exterior of Building 1, (right) View of deteriorated masonry at exterior of Building 1 (MHBC, 2024)

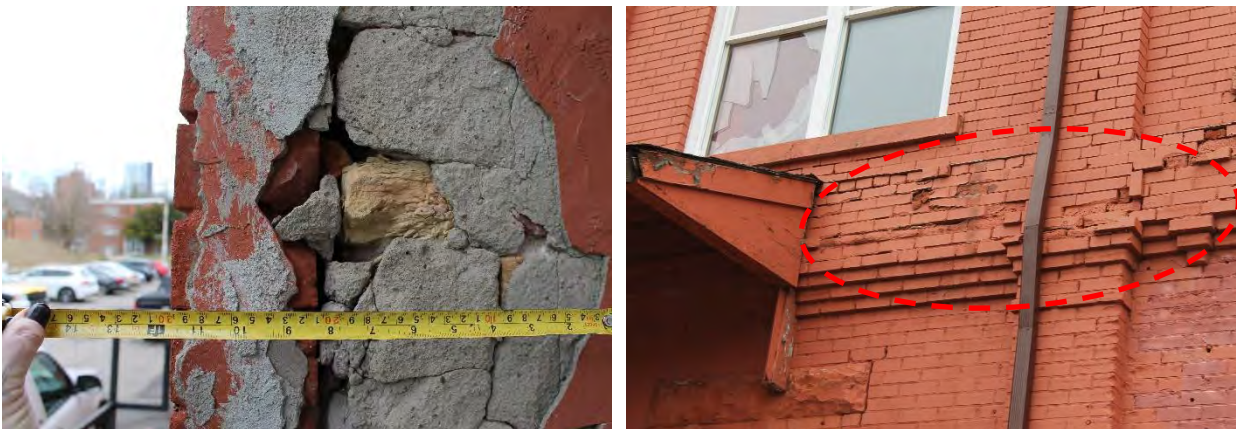
Figures 42 & 43: (left) View of poor masonry repairs at exterior of building 1, (right) View of deteriorated/spalled masonry at exterior of Building 1 (MHBC, 2024)

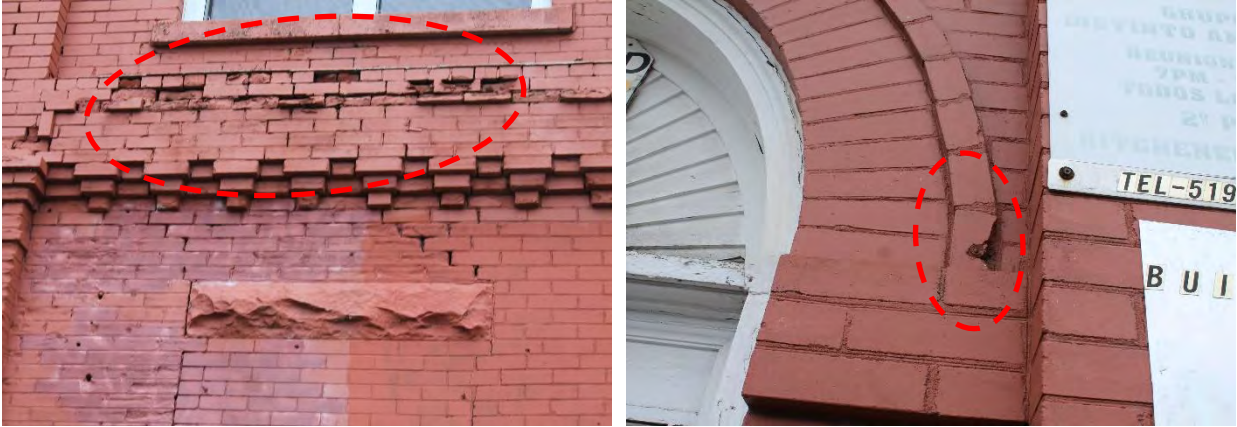
Figures 44 & 45: (left) Secondary view of broken and deteriorated masonry at exterior of Building 1, (right) View of broken masonry in arch above front elevation door opening, (MHBC, 2024)

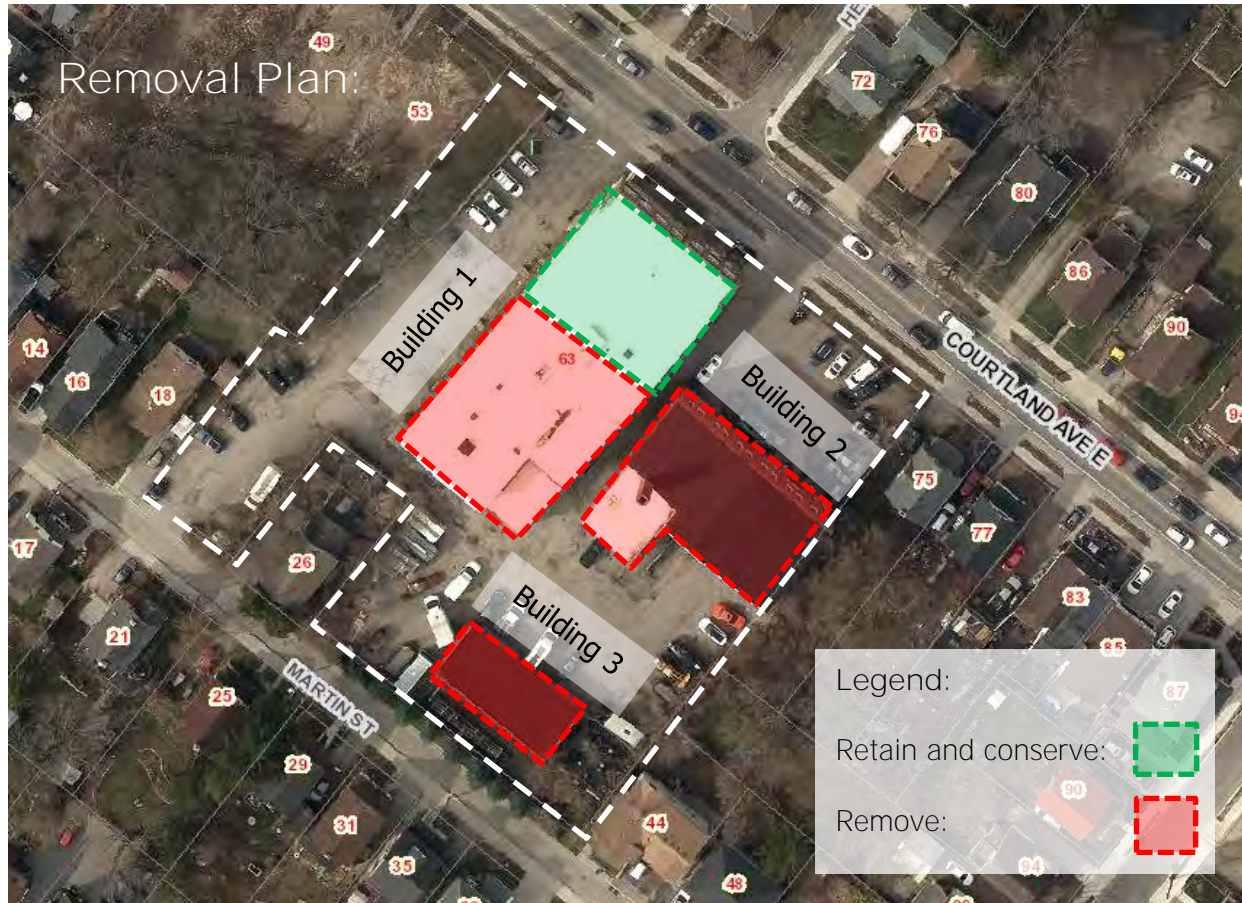
Figure 47: Aerial photo noting the location of the subject property at 63 Courtland Avenue East, outlined in white. Location of building fabric proposed for demolition noted in red (demolish) and retention noted in green. (Source Kitchener Interactive map, accessed 2024)

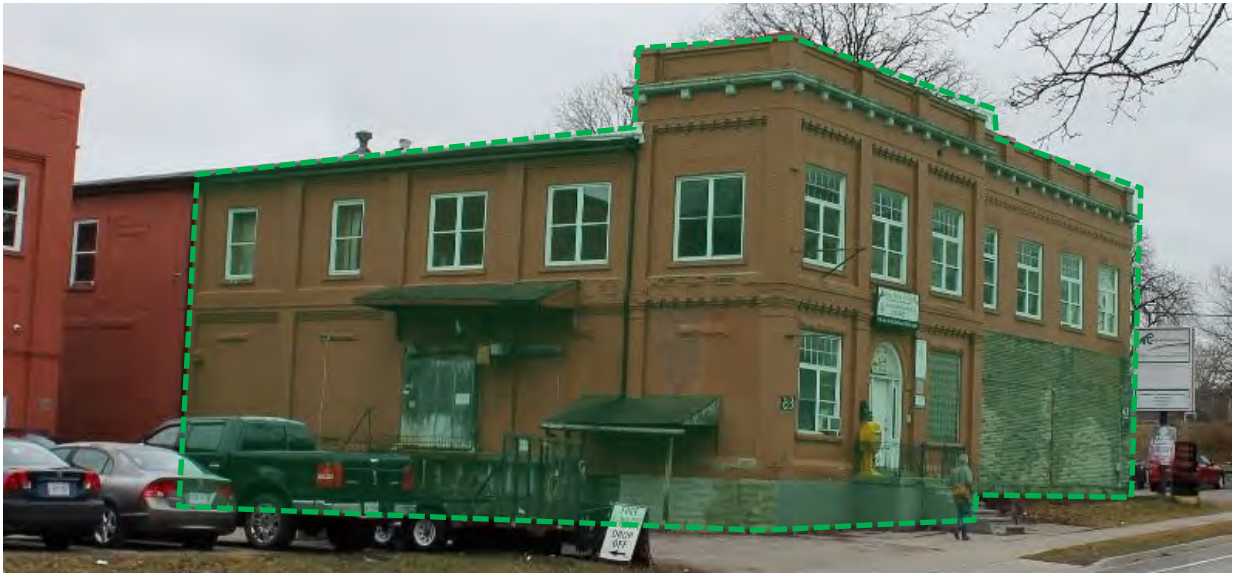
Figure 48: View of Building 1 (east and north elevations) noting portion proposed for retention and conservation (Source: MHBC, 2024)

The proposal includes some alterations to the existing building to facilitate adaptive re-use. All existing windows are not original and are contemporary replacements. All existing windows are proposed to be replaced, respecting original window openings, where present.

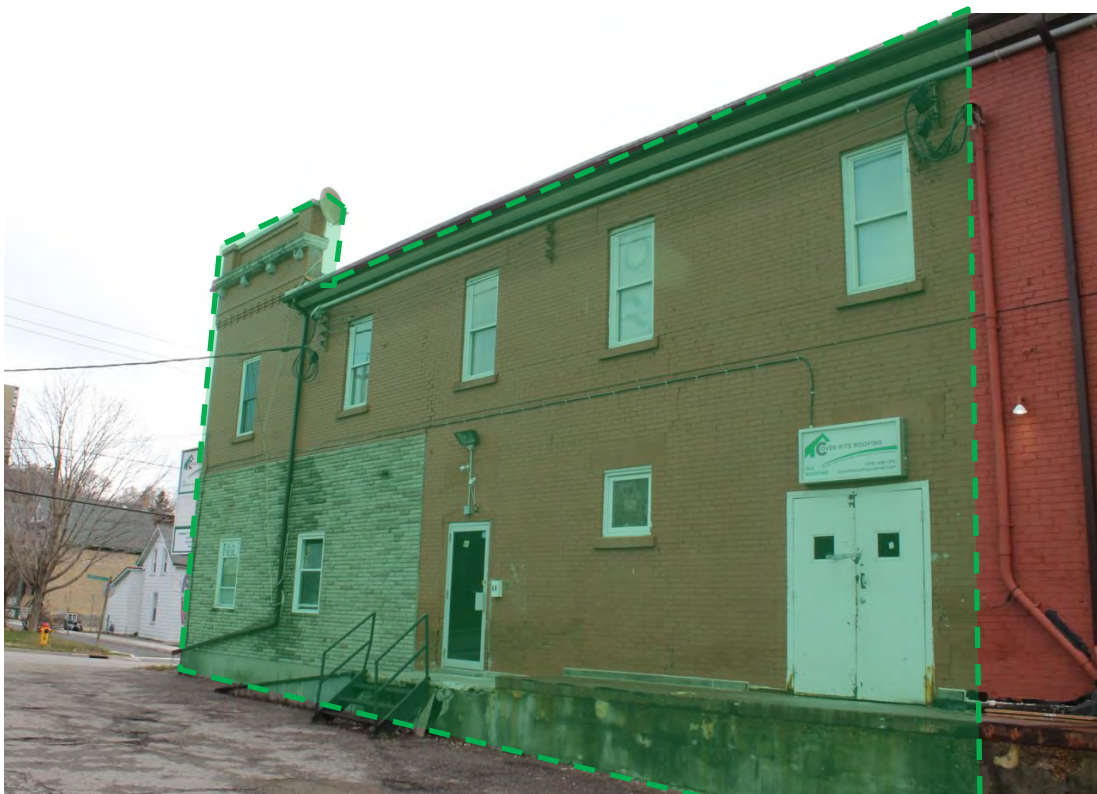
Figure 49: View of Building 1 (west elevation) noting portions proposed for retention (Source: MHBC, 2024)

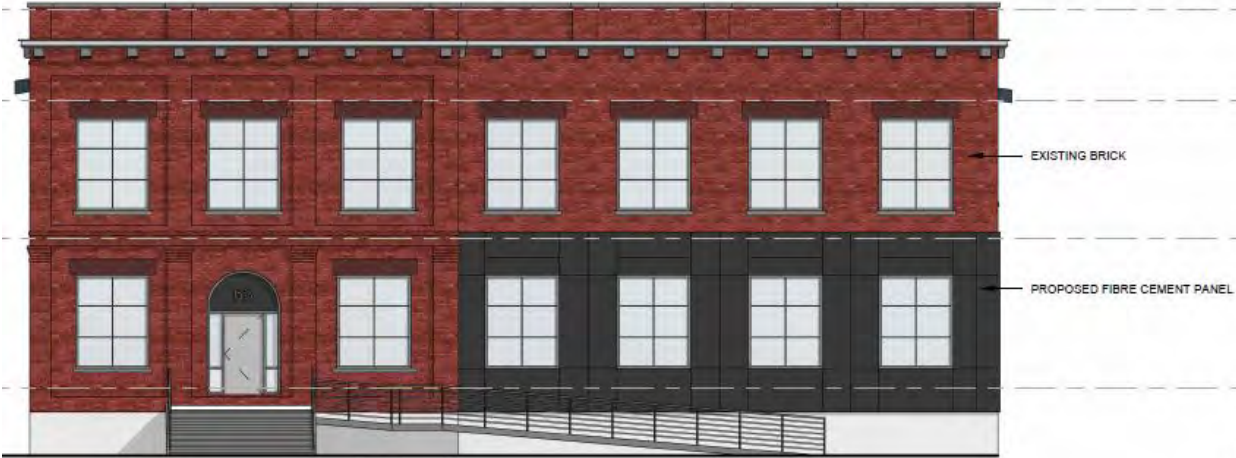
The proposal includes retaining all heritage attributes at the north elevation. Given that the front façade has been altered (i.e. Section Ci), the proposal includes the installation of a dark gray fibre cement panel at the first storey and includes four window openings similar to that of original window openings at the front façade. A new stairway to the front entrance is proposed, with an accessible ramp.

Figure 50: View of proposed front (north) elevation (Source: McCallum Sather, 2025)

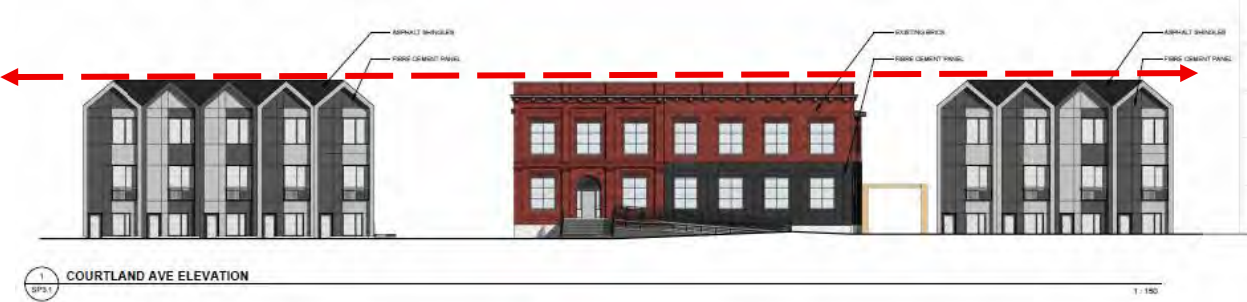
The scale and massing of the proposed new buildings along Courtland Avenue East are similar to that of the heritage building (See Figure 52).

Figure 54: View of proposed north elevations along Courtland Avenue East (noted on site plan as buildings “A”, “B”, and “C” (heritage building and new stacked townhouses) (Source: McCallum Sather, 2025)

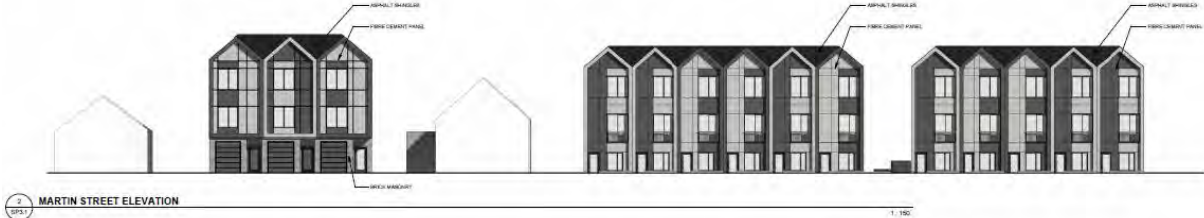
The proposed front (south) elevations of townhouses along Martin Street repeat the same built forms, patterns, positive and negative space, and rhythmic placement of window openings as those along Courtland Avenue.

Figure 55: View of proposed south elevations along Martin Street (new stacked townhouses “E” and “F”, and cluster townhouse “G”) (Source: McCallum Sather, 2025)

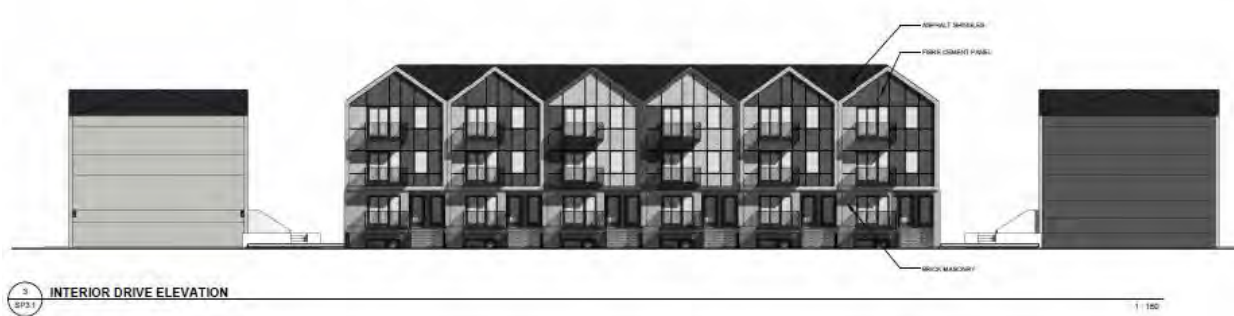
The proposed design of the building fronting onto the interior of the lot at the east property line (Building “D”) is similar to that of proposed new buildings fronting onto Courtland Avenue East and Martin Street. This building is slightly different in that the individual bays separating the stacked townhouses are wider and accommodate balconies.

Figure 56: View of proposed west elevation at the interior of the lot (along the east property line) (new stacked townhouse, noted on site plan as Building “D”) (Source: McCallum Sather, 2025)
