Cultural Heritage Conservation Plan & Commemoration Strategy

628 New Dundee Road, Kitchener ON

Date: November 2023

Prepared for: Fusion Homes

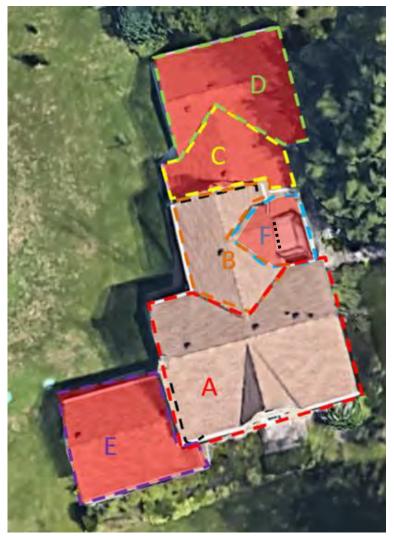
The contemporary additions to the building which are not of Cultural Heritage Value or Interest are proposed for removal. This includes the removal of sections "C", "D","E", and portions of "F".

Figure 3: Aerial image of existing dwelling, noting the contemporary additions to the dwelling which are proposed for removal (shaded in red). Elevations which may require alteration following the removal of contemporary additions noted with dashed black lines. (Source: MHBC, 2023)

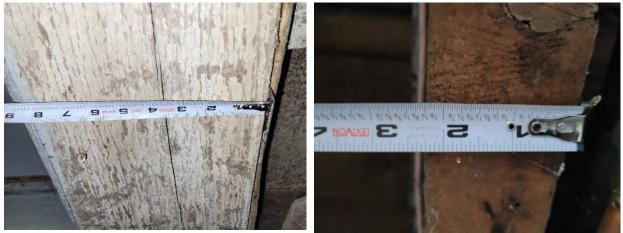
An inspection of the interior of the building from within the basement provides evidence of sawn **structural beams approximately 9" wide and sawn timbers providing floor joists** which are 2 ¼**" wide (**See Figures 12 & 13). The only portion of the building having a basement is Section A.

Figures 12 & 13: (left) Detail view of internal sawn beam, approximately 9" wide, (right) Detail view of interior basement floor joist, approximately 2 <sup>1</sup>/<sub>4</sub>" wide, (Source: MHBC, 2022)

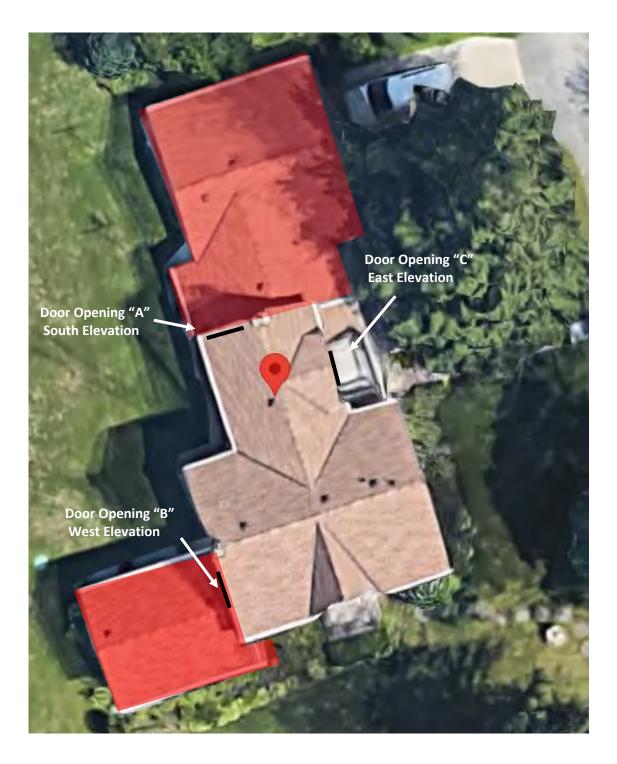
Figure 25: Detail view of building footprint noting portions of the building to be removed (shaded in red) and openings to be exposed following the removal of these sections (see blank lines) (Source: MHBC, 2023)

The removal of Sections "C", "D", "E", and "F" will expose the following door openings of the buildings (See Figures 26 – 28). These openings will require remediation. These door openings will be a) boarded-up shortly after the openings are exposed, b) remain boarded-up during re-location, and c) will be remediated when plans for alterations are formulated as part of Phase II.

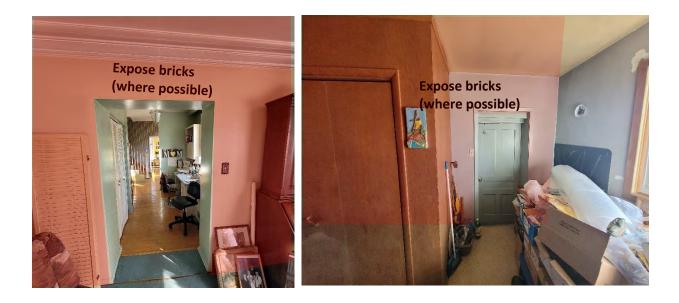
Figures 32 & 33: (left) View door opening "B" (west elevation) noting approximate area where brick may be exposed after contemporary materials are removed, (right) View of door opening "A", looking south, noting area where brick may be exposed (shaded in red) (Source: MHBC, 2023)

Following the removal of the contemporary additions, the portions of the walls being exposed will be covered in drywall and contemporary materials (See these areas as per Figures 32 & 33 below) It is recommended that any original bricks and fabric which may be present underneath these contemporary materials be exposed and repaired, where possible. Bricks should be exposed using hand tools and the gentlest means possible as not to damage authentic heritage fabric.
