BUILDING CONDITION ASSESSMENT

Kitchener Housing

25 JOSEPH ST., Kitchener, ON N2G 4X6

November 22, 2022

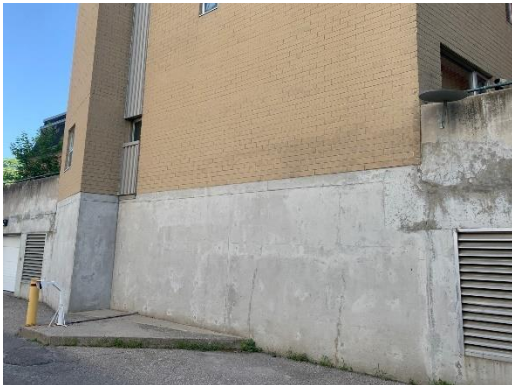
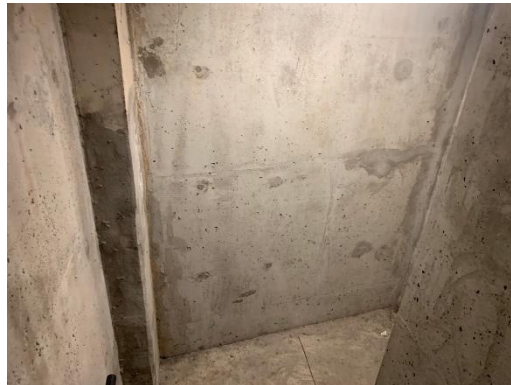
3. 3206 - Wall Foundations

Action Cost:	Not Applicable	Action Year:	Not Applicable
Expected Useful Life:	100	Repeat Cycle:	Not Applicable
Average CoF:	4	Average PoF	2

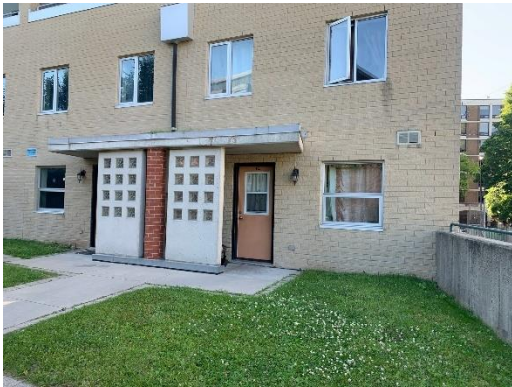
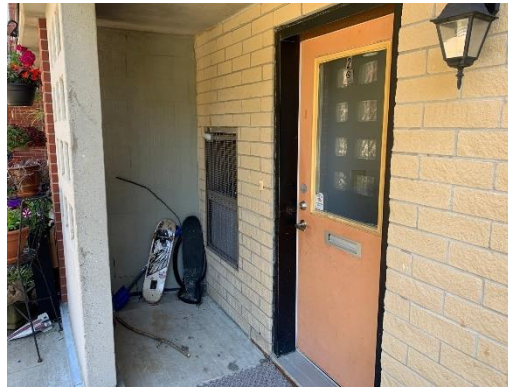
23. 3295 - Other Doors & Entrances

Condition Rating: Fair - 3

Component Condition: The ground-level units of the addition are accessed through hollow-metal glazed doors. Upon inspection, the doors appeared to be in fair condition with signs of wear and aging.

Component Recommendation: An allowance has been included for the replacement of the exterior unit entry doors at the end of their useful life.

Recommended Action: Replacement

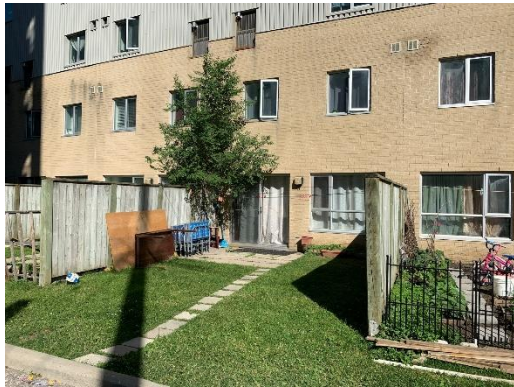
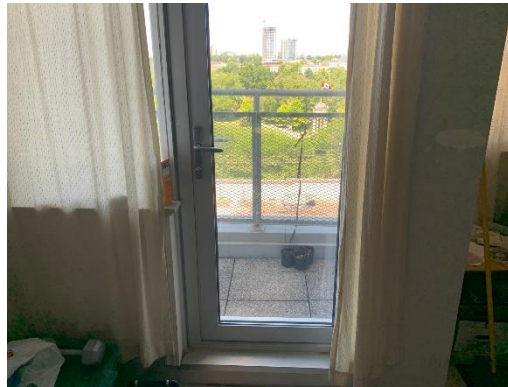
24. 3295 - Other Doors & Entrances

Condition Rating: Fair - 3

Component Condition: Entry onto the unit balconies are provided by aluminum-framed glazed balcony doors. Additionally, the ground-level unit patios are accessed through aluminum-framed glazed sliding doors. Upon inspection, the doors appeared to be in good condition, therefore, their expected service life has been extended.

Component Recommendation: An allowance has been included for the replacement of the unit balcony and patio doors at the end of their useful life.

Recommended Action: Replacement

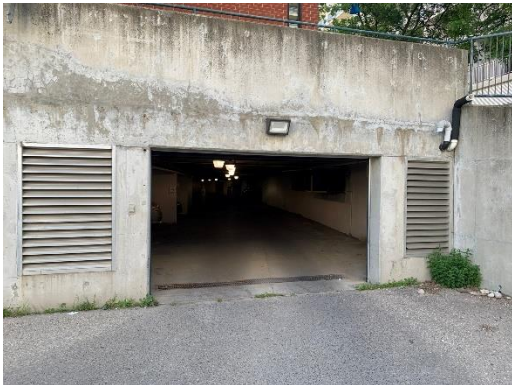
25. 3295 - Other Doors & Entrances

Condition Rating: Fair - 3

Component Condition: There are two aluminum overhead doors which provide access to the parking garage. Additionally, the addition's garbage room is also equipped with an aluminum overhead door. Upon inspection, the doors appeared to be in fair condition with signs of wear and aging.

Component Recommendation: An allowance has been included for the replacement of the overhead doors at the end of their useful life.

Recommended Action: Replacement

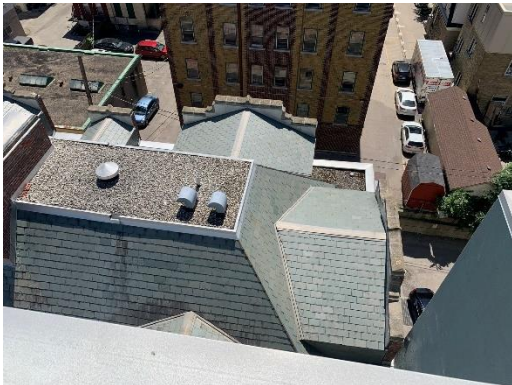
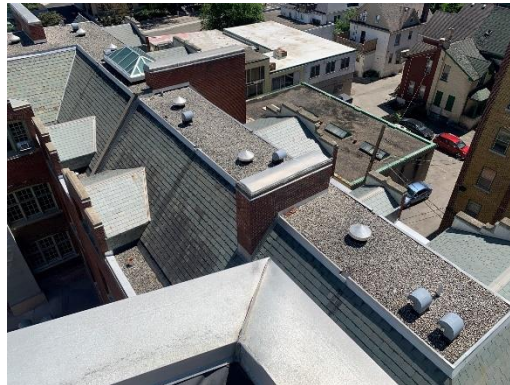
26. 3306 - Roof Finishes

Condition Rating: Good - 2

Component Condition: A portion of the original building's roof is clad with a Built-Up Roofing (BUR) system. The actual age of the roofing is unknown, therefore, the installation year has been estimated. Upon inspection, the roofing appeared to be in good condition.

Component Recommendation: An allowance has been included for the lifecycle replacement of the BUR system at the end of its useful life.

Recommended Action: Replacement

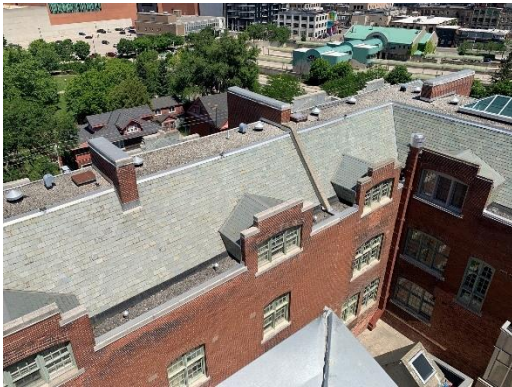
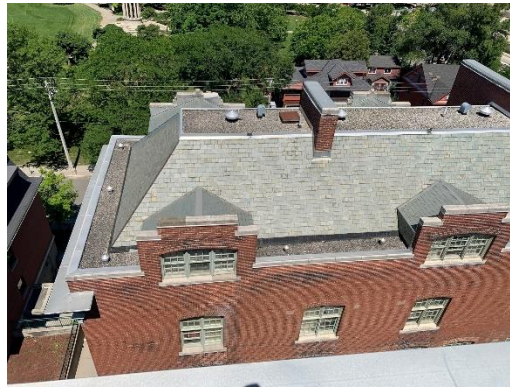
27. 3306 - Roof Finishes

Condition Rating: Good - 2

Component Condition: A portion of the original building's roof is clad with slate roofing. The actual age of the roofing is unknown, therefore, the installation year has been estimated. Upon inspection, the roofing appeared to be in good condition.

Component Recommendation: An allowance has been included for the lifecycle replacement of the slate roofing at the end of its useful life.

Recommended Action: Replacement

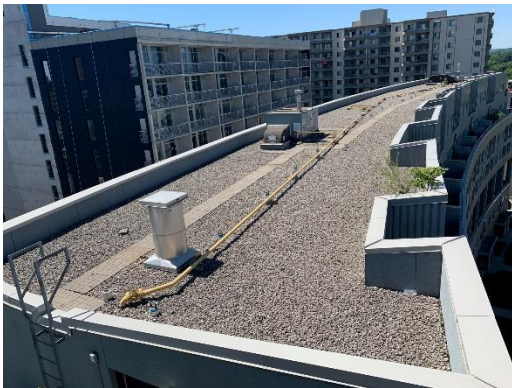
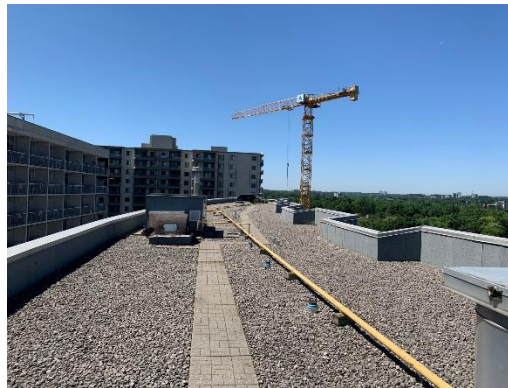
28. 3306 - Roof Finishes

Condition Rating: Good - 2

Component Condition: The addition's roof is clad with a BUR system. The actual age of the roofing is unknown, therefore, the installation year has been estimated. Upon inspection, the roofing appeared to be in good condition.

Component Recommendation: An allowance has been included for the lifecycle replacement of the roofing at the end of its useful life.

Recommended Action: Replacement

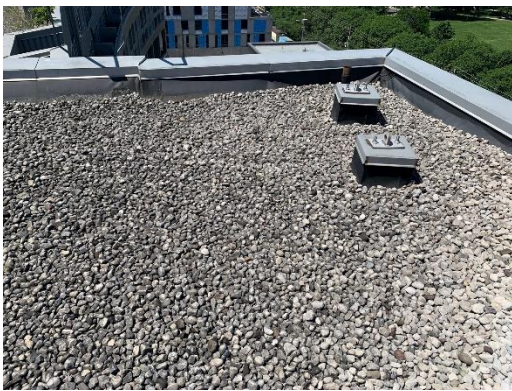
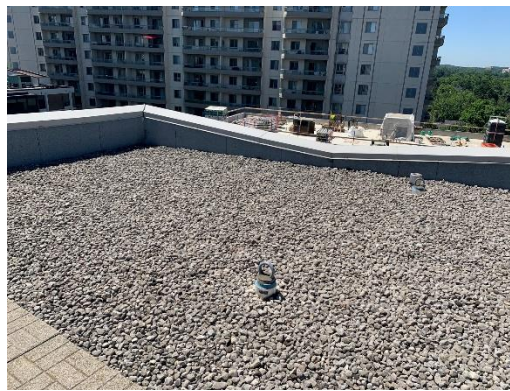
29. 3306 - Roof Finishes

Condition Rating: Good - 2

Component Condition: The roof is equipped with several fall-arrest roof anchors. Upon inspection, the roof anchors appeared to be in good condition.

Component Recommendation: An allowance has been included for the lifecycle replacement of the roof anchors at the end of their useful life.

Recommended Action: Replacement

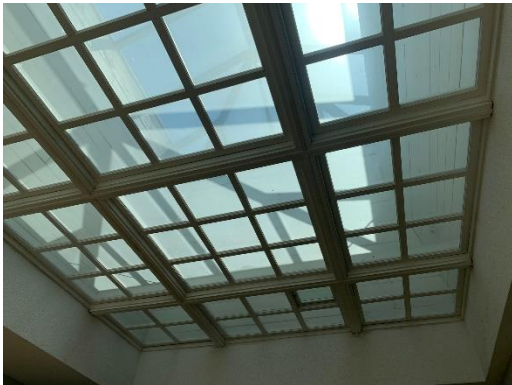
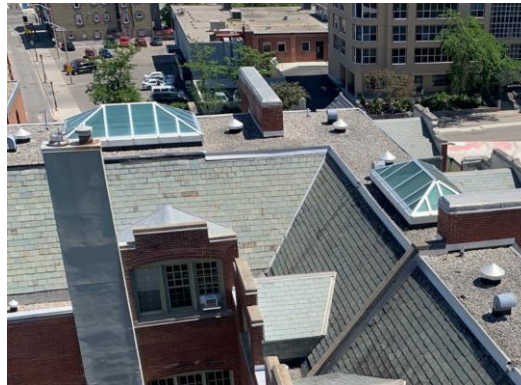
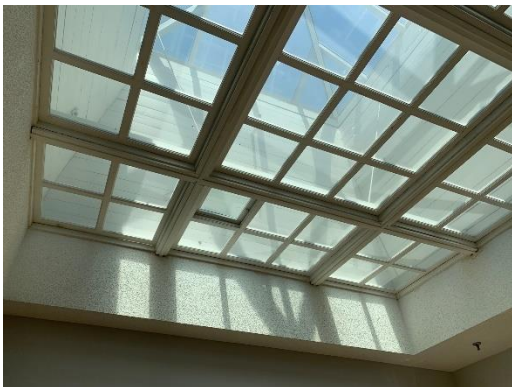
30. 3316 - Glazed Roof Openings

Condition Rating: Good - 2

Component Condition: There are three (3) wood-framed skylights located on the roof of the original building. Upon inspection, the skylights appeared to be in good condition.

Component Recommendation: It is recommended that the skylights be refurbished rather than replaced as they hold value for the building. Therefore, an allowance has been included to refurbish the skylights at the end of their useful life.

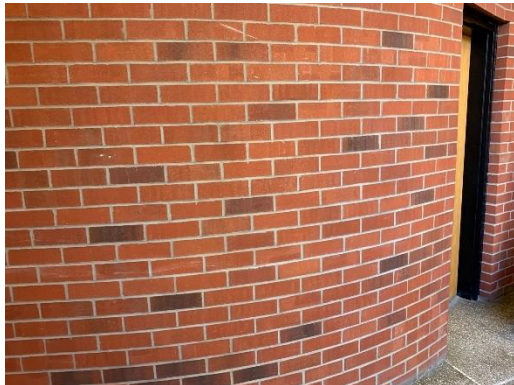
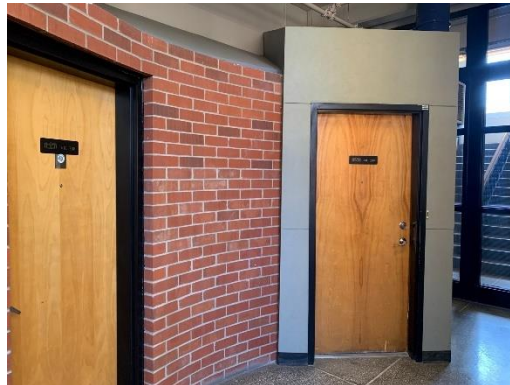
31. 3326 - Fixed Partitions

Condition Rating: Good - 2

Component Condition: There is interior brick masonry present in the lobby of the original building. Upon inspection, the masonry appeared to be in good condition.

Component Recommendation: No major capital expenditures are anticipated within the terms of the study period.

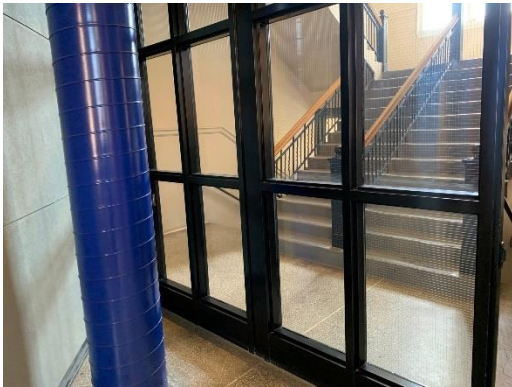
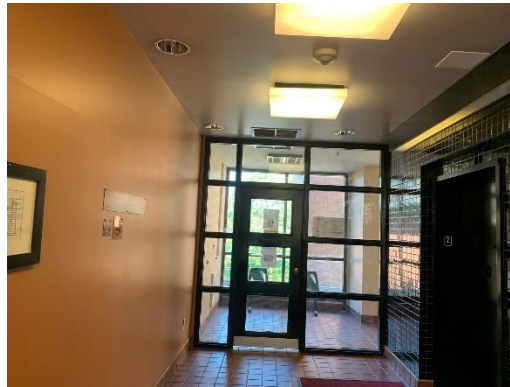
32. 3326 - Fixed Partitions

Condition Rating: Good - 2

Component Condition: There is interior glazing in multiple locations within the common areas of the building. Upon inspection, the glazing appeared to be in good condition.

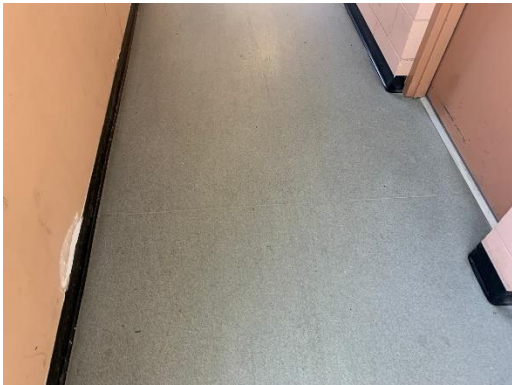
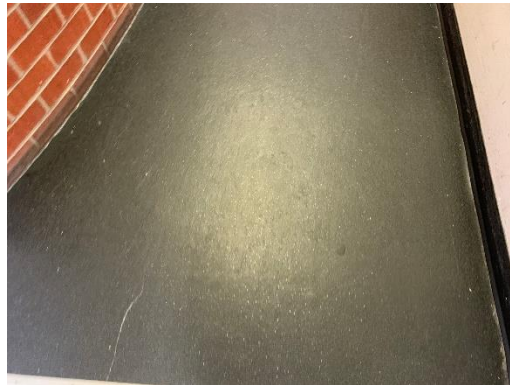
43. 3394 - Flooring

Condition Rating: Good - 2

Component Condition: A portion of the common areas (addition corridors) are equipped with vinyl sheet flooring. Upon inspection, the flooring appeared to be in good condition, therefore, the expected service life of the flooring has been extended.

Component Recommendation: An allowance has been included for the replacement of the vinyl sheet flooring at the end of its useful life.

Action Summary:	Action Description:
Allowance for replacement	Replace vinyl sheet flooring Qty: 1,000 SF Unit Cost: \$8/SF

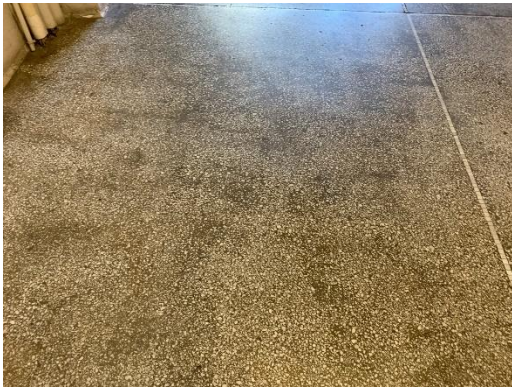
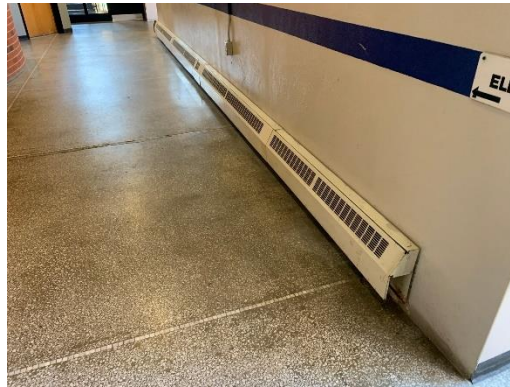
44. 3394 - Flooring

Condition Rating: Good - 2

Component Condition: A portion of floors in the original building are equipped with terrazzo flooring. The actual age of the flooring is unknown, therefore, the installation year has been estimated. Upon inspection, the flooring appeared to be in good condition.

Component Recommendation: An allowance has been included for the lifecycle replacement of the terrazzo flooring at the end of its useful life.

Action Summary:	Action Description:
Allowance for lifecycle replacement	Replace the terrazzo flooring Qty: 1,000 SF Unit Cost: \$95/SF

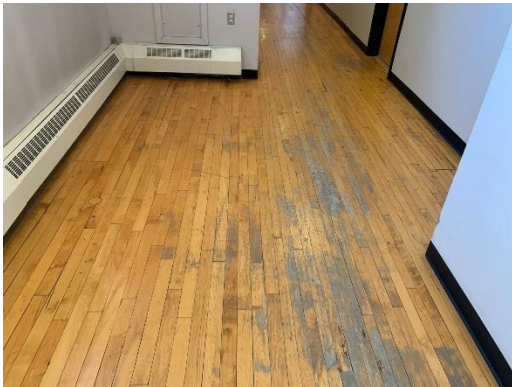
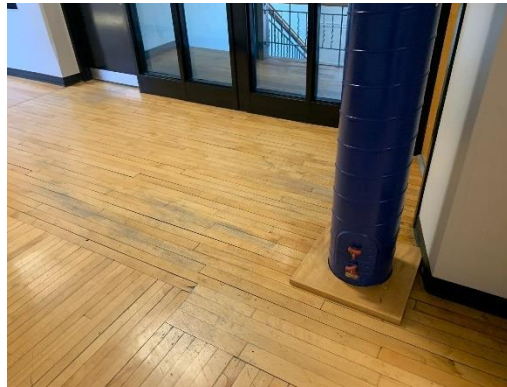
45. 3394 - Flooring

Condition Rating: Fair - 3

Component Condition: A portion of the floors in the original building (corridors) are finished with wood flooring. Upon inspection, the flooring appeared to be in fair condition with visible wear and aging.

Component Recommendation: An allowance has been included for the lifecycle replacement of the wood flooring at the end of its useful life.

Action Summary:	Action Description:
Allowance for replacement	Replace the wood flooring Qty: 2,500 SF Unit Cost: \$25/SF

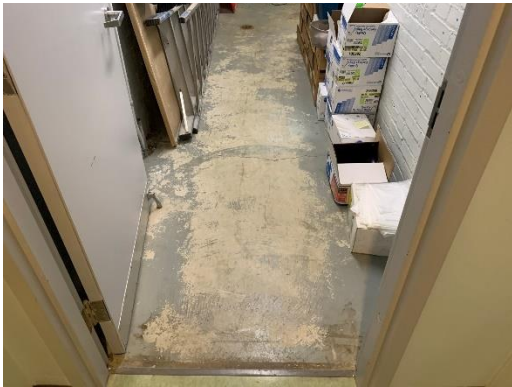
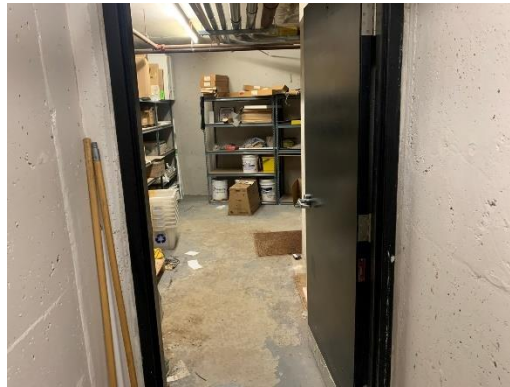
46. 3395 - Carpeting

Condition Rating: Poor - 4

Component Condition: The majority of the service areas are equipped with painted concrete flooring. Upon inspection, the finish appeared to be in poor condition with visible deterioration and damage.

Component Recommendation: An allowance has been included to repaint the service area floors at the end of its useful life.

Action Summary:	Action Description:
Allowance for repairs	Repaint the flooring in the service areas Qty: 5,000 SF Unit Cost: \$3.50/SF

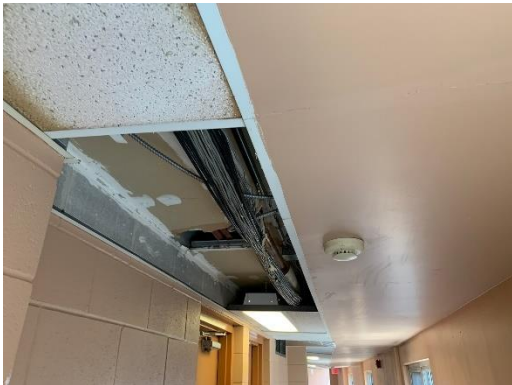
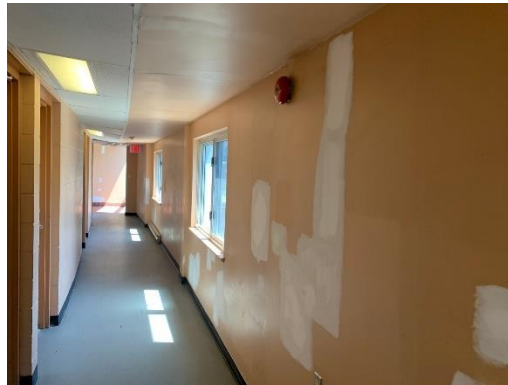
47. 3402 - Suspended Ceilings

Condition Rating: Good - 2

Component Condition: A portion of the addition's corridors are equipped with Acoustic Ceiling Tile (ACT) ceilings. The actual age of the ACT is unknown, therefore, the installation year has been estimated. Upon inspection, the ACT appeared to be in good condition.

Component Recommendation: An allowance has been included for the lifecycle replacement of the ACT at the end of its useful life.

Action Summary:	Action Description:
Allowance for replacement	Replace ACT Qty: 1,000 SF Unit Cost: \$5/SF

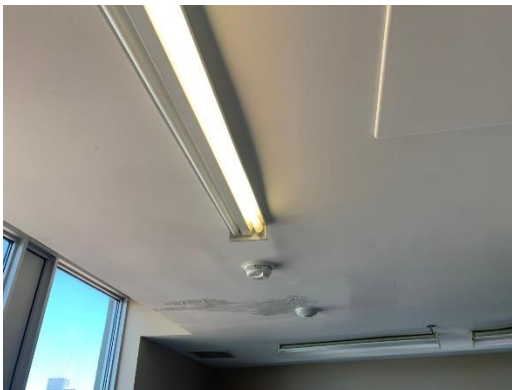
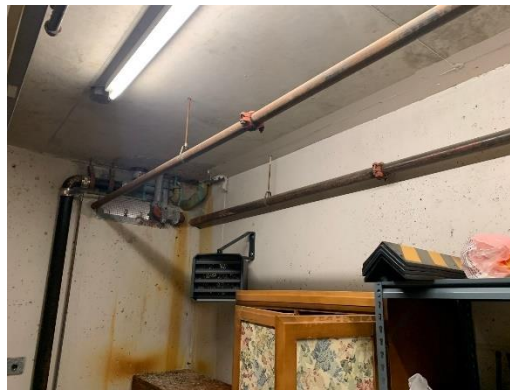
48. 3402 - Suspended Ceilings

Condition Rating: Fair - 3

Component Condition: The majority of the common area ceilings are finished with paint on drywall and concrete ceilings. The actual age of the finish is unknown, therefore, the installation year has been estimated. Upon inspection, the finish appeared to be in fair condition with signs of wear and deterioration.

Component Recommendation: An allowance has been included to repaint the common area ceilings at the end of their useful life.

Action Summary:	Action Description:
Allowance for repairs	Repaint/repair the common area drywall and concrete ceilings Qty: 6,500 SF Unit Cost: \$3.50/SF

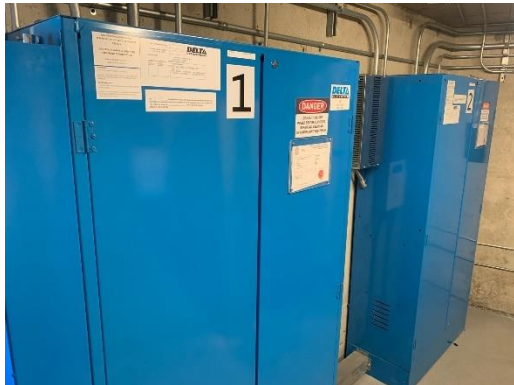
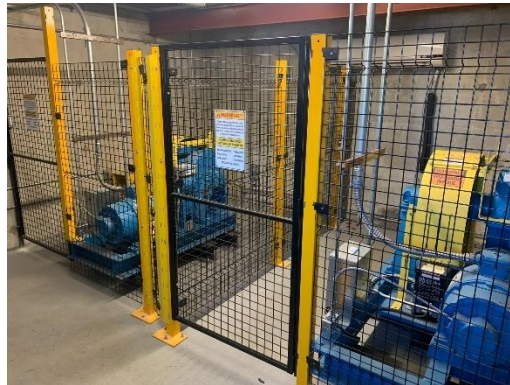
49. 3426 - Passenger Elevators

Condition Rating: Good - 2

Component Condition: Vertical transportation for the building is provided by two (2) traction passenger elevators. The elevators were originally installed in 1992 by Northern Elevator and were modernized in 2017 by Delta. The elevators are currently maintained by Delta. Upon inspection, the elevators appeared to be in good condition. For further details, please refer to the Solucore Elevator Report dated May 9, 2022.

Component Recommendation: An allowance has been included for the major modernization of the passenger elevators at the end of their useful life.

Action Summary:	Action Description:
Allowance for replacement	Major modernization

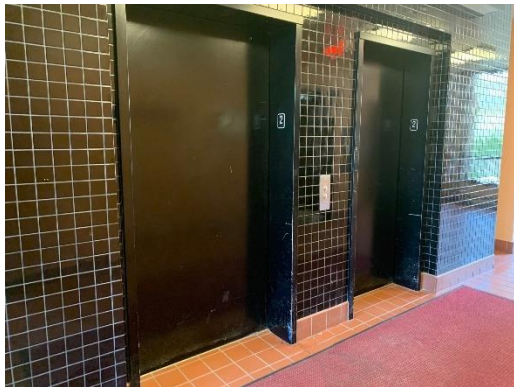
50. 3426 - Passenger Elevators

Condition Rating: Good - 2

Component Condition: The Technical Standards and Safety Authority (TSSA) periodically upgrade/change the requirements for elevators. The elevators may need upgrades to meet the requirements of the TSSA. The elevators may also require repairs due to vandalism. These repairs and upgrades to ensure the elevators comply with the Rulings are not covered under the maintenance contract and are the responsibility of the Owner. For more details please refer to the Elevator Report by Solucore dated May 9, 2022.

Component Recommendation: An allowance has been included for code changes and vandalism repairs to the passenger elevators.

Action Summary:	Action Description:
Allowance for repairs	Upgrades due to code changes and vandalism

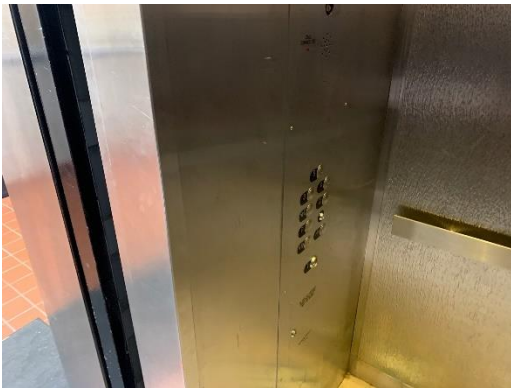
51. 3426 - Passenger Elevators

Condition Rating: Good - 2

Component Condition: The existing door operators have a closed-loop system and are currently in good condition. However, more efficient door operators are entering the market. For more details please refer to the Elevator Report by Solucore dated May 9, 2022.

Component Recommendation: An allowance has been included to replace the door operators at the end of their useful life.

Action Summary:	Action Description:
Allowance for replacement	Replace door operators

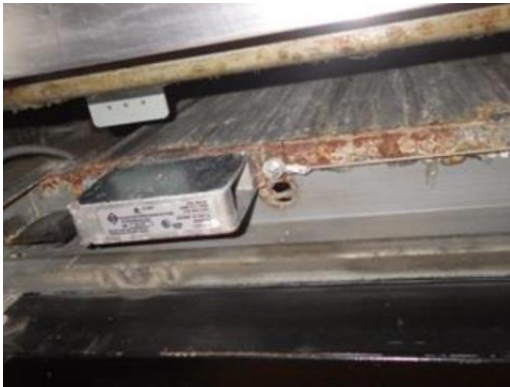
52. 3426 - Passenger Elevators

Element Name: Passenger Elevators 1 and 2 - Rusting

Condition Rating: Good - 2

Recommended Action: Repair

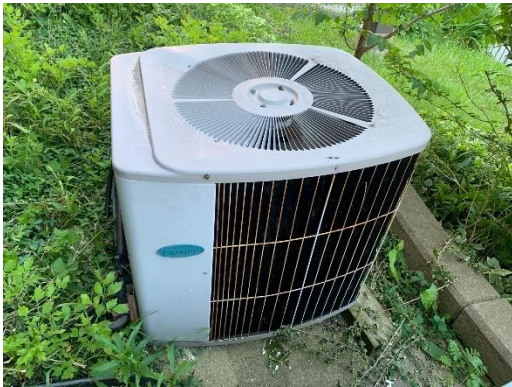
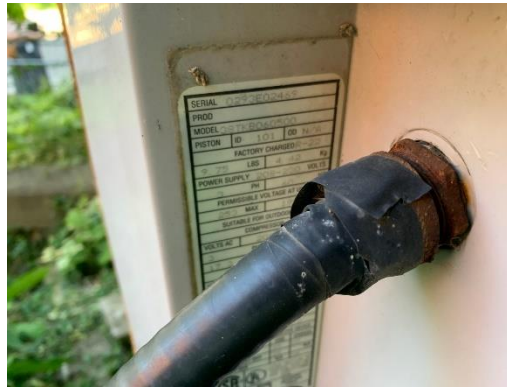
67. 3510 - Cooling Generating Systems

Condition Rating: Good - 2

Component Condition: There is a condensing unit which is manufactured by Carrier (M/N: 38TKB060500) located on the exterior of the building. Upon inspection, the condensing unit appeared to be in fair condition with signs of wear and aging.

Component Recommendation: An allowance has been included for the lifecycle replacement of the condensing unit at the end of its useful life.

Recommended Action: Replacement

Action Summary:	Action Description:
Allowance for lifecycle replacement	Replace condensing unit

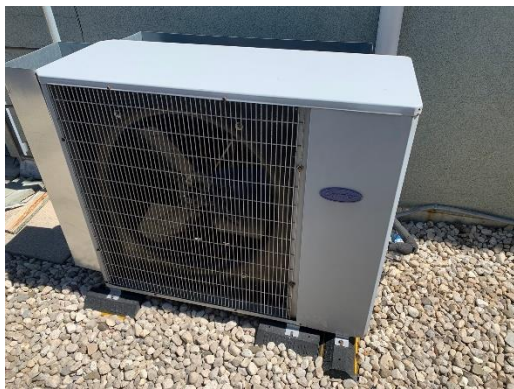
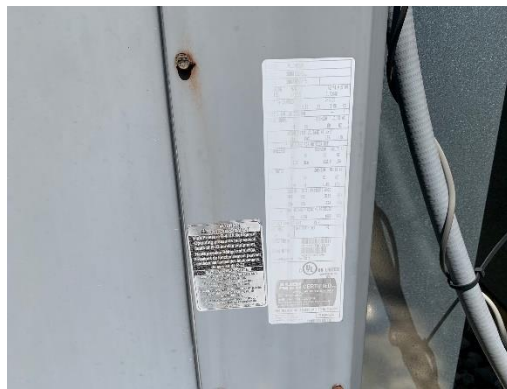
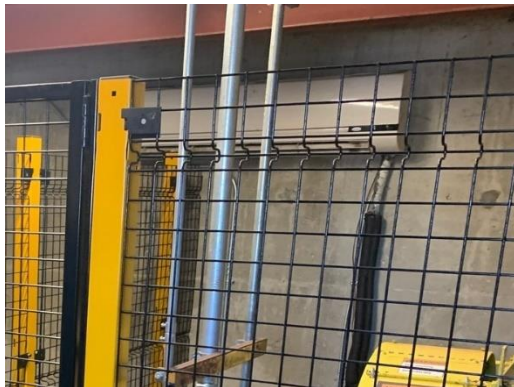
68. 3510 - Cooling Generating Systems

Condition Rating: Good - 2

Component Condition: There is a split system which is manufactured by Carrier (M/N: 38HDF036---3) and is located in the elevator room. Upon inspection, the split system appeared to be in good condition.

Component Recommendation: An allowance has been included for the lifecycle replacement of the split system at the end of its useful life.

Recommended Action: Replacement

Action Summary:	Action Description:
Allowance for lifecycle replacement	Replace split system

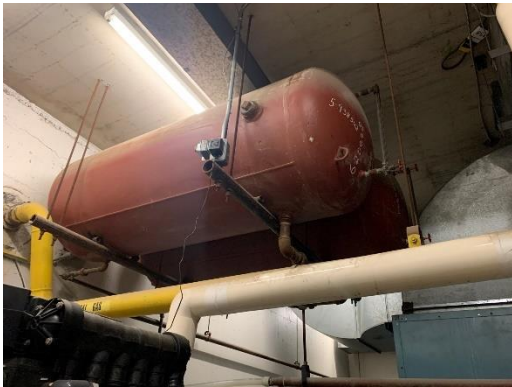
69. 3512 - Direct Expansion Systems

Condition Rating: Good - 2

Component Condition: The hydronic heating system is equipped with two (2) expansion tanks. Upon inspection, the tanks appeared to be in good condition, therefore, their expected service life has been extended.

Component Recommendation: An allowance has been included for the replacement of the expansion tanks at the end of their useful life.

Recommended Action: Replacement

Action Summary:	Action Description:
Allowance for lifecycle replacement	Replace the expansion tanks Qty: 2 Tanks Unit Cost: \$4,000/Tank

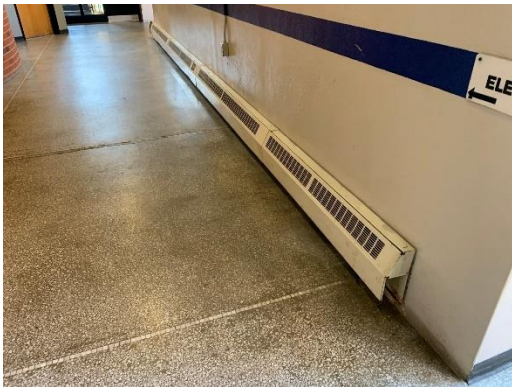
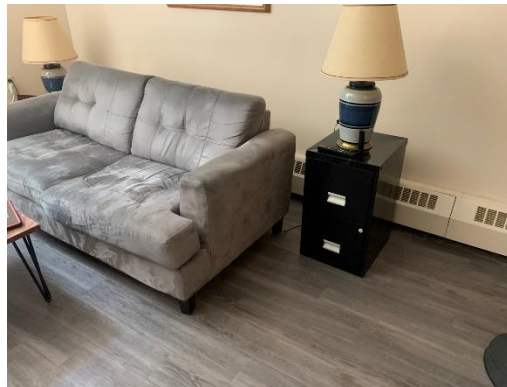
70. 3531 - Heating Generating Systems

Condition Rating: Fair - 3

Component Condition: Heating in the common areas and units of the original building is provided by hydronic baseboard heaters. The actual age of the heater is unknown, therefore, the installation year has been estimated. Upon inspection, the heaters appeared to be in fair condition with signs of wear and aging.

Component Recommendation: An allowance has been included for the lifecycle replacement of the hydronic baseboard heaters at the end of their useful life.

Recommended Action: Replacement

Action Summary:	Action Description:
Allowance for lifecycle replacement	Replace the hydronic baseboards in the original building Qty: 300 Heaters Unit Cost: \$1,000/Heater

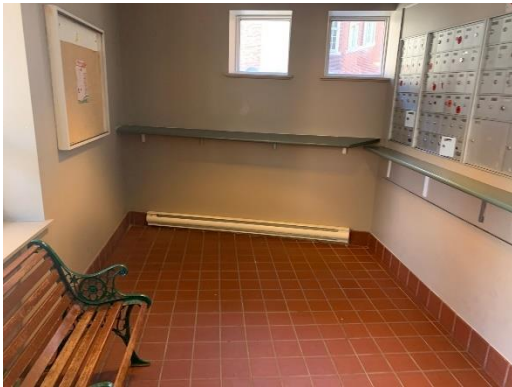
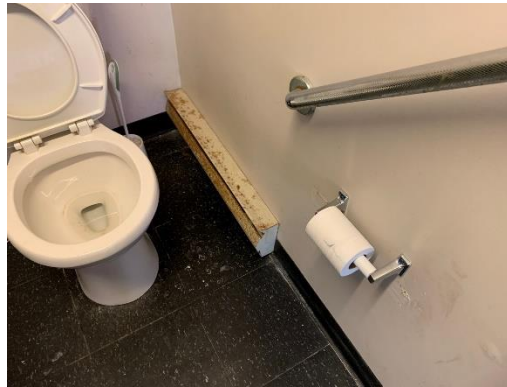
71. 3531 - Heating Generating Systems

Condition Rating: Fair - 3

Component Condition: Heating in the common areas of the building addition is provided by hydronic baseboard heaters. Upon inspection, the heaters appeared to be in fair condition with signs of wear and aging.

Component Recommendation: An allowance has been included for the replacement of the hydronic baseboard heaters at the end of their useful life.

Recommended Action: Replacement

Action Summary:	Action Description:
Allowance for replacement	Replace the hydronic baseboards in the addition Qty: 20 Heaters Unit Cost: \$1,000/Heater

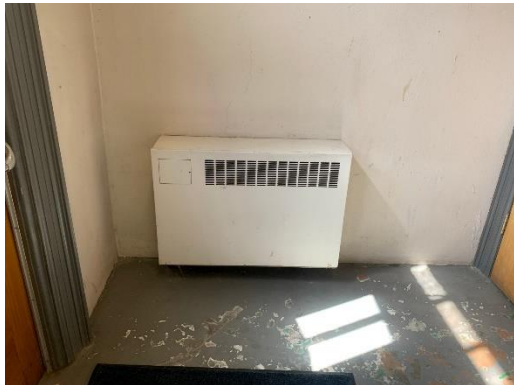
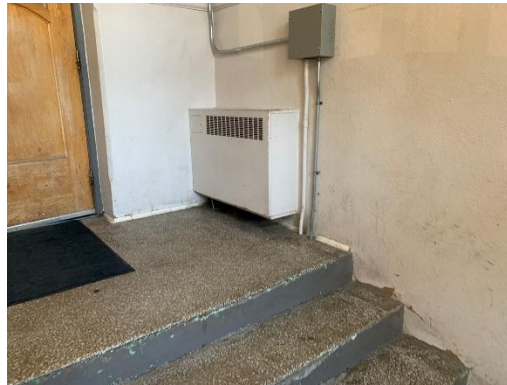
72. 3531 - Heating Generating Systems

Condition Rating: Good - 2

Component Condition: There are approximately ten (10) hydronic cabinet heaters which are located at the entrances to the original building. The actual age of the heaters is unknown, therefore, the installation year has been estimated. Upon inspection, the heaters appeared to be in good condition.

Component Recommendation: An allowance has been included for the lifecycle replacement of the hydronic cabinet heaters at the end of their useful life.

Recommended Action: Replacement

Action Summary:	Action Description:
Allowance for lifecycle replacement	Replace the hydronic cabinet heaters Qty: 10 Heaters Unit Cost: \$1,500/Heater

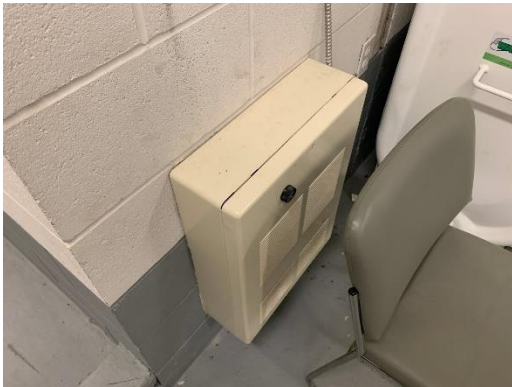
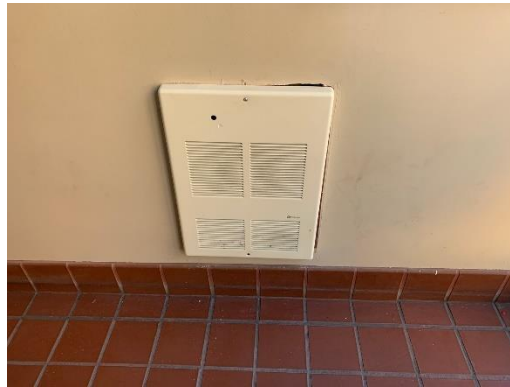
73. 3531 - Heating Generating Systems

Condition Rating: Fair - 3

Component Condition: There are approximately twenty (20) fan-forced unit heaters located throughout the building. Upon inspection, the heaters appeared to be in fair condition with signs of wear and aging.

Component Recommendation: An allowance has been included for the replacement of the fan-forced unit heaters at the end of their useful life.

Recommended Action: Replacement

Action Summary:	Action Description:
Allowance for lifecycle replacement	Replace the fan-forced unit heaters Qty: 20 Heaters Unit Cost: \$1,500/Heater

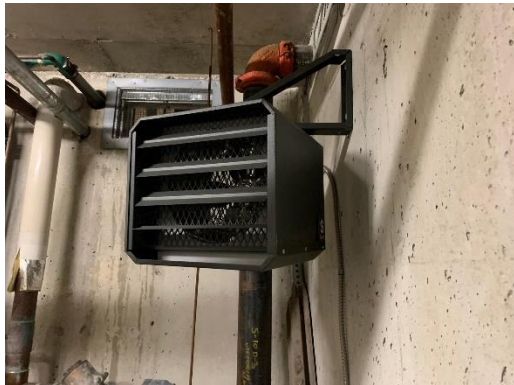
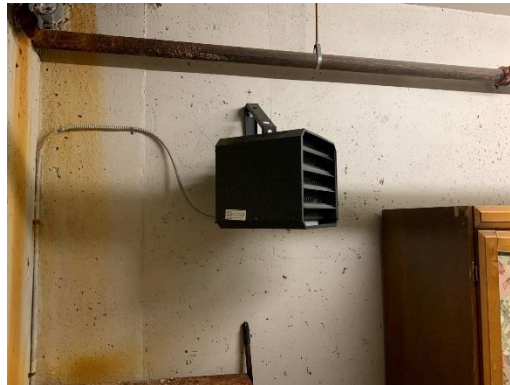
74. 3531 - Heating Generating Systems

Condition Rating: Good - 2

Component Condition: There are approximately four (4) electric ceiling-hung unit heaters located in the service areas of the building. The actual age of the heaters is unknown, therefore, their installation year has been estimated. Upon inspection, the unit heaters appeared to be in good condition overall.

Component Recommendation: An allowance has been included for the lifecycle replacement of the ceiling-hung unit heaters at the end of their useful life.

Recommended Action: Replacement

Action Summary:	Action Description:
Allowance for lifecycle replacement	Replace the electric ceiling-hung unit heaters Qty: 4 Heaters Unit Cost: \$2,500/Heater

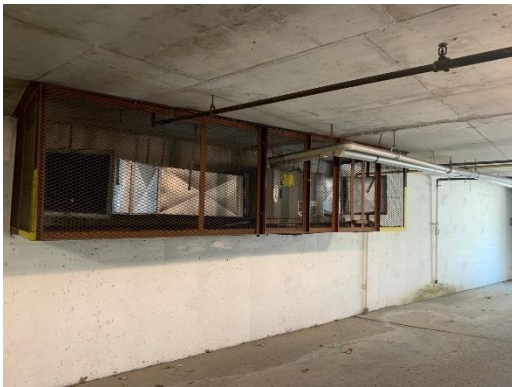
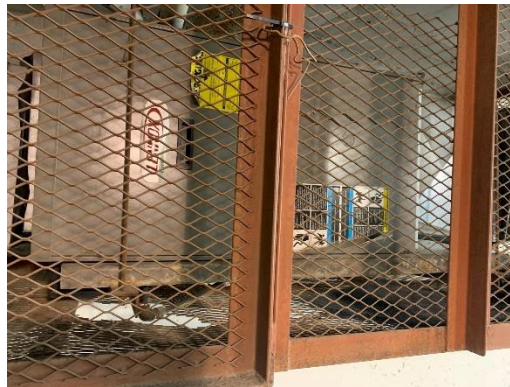
75. 3531 - Heating Generating Systems

Condition Rating: Good - 2

Component Recommendation: An allowance has been included for the lifecycle replacement of the furnaces at the end of their useful life.

Recommended Action: Replacement

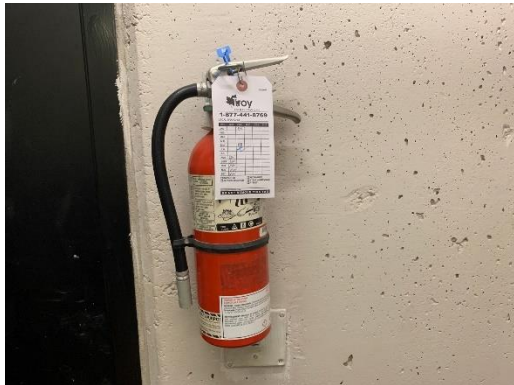
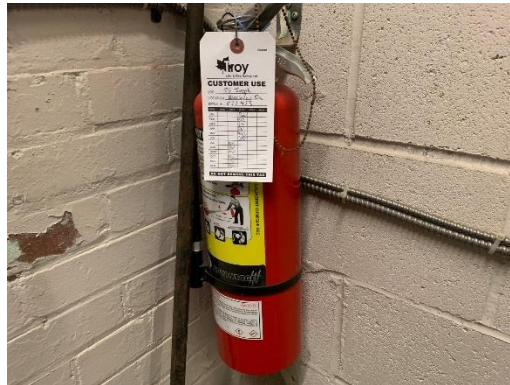
86. 3576 - Fire Extinguishers

Condition Rating: Good - 2

Component Condition: There are approximately twenty (20) fire extinguishers located throughout the building. The actual age of the fire extinguishers is unknown, therefore, the installation year has been estimated. Upon inspection, the fire extinguishers appeared to be in good condition.

Component Recommendation: An allowance has been included for the lifecycle replacement of the fire extinguishers at the end of their useful life.

Recommended Action: Replacement

Action Summary:	Action Description:
Allowance for lifecycle replacement	Replace the fire extinguishers Qty: 20 Units Unit Cost: \$500/unit

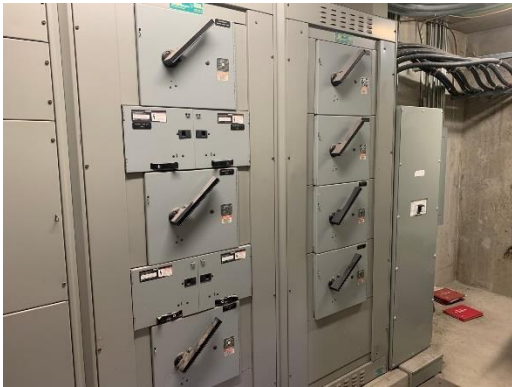
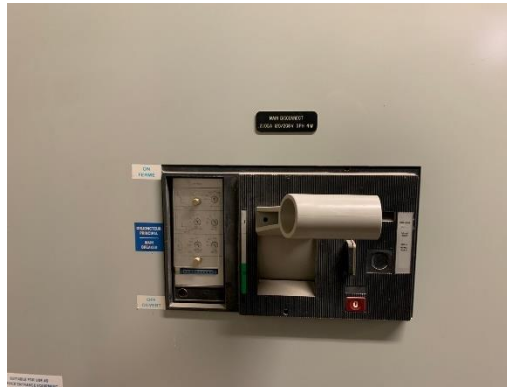
87. 3596 - High Tension Service & Dist.

Condition Rating: Good - 2

Component Condition: The primary electrical distribution system for the building is comprised of a 2500A switchboard which is manufactured by Siemens (3-Phase, 4-Wire) and located in the electrical room. Upon inspection, the switchboard appeared to be in good condition.

Component Recommendation: An allowance has been included for the lifecycle replacement of the switchboard at the end of its useful life.

Recommended Action: Replacement

Action Summary:	Action Description:
Allowance for lifecycle replacement	Replace the main switchboard

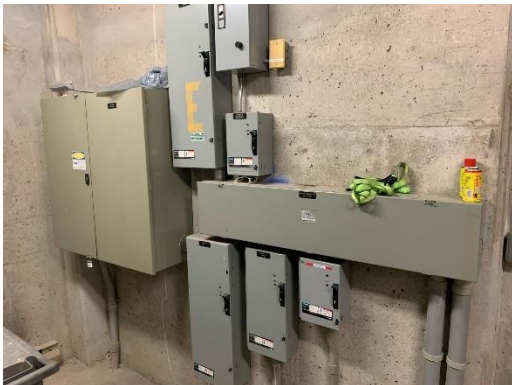
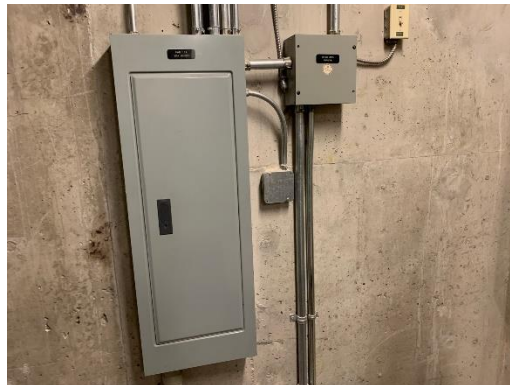
88. 3597 - Low Tension Service & Dist.

Condition Rating: Good - 2

Component Condition: The secondary electrical distribution system for the building is comprised of approximately fourteen (14) distribution panels and three (3) safety switches. Upon inspection, the panels and switches appeared to be in good condition.

Component Recommendation: An allowance has been included for the lifecycle replacement of the secondary electrical panels and switches at the end of their useful life.

Recommended Action: Replacement

Action Summary:	Action Description:
Allowance for lifecycle replacement	Replace secondary electrical panels and switches 60-200A Panels: Qty: 6 Panels Unit Cost: \$2,500/Panel 200A Panels: Qty: 6 Panels Unit Cost: 5,000/Panel 600A Panels: Qty: 2 Panels Unit Cost: 8,000/Panel 60-200A Switches: Qty: 3 Switches Unit Cost

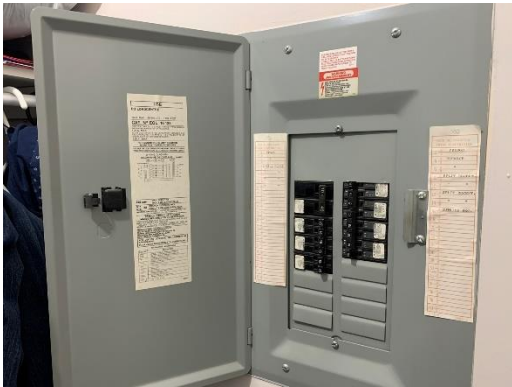
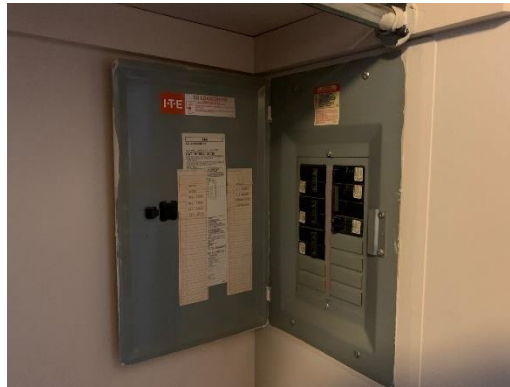
89. 3597 - Low Tension Service & Dist.

Condition Rating: Good - 2

Component Condition: Each unit is equipped with a 125A electrical distribution panel which is manufactured by ITE. Upon inspection, the panels appeared to be in good condition.

Component Recommendation: An allowance has been included for the lifecycle replacement of the unit electrical panels at the end of their useful life.

Recommended Action: Replacement

Action Summary:	Action Description:
Allowance for lifecycle replacement	Replace the unit electrical panels Qty: 100 Units Unit Cost: \$1,500/Unit

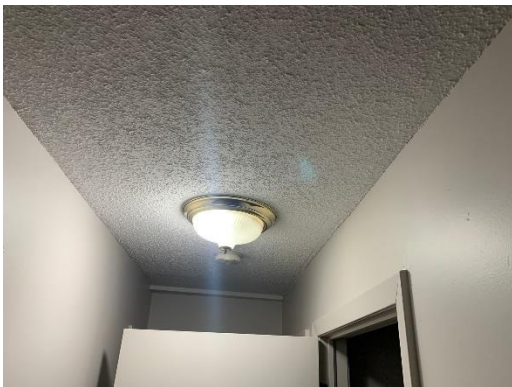
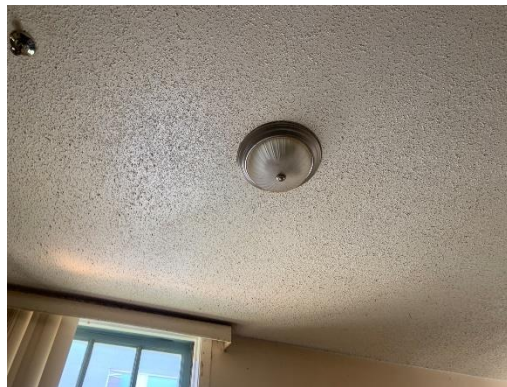
90. 3602 - Lighting Equipment

Condition Rating: Fair - 3

Component Condition: Hardwired light fixtures in the units use incandescent and CFL bulbs in ceiling-mounted lighting fixtures. Each unit has approximately seven (7) lighting fixtures. Upon inspection, the lighting fixtures appeared to be in fair condition with signs of wear and aging.

Component Recommendation: It is recommended the existing fixtures be replaced with LED fixtures for improved energy saving and illumination quality. A turnover rate of 5% (5 units) is anticipated annually, at which time replacement of the unit lighting fixtures is recommended. Therefore, an allowance has been included for the replacement of the lighting fixtures in five (5) units every year.

Recommended Action: Replacement

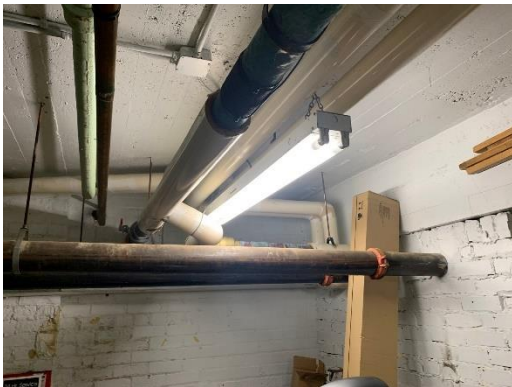
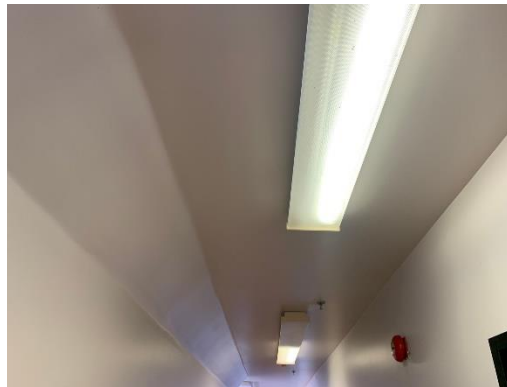
91. 3602 - Lighting Equipment

Condition Rating: Good - 2

Component Condition: Hardwired light fixtures in the common areas use incandescent and CFL bulbs and tubes in ceiling-mounted lighting fixtures. The actual age of the fixtures is unknown, therefore, the installation year has been estimated. Upon inspection, the fixtures appeared to be in good condition

Component Recommendation: It is recommended the existing fixtures be replaced with LED fixtures for improved energy saving and illumination quality. An allowance has been included for the lifecycle replacement of the common area lighting fixtures at the end of their useful life.

Recommended Action: Replacement

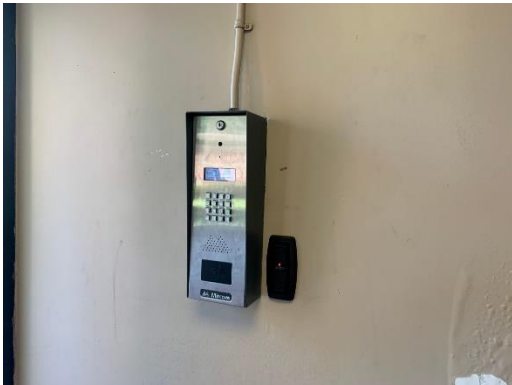
92. 3607 - Intercommunication & Paging System

Condition Rating: Good - 2

Component Condition: The building is equipped with an Enterphone system at the main entrance. The actual age of the system is unknown, therefore, the installation year has been estimated. Upon inspection, the Enterphone appeared to be in good condition, therefore, the expected service life of the Enterphone has been extended.

Component Recommendation: An allowance has been included for the replacement of the Enterphone at the end of its useful life.

Recommended Action: Replacement

Action Summary:	Action Description:
Allowance for lifecycle replacement	Replace Enterphone

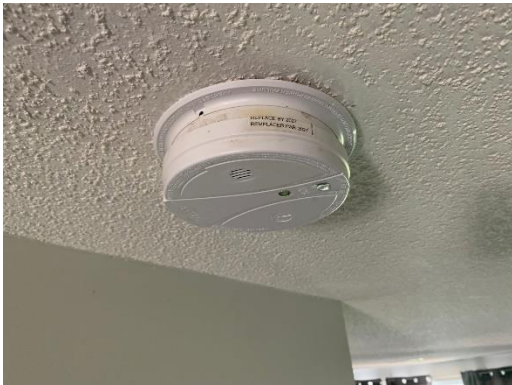
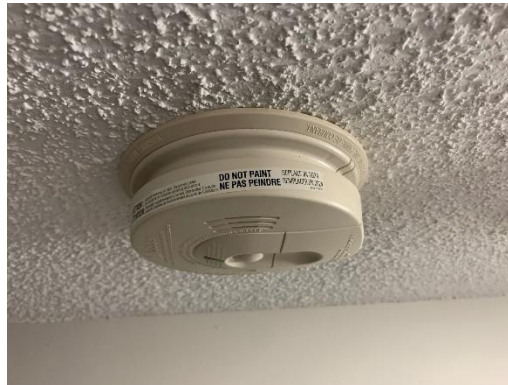
93. 3612 - Fire Alarm Systems

Condition Rating: Good - 2

Component Condition: Each unit is equipped with a hard-wired smoke detector. Upon inspection, the smoke detectors appeared to be in good to fair condition based on the replacement dates of the observed units.

Component Recommendation: An allowance has been included for the replacement of the smoke detectors as needed.

Recommended Action: Replacement

Action Summary:	Action Description:
Allowance for lifecycle replacement	Replace smoke detectors as needed (10% of total units) Quantity: 10 Units Unit Cost: \$150/Unit

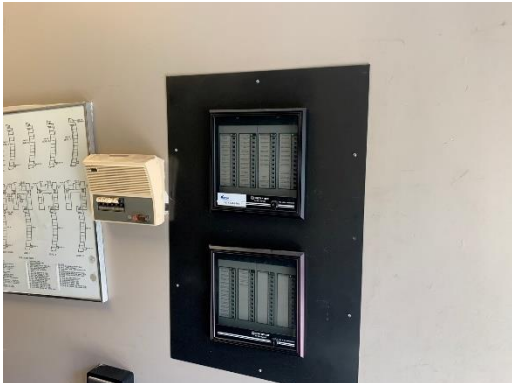
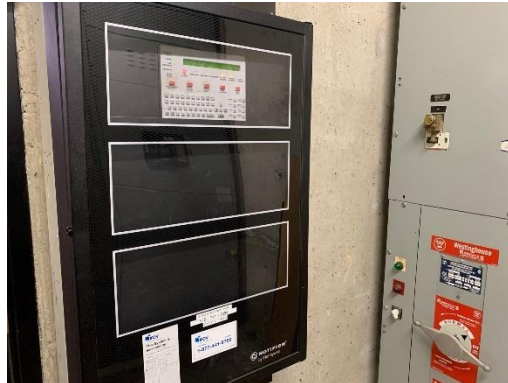
94. 3612 - Fire Alarm Systems

Condition Rating: Good - 2

Component Recommendation: An allowance has been included for the lifecycle replacement of the fire alarm panels at the end of their useful life.

Recommended Action: Replacement

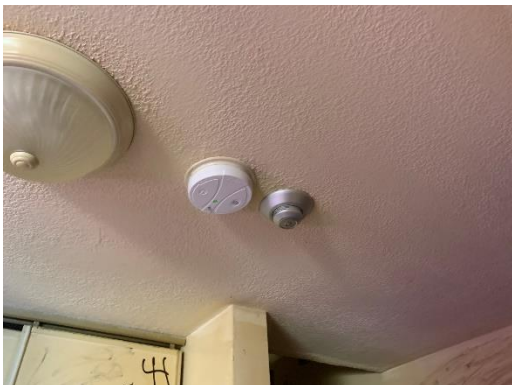
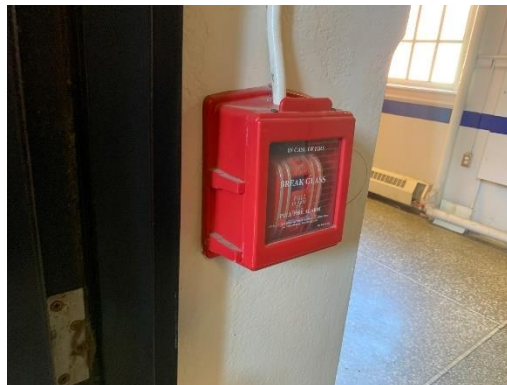
95. 3612 - Fire Alarm Systems

Condition Rating: Good - 2

Recommended Action: Replacement

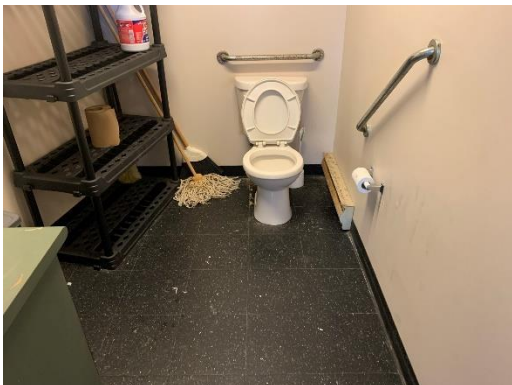
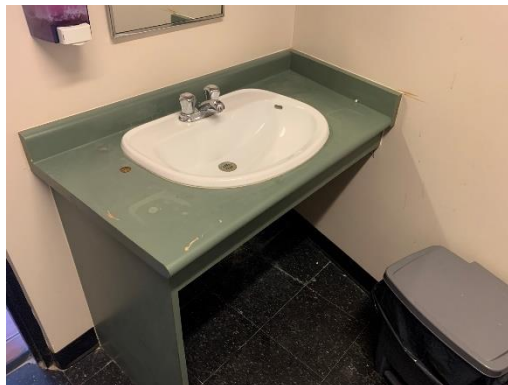
Condition Rating: Fair - 3

Component Condition: The addition of the building is equipped with four (4) common area washrooms. The washrooms are equipped with a wood vanity, a laminate countertop, a ceramic sink with a metal faucet, a toilet (unknown LPF), a ceiling-mounted exhaust fan, VCT (Vinyl Composite Tile) flooring, and painted drywall walls and ceilings. The actual age of the washrooms is unknown, therefore, the installation year has been estimated. Upon inspection, the washrooms appeared to be in fair condition. Washroom renovations are inclusive of a vanity, a countertop, a ceramic sink with a metal faucet, a toilet, flooring finishes and paint touch-ups.

Component Recommendation: An allowance has been included for the renovation of the common washrooms at the end of their useful life.

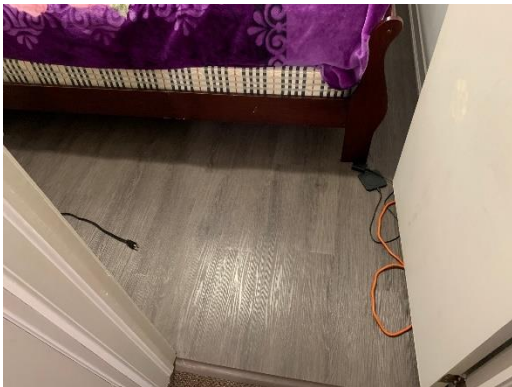
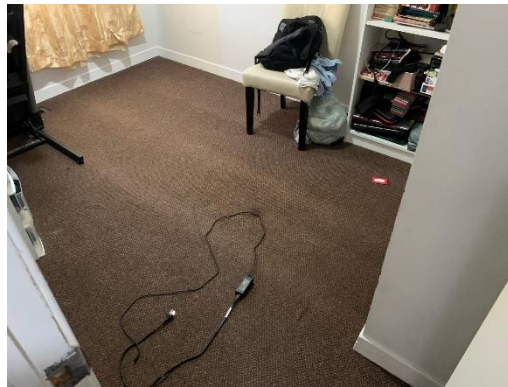
Condition Rating: Good - 2

Component Condition: The interior finishes of the units are comprised of painted drywall ceilings with or without a stipple finish, painted drywall walls, and either wood, laminate, carpet, or VCT flooring. Upon inspection, the unit interior finishes appeared to be in good condition.

Component Recommendation: A turnover rate of 5% (5 units) is anticipated annually, at which time renovation of the unit interior finishes is recommended. Therefore, an allowance has been included for the renovation of the interior finishes of five (5) units every year.

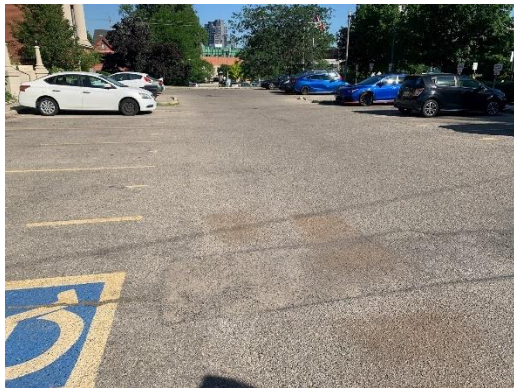
Condition Rating: Good - 2

Component Condition: There is an asphalt roadway which leads from Joseph Street through the site. Site parking is provided by an asphalt parking lot which is located on the North end of the site. Upon inspection, the asphalt paving appeared to be in good condition.

Component Recommendation: An allowance has been included to resurface the asphalt paving within the study period.

Action Summary:	Action Description:
Allowance for repairs	Resurface the asphalt paving Qty: 16,700 SF Unit Cost: \$2.50/SF
