BUILDING CONDITION ASSESSMENT

Kitchener Housing

25 JOSEPH ST., Kitchener, ON N2G 4X6

November 22, 2022

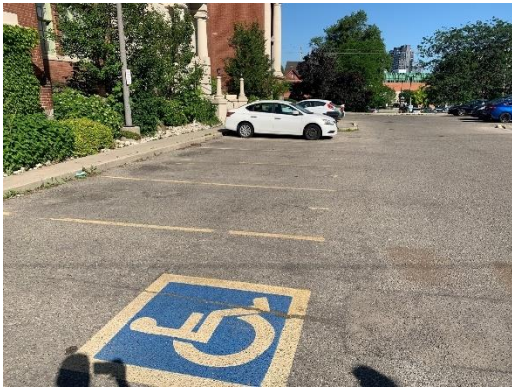
Condition Rating: Good - 2

Component Condition: Please refer to the previous element for commentary.

Component Recommendation: An allowance has been for the replacement of the asphalt paving at the end of its useful life.

Action Summary:	Action Description:
Allowance for replacement	Replace the asphalt paving Qty: 16,700 SF Unit Cost: \$7/SF

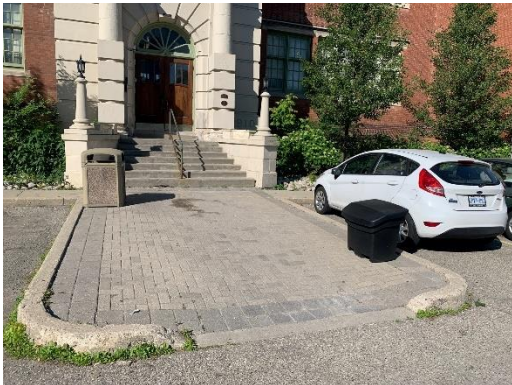
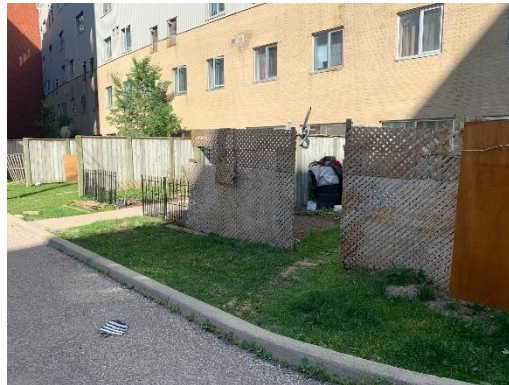
Condition Rating: Good - 2

Component Condition: The perimeter of the paved asphalt parking and roadways are equipped with poured concrete curbs. The concrete curbs were observed to be in good condition overall with minor cracks and chipping noted.

Component Recommendation: An allowance has been included for the lifecycle replacement of the concrete curbs at the end of their useful life.

Action Summary:	Action Description:
Allowance for repairs	Replace the concrete curbs Qty: 970 LF Unit Cost: \$25/LF

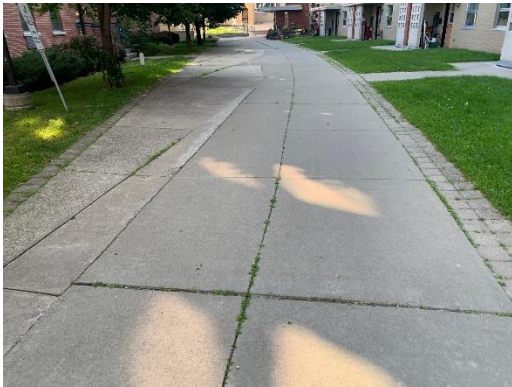
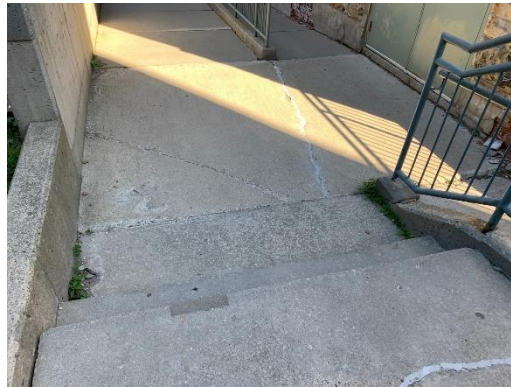
Condition Rating: Good - 2

Component Condition: Pedestrian walkways for the site are comprised of poured concrete and interlocking brick. Upon inspection, the walkways appeared to be in good condition.

Component Recommendation: An allowance has been included for the lifecycle replacement of the concrete walkways at the end of their useful life.

Action Summary:	Action Description:
Allowance for lifecycle replacement	Replace concrete walkways Qty: 500 LF Unit Cost: \$25/LF

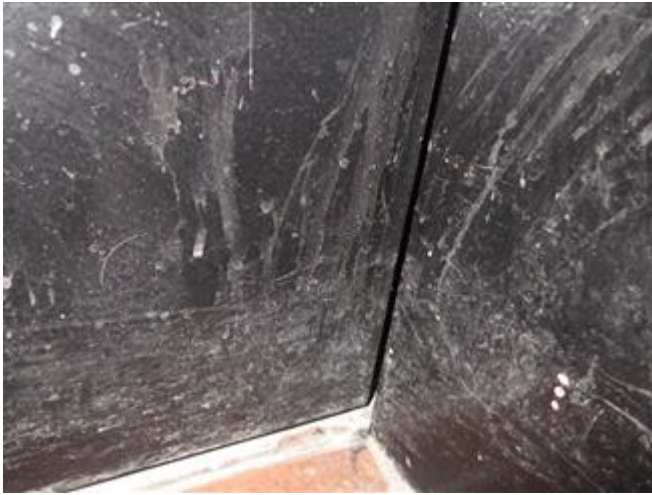
Photo - 1

#	Elevator	Description	Photo
1	1	The cab handrail is loose or damaged. The cab handrail should be repaired or secured properly. Right hand side is loose.	
2	1	We observed rollback in one or both directions. The contractor should adjust the preloading and rollback of the elevator as well as review the drive and acceleration parameters.	
3	1	The car door is scratched, scuffed, or damaged. The contractor should refinish or repair the door as required.	
4	1	The overlap between the hall door and entrance frame is less than the allowable limit. Adjust the door to increase the overlap and prevent any passenger injuries. On floor 4.	
5	1	One or more hall door gibs are loose or worn. The worn gibs should be replaced or adjusted to prevent excessive door movement or scraping. On floor 4	
6	1	The grounding/bonding for the machine guards is missing or not secured properly. The grounding should be provided and properly installed. Missing.
