Documentation, Salvage & Commemoration Report (revised)

1027 King Street East,
Kitchener ON.

Date:
January, 2024
(original submission October 2023;
updated December 2023; and
January 2024)

Prepared for:
VIVE Development

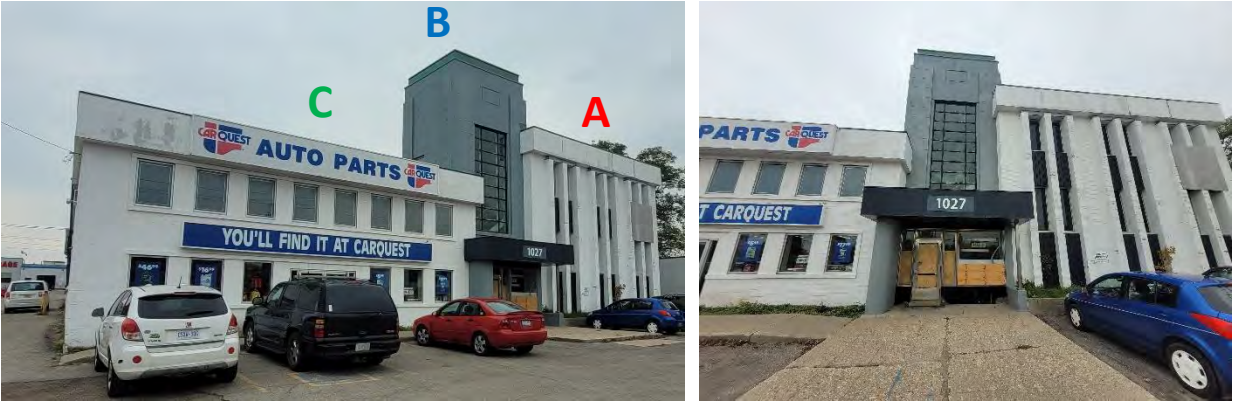
The north elevation includes the front façade of Sections 'A', 'B', and 'C' of the building. Section 'A' (to the west) includes a main floor (slightly below grade), as well as a second and third storey above. The north elevation displays three bays of vertical windows which have been altered from their original appearance to include contemporary windows with dark tinted spandrel glass.

The north elevation of Section 'B' is an Art Deco style tower that was the original main entrance and includes a staircase that provides access to the upper floors. This portion of the building has been altered, but retains most of its original features including the staircase and windows. The north elevation of Section 'C' (to the east) has been altered. This building formerly displayed a brick facade with two sets of 8 rectangular-shaped windows across the front of the building.

Figures 6 & 7: (left) View of north elevation looking south towards the front elevation of sections "A", "B", and "C", (right) Detail view of the front elevation, looking south towards Section "B", (Source: MHBC, 2023)

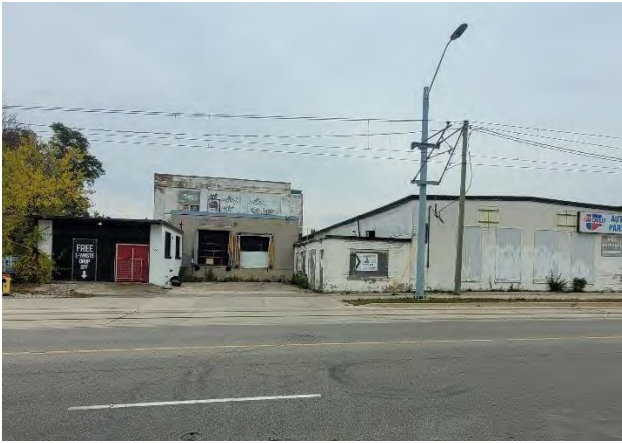
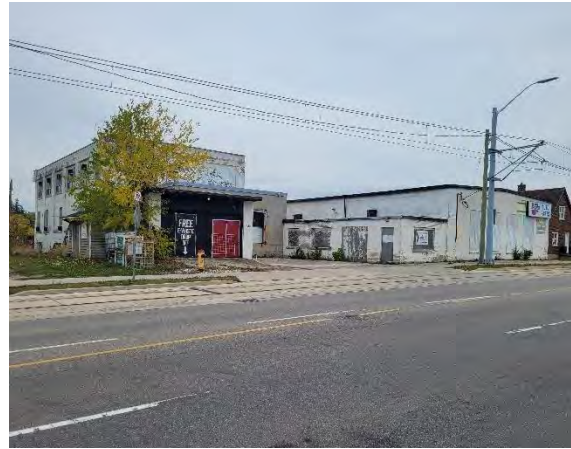
displays two small boarded-up window openings just below the roof, with four large boarded-up rectangular-shaped window openings below. **While Section 'D' displays cinder block construction, the rear of Sections 'B' and 'C' appear to include painted red brick.** The existing single storey garage/outbuilding constructed of cinder blocks and displays a flat roof and garage door at the south elevation. This structure as well as **Section 'D' are 20th century additions to the site and are not of cultural heritage value or interest.**

Figures 12 & 13: (left) View of south elevation looking north from Charles Street east, (right) View of west and south elevations looking north-east from Charles Street east, (Source: MHBC, 2023)

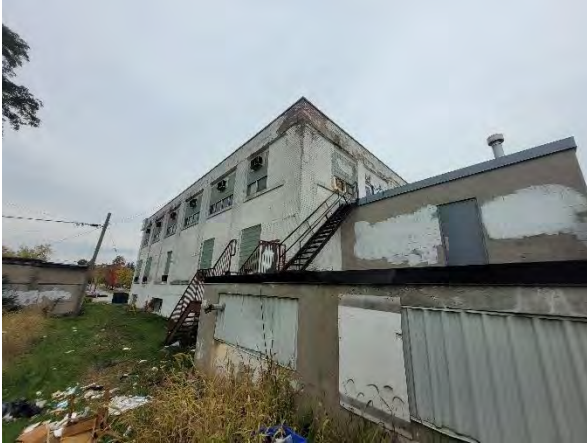
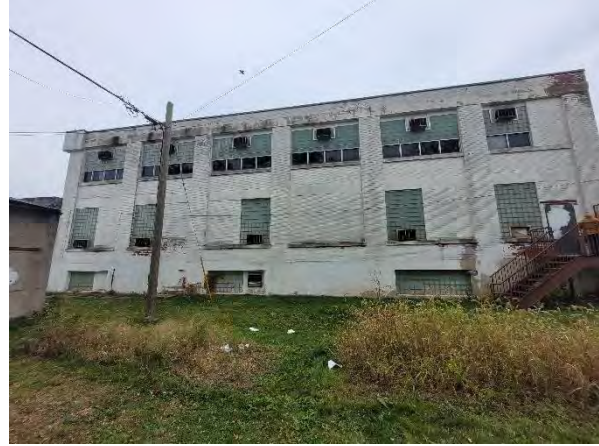
The west elevation is primarily the side facade of Section 'A'. The building originally displayed 5 bays of very large windows spanning the second and third storeys. These windows have been partially bricked-over and portions of the windows now include contemporary block-style glass.

Figures 14 & 15: (left) View of west elevation looking north-east, (right) View of west elevation of Section "A" looking east, (Source: MHBC, 2023)

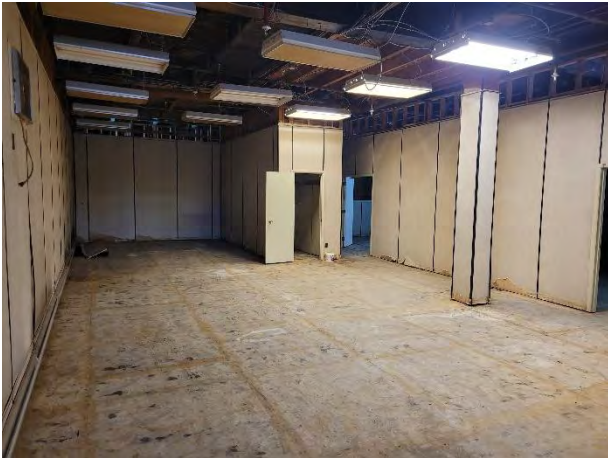
The main floor of **Section 'A'** is not at ground level. Instead, it is elevated above the ground level above the basement. The second floor of **Section 'A'** has been altered to include partitioned walls to function as office space. The building has been carpeted and re-finished with 20th century materials. It is important to note that the ceiling provides evidence of considerable fire damage, where the ceiling in several places has been scorched black.

Figures 18 & 19: (left) View of open area, looking south-west, (right) Detail view of ceiling noting fire damage, (Source: MHBC, 2023)

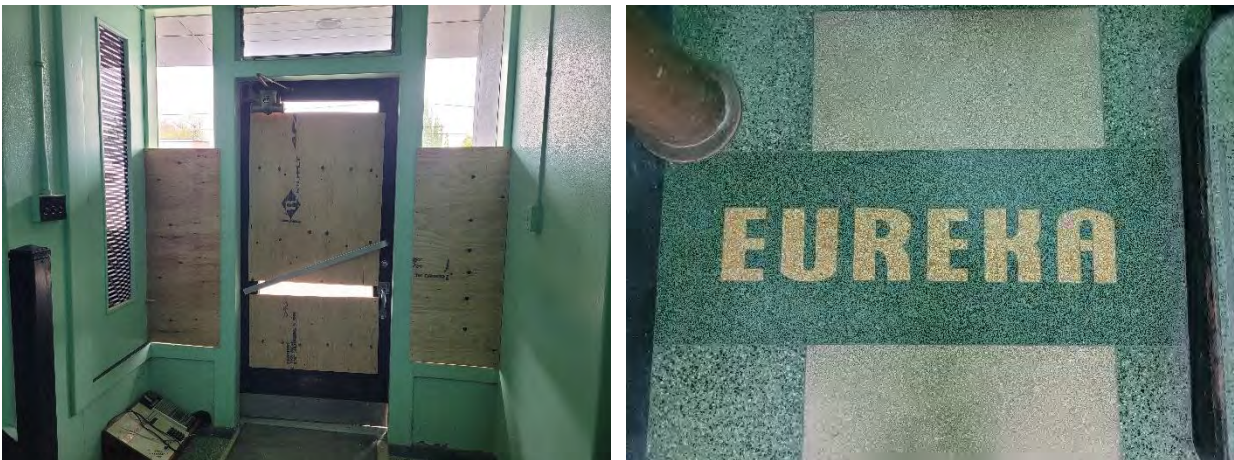
The ground floor of Section 'B' is the main entrance and access to the staircase. The floor is tile with the 'Eureka' brand name in the tile.

Figures 22 & 23: (left) View of entrance to Section "B", looking north (right) Detail of "Eureka" terrazzo floor tile, (Source: MHBC, 2023)

The site is recommended to be interpreted through an interior display of the proposed new building (See Figure 28). The items recommended to be salvaged in this report (See Section 4.2) includes the column, door and windows (including trim), and the "Eureka" tile. **If exterior cornice materials can be removed, these would be displayed and incorporated on an interior wall.**

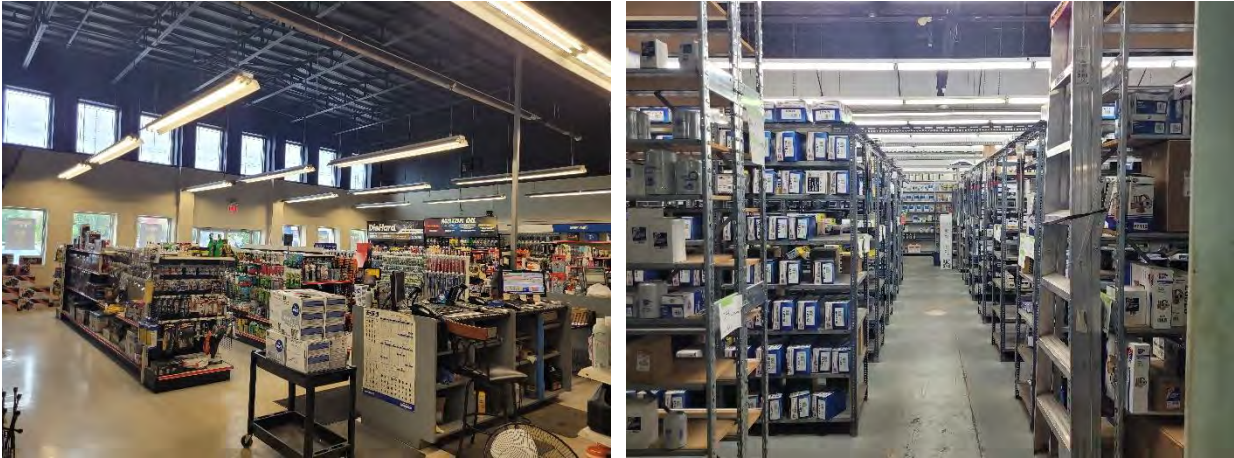
Section 'C' is one room used as a retail area, with open concept storage areas towards the rear. The interior of the building has been altered and provides little evidence of its construction date. The roof may have been altered as it now appears to be contemporary metal roofing. All original windows have either been removed and replaced with contemporary windows or been covered.

Figures 26 & 27: (left) View of store front, Section "C", looking north-east, (right) View of Section "C", rear storage area, (Source: MHBC, 2023)
