**Cultural Heritage Protection Plan & Temporary Protection Plan  
58-60 Ellen Street East & 115 Lancaster Street East  
City of Kitchener  
Region of Waterloo  
Lot 3, German Company Tract  
Geographic Township of Waterloo  
Former Waterloo County**

HR-517-2024

2024-10-01

**58-60 Ellen & 115 Lancaster  
Structural Condition Assessment Rev1**

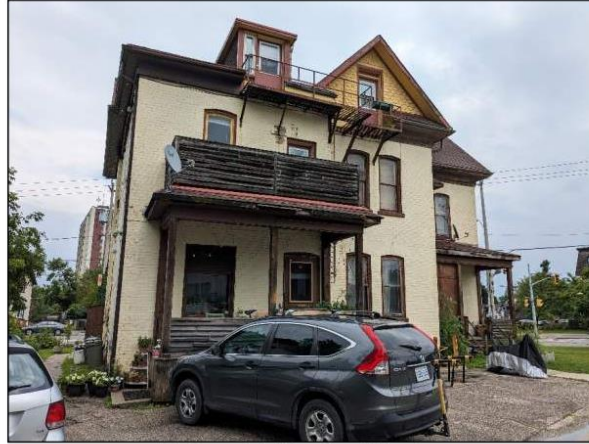
Photograph 1: Ellen Street Elevation

The exterior walls consisted of painted multi-wythe brick walls. The paint (Photograph 1 & Photograph 2) precluded a direct visual assessment of the brick units and mortar; however, larger deficiencies typically propagate through paint and are apparent for visual review. For long term durability reasons, paint should be removed from the exterior of the brick walls.

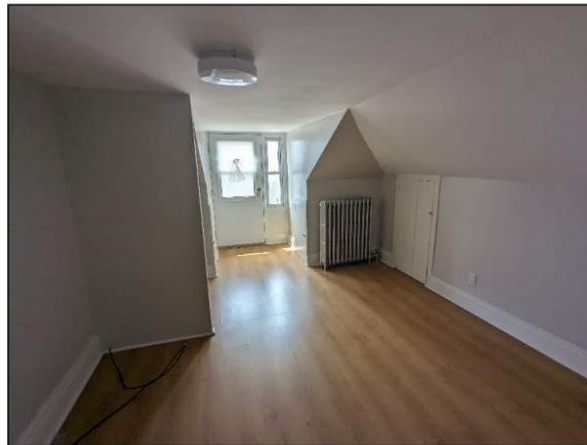
Photograph 11: Unit 4 Interior

Due to applied finishes throughout the rental units, the building structure could not be determined.
