FINAL
Documentation & Salvage Report
58-60 Ellen Street East & 115 Lancaster Street East
City of Kitchener
Region of Waterloo
Lot 3, German Company Tract
Geographic Township of Waterloo
Former Waterloo County

HR-517-2024
Project #: 2023-0269/2023-0269

2024-10-01

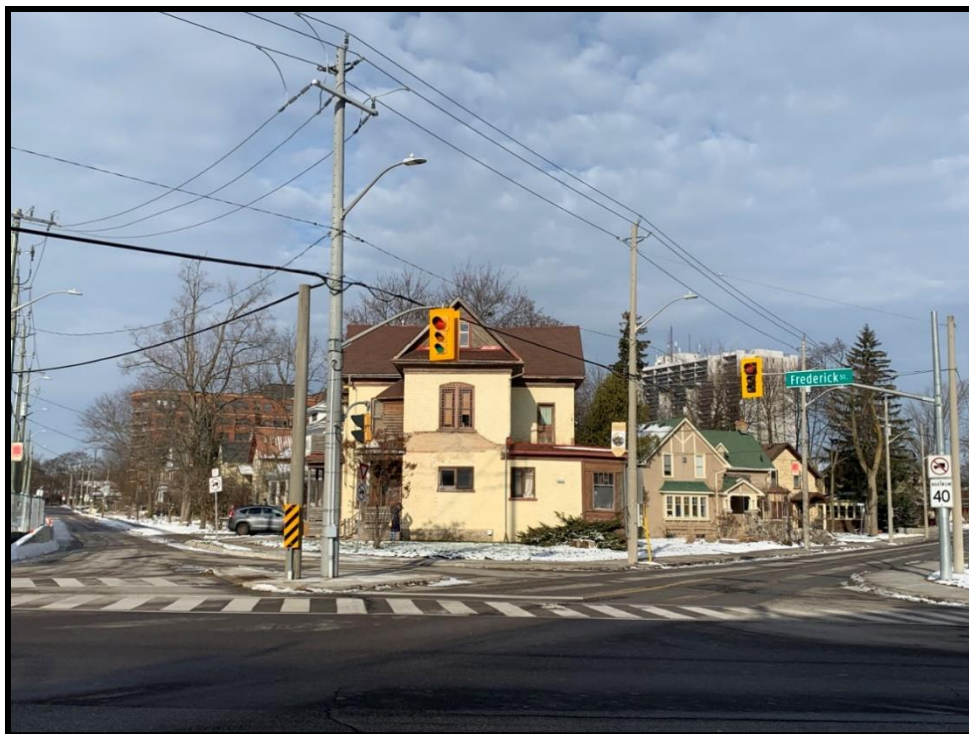
The residence is situated on a triangularly shaped lot with a façade facing the Five Points intersection to the south (see Image 6). The building was initially designed with a Greek cross floor plan, though additions to the initial design have created an irregular roofline and partially obscured this plan. While the building's original façade faces south, modifications to the building's internal layout have resulted in no entrances accessed from the facade. The former single-family residence has been converted to a multi-unit residence with entrances along the building's side elevations fronting Ellen Street East and Lancaster Street East. The paved parking area is located along the west elevation. The remainder of the property is covered in grass with some gardens placed around the residence. There are pedestrian sidewalks on both the east and west sides of the property along Ellen Street East and Lancaster Street East.

Image 6: Context – View of Subject Property from Five Points Intersection
(Photo taken December 20, 2021; Facing Northwest)

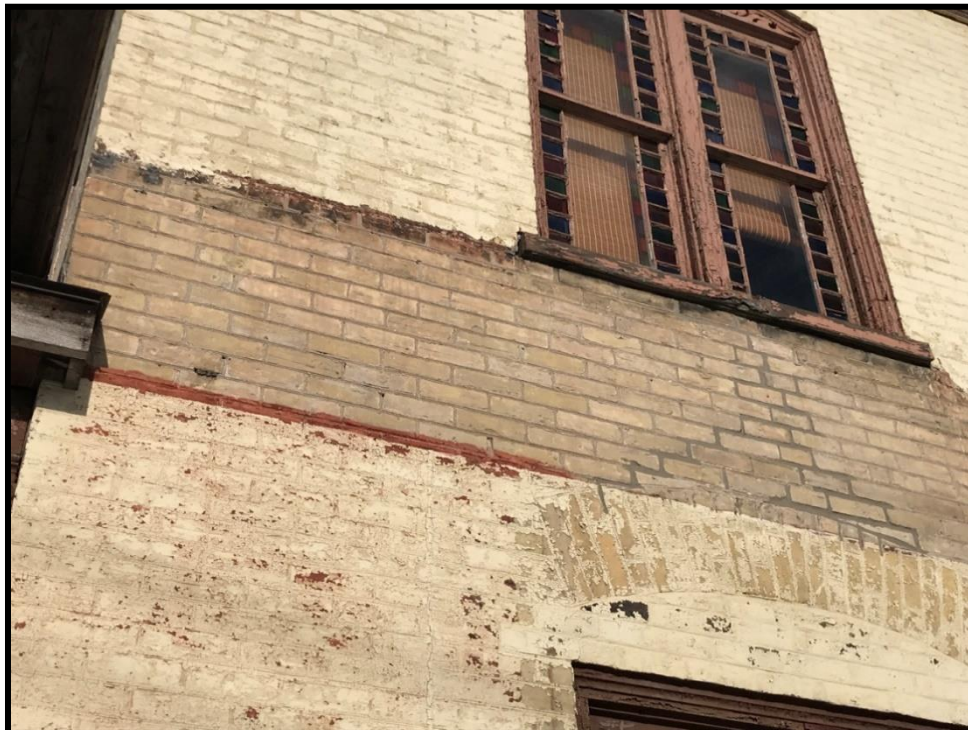
A portion of the brick on the residence's façade is currently unpainted and reveals that the building is constructed of buff brick masonry (see Image 10). The shape of the unpainted section of brick also suggests that the façade formerly featured a porch structure with a bell-cast roof (see Image 11). Further, a concrete pedestrian pathway that currently terminates in the centre of the grassed area in front of the structure delineates where the porch stairs would have landed. The first-storey window opening on the façade has been partially infilled and altered from its initial shape and may reflect a former door opening (see Image 11).

Image 10: Subject Property – Unpainted Brick Area Revealing Buff Brick Construction
(Photo taken December 20, 2021; Facing North)

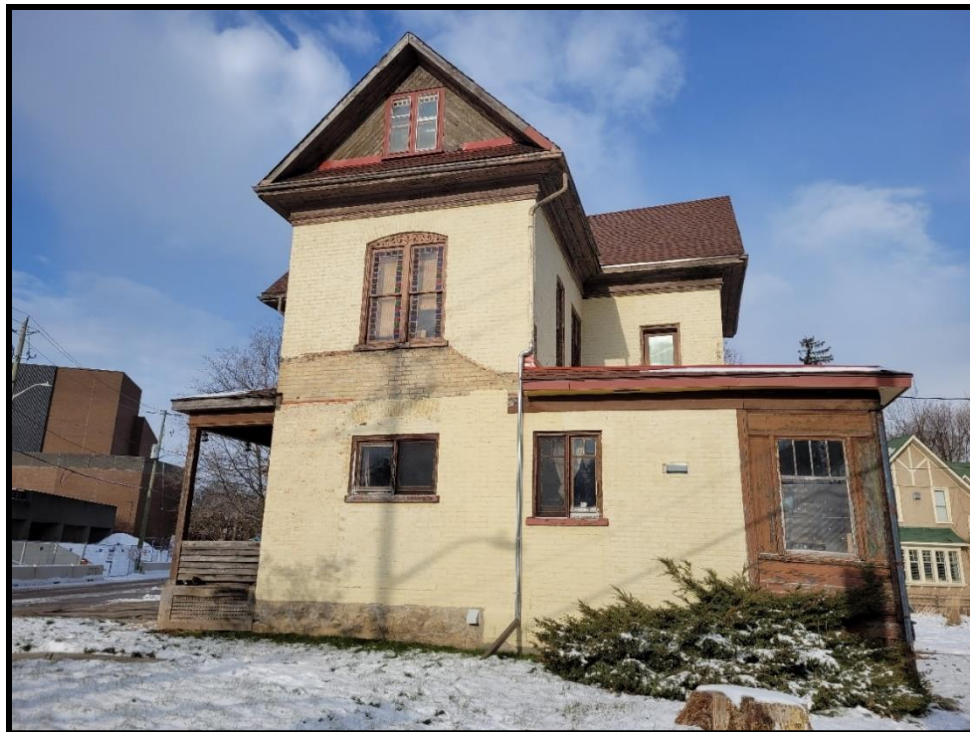
A one-storey addition has been added to the eastern corner of the residence (see Image 12). While the construction date of this addition is unknown, the addition is built upon a cinder-block foundation, suggesting it was constructed as a later addition and not as part of the residence's initial design (see Image 13). The addition has a flat roof and features a sunroom with a bank of windows along the northeast elevation (see Image 14). The northeast elevation contains similarities to the façade with a central projecting wing as part of a Greek cross floor plan (see Image 15). The northeast elevation would have originally been symmetrical, however additions to the first storey and the addition of new openings on the second storey have been introduced. These new openings are distinguished by flat or jack arches, whereas the original openings feature a segmental arch opening (see Image 16). The wooden cornice with molded wooden frieze continues along this elevation (see Image 17) with a portion that appears to have been covered with aluminum flashing (see Image 18). The gable end on the northeast elevation has been clad in alternating octagonal and rectangular shingles (see Image 19). The attic storey windows on this elevation have been replaced with vinyl sash windows. A portion of unpainted brick on this elevation suggests that the residence may have had dichromatic brick detailing, as bricks with red glazing were visible alongside buff bricks (see Image 20 and Image 21). Inspection of the brick masonry also reveals a beaded mortar profile (see Image 21). The projecting wing on the northeast elevation contains two paired window openings with segmental arches on both the first and second storey (see Image 22). There are signs of deterioration along this elevation, ranging from cosmetic deterioration such as peeling and uneven paint finishes as well as masonry deterioration in the form of running cracks and masonry repointing using inappropriate mortars (see Image 23). The window openings have wooden painted sills of varying conditions (see Image 24). Wooden fixed storm windows have been affixed to the majority of the openings (see Image 25). A concrete staircase leads downward to a basement doorway on this elevation (see Image 26). This egress is supported by concrete retaining walls.

Image 12: Subject Property – Addition on East Corner
(Photo taken December 20, 2021; Facing Northwest)

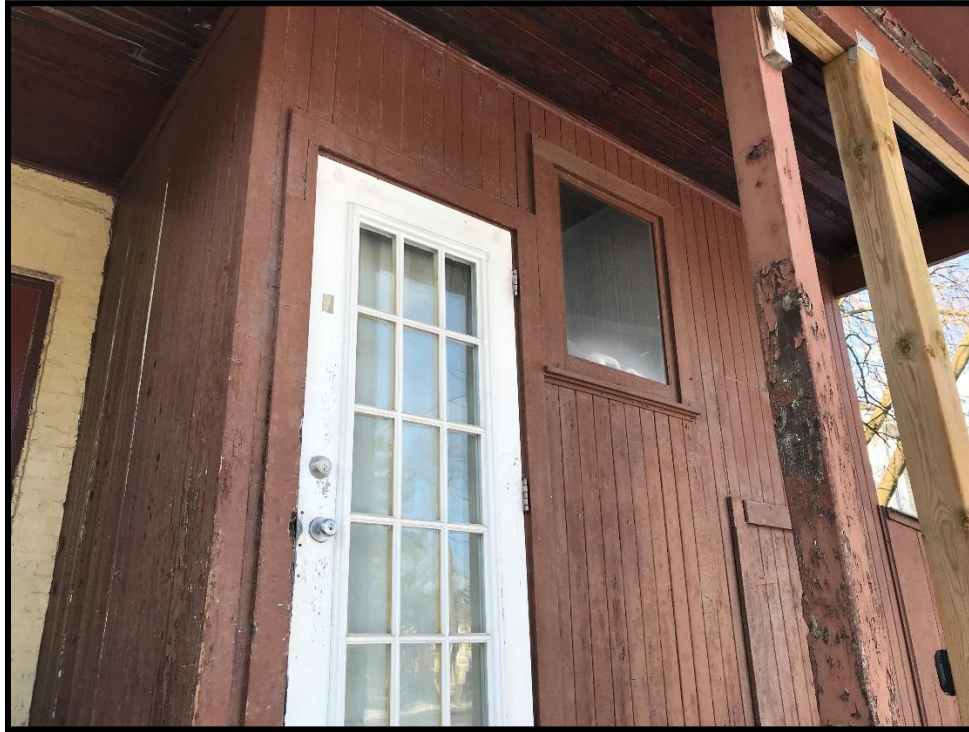
A porch and enclosed addition on the north corner of the residence provides access to the Lancaster Street East units. The addition contains an additional doorway opening as well as an opening with a fiberglass window (see Image 27). A first-storey window opening and second door access to the basement has been encased within this addition (see Image 28). The masonry in

Image 27: Subject Property – Addition on North Corner
(Photo taken December 20, 2021; Facing Northwest)

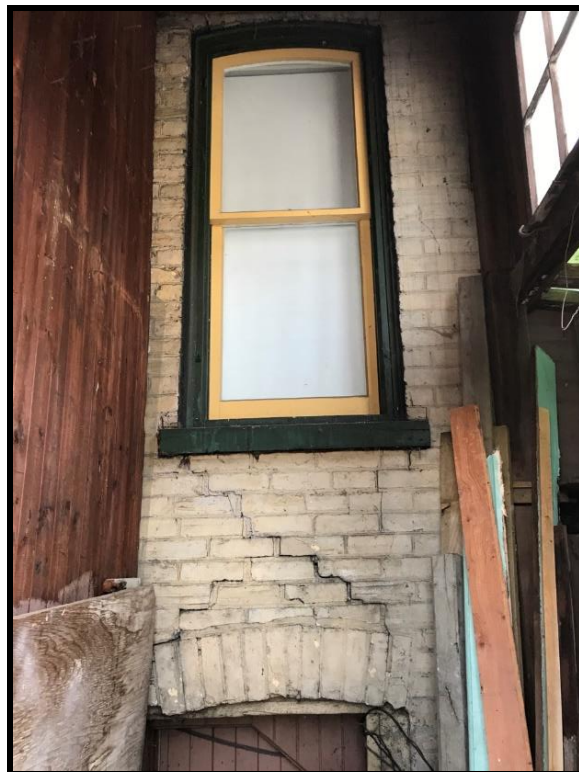
Image 28: Subject Property – Window Opening Inside North Addition
(Photo taken December 20, 2021; Facing Southwest)

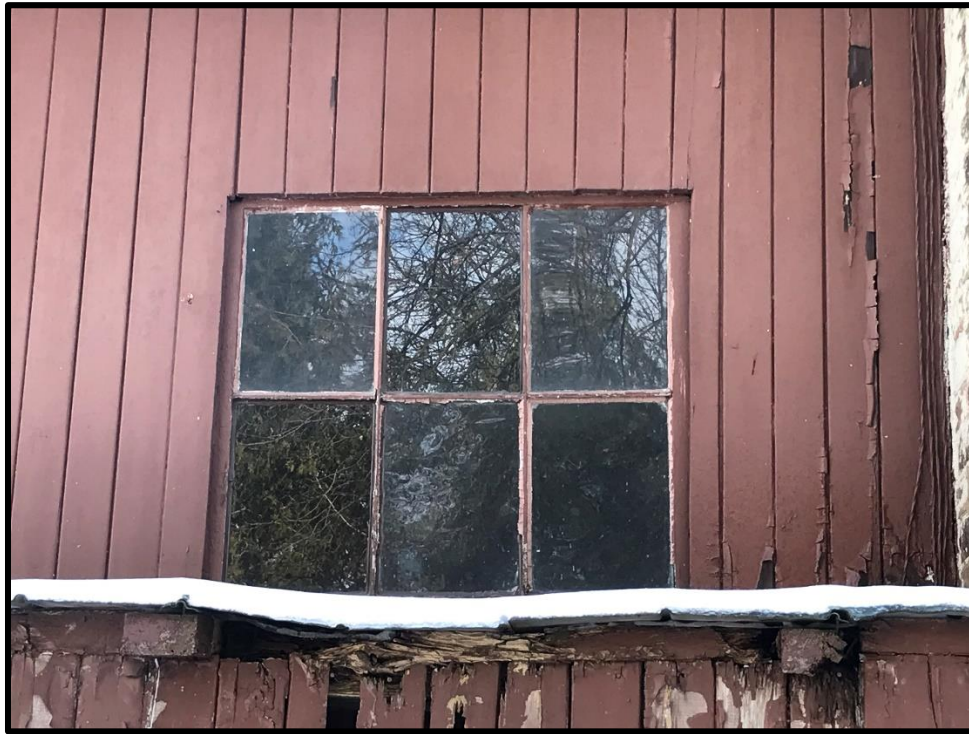
The rear (northwest) elevation contains fewer openings than the façade and side elevations (see Image 30). The one-storey addition on the north corner contains one window opening on this elevation and contains a six-paned fixed wooden window (see Image 31). Brick discoloration on the residence's north corner and lumber deterioration on the one-storey addition suggest water is not being adequately shed (see Image 32). The northwest elevation contains an outside chimney placed at the centre of the gable end (see Image 33). The gable end on this elevation is clad in rectangular shingles and the two attic window openings contain vinyl sash windows (see Image 34). The wooden soffit and molded frieze have been clad in aluminum flashing on this elevation. The two-storey addition on the west corner of the residence is distinguished by a change in the roofline as well as some discolouration at the intersection of the addition and residence masonry (see Image 35). A portion of the brick masonry has been replaced and repointed along this intersecting line (see Image 36). The addition appears to use similar construction methods as the initial residence, with brick laid in a stretcher pattern and built on a stone foundation (see Image 37). A single header course laid on the stone foundation is seen on both the two-storey addition and the residence (see Image 38). A key difference between the finishes on the two-storey addition and the residence is the framing of the openings, with segmental arches framing the residence's openings and flat or jack arches framing the openings on the two storey addition (see Image 39 and Image 40).

Image 31: Subject Property – Six-Paned Fixed Window on Northwest Elevation of One-Storey Addition
(Photo taken December 20, 2021; Facing South)

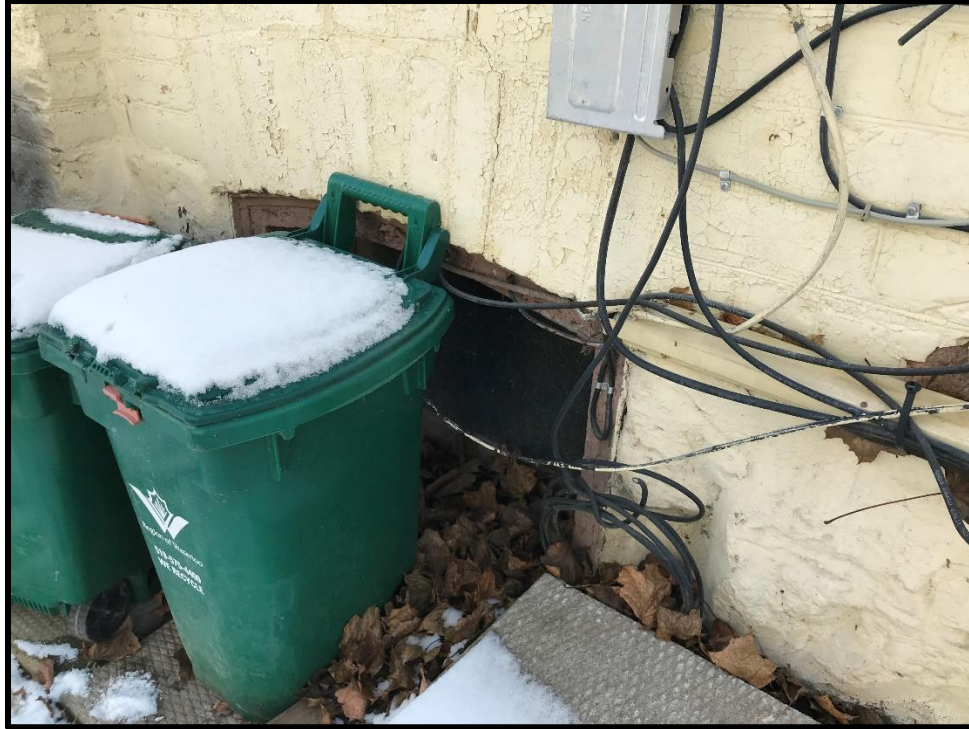
Image 39: Subject Property – Segmental Arch on Basement Opening
(Photo taken December 20, 2021; Facing South)

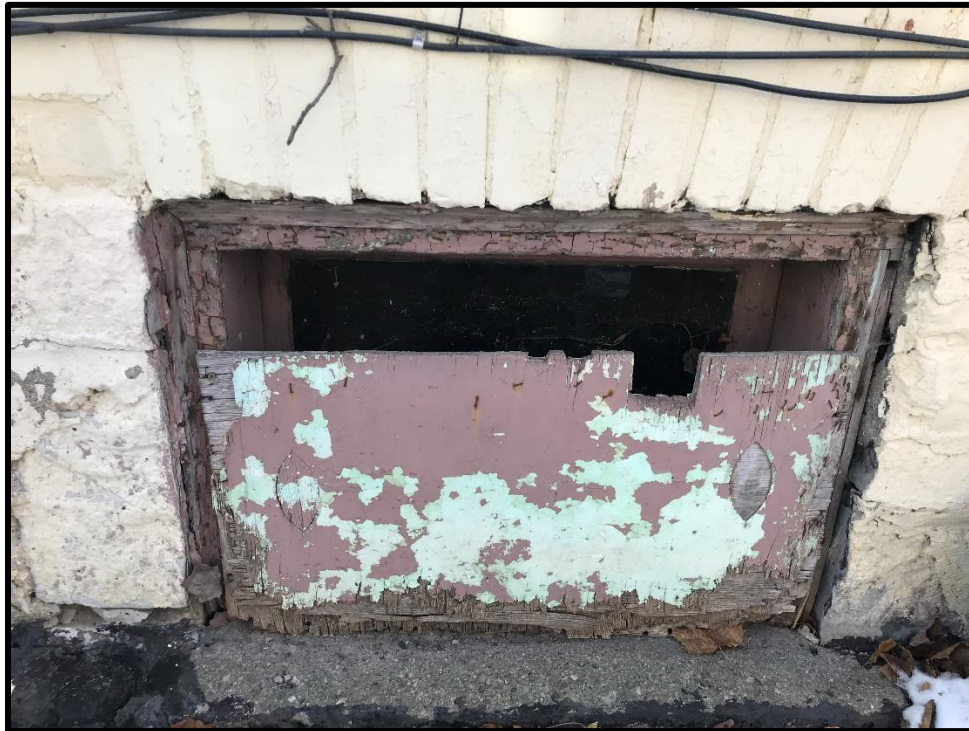
Image 40: Subject Property – Flat Arched Basement Opening on Two-Storey Addition on West Corner
(Photo taken December 20, 2021; Facing South)

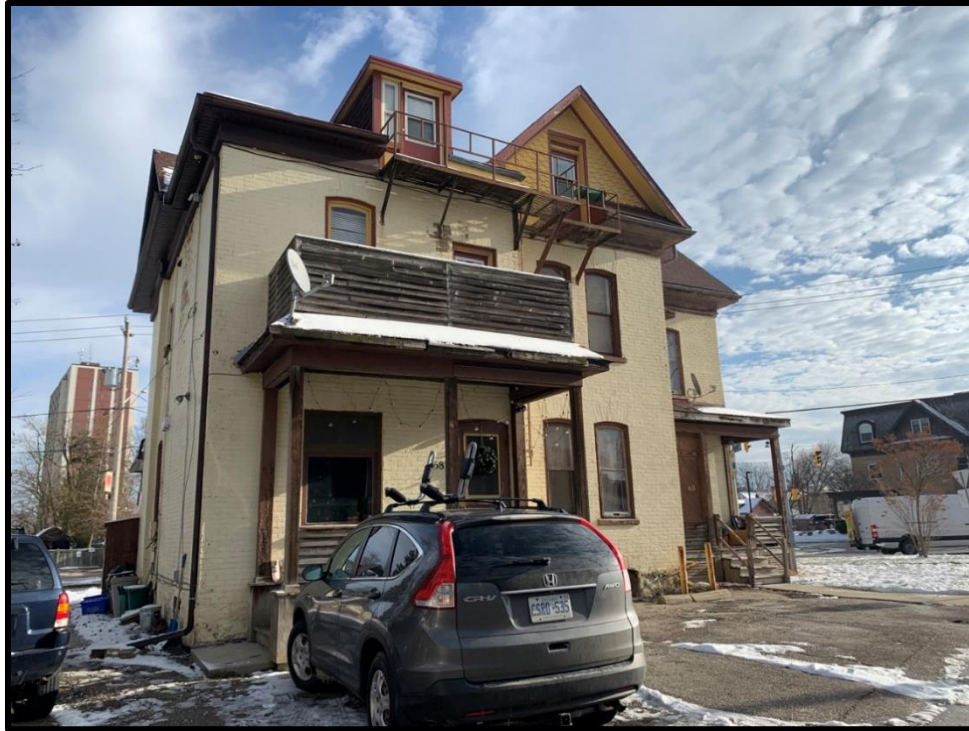
The southwest elevation provides the access to units from Ellen Street East (see Image 41). The attic storey features a dormer with a shed roof that connects to an exterior fire escape (see Image 42). There is a balcony and porch on the southwest elevation that spans the width of the two-storey addition on the west corner (see Image 43 and Image 44). A large rectangular window with transom is located on the first storey of the brick addition with a flat arch and wooden sill (see Image 45). The entrance to 58 Ellen Street East has a segmental arch and is located on the first storey porch (see Image 46). The gable end on this elevation is clad in decorative shingles arranged in octagon, rectangular and diamond patterns (see Image 47). The gable end also contains a doorway connecting to an exterior fire escape. The southwest elevation contains paired window openings with segmental arches in the same style as those viewed on the northeast elevation (see Image 48). Portions of the foundation visible from this elevation display deteriorated or missing mortar (see Image 49). A one storey porch with a shed roof is located on the southern half of the southwest elevation (see Image 50). A small addition with a shed roof and wooden siding is located on the second storey. The first storey porch contains an enclosed entrance that features decorative wooden elements applied to the exterior (see Image 51). Window openings along this portion of the southwest elevation are of varying condition, with some showing cosmetic and sill deterioration and without storm windows whereas some appear to have been recently restored or reconstructed with storms (see Image 52 and Image 53). The porch on the southern half of the southwest elevation contains an entrance to the 60 Ellen Street East unit and the porch is finished with a beadboard wooden ceiling (see Image 54 and Image 55).

Image 41: Subject Property – Southwest Elevation
(Photo taken December 20, 2021; Facing East)

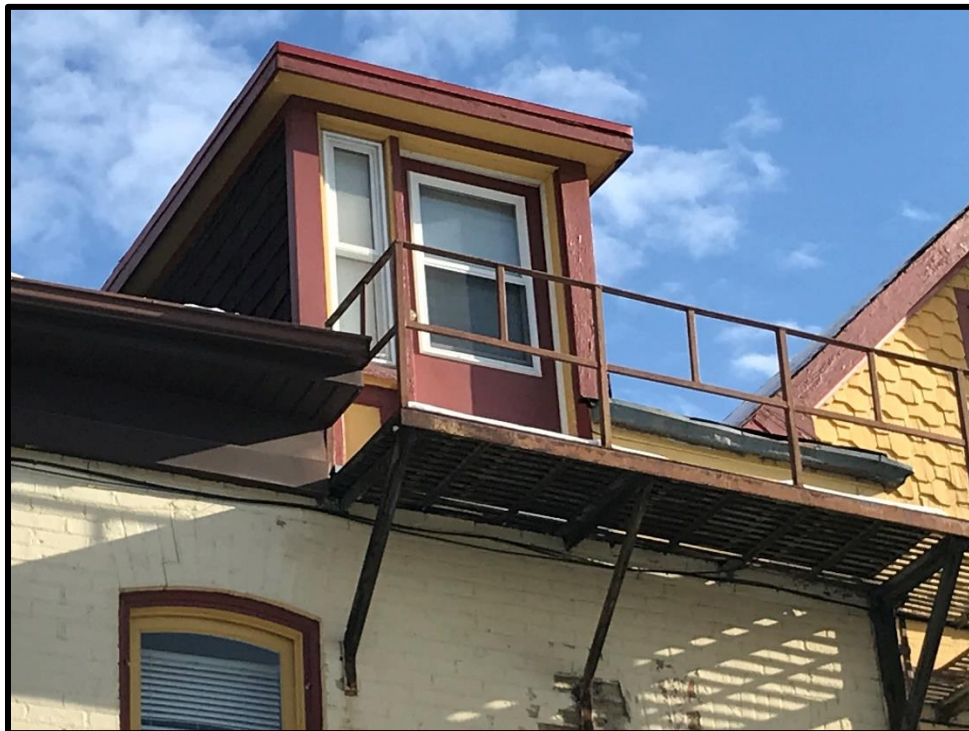
Image 42: Subject Property – Attic Storey Dormer and Fire Escape
(Photo taken December 20, 2021; Facing East)

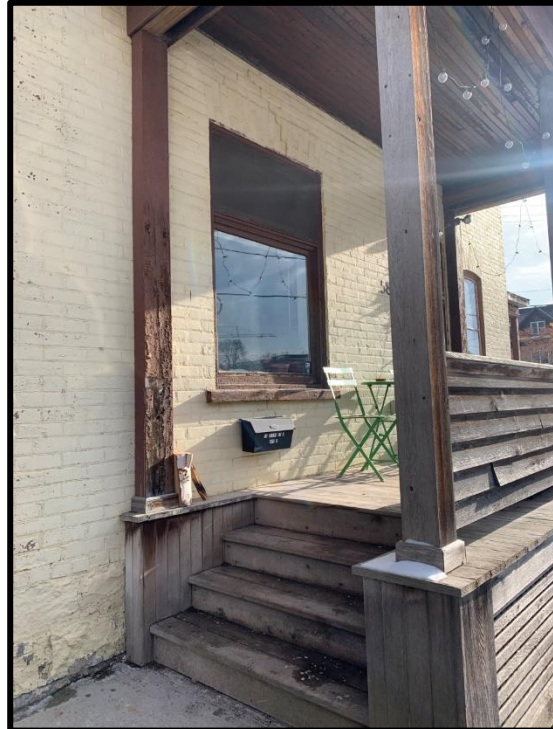
Image 45: Subject Property – Large Window Opening with Flat Arch
(Photo taken December 20, 2021; Facing South)

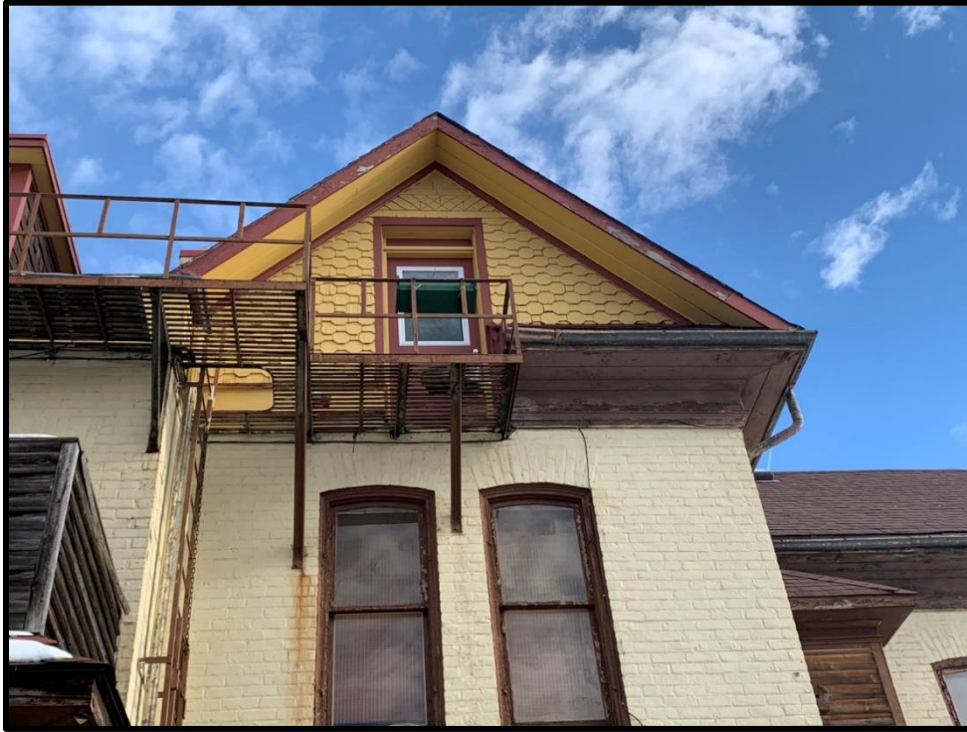
Image 47: Subject Property – Decorative Shingles on Gable End
(Photo taken December 20, 2021; Facing East)

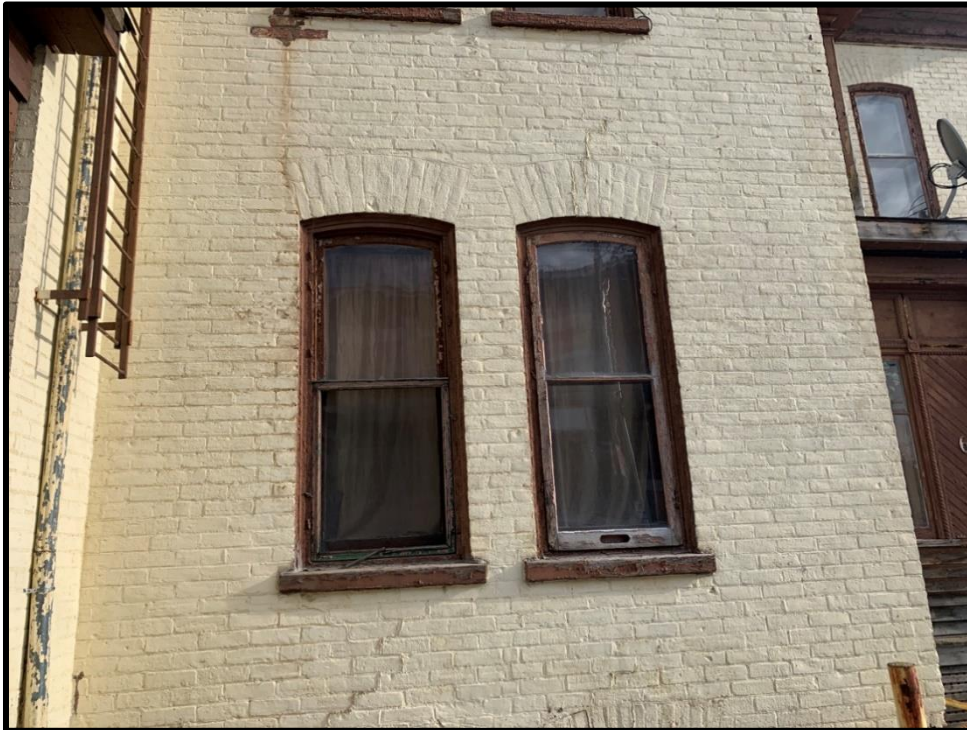
Image 48: Subject Property – Paired Window Openings with Segmental Arches
(Photo taken December 20, 2021; Facing East)

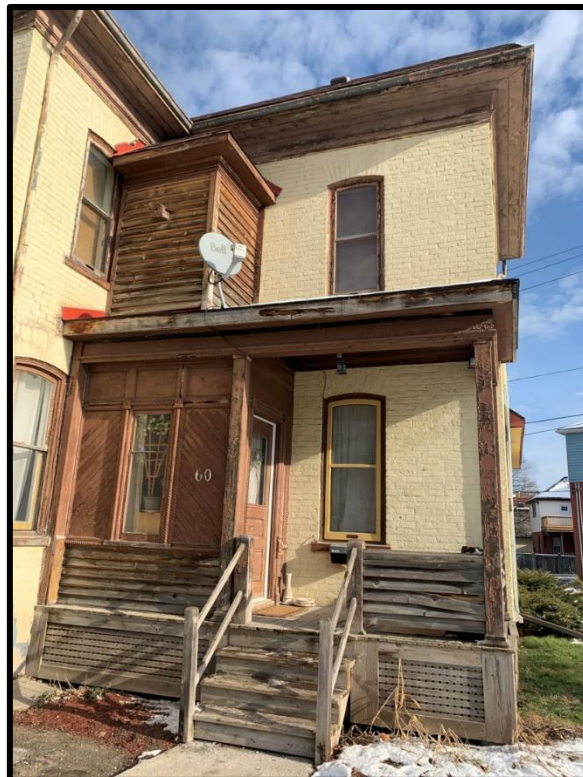
Image 50: Subject Property – Closet Addition on Second Floor
(Photo taken December 20, 2021; Facing Northeast)

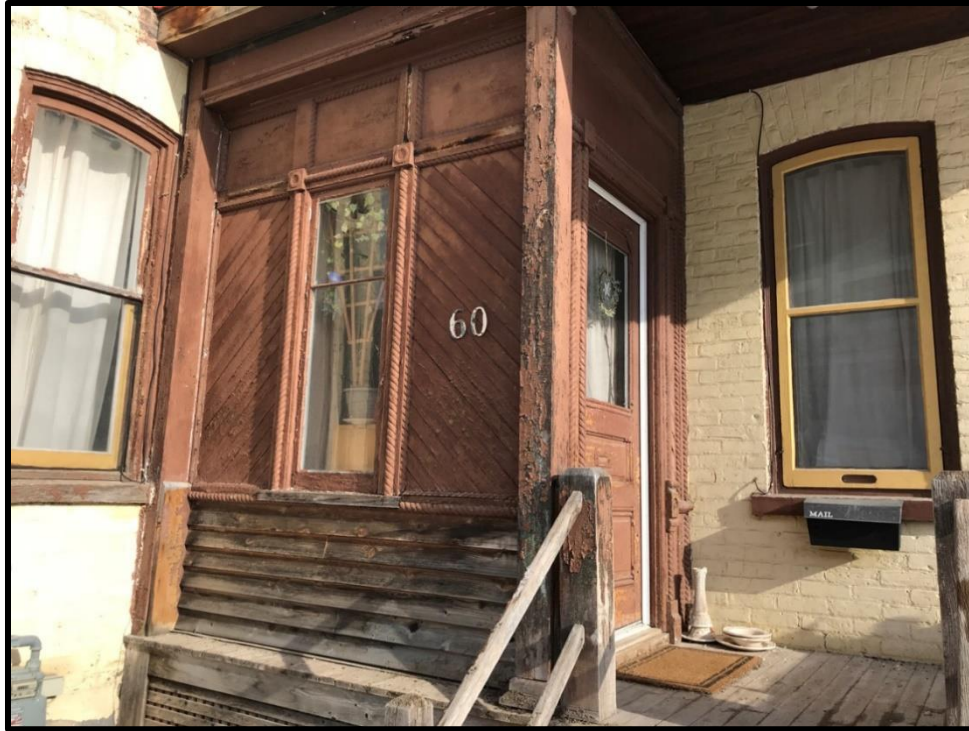
Image 51: Subject Property – 60 Ellen Street Enclosed Entrance
(Photo taken December 20, 2021; Facing Northeast)

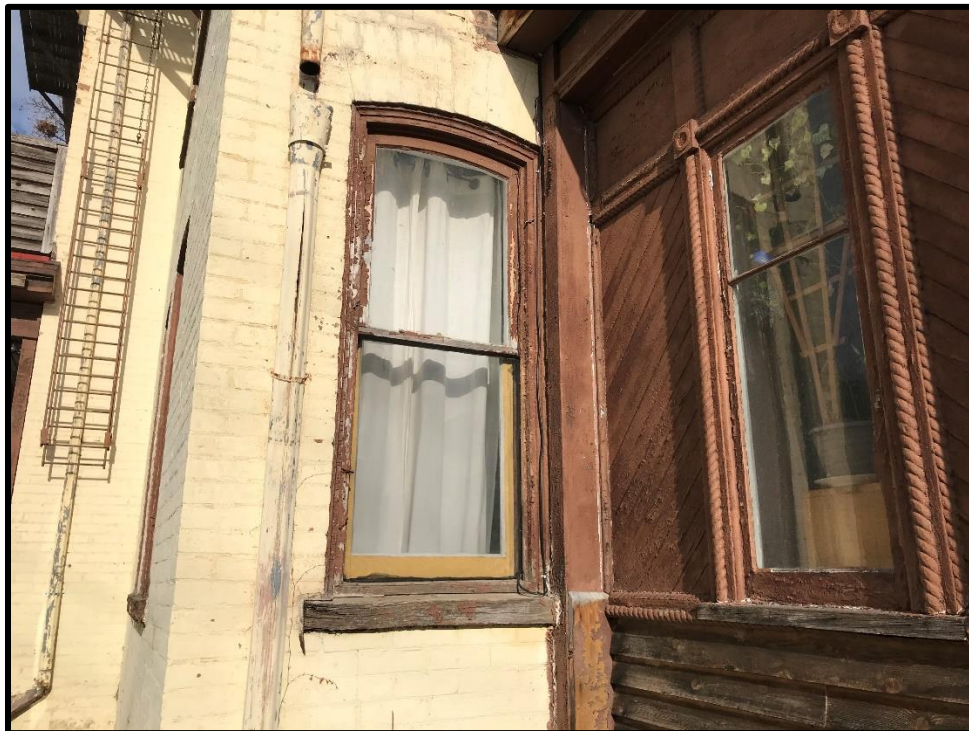
Image 52: Subject Property – One-over-one Wooden Sash Window with Segmental Arch
(Photo taken December 20, 2021; Facing North)

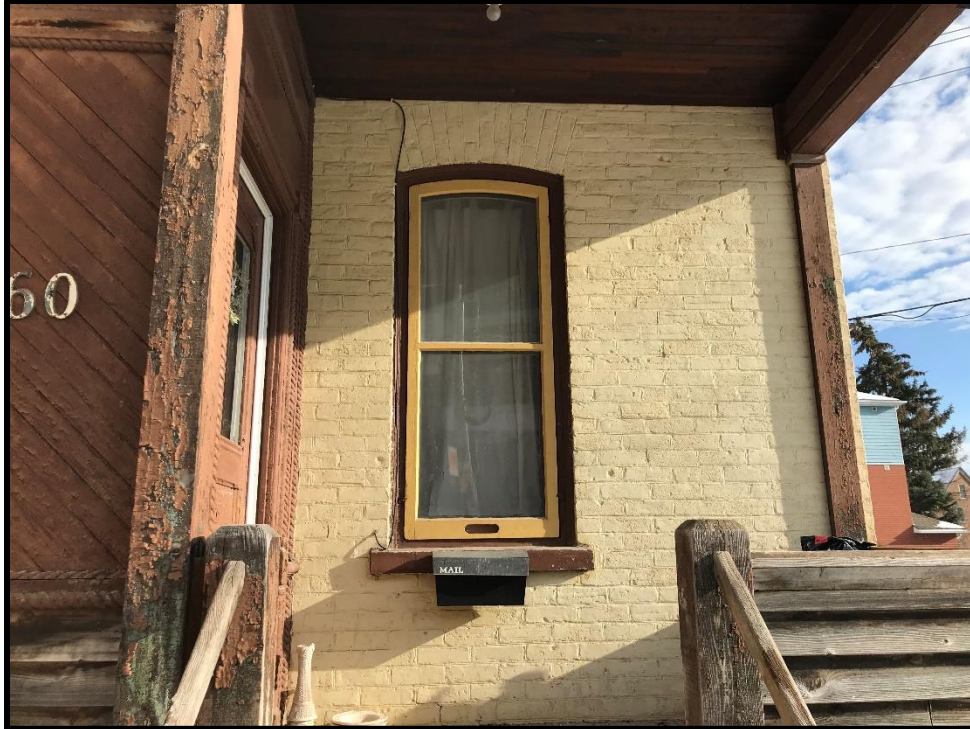
**Image 53: Subject Property – One-over-one Wooden Sash Window with a Segmental Arch and New or Restored Wooden Fixed Storm Window
(Photo taken December 20, 2021; Facing East)**

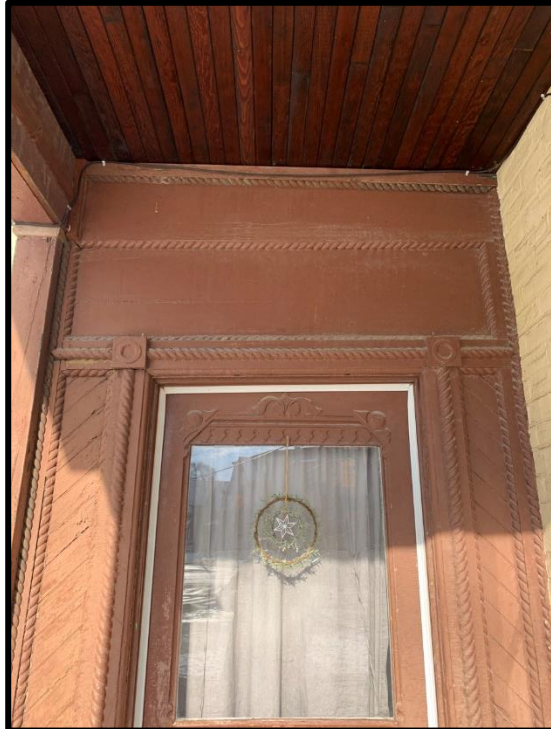
**Image 55: Subject Property – 60 Ellen Street Porch with Beadboard Wooden Ceiling
(Photo taken December 20, 2021; Facing North)**

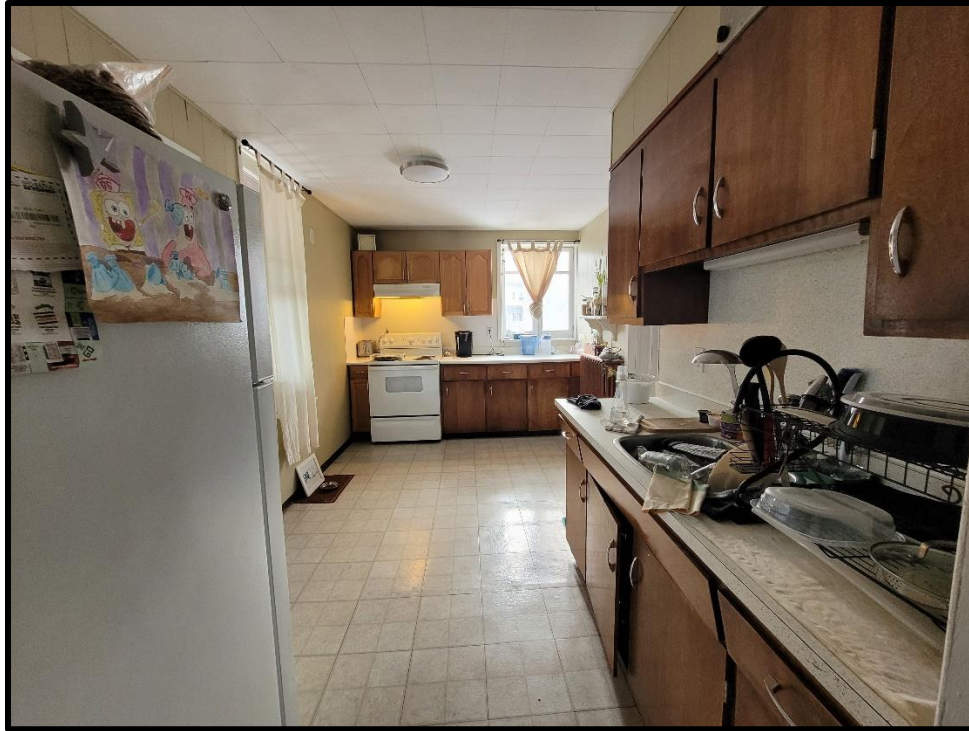
Image 73: 60 Ellen Street East Interior – Modified Interiors
(Photo taken December 20, 2021)

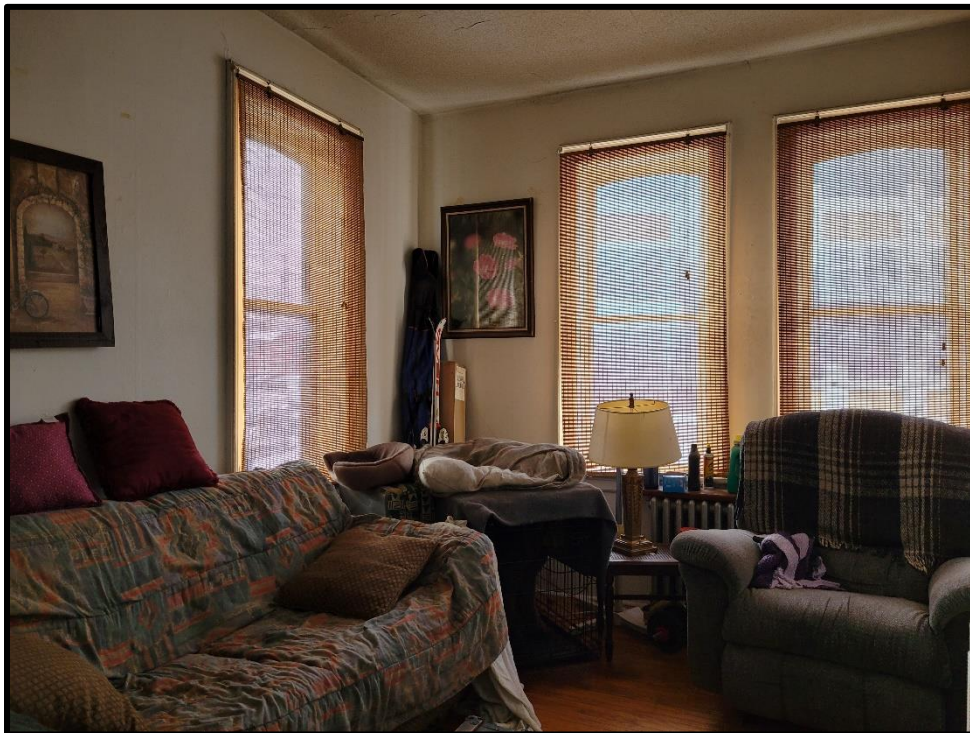
Image 86: 115 Lancaster Street East Interior – Historic Wooden Sash Windows
(Photo taken December 20, 2021)

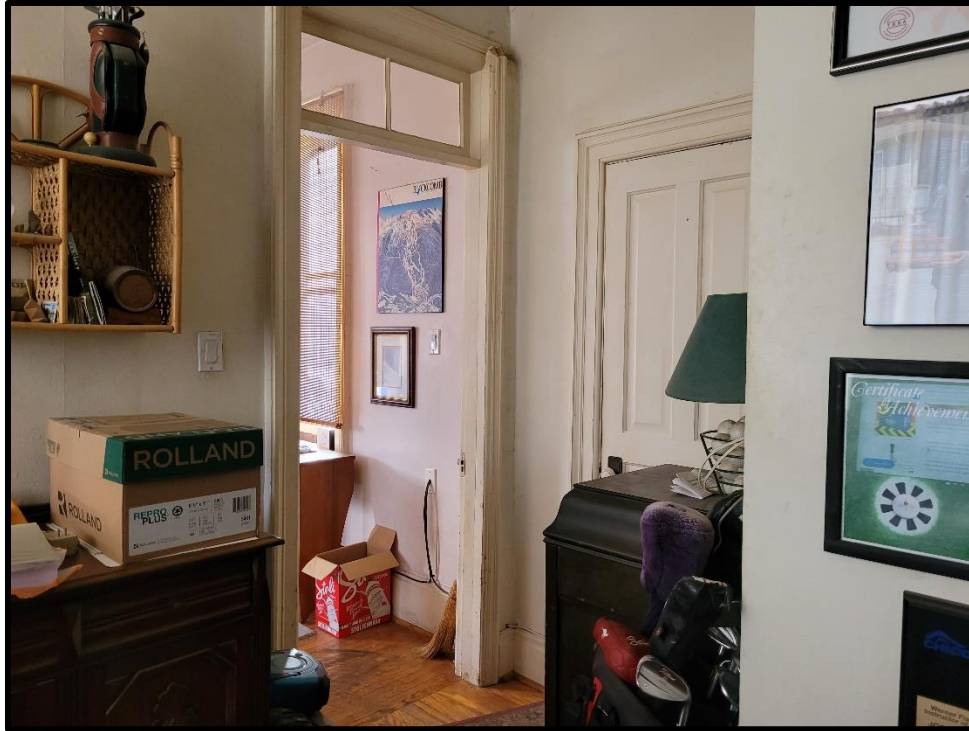
**Image 87: 115 Lancaster Street East Interior – Historic Trim and Interior Door Transom, Four-Panel Wooden Door
(Photo taken December 20, 2021)**

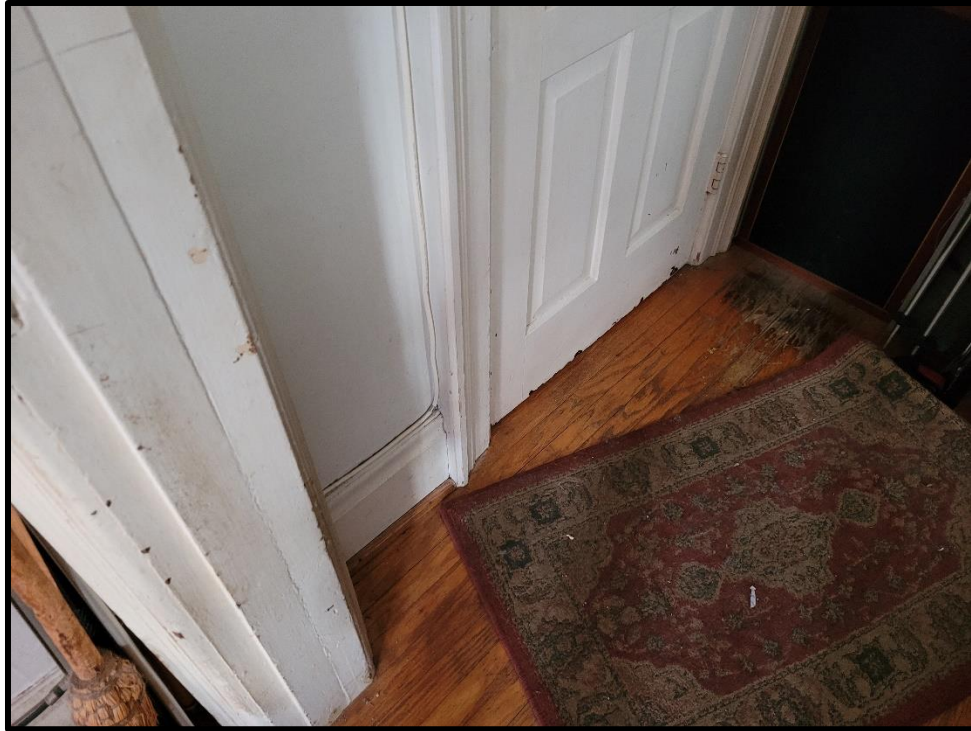
Image 89: 115 Lancaster Street East Interior – Historic Hardwood Flooring
(Photo taken December 20, 2021)

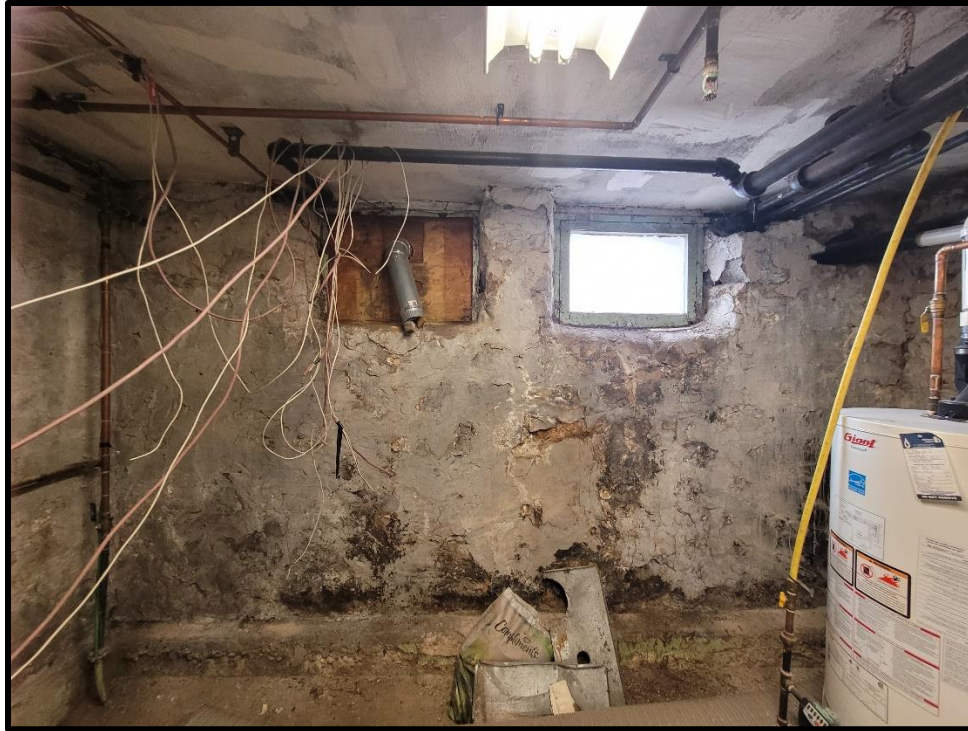
Image 93: Basement – Some Basement Windows Remaining
(Photo taken December 20, 2021)

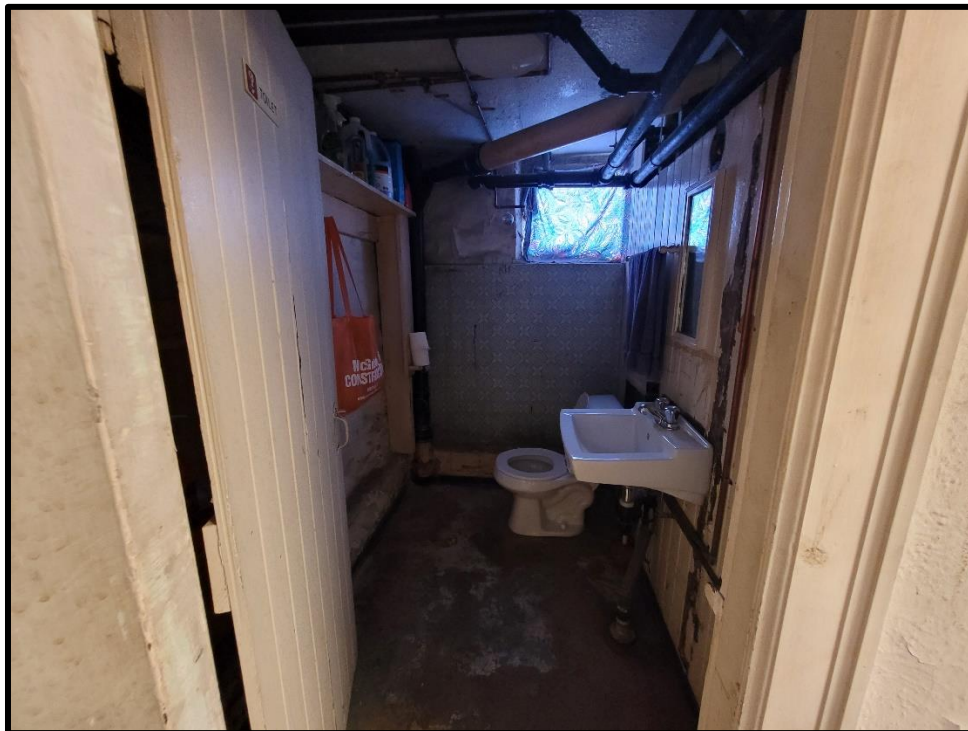
Image 94: Basement – Former Washroom
(Photo taken December 20, 2021)

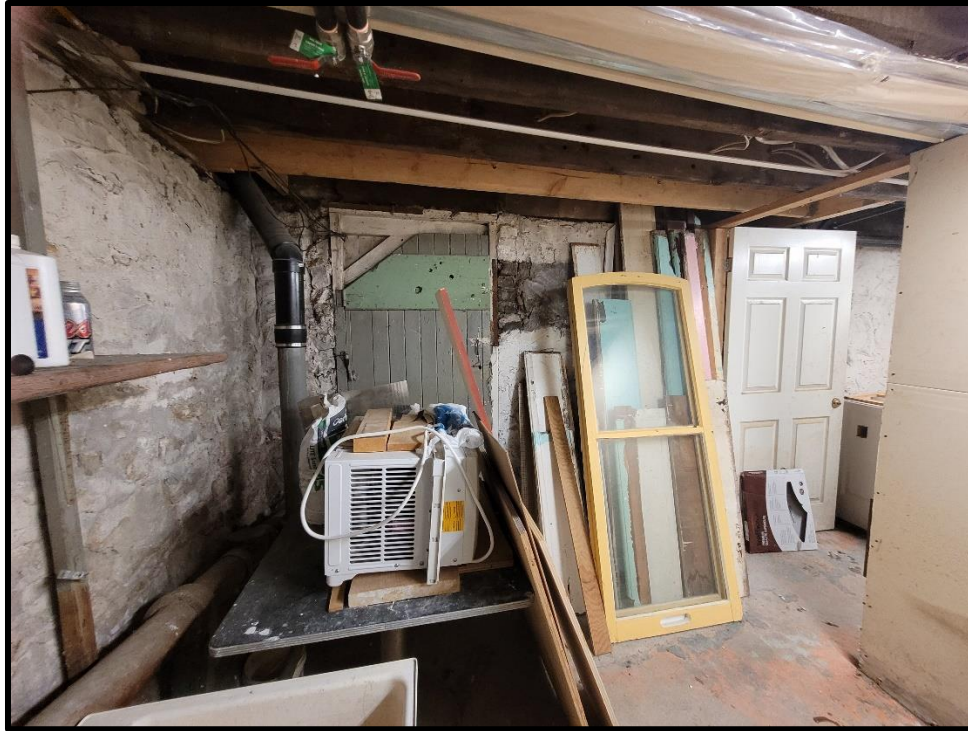
Image 95: Basement – Storm Windows for First and Second Storey Openings in Storage
(Photo taken December 20, 2021)
