Heritage Impact Assessment

East Side Lands Trunk Sewer

Region of Waterloo, Ontario

Interim Draft Report

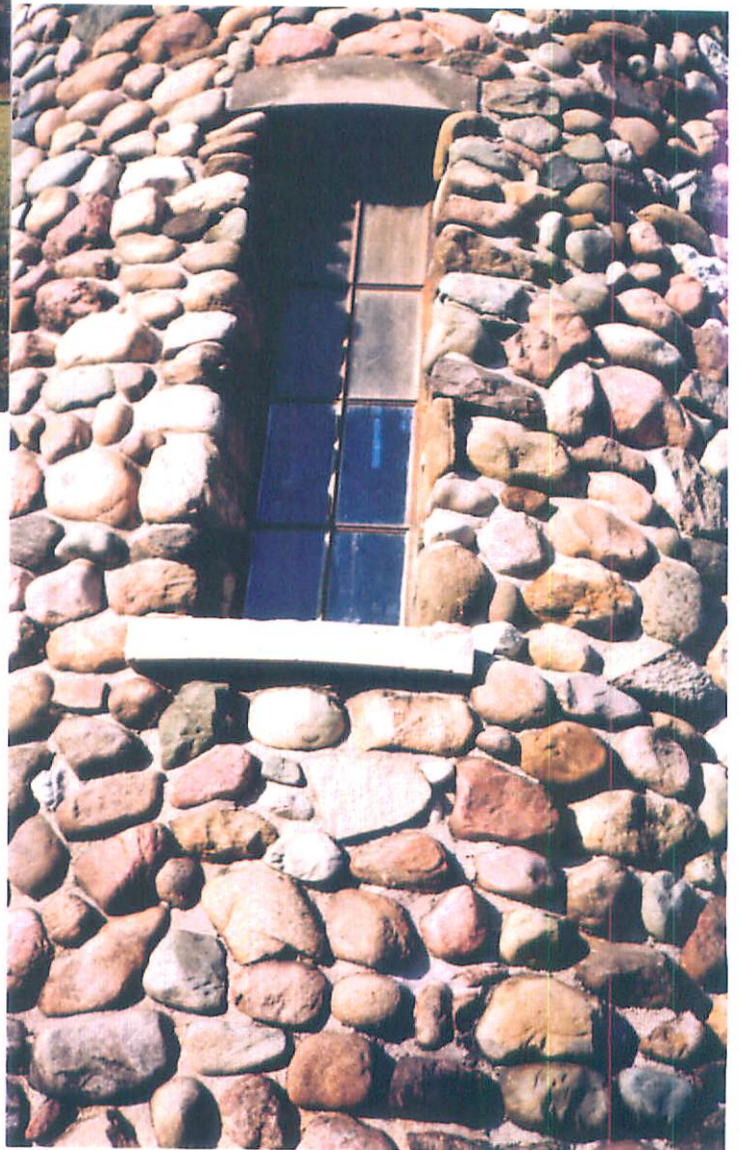
Photo 2: Window & exterior stonework

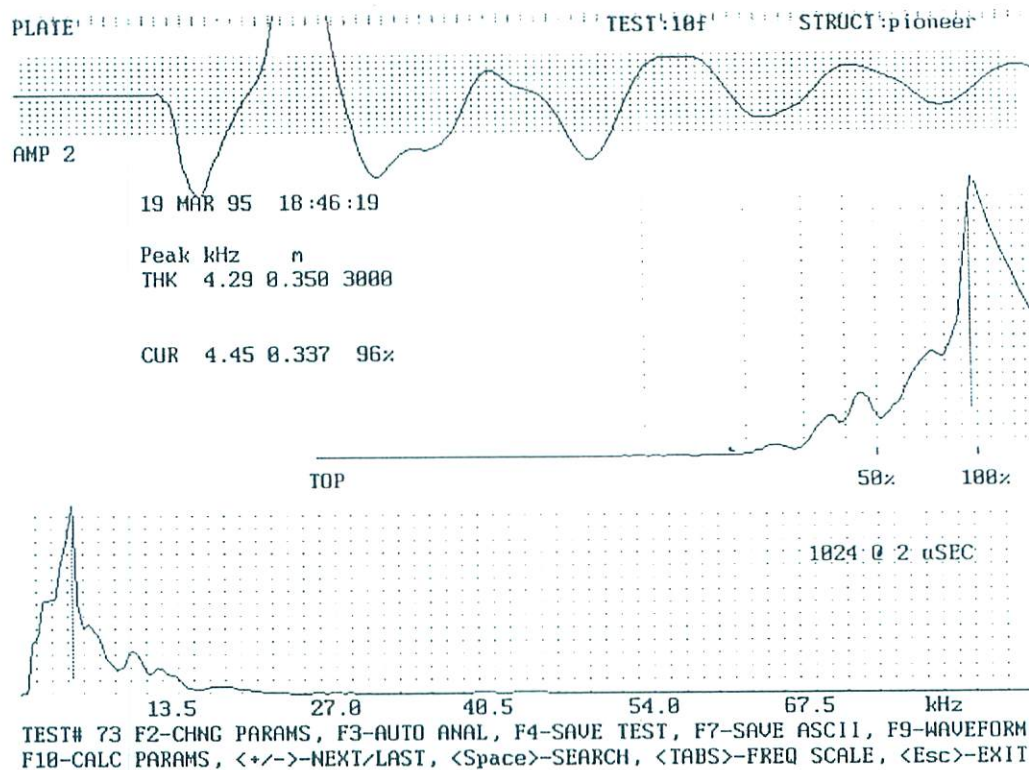
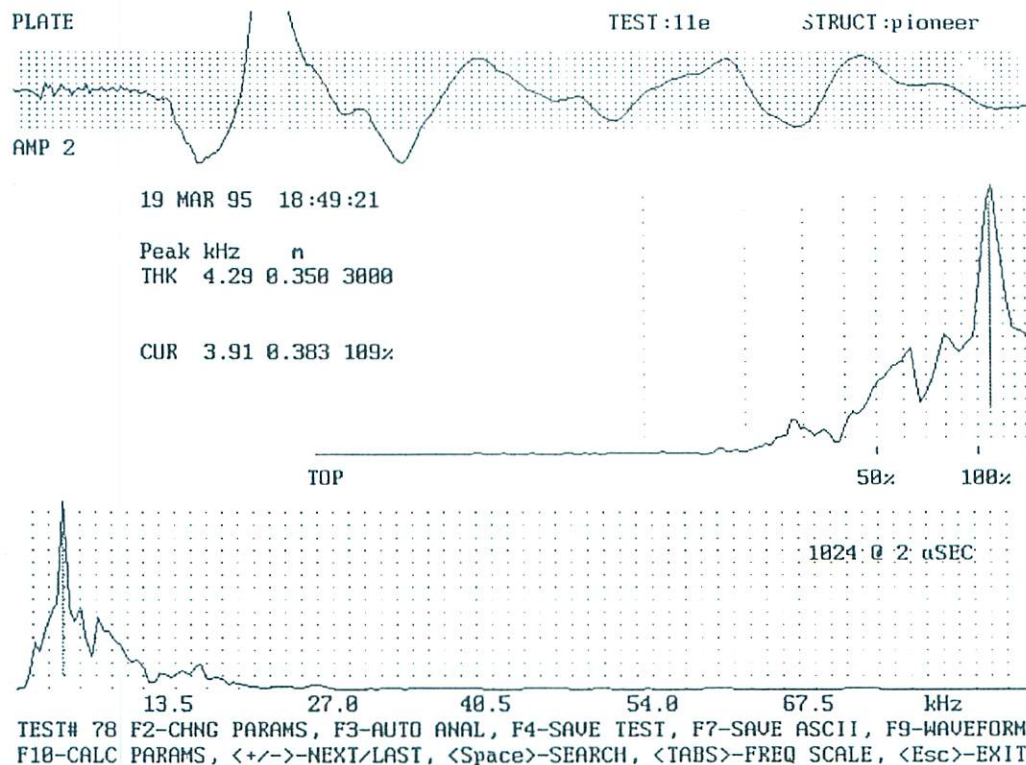
Figure 3.

Examples of signal response from solid section of concrete shell

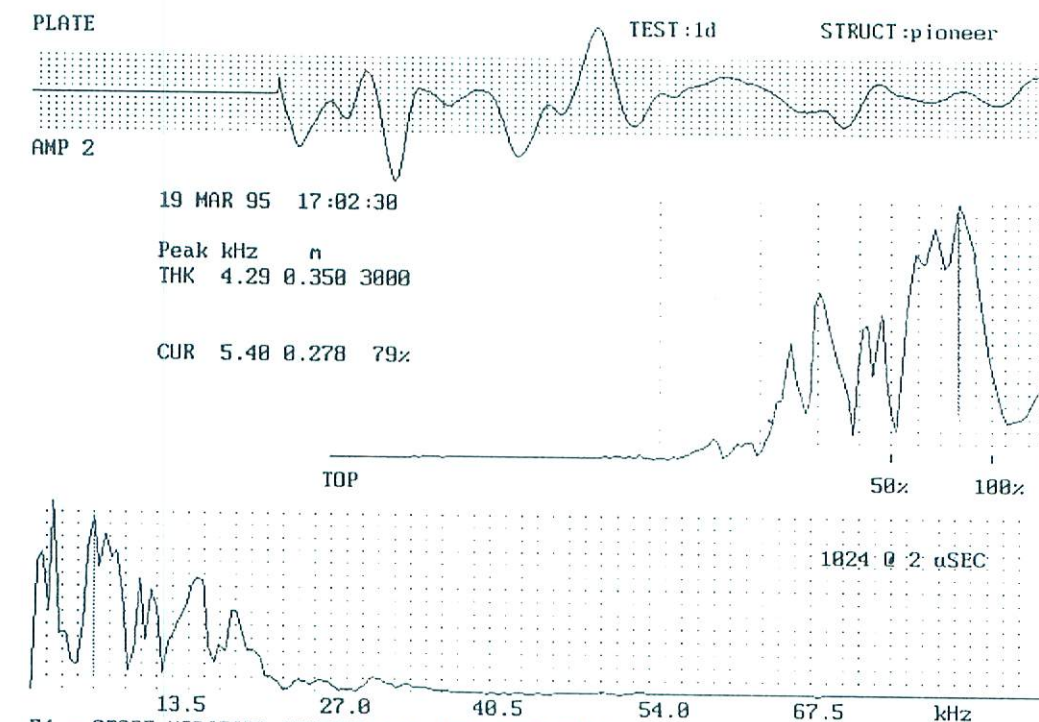
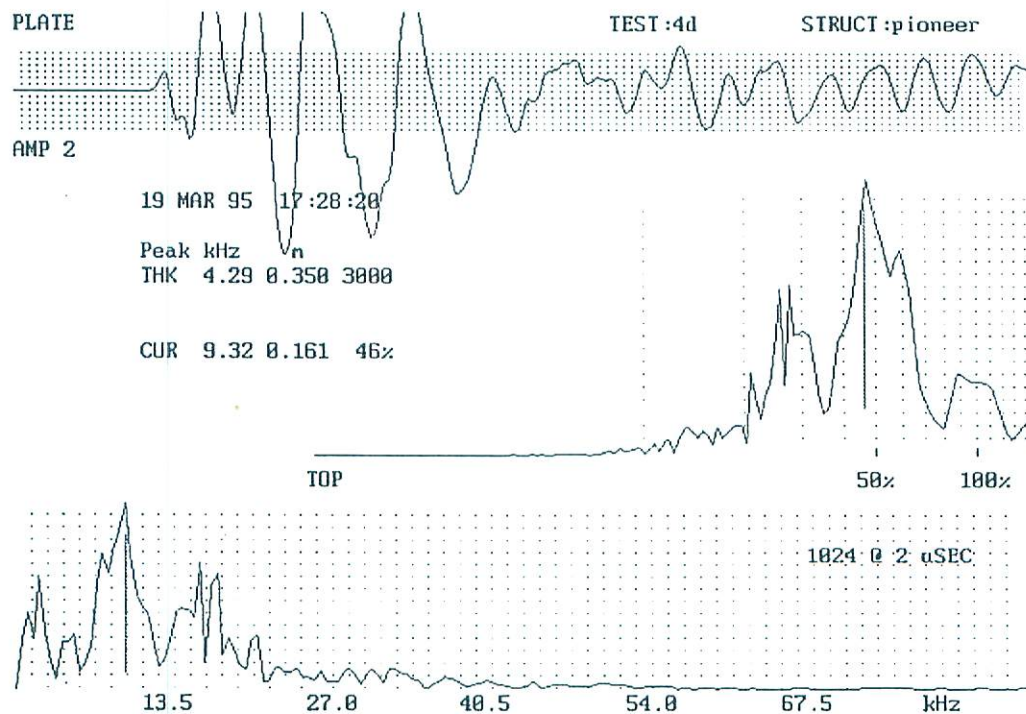
Figure 4.

Examples of signal response where multiple fractures of concrete shell are indicated

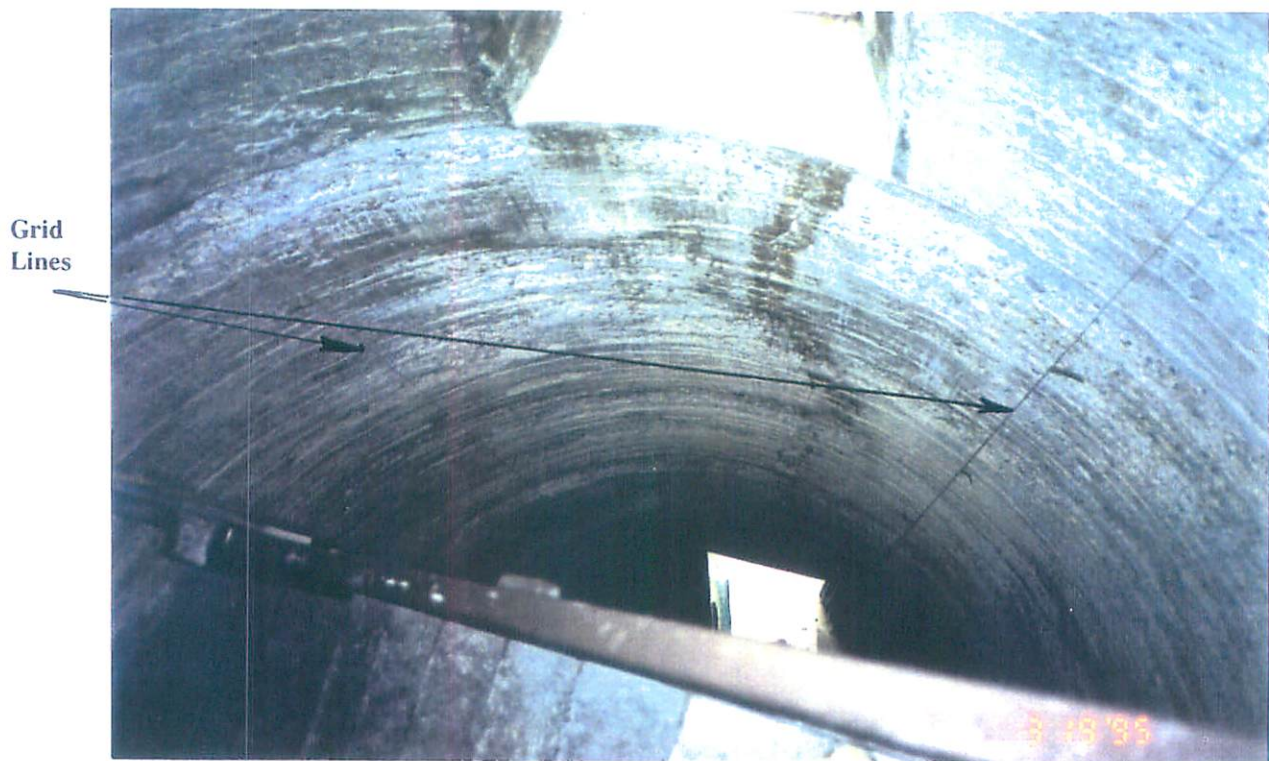
View of inside concrete surface from top of staircase (facing entrance)
Note: grid string lines

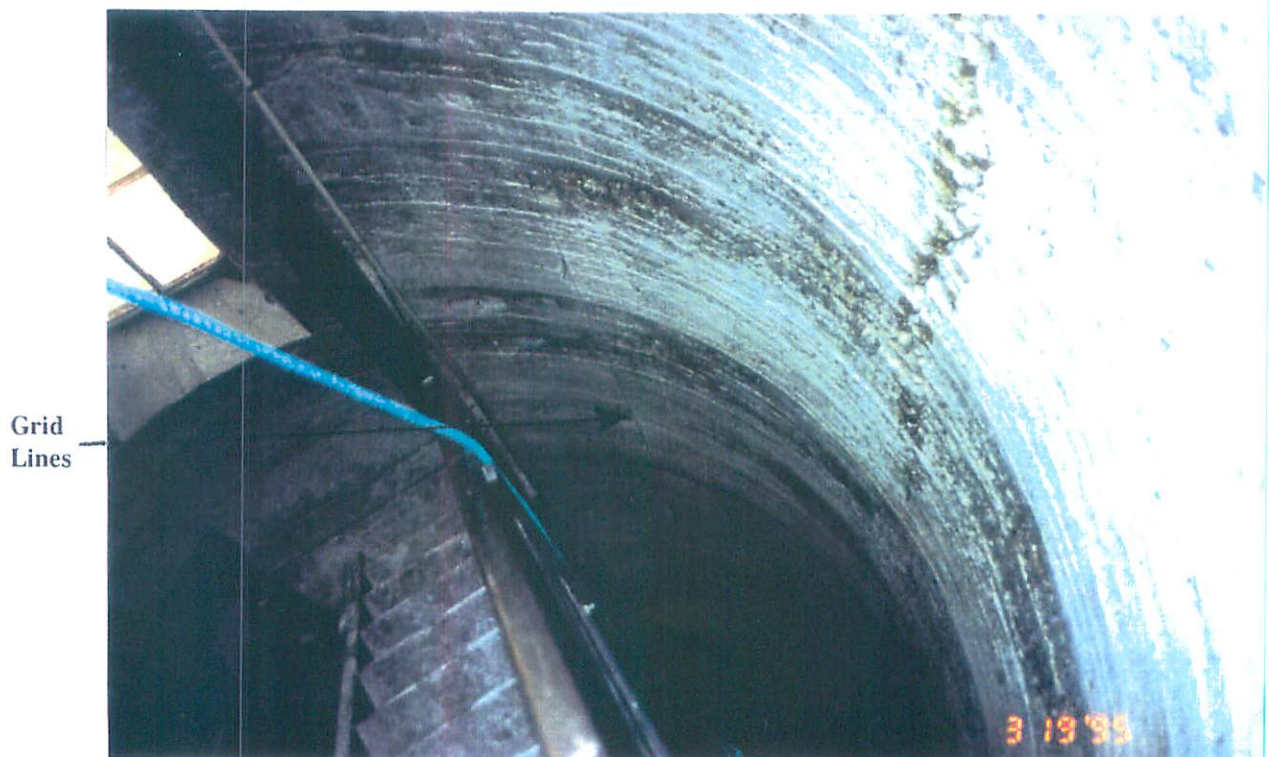
View of inside concrete surface from top of staircase (opposite entrance)
Note: grid string lines

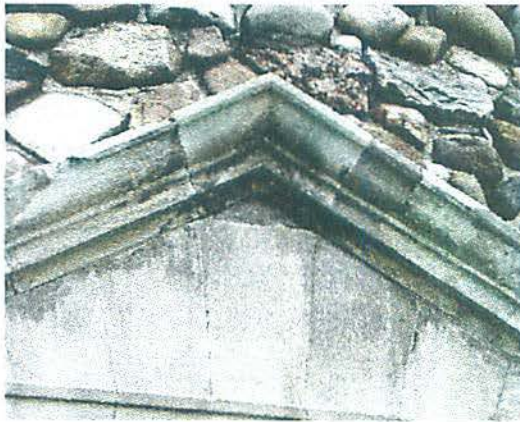
The entablature has been damaged by acts of vandalism, chips of stone are missing from the outside edges. This is a result of rocks being dropped from the tower's viewing platform onto the entablature. There is evidence that previous damage was repaired doubtlessly caused in the same fashion. This appears to be an ongoing problem with the entablature as FHBRO's 1988 Building Report makes reference to this type of damage.

Previous patches to the entablature.

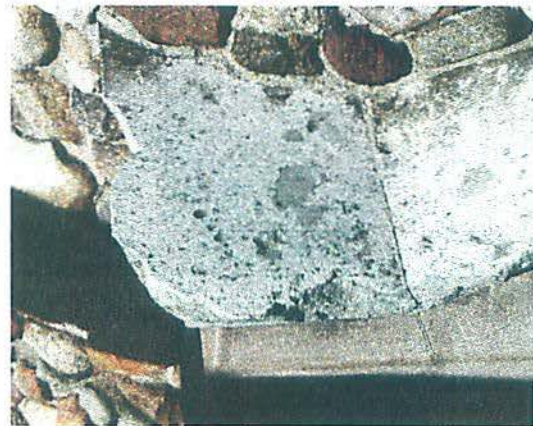
Gypsum crust on top of the entablature and chips of stone missing as a result of vandalism.

The limestone portico is stained with pollutants, grime and copper oxide from the roof above. There is also a layer of gypsum crust on top of the entablature.

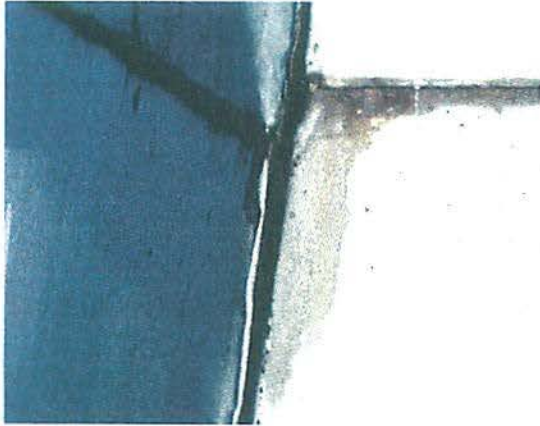
As observed from the attic the roof planking is not unduly rough but does show evidence of cupping, water stains and daylight is visible. From the outside the visual evidence indicates that these wooden boards have cupped at the ridges expanding these seams thereby reducing the weather tightness and accelerating corrosion. This corrosion condition is predominant at the ridges and at some of the horizontal seams. Some of these seams have been ineffectively patched using a sealant which appears to be 'tar'.

Ridge seams separating.

Copper cladding is generally considered to have a 100 year life span. Despite the fact that the existing roof is only 75 years old the observations and analysis indicate that it is at the end of its life. The original roof on Pioneer Tower might have achieved its life expectancy had it been properly installed at the onset. The deterioration of the copper cladding is so extensive that very little original material could be salvaged if a repair was undertaken. Therefore it is recommended that the copper roofing be replaced. Similarly it is recommended that the decorative cap and spun ball be replaced *in-kind*. The deterioration is too extensive to make repairs a viable option. Conservation practices consider the copper roofing as sacrificial when taking into account the overall maintenance of the Tower. A number of reports over the years have recommended replacing the copper roof before any serious damage is made to the roofs' wooden superstructure.

Replace the copper roofing, decorative cap and spun ball following the original materials, profiles and seaming pattern.

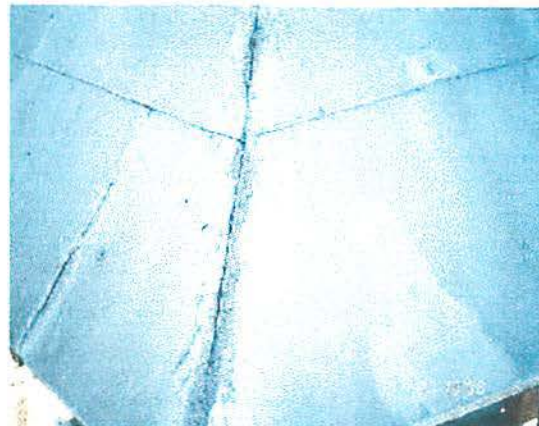
Tar patches.

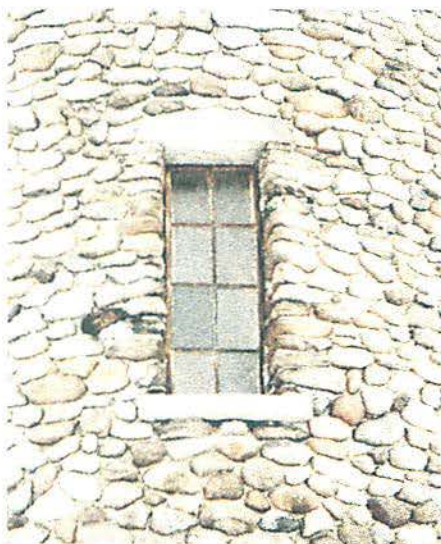
Field stone veneer.

The UMA report noted "the exclusion of water from the structure is one of the key therapy procedures which should be implemented..." Presumably they recommended repointing the stone veneer of the tower as a method of reducing water infiltration. In 1990, the bottom 2/3 of the tower was repointed. At that time the contractor was to chip away any loose mortar and reset any loose stones. At the recent site investigation it was observed that the mortar on the tower is generally sound, but with hairline to 1mm wide separations around each field stone unit. A mortar analysis conducted by Cornerstone indicates the mortar has a high compressive strength and absorption rate. The bulge on the north east face mentioned by UMA is difficult to discern and does not seem to have had any negative structural consequences.

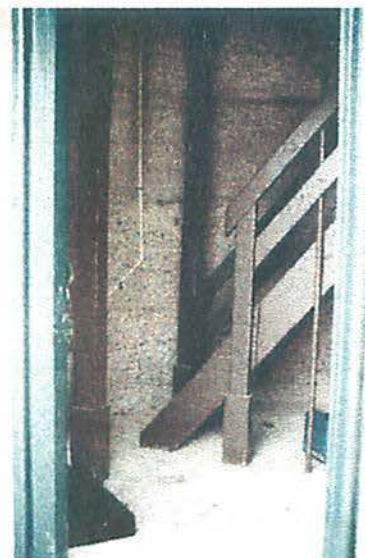
The stairs at Pioneer Tower are below the standards as they are set out in the NBC. The treads and risers are not of uniform size throughout any of the five flights and they are smaller than the suggested minimum. The width of the stairs is approximately 465mm as opposed to the minimum suggested of 900mm. The handrails are very close to the suggested 'graspable' size and section intended to provide ease of guidance and support.

Base of Tower stairs.

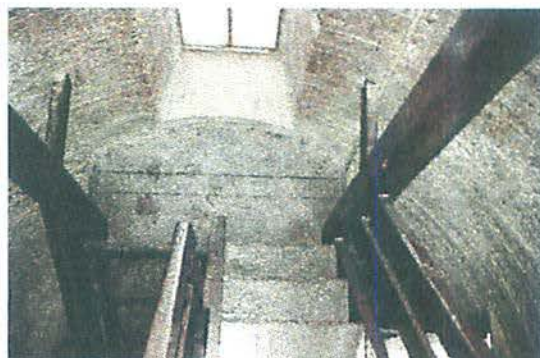
Guards at the landings are to open.

The height of the handrails from each step or landing is low. The space between the top and intermediate handrails and the stringers is a little larger than the suggested minimum. The suggested minimum is 100mm, a small enough size that a child could not put their head through the space. The handrails or guards at the landings are to open to be considered safe. The other concern with children is the ease with which they could climb the guardrails as they are designed at the Tower.
