10 Duke Steet West
Kitchener, Ontario

**Existing Façade Retention
Heritage Risk Assessment Report**

Project No. 24012

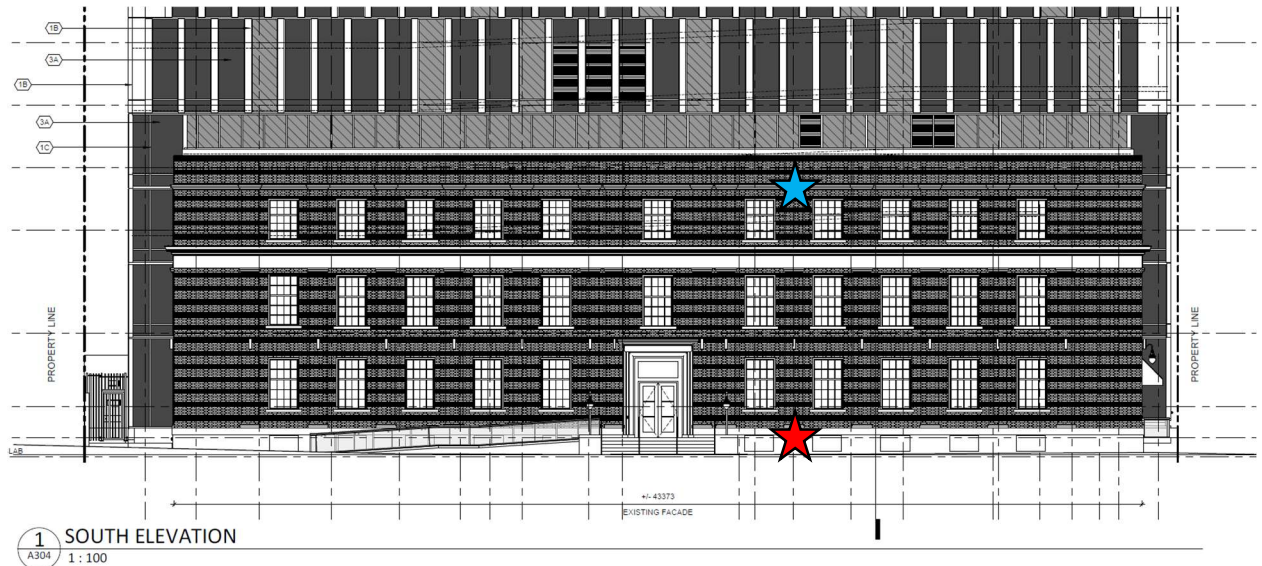
Fig 3: Part South Elevation, indicating proposed locations of vibration monitors.

- The first monitor is to be affixed to the interior face of the concrete foundation wall below the façade, just above the level of the raft slab, within the central third of the South (front) elevation wall. See red star in Fig 3.
- The second monitor is to be affixed to the interior face of the façade, immediately above the first monitor, within 600 mm of the underside of the roof level. See blue star in Fig 3.

We recommend that vibration monitoring be implemented with the placement of two tri-directional digital seismographs to be securely affixed to the façade. See Figure 3.
