STATEMENT OF SIGNIFICANCE

97 VICTORIA STREET NORTH

City of Kitchener - Cultural Heritage Resource Evaluation Form

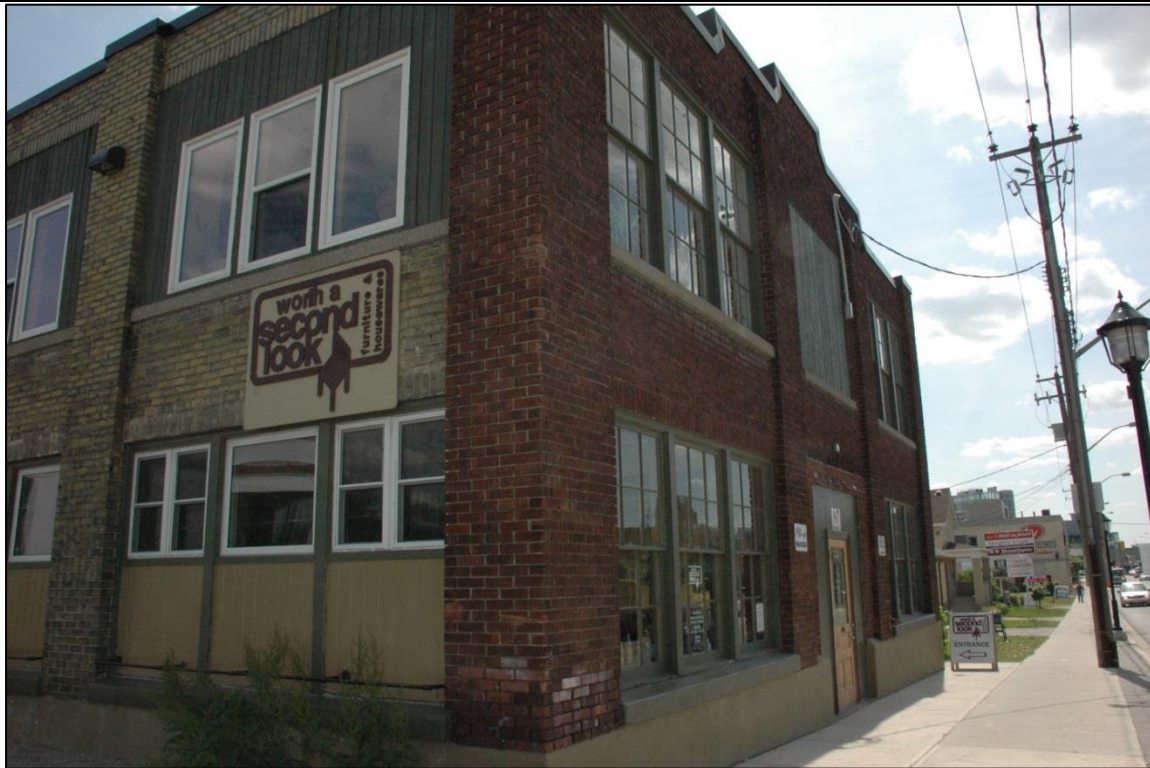
97 Victoria Street North – Front and side façade

- flat roof with shaped parapet on the front façade;
- 3 by 9 bays;
- red, yellow and beige brick Construction;
- shallow buttressing between the windows;
- original window openings with brick headers and concrete sills; and,
- Groups of three 6/6 windows on the front façade with brick headers and concrete sills.

- All elements related to the Industrial Vernacular architectural style of the building, including:
 - Two-storey height;
 - Symmetrical northwest (primary) façade;
 - Flat roof with shaped parapet on the northwest (primary façade);
 - Shallow buttresses that define distinct bays along each of the building's elevations;
 - Brick construction comprising of red, yellow, and beige brick;
 - Original window openings with soldier course brick headers and concrete sills;
 - Six-over-six windows on the northwest (primary) façade; and
 - Chimney set in stretcher bond, yellow brick with concrete banding.
