Heritage Conservation Plan CITY OF KITCHENER // 10 DUKE STREET WEST

REVISION 1: JANUARY 2024
APRIL 25, 2022

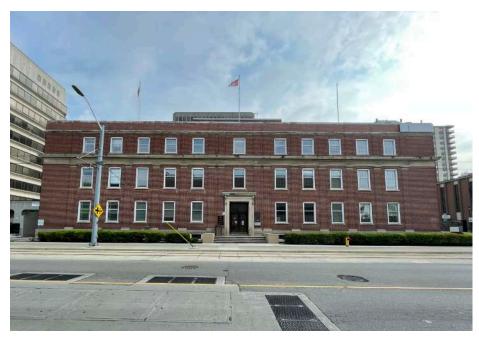
Figure 4. South Façade facing Duke Street West to be retained. July 2021. (Source: mcCallumSather, 2021)

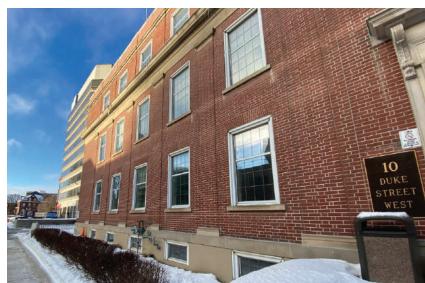
Figure 7. Staining on bricks below second floor window sills, bays 4 & 5 from southwest. Figure 8. Damaged sealant, sills & stone at bay 4 first floor. Figure 9. Enlarged cracked stone banding base of L1.

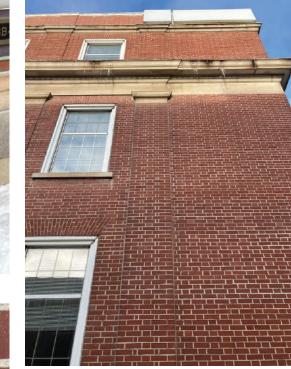
Figure 6. Southeast corner of Duke St facade (right corner)

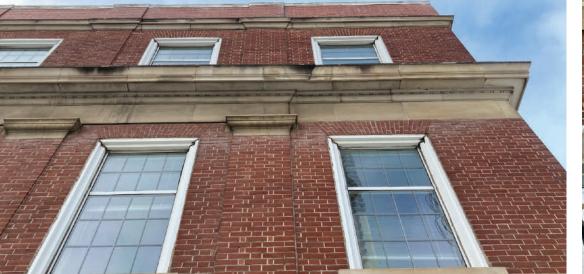
Figure 20. Enlarged north portion of east facade stone banding to be cleaned and retained.

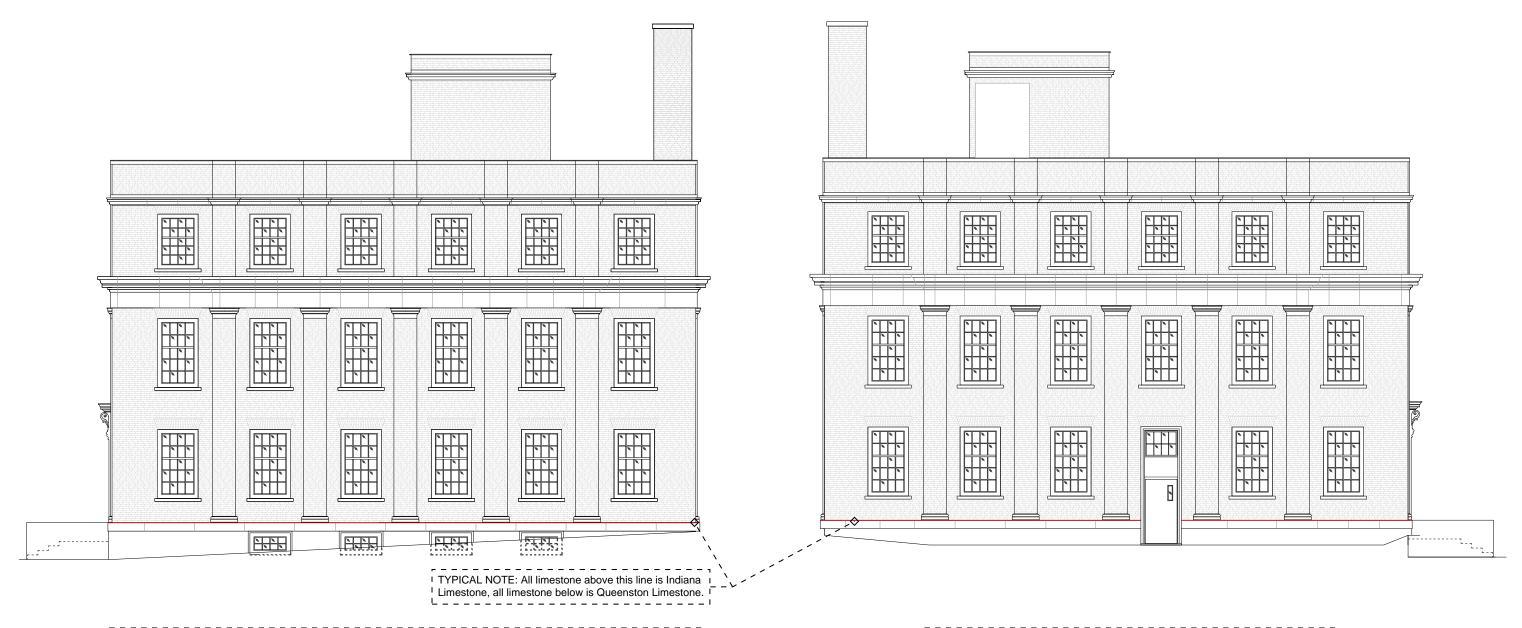
East elevation to be fully retained to top of roof parapet

West elevation to be partially retained
